## Air Safety Investigations Aircraft Incident/Accident Technical Report

| Aircraft Incident/<br>Accident Information | Year: 1981 | Make: Beechcraft | Model: C90 |
| | Serial number: LJ-991 | | Registration: N19LW |
| Senior Air Safety Investigator: Peter J. Basile | | Report #: ASI-17-DL-T | Report date: 04-30-18 |

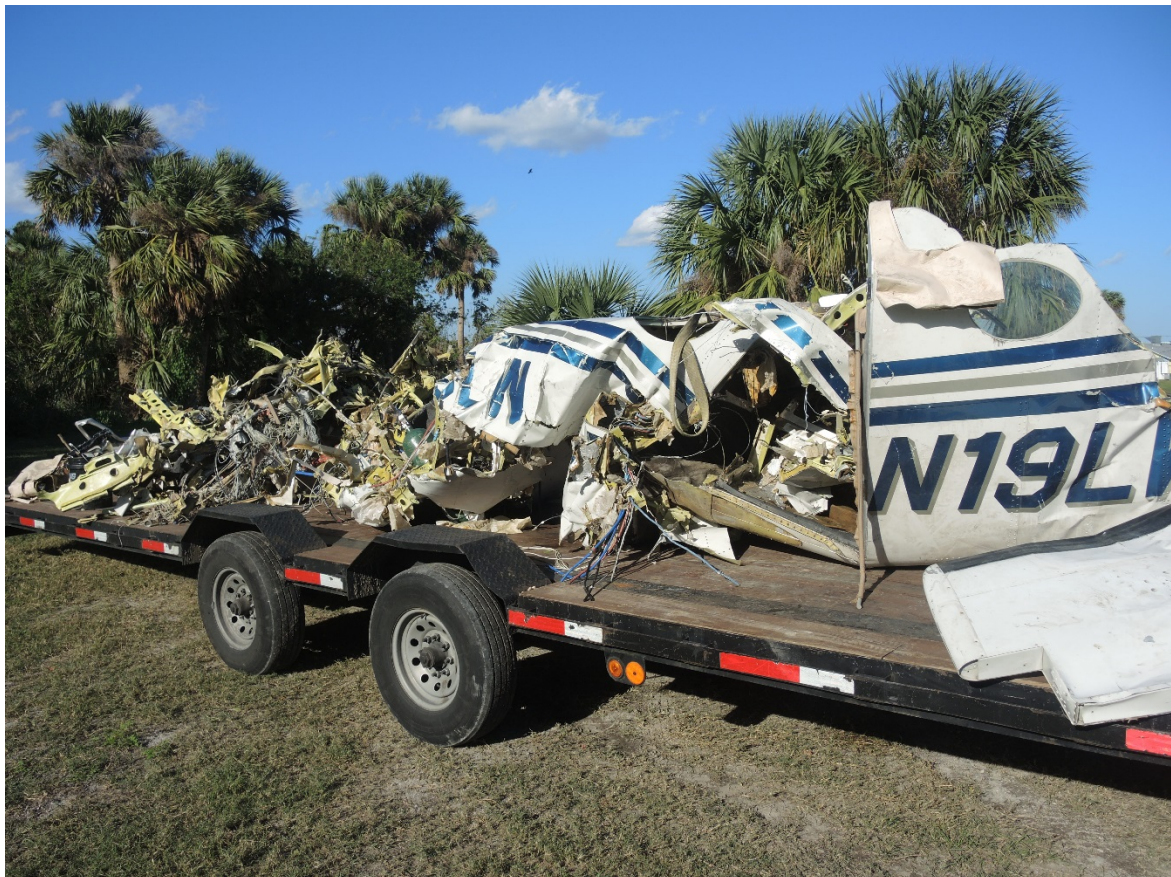
The aircraft impacted water near the northwestern shore of Lake Harney. The aircraft separated into multiple pieces and was spread over about 200 square feet along the bottom of the lake at a depth of approximately 10 feet.

Wreckage overview

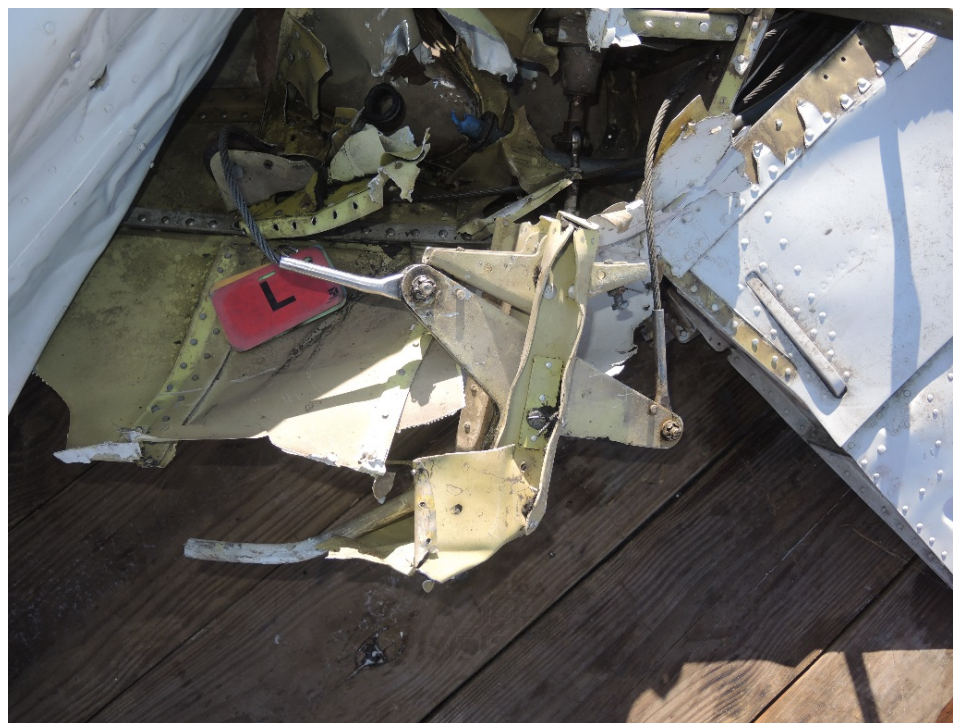
Both wings exhibited accordion style compression damage throughout. The left aileron and inboard flap were separated from the left wing. The outboard left flap remained attached to the left wing. The left aileron control cables remained attached to the left aileron bell crank which was loosely located in the outboard left-wing area. The left aileron control cables had been cut by recovery personnel near the location where the outboard left wing attaches to the outboard side of the left engine nacelle. The left aileron trim cables were separated in the same general area of the nacelle and appeared to have failed in tensile overload.

Left aileron bellcrank

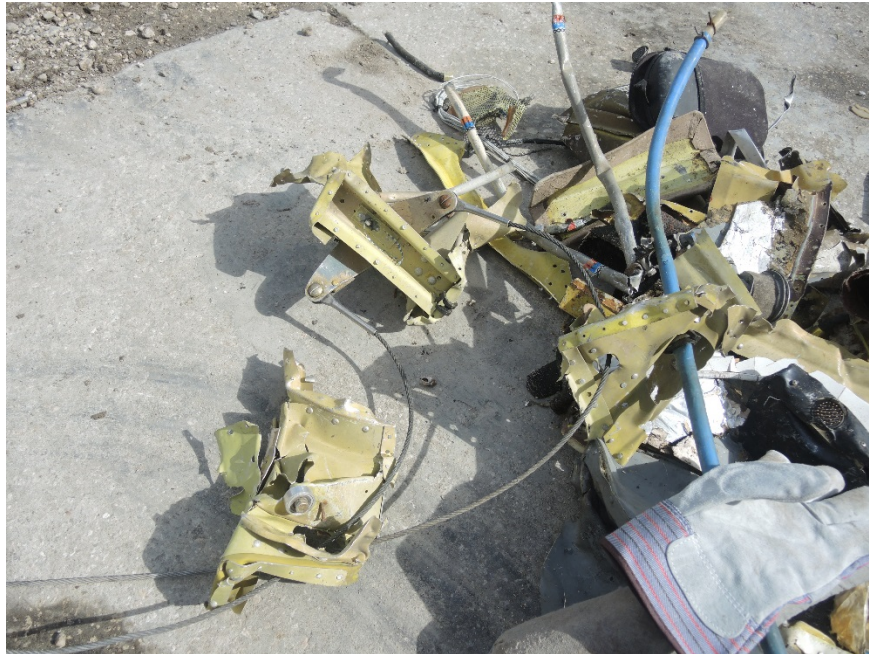
The right inboard flap, outboard flap, and aileron were separated from the right wing. The right aileron control cables and bell crank were separated from the right wing. The right aileron control cables remained attached to the separated bell crank. The right aileron control cables were found separated in tensile overload near the aileron quadrant. One of the right aileron control cables remained connected to the roll servo bridal clamp. The aileron cables were continuous from the control column to the impact damaged aileron quadrant. The left and right engine nacelle structure and the inboard portions of the left and right wing, located between the nacelle and the fuselage, were heavily fragmented.

Right aileron bellcrank

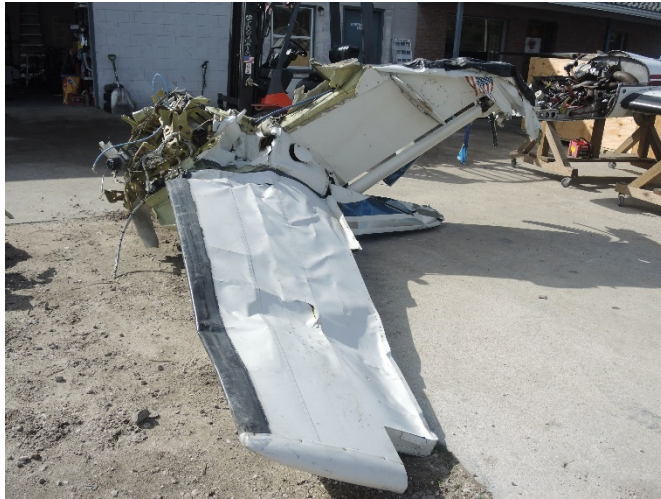
The empennage was separated from the fuselage. The left horizontal stabilizer remained attached to the tail; the left elevator was separated. The right horizontal stabilizer and elevator were separated from the tail; the right elevator remained attached to the right horizontal stabilizer. The vertical stabilizer and rudder remained attached to the tail. The top 2-3' of the vertical stabilizer and rudder were crushed aft in a tapering manner. The top portion of the rudder was bent downward. The rudder trim tab remained attached to the rudder.

Left horizontal stabilizer

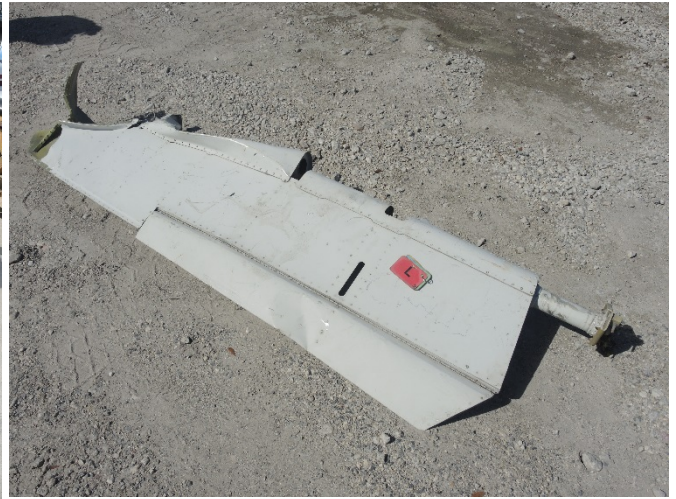
Left elevator

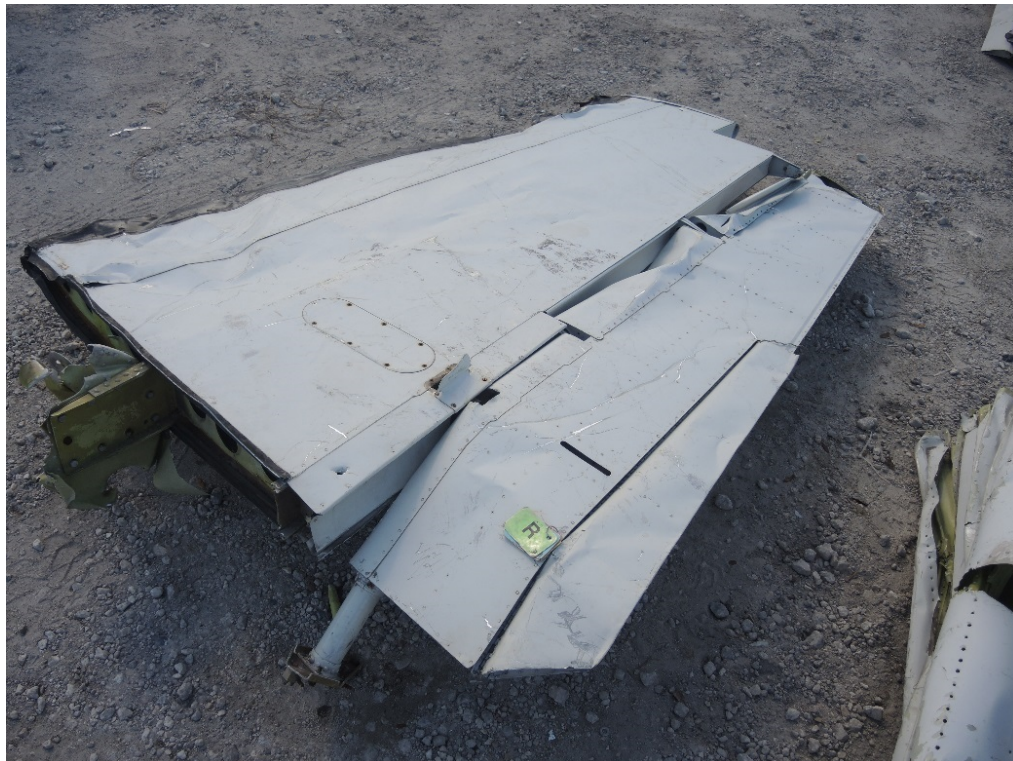
Right horizontal stabilizer and elevator

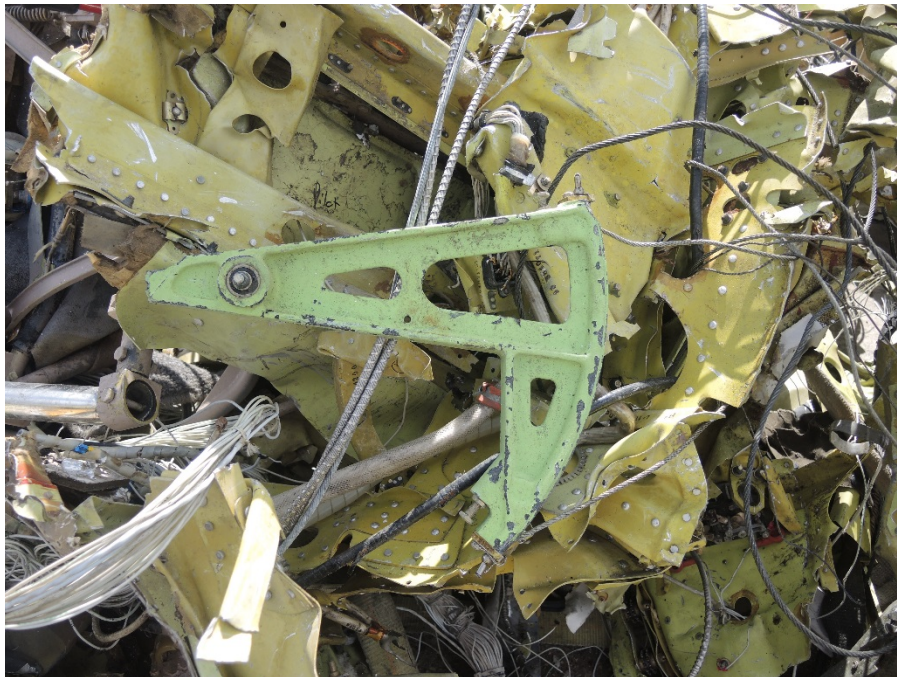
The elevator cables remained attached to the forward elevator bellcrank. The elevator cables had been cut by recovery personnel in the fuselage area during the recovery process. The elevator cables remained attached to the aft elevator bellcrank. The elevator push/pull tubes remained attached to the aft elevator bellcrank, but were separated from the elevator torque tubes.

Forward elevator bellcrank

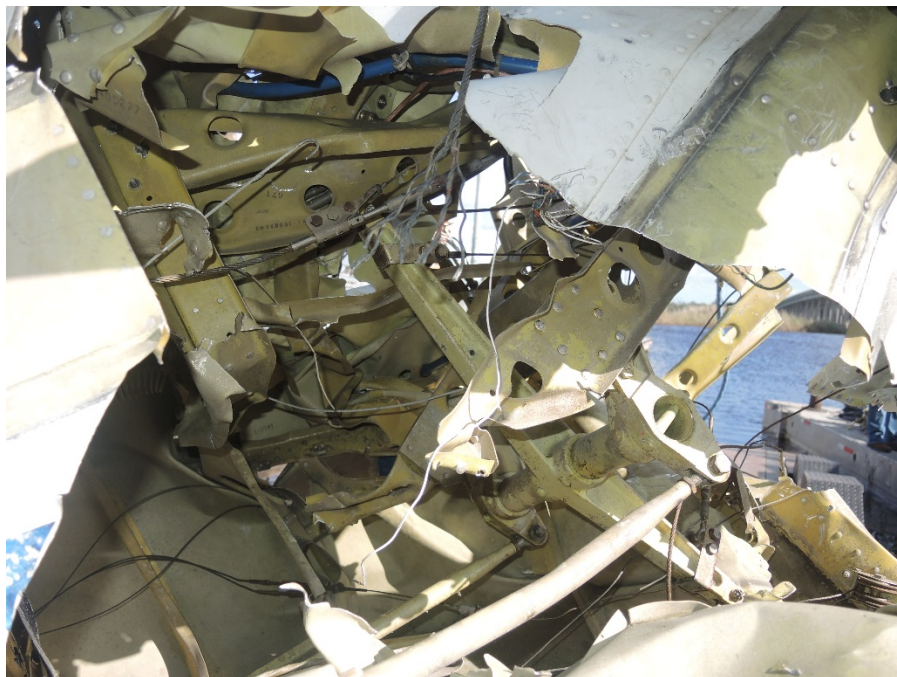
Aft elevator bellcrank

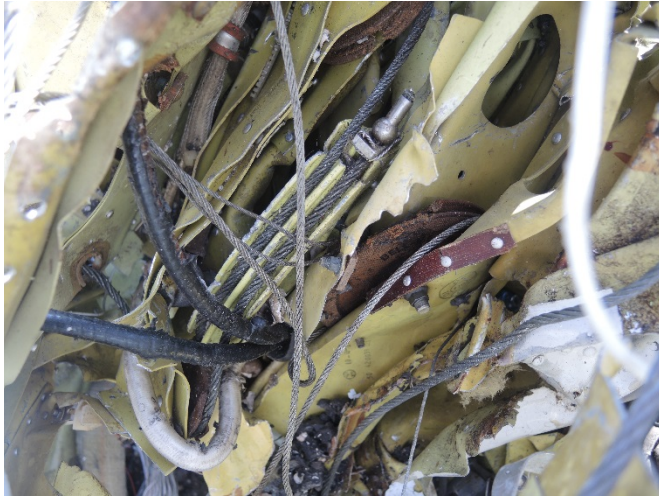
The rudder control cables remained attached to the forward rudder control bellcrank. The rudder cables had been cut by recovery personnel in the fuselage area during the recovery process. The rudder cables remained attached to the rudder horn in the empennage.

Forward rudder bellcrank

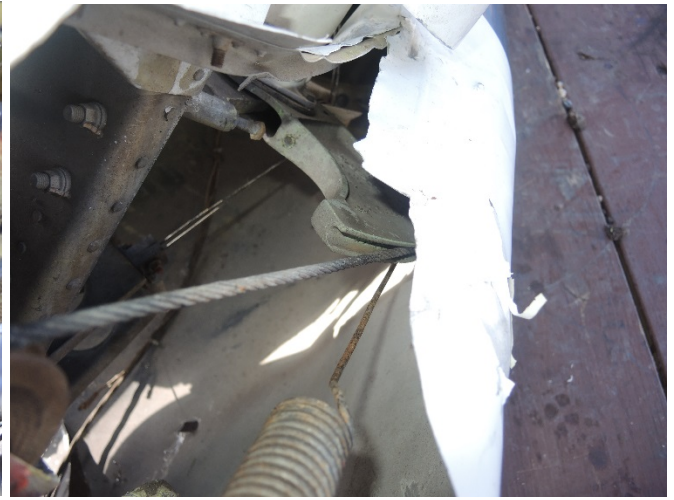
Left rudder cable on rudder horn

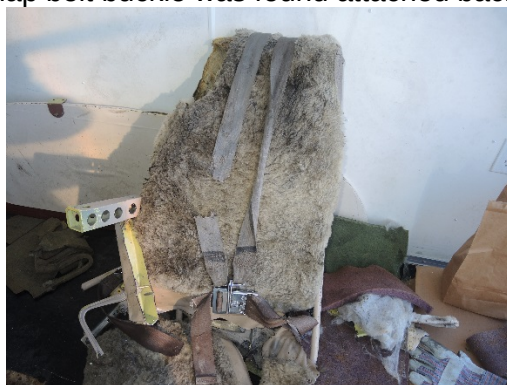
Seat 1 remained partially attached to the forward floor assembly. Seat 2 separated from the floor and was found separated from the aircraft. The seat 1 and 2 seat bases sustained impact compression damage; the seat backs remained attached and were deformed. All cabin seats were separated from the structure and exhibited impact compression damage.

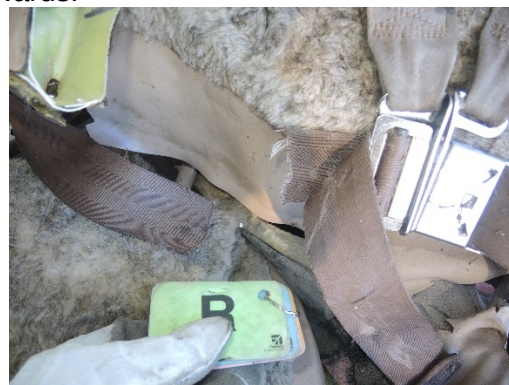
The seat 2 lap belt buckle was found attached backwards.

Seat 2 restraint
