# Continental Motors

## ENGINE EXAMINATION REPORT

| ENGINE MODEL | IO-550-B |
| FILE NUMBER | 17-337 |

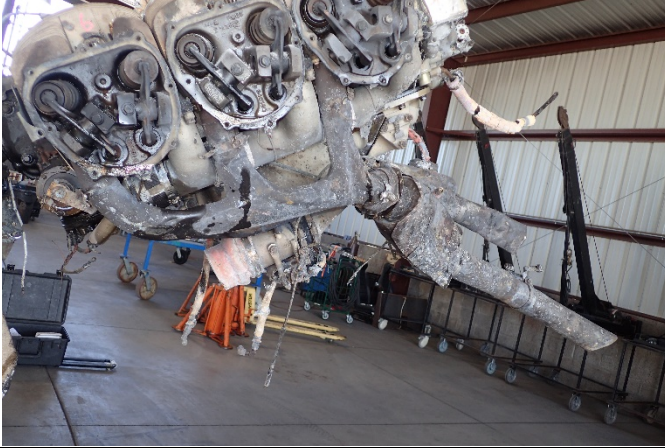
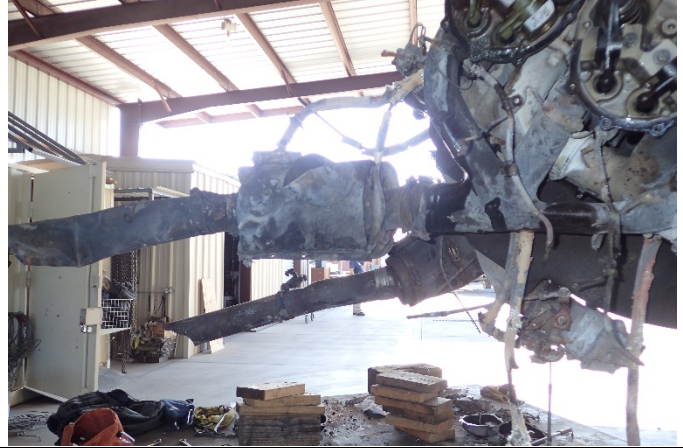
#### EXHAUST SYSTEM

**Condition:** The exhaust system remained attached to the engine and displayed impact damage signatures in the forms of bending and minor crushing. There were no signs of exhaust leaks or any other anomalies noted.

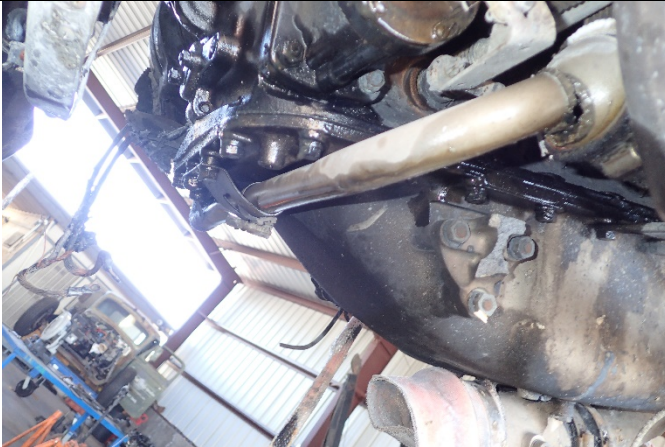
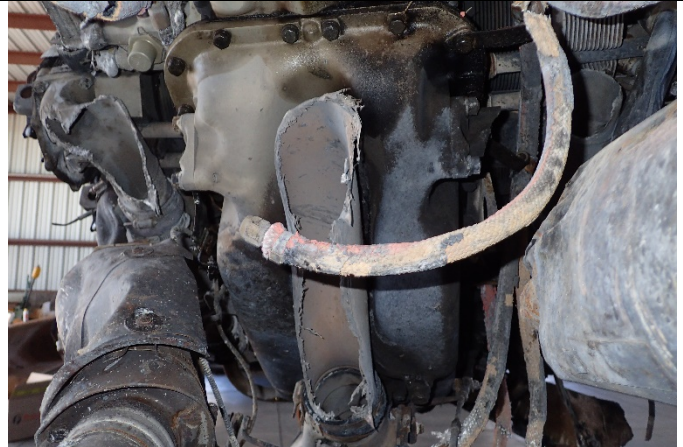
#### INDUCTION SYSTEM

**Condition:** The induction system displayed a significant amount of thermal damage signatures. Several of the induction tubes were partially melted. The balance tube displayed impact damage signatures; a portion of the balance tube was fractured. There were no signs of induction leaks or any other anomalies noted.

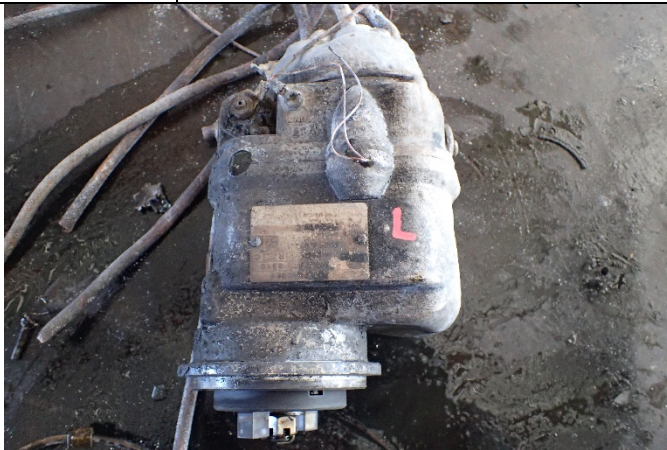
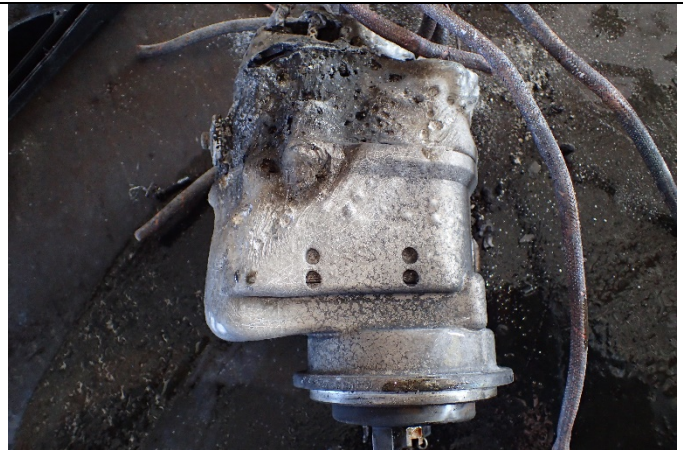
### LEFT MAGNETO

The left magneto remained attached to its installation point and displayed a significant amount of thermal damage signatures. The magneto was removed and it was noted that the magneto was not capable of producing a spark. Due to the significant thermal damage, the magneto could not be disassembled by nondestructive means. There were no anomalies noted.

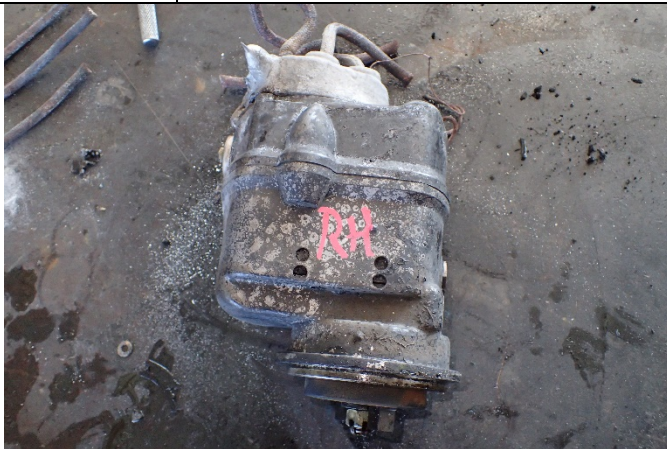
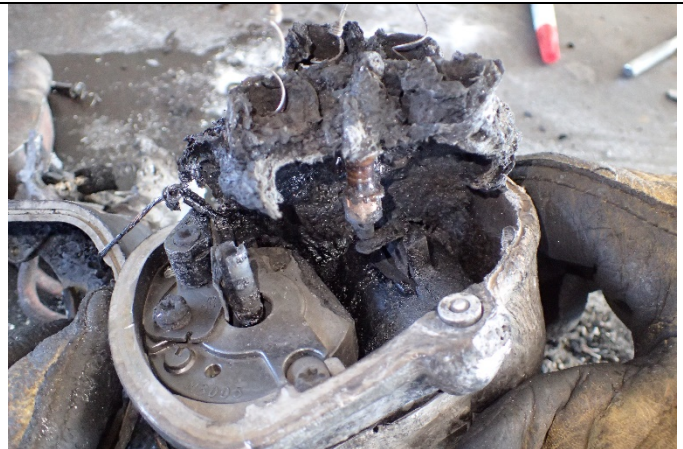
### RIGHT MAGNETO

The right magneto remained attached to its installation point and displayed a significant amount of thermal damage signatures. The magneto was removed and it was noted that the magneto was not capable of producing a spark. The magneto was disassembled with all of the internal components displayed significant thermal damage which was consistent with a post-crash fire. There were no anomalies noted.

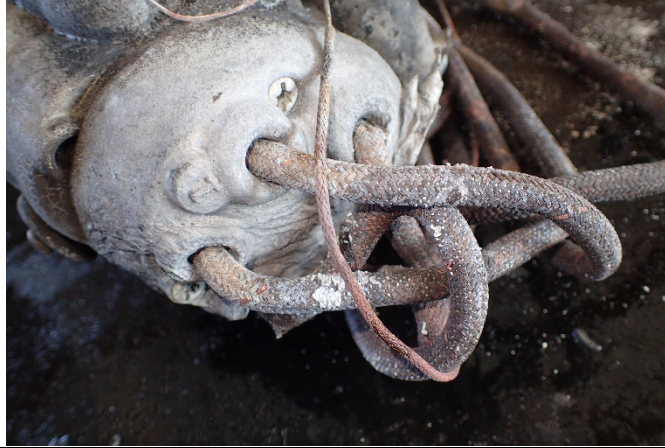
## IGNITION HARNESS

The ignition harness displayed a significant amount of thermal damage signatures throughout the ignition harness. There were no anomalies noted with the harness.

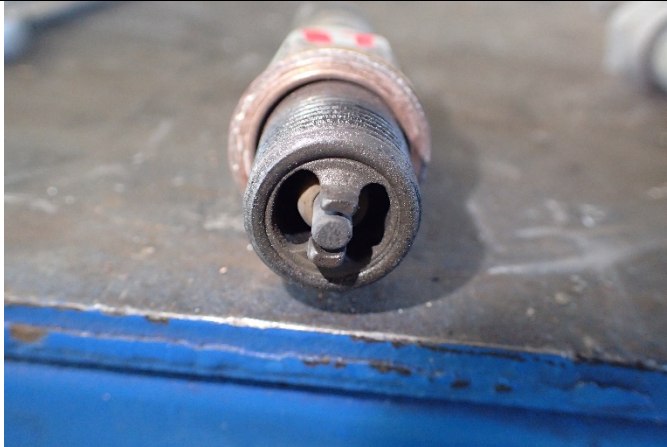
#1 Top

All of the spark plugs remained installed in their cylinders and displayed varying amounts of thermal damage signatures. The top spark plugs were removed and visually inspected and the bottom spark plugs were inspected using a lighted borescope. The electrodes displayed normal operating and wear signatures when compared with Champion Aviation Service Manual AV6-R. There were no anomalies noted.

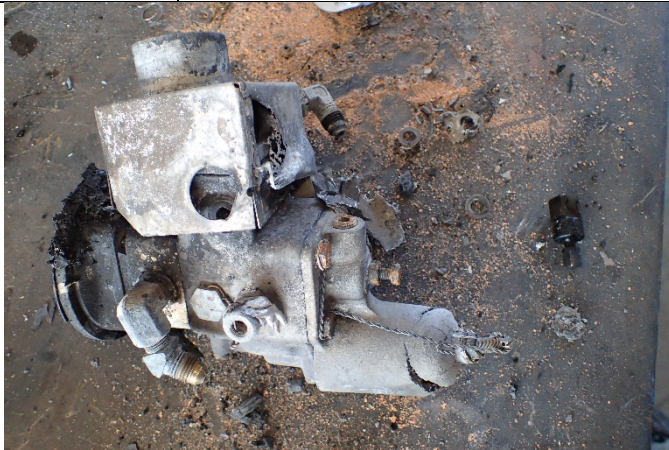
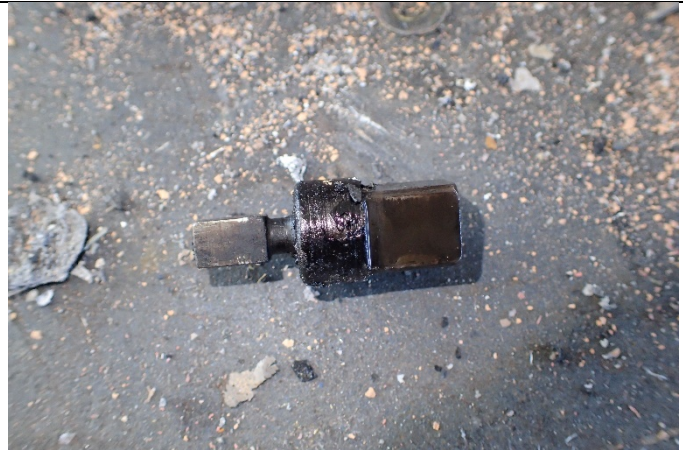
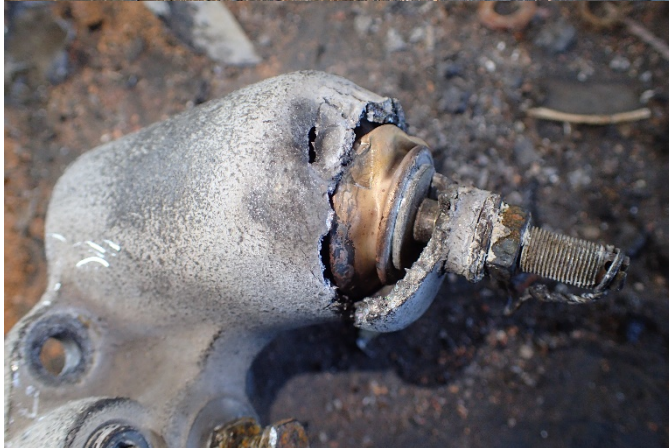
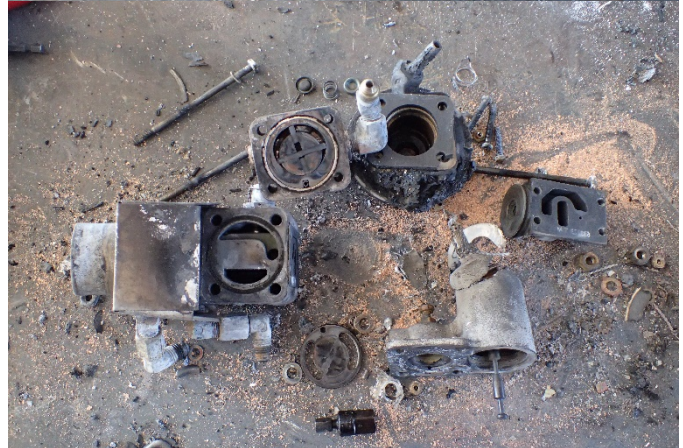
### FUEL PUMP

The fuel pump remained attached to its installation point and displayed some impact damage signatures to the aneroid housing and significant thermal damage signatures throughout the fuel pump. The fuel pump was removed and the drive coupling was noted to have remained intact. The fuel pump was disassembled and the internal components were visually inspected. All of the internal components displayed thermal damage signatures and the aneroid also displayed impact damage signatures. There were no anomalies noted with the fuel pump.

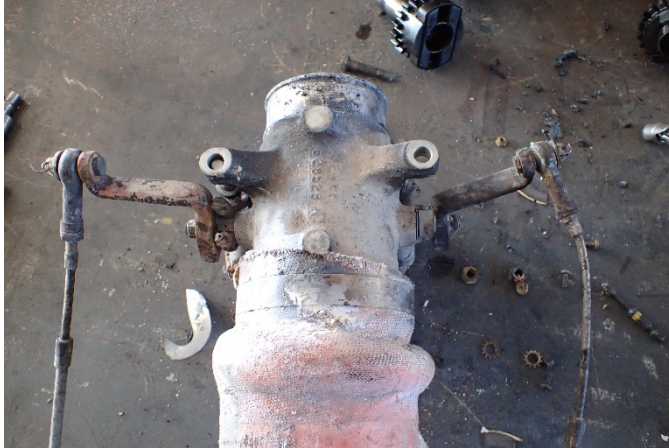
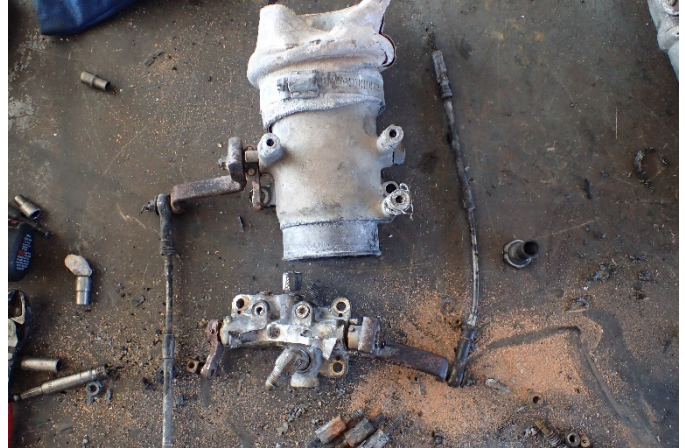
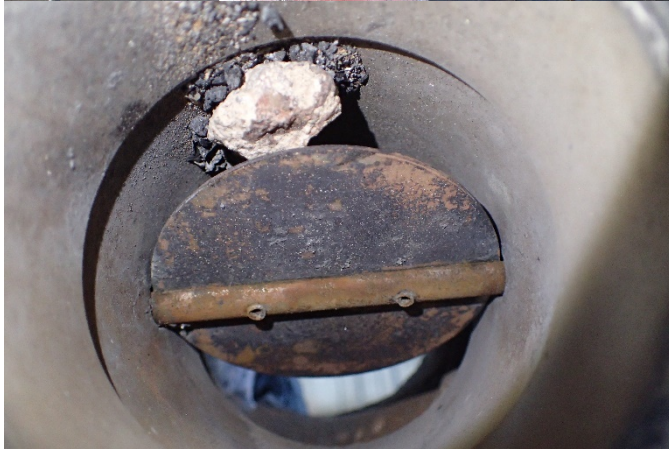
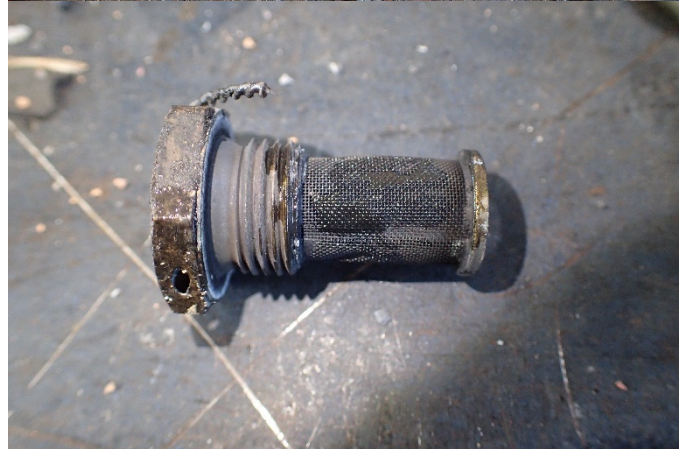
## THROTTLE BODY METERING UNIT

The throttle and metering assembly remained attached to its installation point. The mixture and control rod ends remained secured to their control arms and the control arms remained secured to their shafts. The fuel inlet screen was removed and there were no anomalies noted within the fuel screen. Due to the extensive thermal damage, the assembly could not be disassembled. There were no anomalies noted during the inspection.

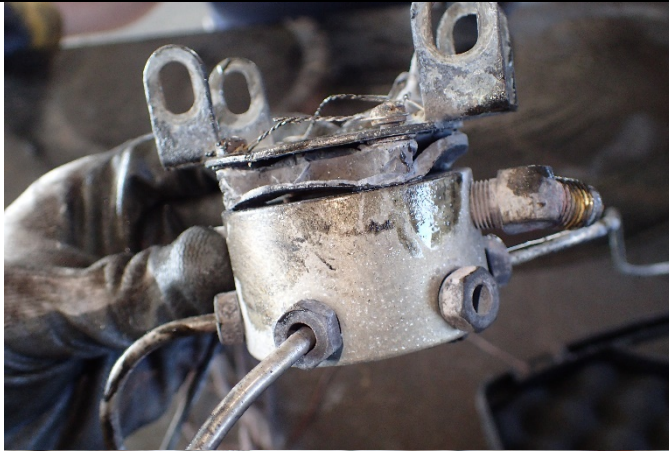
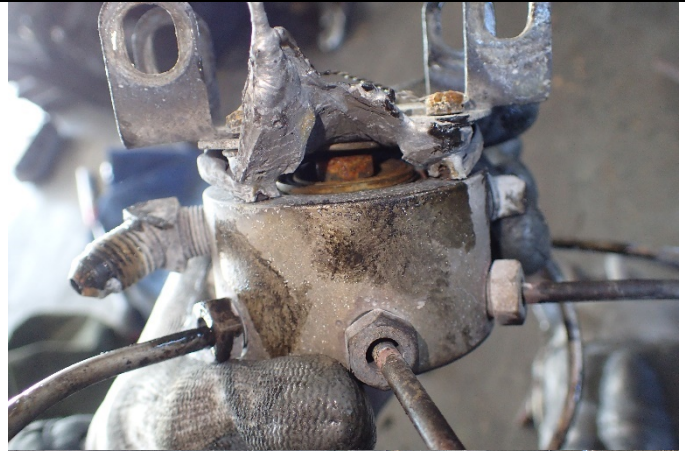
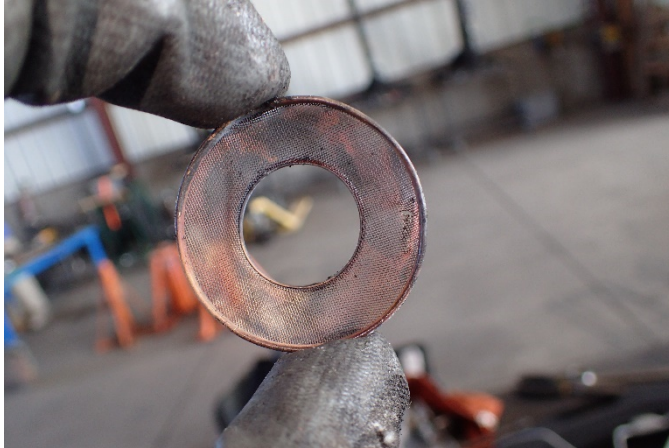
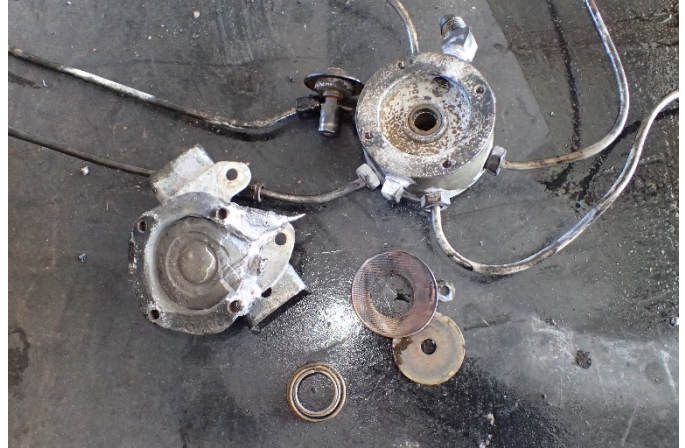
## FUEL MANIFOLD VALVE

The fuel manifold valve remained attached to its installation point and displayed a significant amount of thermal damage signatures. The manifold valve was removed and disassembled. The diaphragm had been destroyed by thermal forces and the rest of the components displayed thermal damage signatures. There were no anomalies noted with the manifold valve.

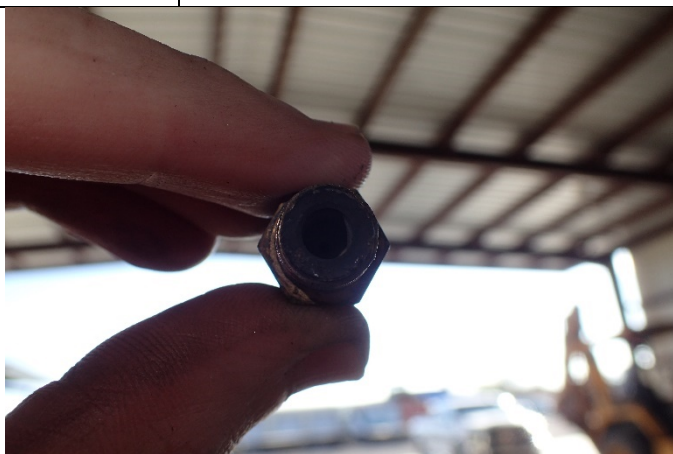
#1 Nozzle

| Position | #1 | #3 | #5 | #2 | #4 | #6 |
|---|---|---|---|---|---|---|
| Condition: | All of the fuel nozzles remained installed in their cylinders and displayed minor thermal damage signatures; the #1 injector also displayed impact damage signatures and was bent. All of the nozzles were removed and checked for blockages; only a small amount of light was visible through the #1 injector which was consistent with the nozzle being bent, the remaining injectors were clear of any obstructions. There were no anomalies noted with the fuel nozzles. | | | | | |

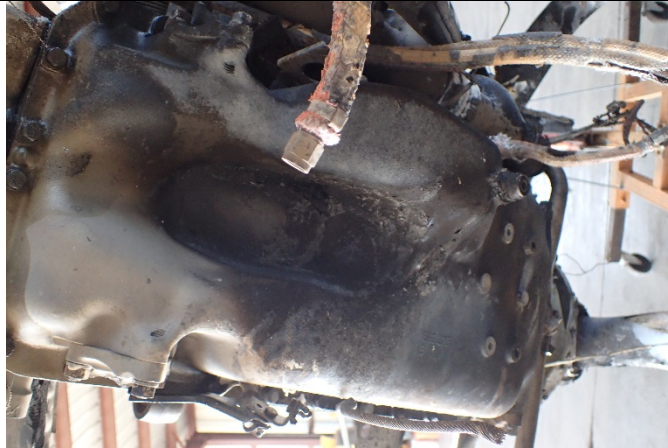
**Condition:** The oil sump remained attached to its installation point and remained intact. Several quarts of oil were drained from the oil sump. There were no anomalies noted.

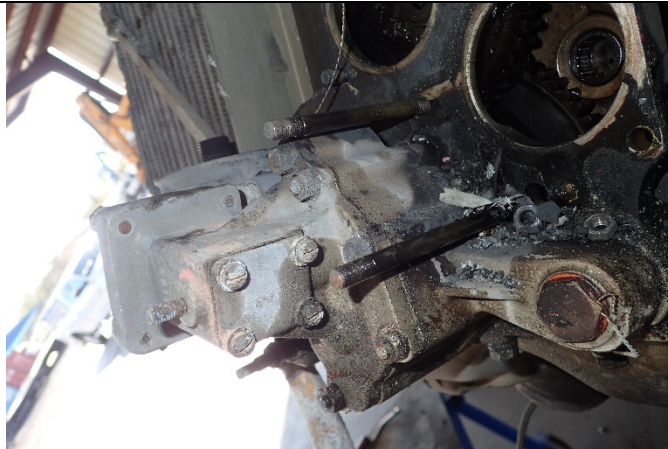
**OIL PUMP**

**Condition:** The oil pump housing remained intact and displayed thermal damage signatures. There were no anomalies noted.

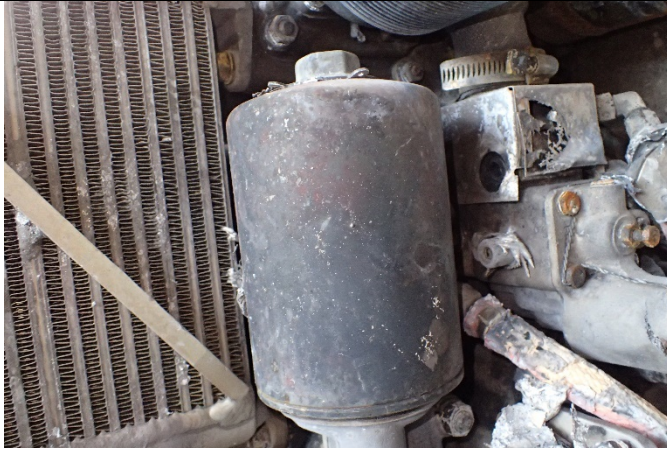
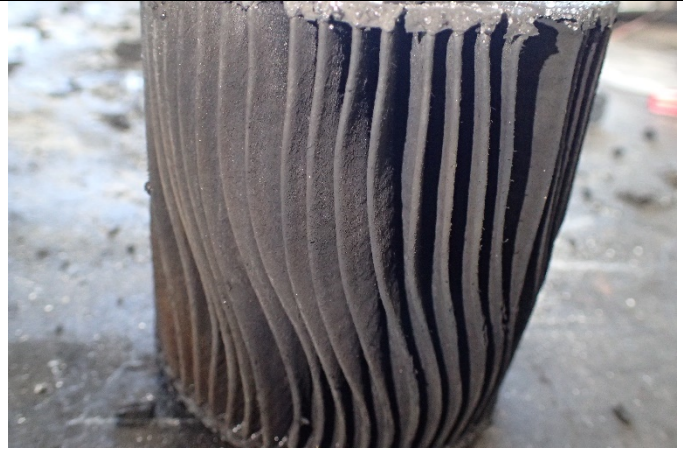
## OIL FILTER

The oil filter remained attached to the oil filter adapter and displayed thermal damage signatures. The oil filter housing was cut open and the filter pleats were visually inspected. The filter pleats were thermally damaged consistent with a post-crash fire; there were no metallic contaminants noted within the filter pleats. There were no anomalies noted with the oil filter inspection.

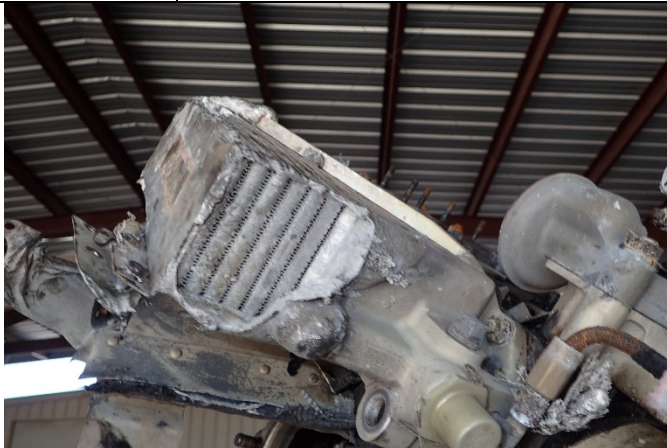
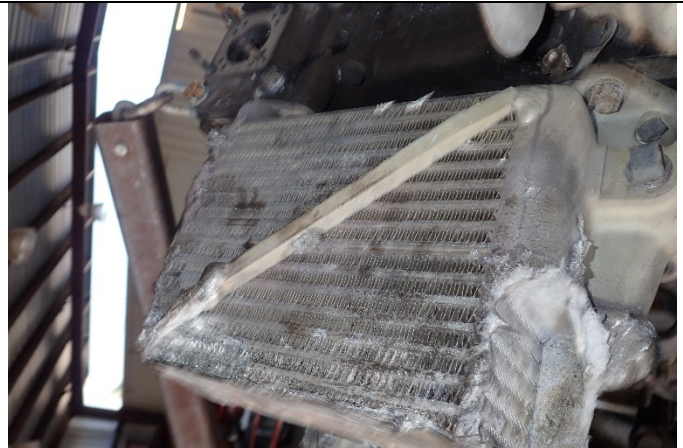
## OIL COOLER

The oil cooler remained attached to its installation point and displayed a significant amount of thermal damage. A portion of the oil cooler had melted off and exposed some of the internal portions of the cooler. There were no anomalies noted with the oil cooler.

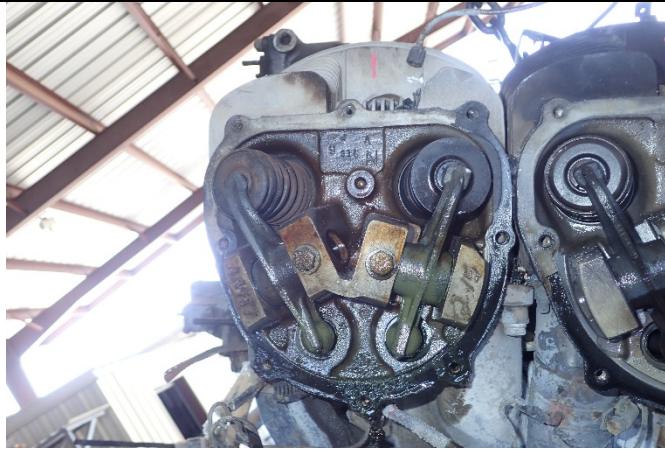
| CYLINDER #1 | P/N: Not observed | S/N: AC15AA987 | Head Date: 2-15 |
|---|---|---|---|
| Condition: | The cylinder remained attached to its cylinder bay and displayed thermal damage signatures. The internal portion of the cylinder was inspected using a lighted borescope; the cylinder bore, piston face, and valve heads displayed normal operating and combustion signatures. The crankshaft was rotated and the cylinder displayed good thumb compression and suction. The cylinder overhead components (valves, springs, and rocker arms) displayed thermal damage signatures consistent with a post-crash fire and normal operating signatures. | | |

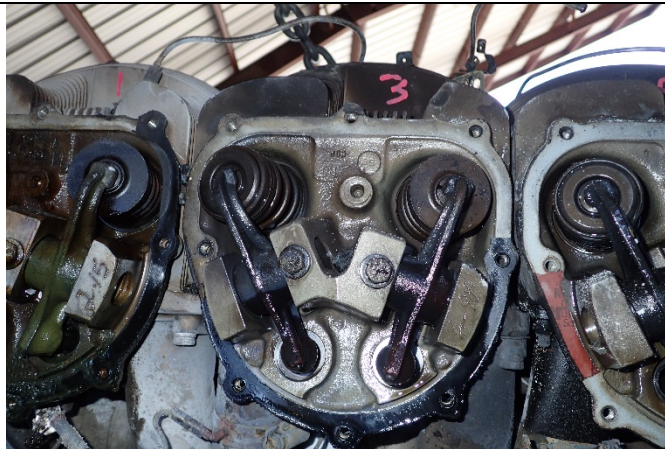
| CYLINDER #3 | P/N: Not observed | S/N: Not observed | Head Date: 6-98 |
|---|---|---|---|
| Condition: | The cylinder remained attached to its cylinder bay and displayed thermal damage signatures. The internal portion of the cylinder was inspected using a lighted borescope; the cylinder bore, piston face, and valve heads displayed normal operating and combustion signatures. The crankshaft was rotated and the cylinder displayed good thumb compression and suction. The cylinder overhead components (valves, springs, and rocker arms) displayed minor thermal damage signatures consistent with a post-crash fire and normal operating signatures. | | |

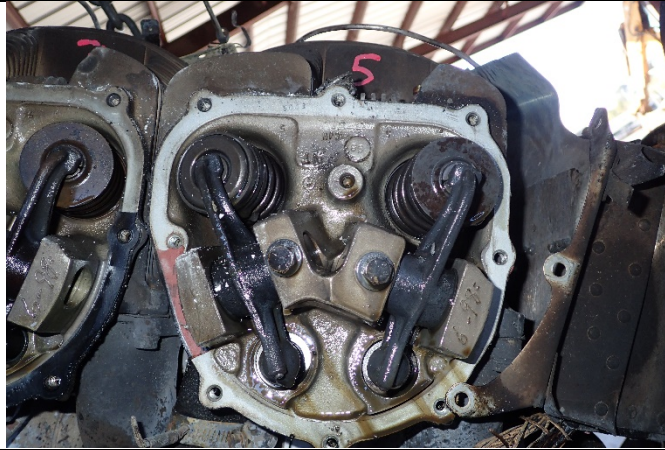
## CYLINDER #5

The cylinder remained attached to its cylinder bay and displayed thermal damage signatures. The internal portion of the cylinder was inspected using a lighted borescope; the cylinder bore, piston face, and valve heads displayed normal operating and combustion signatures. The crankshaft was rotated and the cylinder displayed good thumb compression and suction. The cylinder overhead components (valves, springs, and rocker arms) displayed minor thermal damage signatures consistent with a post-crash fire and normal operating signatures.

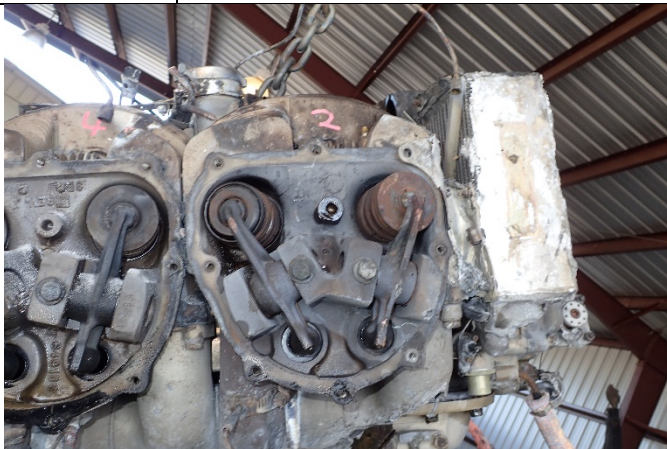
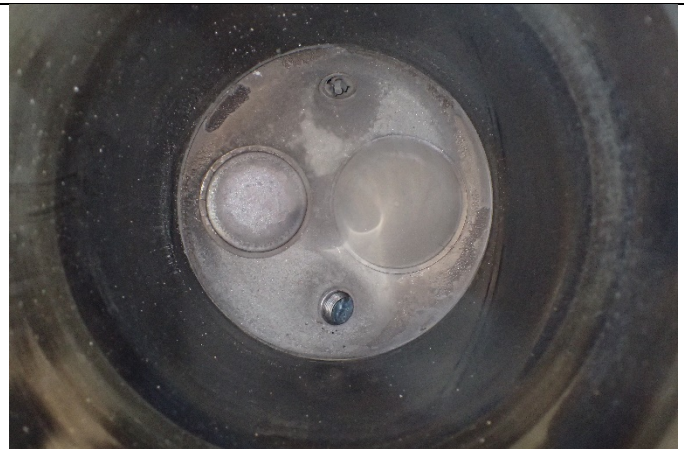
## CYLINDER #2

The cylinder remained attached to its cylinder bay and displayed thermal damage signatures. The internal portion of the cylinder was inspected using a lighted borescope; the cylinder bore, piston face, and valve heads displayed normal operating and combustion signatures. The crankshaft was rotated and it was noted that the cylinder did not have any thumb compression or suction. The cylinder was removed and visually inspected; it was noted that the intake valve was not seating completely which is consistent with the thermal damage to the overhead components. The overhead components (valves, springs, and rocker arms) displayed a significant amount of thermal damage consistent with a post-crash fire.

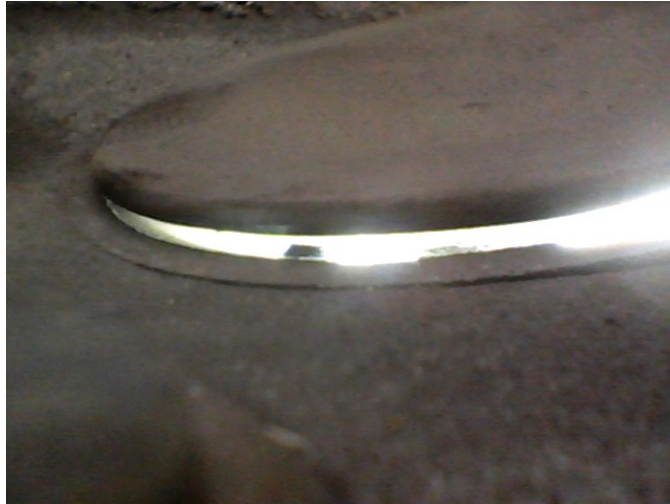
#2 Intake Valve and Valve Seat

All of the valve heads displayed normal operating and combustions signatures. The #2 intake valve was noted to not fully seat which was consistent with the thermal damage to that cylinder. During crankshaft rotation, all of the valves operated normally. There were no anomalies noted.

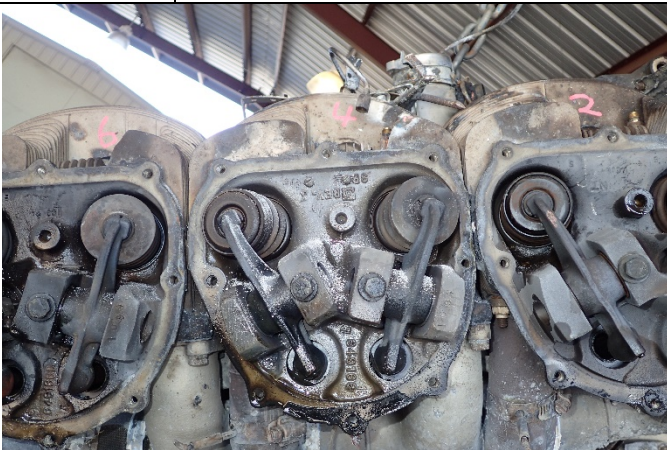
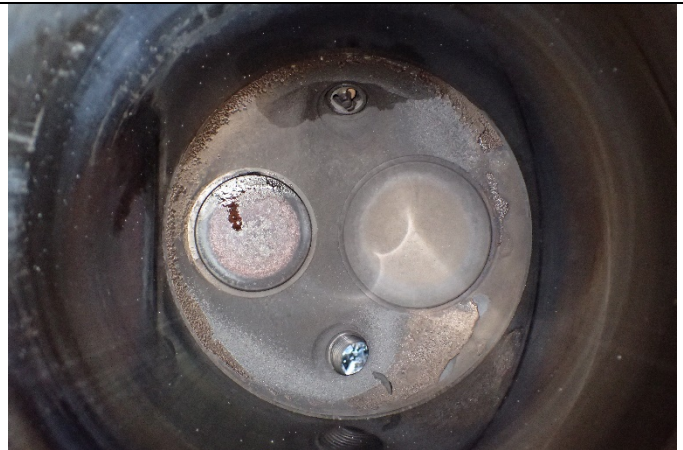
| CYLINDER #4 | P/N: Not observed | S/N: Not observed | Head Date: 10-94 |
|---|---|---|---|
| Condition: | The cylinder remained attached to its cylinder bay and displayed thermal damage signatures. The internal portion of the cylinder was inspected using a lighted borescope; the cylinder bore, piston face, and valve heads displayed normal operating and combustion signatures. The crankshaft was rotated and the cylinder displayed good thumb compression and suction. The cylinder overhead components (valves, springs, and rocker arms) displayed minor thermal damage signatures consistent with a post-crash fire and normal operating signatures. The cylinder was removed and visually inspected; there were no anomalies noted. | | |

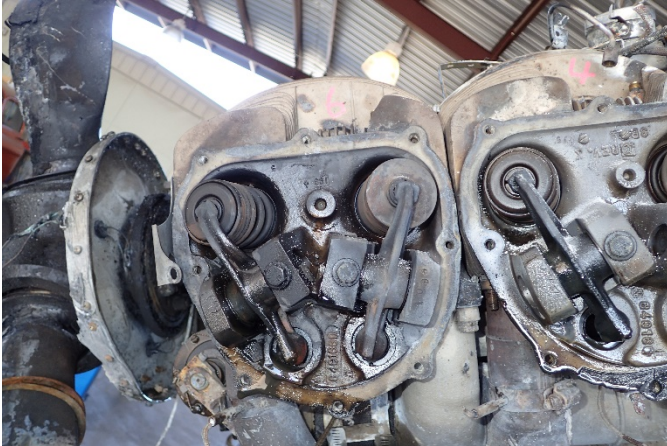
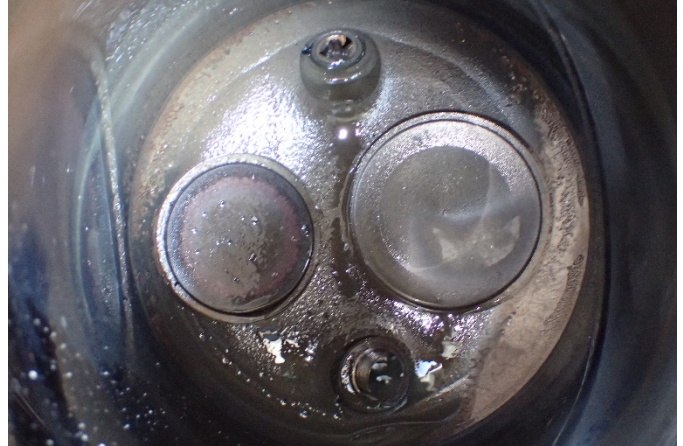
## CYLINDER #6

The cylinder remained attached to its cylinder bay and displayed thermal damage signatures. The internal portion of the cylinder was inspected using a lighted borescope; the cylinder bore, piston face, and valve heads displayed normal operating and combustion signatures. The crankshaft was rotated and the cylinder displayed good thumb compression and suction. The cylinder overhead components (valves, springs, and rocker arms) displayed minor thermal damage signatures consistent with a post-crash fire and normal operating signatures. The cylinder was removed and visually inspected; there were no anomalies noted.

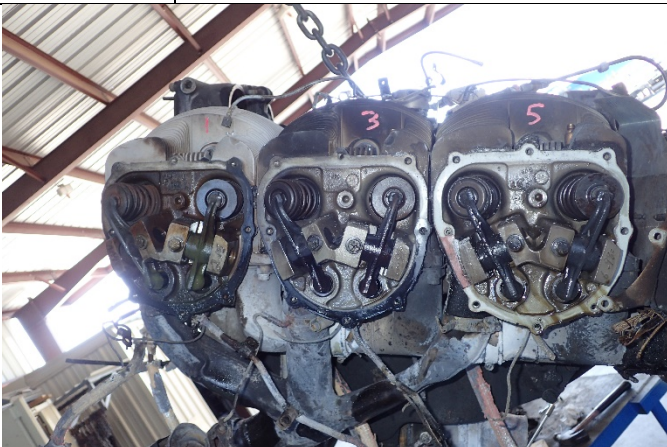
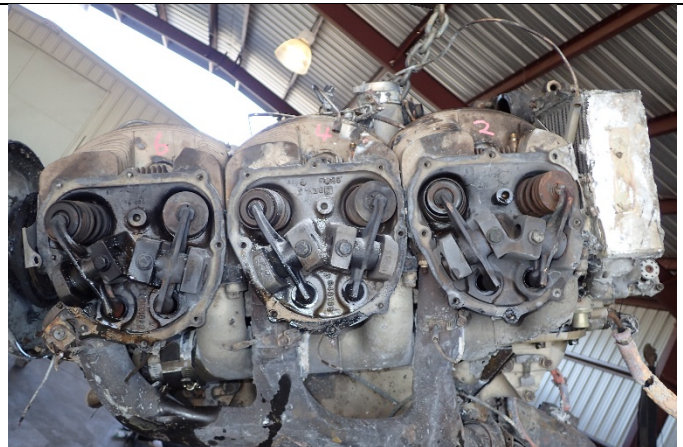
## ROCKER ARMS AND SHAFTS

All of the rocker arms displayed varying degrees of thermal damage with the #2 rocker arms displaying the most thermal damage. The rocker arms operated normally during crankshaft rotation; there were no anomalies noted.

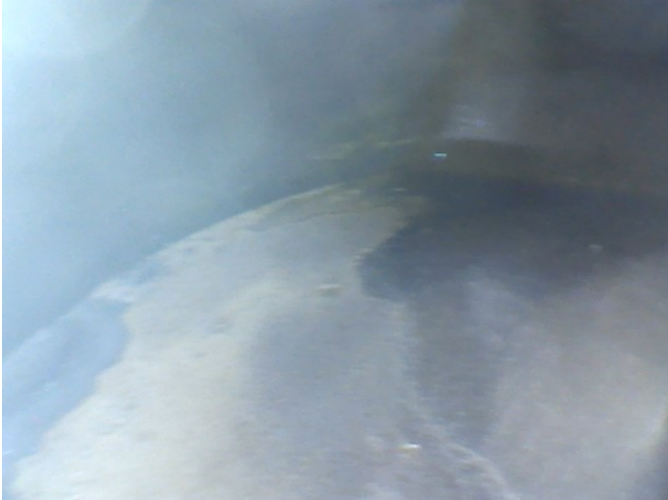
#1 Piston

The piston faces were inspected using a lighted borescope. The piston faces displayed normal operating and combustion signatures. During crankshaft rotation, all of the pistons operated normally. After the #2, #4, and the #6 cylinders were removed the pistons were examined again. The #2, #4, and the #6 piston skirts and piston rings displayed normal operating signatures. The back side of the #1, #3, and the #5 pistons were inspected through the opened cylinder bays; the pistons displayed normal operating signatures. There were no anomalies noted.

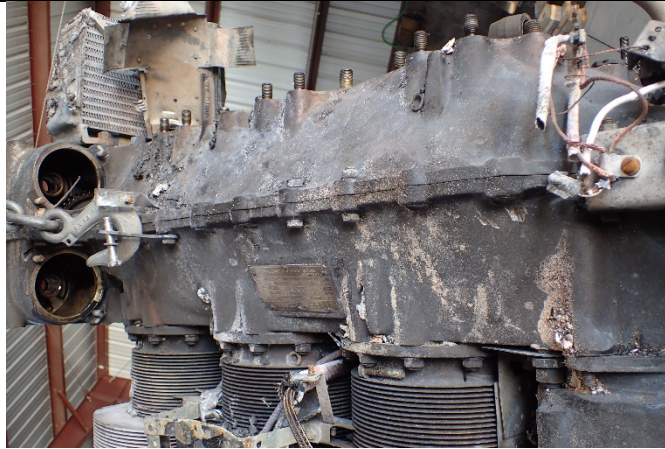
| CRANKCASE | Casting Number: | 1-3-5: Not observed | 2-4-6: Not observed | S/N: 08 94 16 RPL |
|---|---|---|---|---|
| Condition: | The crankcase remained intact and displayed thermal damage signatures. The inside of the crankcase was visually inspected after the removal of the #2, #4, and the #6 cylinders through the open cylinder bays. There were no signs of bearings being extruded out of their bearing supports. There were no anomalies noted with the crankcase. | | | |

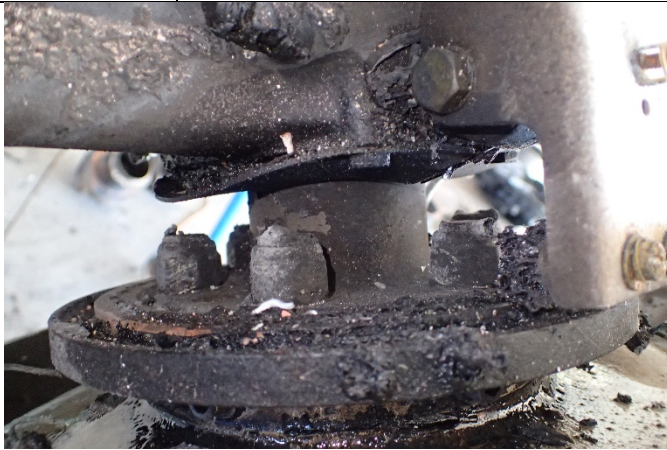
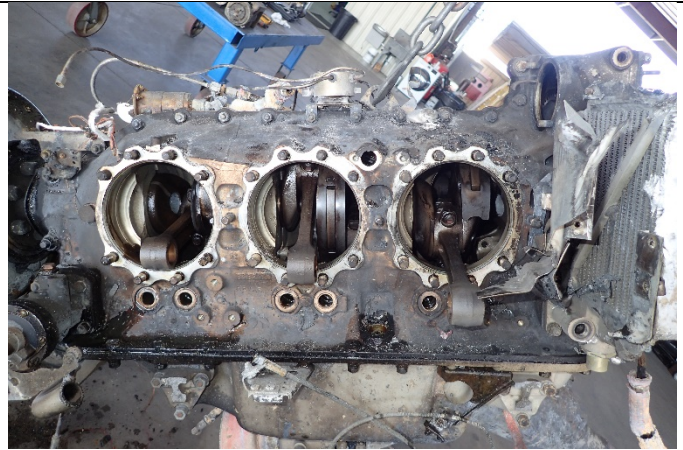
The crankshaft remained intact and displayed thermal damage signatures consistent with a post-crash fire. The crankshaft was rotated by hand and continuity was established between the crankshaft, camshaft, connecting rods, and associated components. The crankshaft rotated smoothly without any binding noted. The crankshaft was visually inspected after the #2, #4, and the #6 cylinders were removed. The visible portions of the crankshaft displayed normal operating and lubrication signatures.

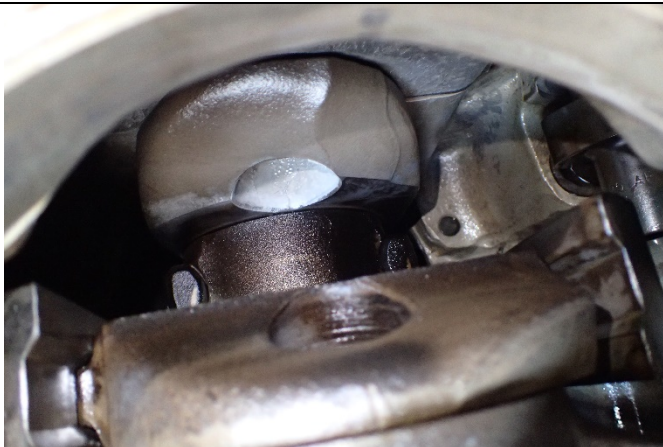
#1 CONNECTING  
ROD

Operation of the connecting rod was verified by rotating the crankshaft and observing piston movement; the connecting rod operated normally. The connecting rod was partially visible after removing the cylinders on the 2, 4, 6 side of the engine. The visible portions of the connecting rod displayed normal operating and lubrication signatures. There were no anomalies noted.

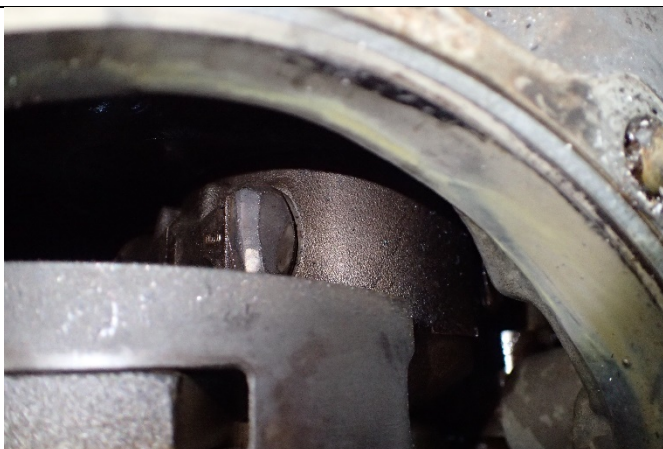
#3 CONNECTING  
ROD

Operation of the connecting rod was verified by rotating the crankshaft and observing piston movement; the connecting rod operated normally. The connecting rod was partially visible after removing the cylinders on the 2, 4, 6 side of the engine. The visible portions of the connecting rod displayed normal operating and lubrication signatures. There were no anomalies noted.

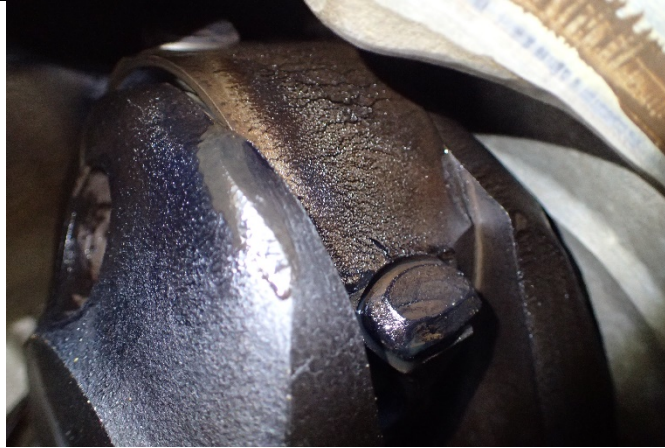
#5 CONNECTING  
ROD

Operation of the connecting rod was verified by rotating the crankshaft and observing piston movement; the connecting rod operated normally. The connecting rod was partially visible after removing the cylinders on the 2, 4, 6 side of the engine. The visible portions of the connecting rod displayed normal operating and lubrication signatures. There were no anomalies noted.

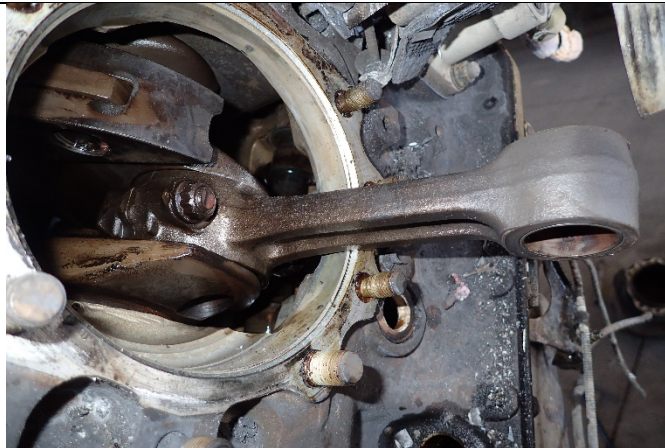
## #2 CONNECTING ROD

Operation of the connecting rod was verified by rotating the crankshaft and observing piston movement; the connecting rod operated normally. The connecting rod was visually inspected after the #2 cylinder was removed. The connecting rod displayed normal operating and lubrication signatures and was capable of normal movement around the connecting rod journal. There were no anomalies noted.

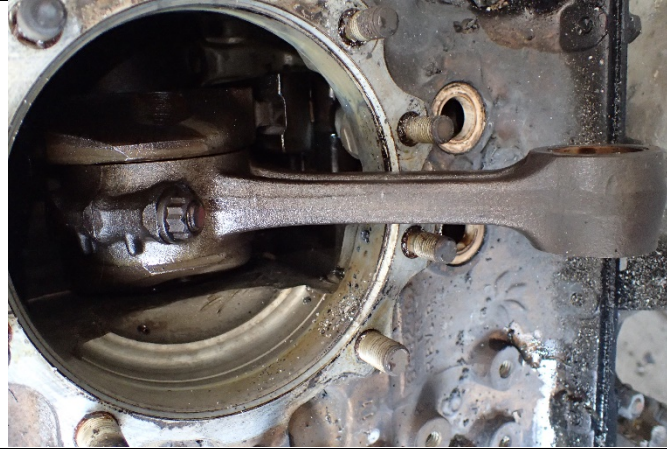
## #4 CONNECTING ROD

Operation of the connecting rod was verified by rotating the crankshaft and observing piston movement; the connecting rod operated normally. The connecting rod was visually inspected after the #2 cylinder was removed. The connecting rod displayed normal operating and lubrication signatures and was capable of normal movement around the connecting rod journal. There were no anomalies noted.

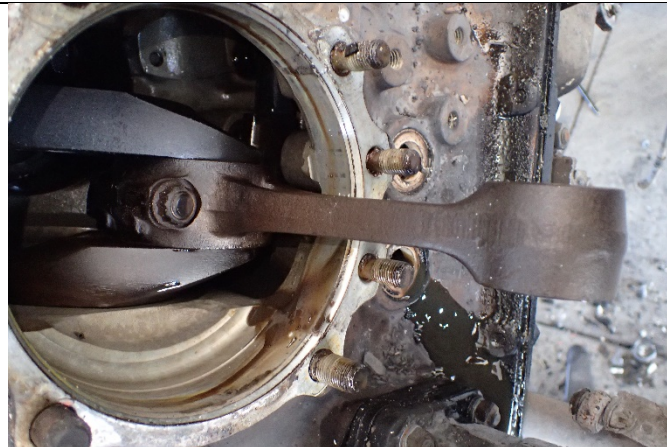
## #6 CONNECTING ROD

Operation of the connecting rod was verified by rotating the crankshaft and observing piston movement; the connecting rod operated normally. The connecting rod was visually inspected after the #2 cylinder was removed. The connecting rod displayed normal operating and lubrication signatures and was capable of normal movement around the connecting rod journal. There were no anomalies noted.

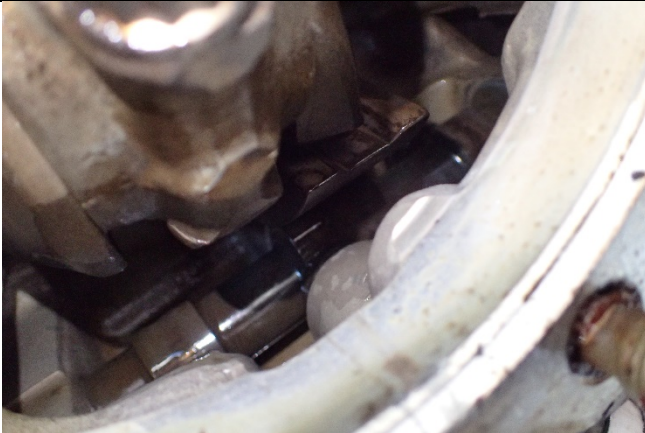
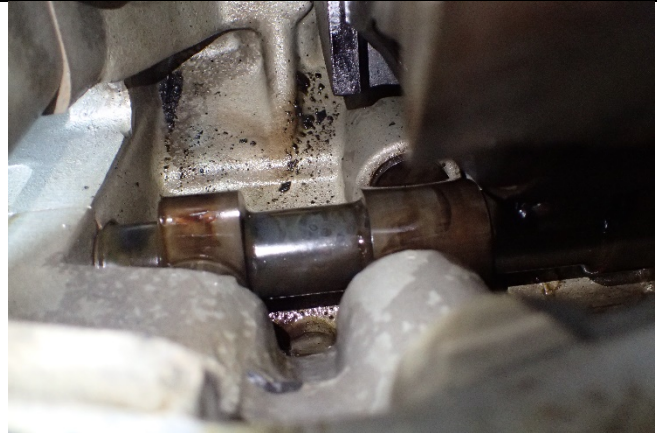
### CAMSHAFT

Operation of the camshaft was verified by rotating the crankshaft and observing rocker arm movement; the camshaft operated normally. After the #2, #4, and the #6 cylinders were removed the camshaft was partially visible. The camshaft displayed normal operating and lubrication signatures. There were no anomalies noted with the camshaft.

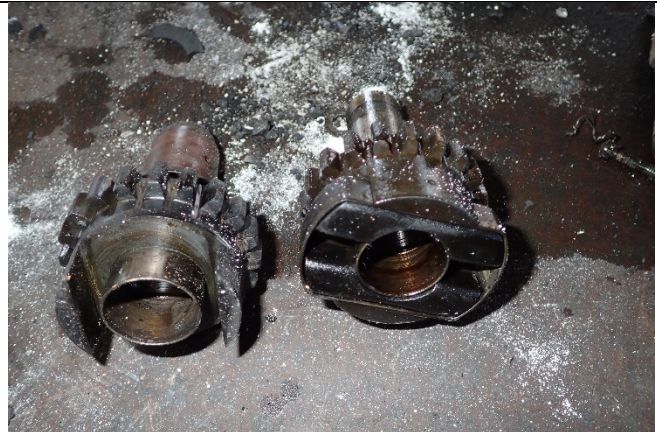
### ACCESSORY GEARS

The accessory gears displayed normal operating signatures. There were no anomalies noted with any of the gears.

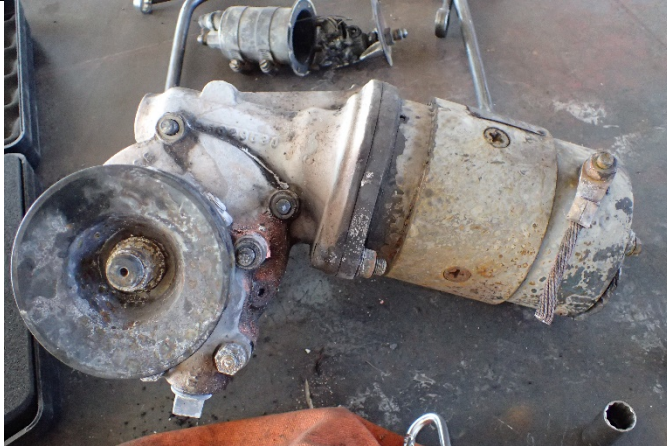
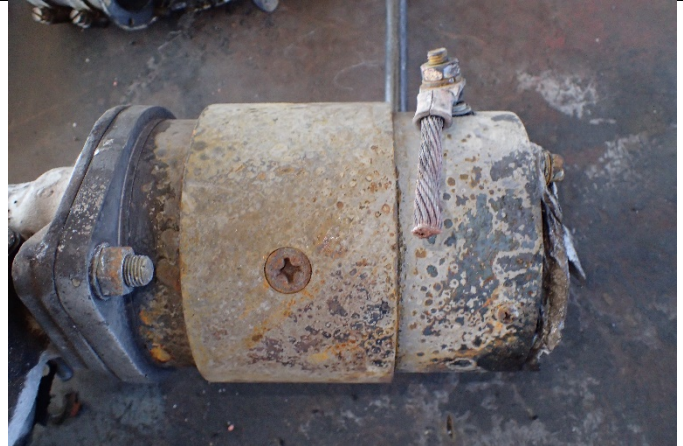
### STARTER

The starter remained attached to the starter adapter and displayed thermal damage signatures. There were no anomalies noted with the starter.

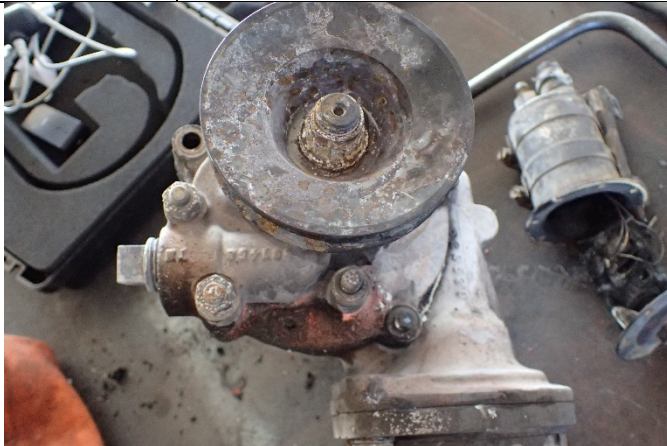
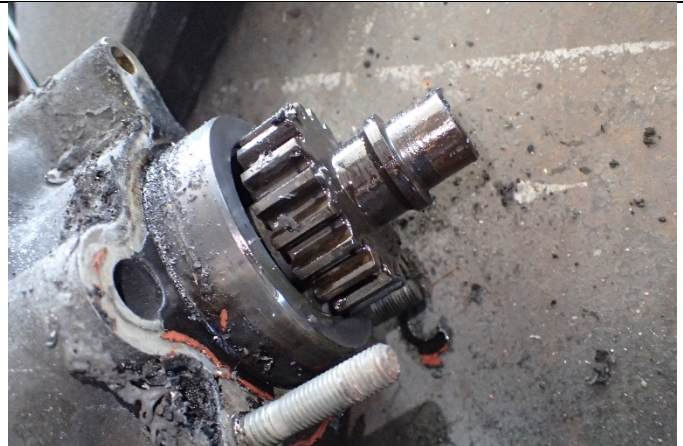
### STARTER ADAPTER

The starter adapter remained attached to the engine and displayed thermal damage signatures. The starter adapter was removed; the starter adapter gear displayed normal operating signatures. There were no anomalies noted.

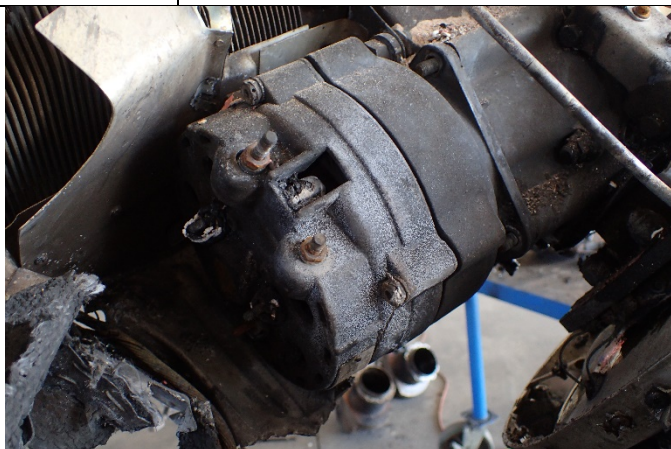
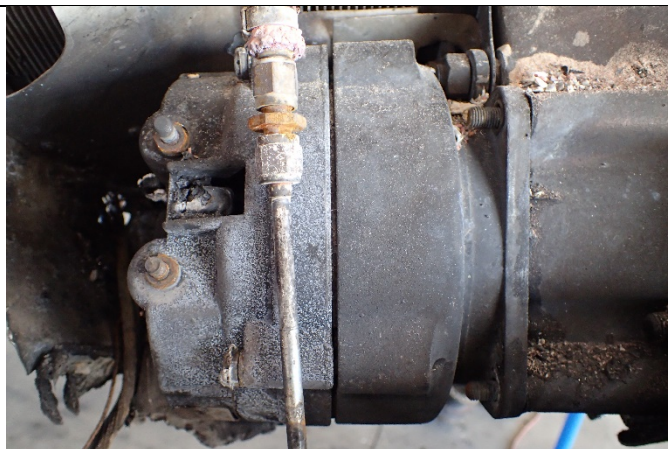
The alternator remained attached to the engine and displayed thermal damage signatures. There were no anomalies noted with the alternator.

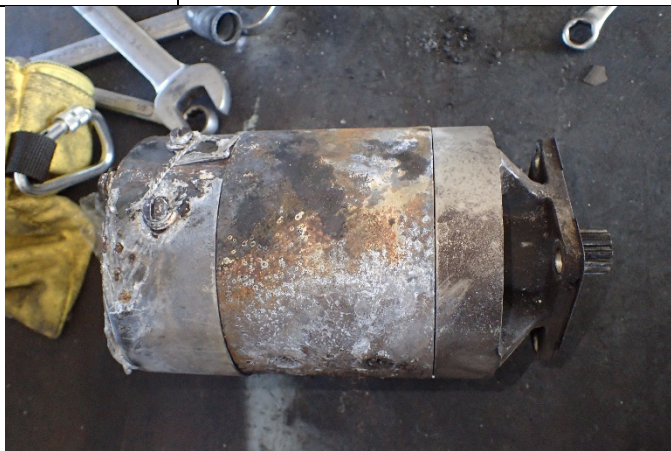
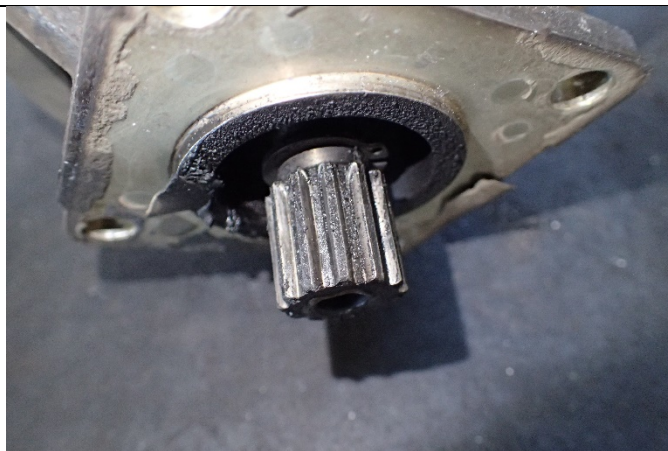
**ALTERNATOR  
#2**

The alternator remained attached to its installation point and displayed a significant amount of thermal damage signatures. There were no anomalies noted with the alternator.
