# Continental Motors

## ENGINE EXAMINATION REPORT

| ENGINE MODEL | IO-550-B |
| FILE NUMBER | 17-337 |

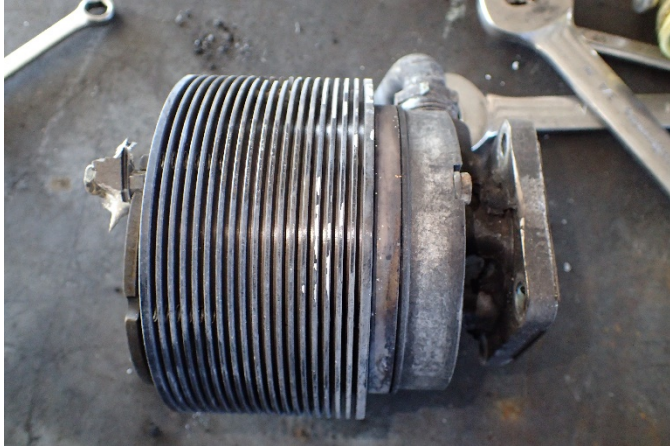
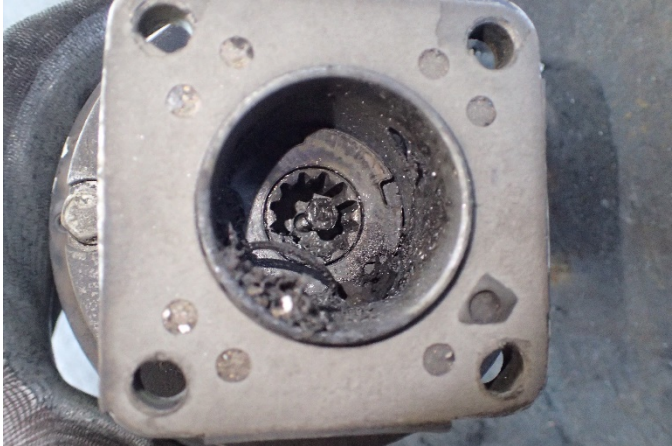
| VACUUM PUMP | Manufacturer: Illegible | P/N: Illegible | S/N: Illegible |
|---|---|---|---|
| Condition: | The vacuum pump remained attached to its installation point and displayed a significant amount of thermal damage signatures. The vacuum pump was removed and the drive shaft was noted to have melted. There were no anomalies noted with the vacuum pump. | | |

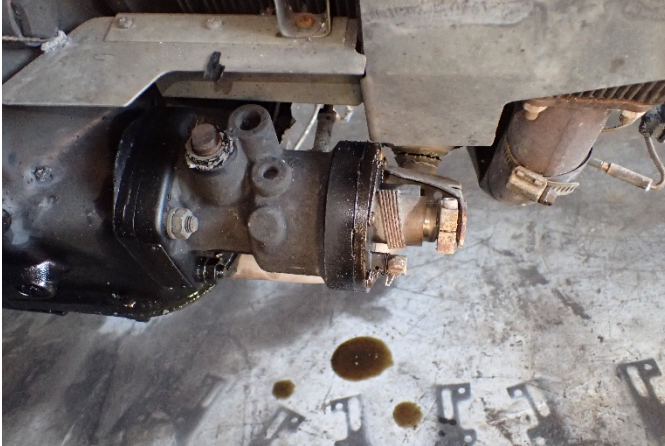
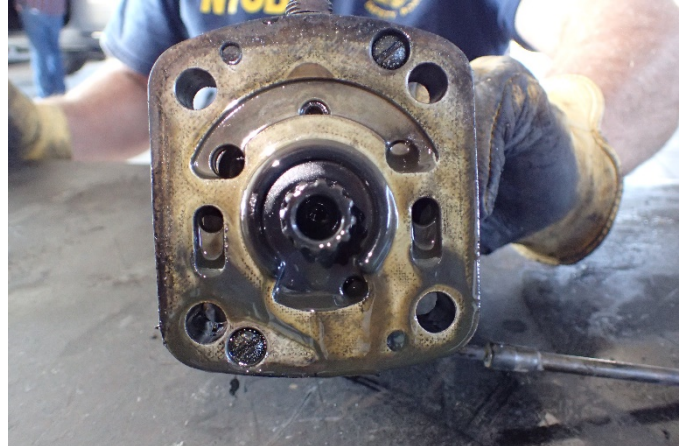
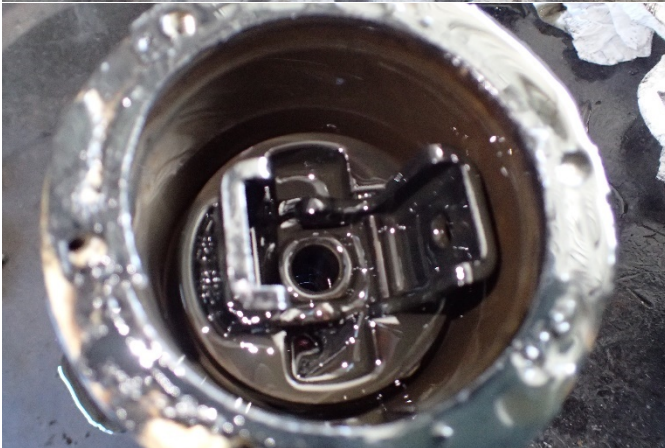
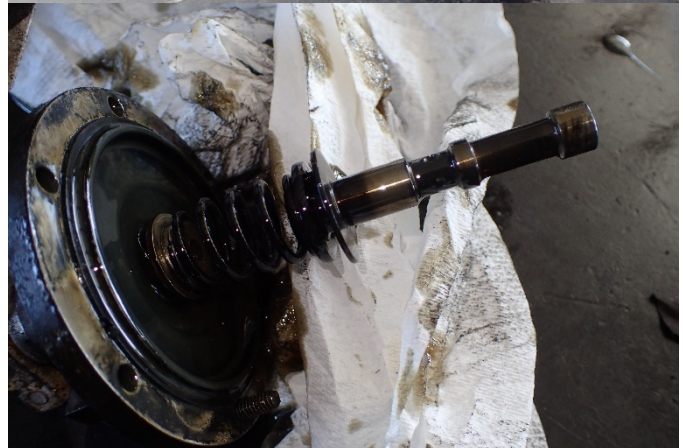
PROPELLER  
GOVERNOR

The governor remained attached to its installation point and displayed minor thermal damage signatures. The governor was removed and it was noted that the gasket screen was clear of any contaminants. The governor was noted to be capable of pump oil during drive shaft rotation. The governor was partially disassembled and it was noted that the flyweights and the valve displayed normal operating signatures.

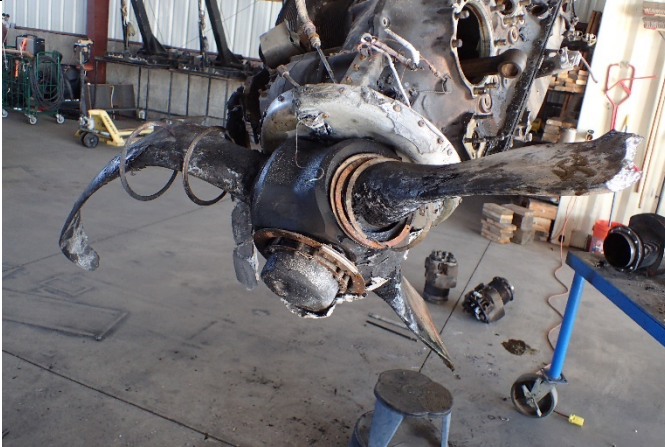
Propeller

The propeller remained attached to the crankshaft and displayed a significant amount of thermal damage signatures consistent with a post-crash fire. Two of the propeller blades were melted approximately in half. The third propeller blade displayed aft bending deformation and thermal damage signatures.
