## **NATIONAL TRANSPORTATION SAFETY BOARD**

# **ACCIDENT SITE EXAMINATION SUMMARY**

**WPR18FA046**

Location: San Diego, Ca  
Date: December 9, 2017  
Aircraft: N248SB, Beechcraft A39  
NTSB Investigator-in-Charge: Maja Smith

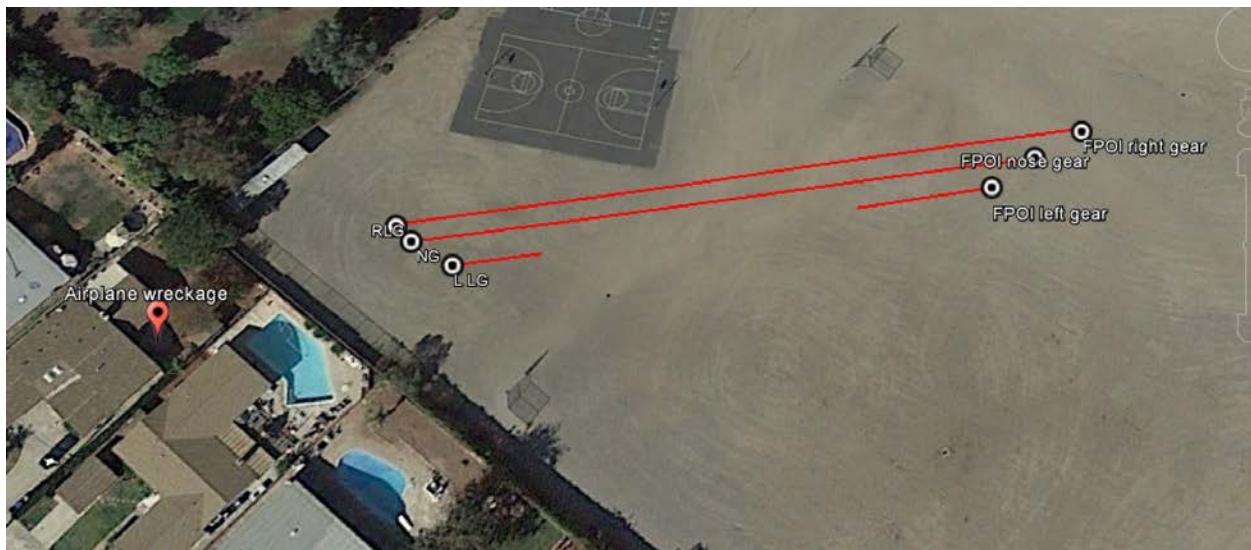
Figure 1-Landing roll on Google Earth

Examination of the accident site revealed that the airplane impacted a chain link fence, a tree and came to rest at the back side of a residential house. A post-crash fire ensued. The touchdown point was defined by the right landing gear tire imprint located about 380 ft from the airplane wreckage. About 17 ft and 25 ft lateral distance from the touchdown point, the nose gear and the left landing gear tire tracks were observed. The tracks indicated that right landing gear and the nose gear had a continuous contact with the ground until 50 ft prior to the chain link fence. The left landing gear lost contact with the ground twice. The airplane landed on a heading of about 240° magnetic.

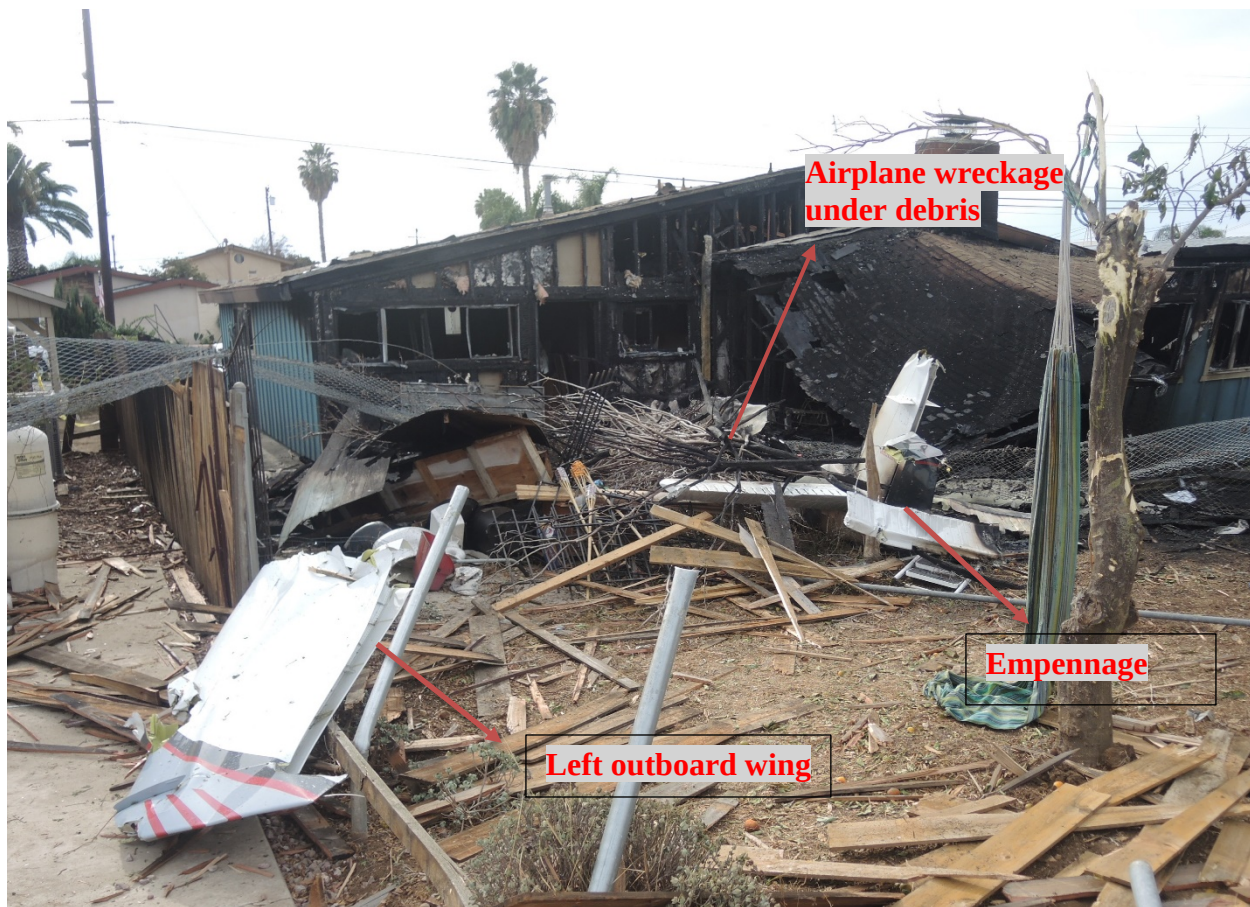
Figure 2-Airplane wreckage

The airplane was found with its longitudinal axis oriented in a southerly direction (200° magnetic bearing). Most of the airplane was destroyed by post-impact fire.

The left outboard wing separated from the fuselage. All flight control surfaces were still attached to the airframe and the engine was attached to the firewall. Flight control cable continuity was established from the elevator and rudder to the cockpit. Partial control cable continuity was established from the aileron bellcranks to the cabin. Instrument panel was fire damage. No seat restraint buckles or webbing was observed. The flaps were found in the up position. Elevator trim actuator was measured and found to be 10° tab down. Fuel selector handle and valve was in the right tank position. A large amount of a red looking fluid (blood) was observed inside the fuel selector.

McCauley three blades propeller remained attached to the engine; spinner was fire damage. Two of the three blades were fire damage. One blade was bent aft under the engine. Landing gear was in the extended position.
