## **NATIONAL TRANSPORTATION SAFETY BOARD**

# **AIRFRAME AND ENGINE EXAMINATION**

**WPR18FA063**

Location: Ogden, UT  
Date: December 29, 2017  
Aircraft: Cessna 172M, N4395R  
Serial # 17263145  
NTSB IIC: Albert Nixon

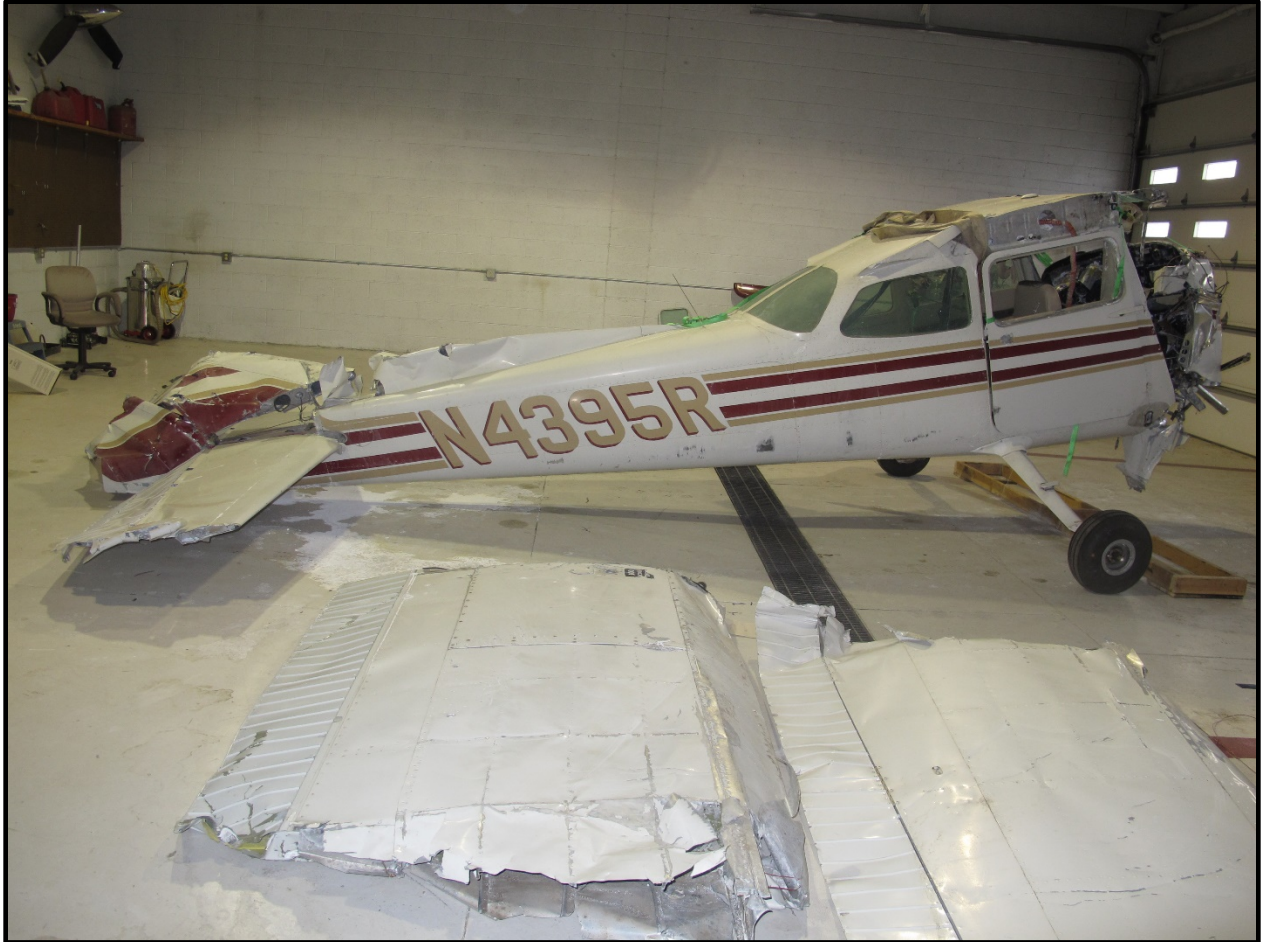
Figure 1: The airplane wreckage as viewed from the right side.

The fuselage remained mostly intact. The wind screen was fragmented, and the firewall and instrument panel were partially attached. Both cabin doors remained attached. The right door window was separated and located with the main wreckage. The baggage door was closed and locked. The elevator push pull tube in the cockpit was observed separated at the forward end of the tube where it attaches to the control “Y” assembly. Flight control continuity was established during the examination.

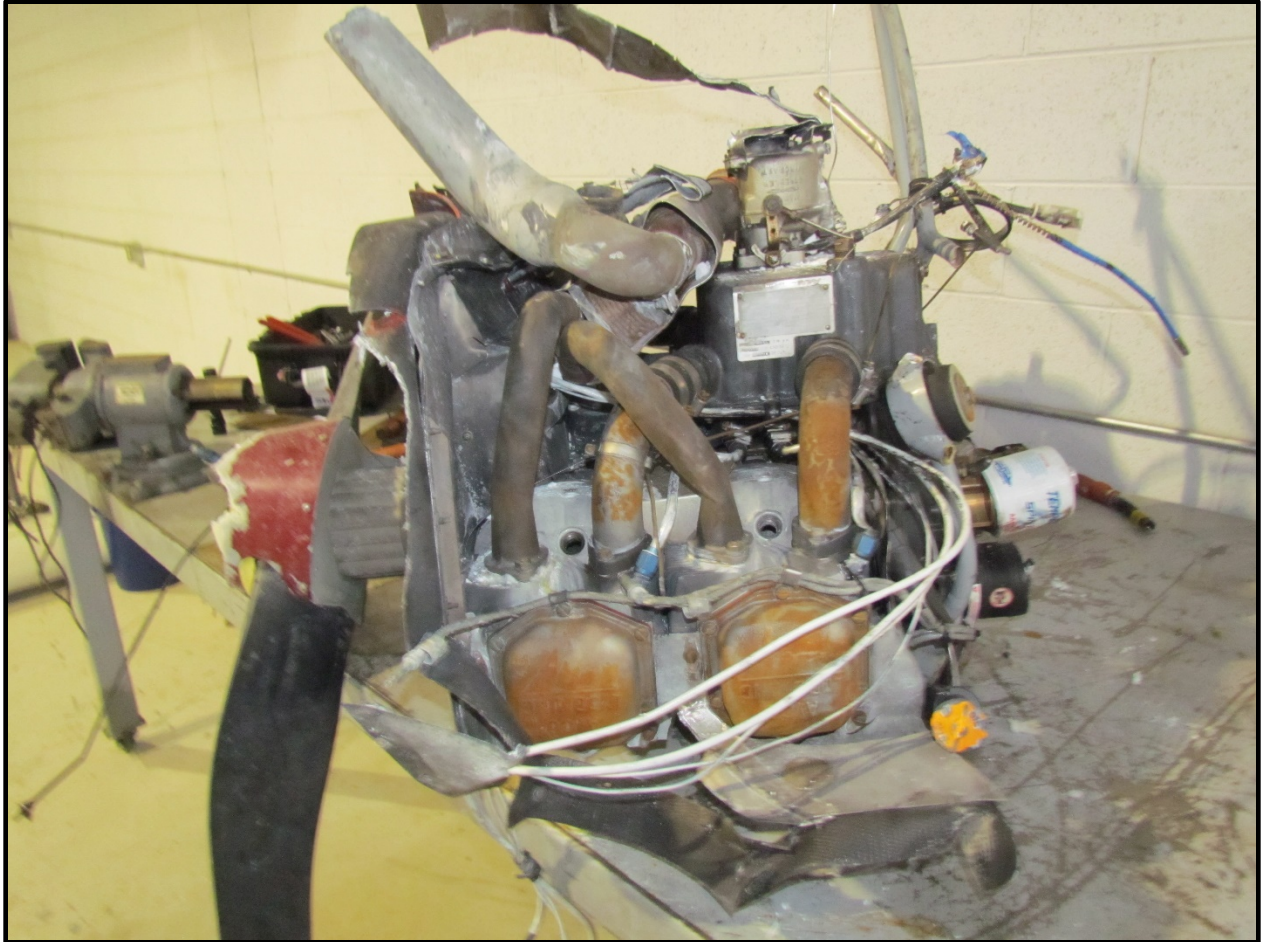
The fixed pitch propeller remained attached to the engine. Both propeller blades were observed displaced towards the flat side of the blade approximately 16 inches out from the propeller hub. The power flow exhaust system was examined and was crushed slightly aft, consistent from impact. The heat muff was removed and found intact. No anomalies were noted.

Figure 2: Engine as viewed from the left side.

The examination of the engine revealed no evidence of pre-impact mechanical malfunctions or failures that would have precluded normal operation.
