## **NATIONAL TRANSPORTATION SAFETY BOARD**

# **ACCIDENT SITE EXAMINATION SUMMARY**

**WPR18FA073**

| Aircraft: | N54857; Piper PA-23-250 |

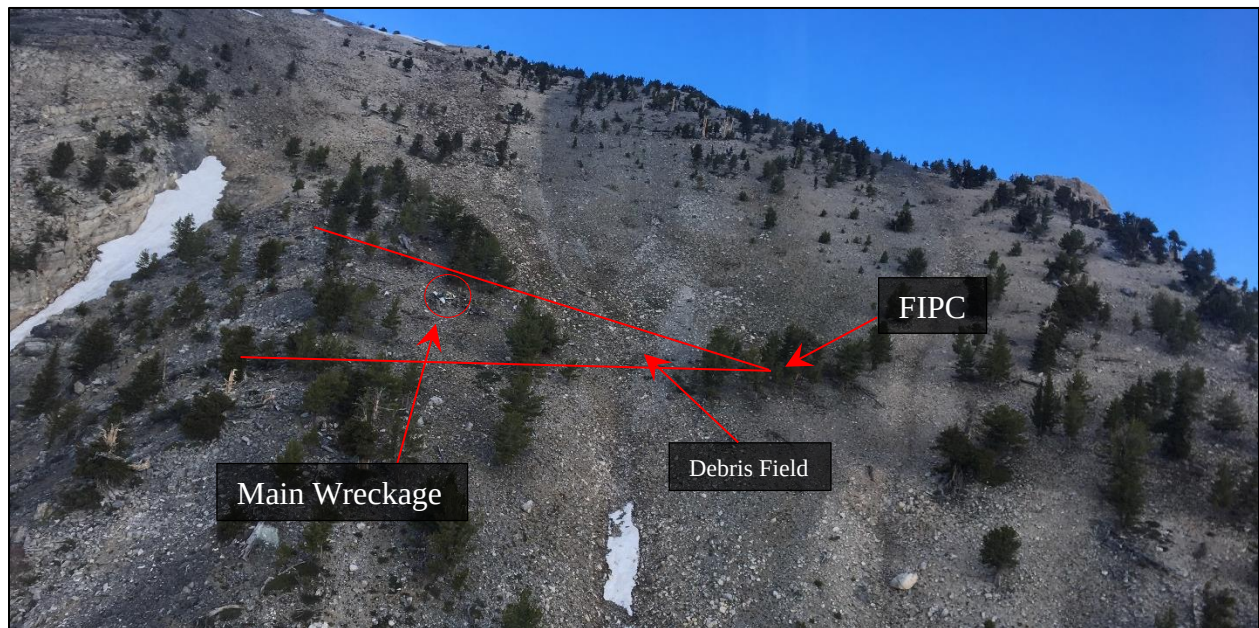
Figure 1-Accident Site

Pearl Peak is a 10,777-foot summit in the southern part of the Ruby Mountains, southeast of Elko, Nevada. The accident site is located about 800ft below the summit on a southeast facing slope. The debris field spread along the side of a 30-degree rocky slope and was about 325 feet in length on a magnetic heading of about 213 degrees. The slope contained mature 20-30ft tall bristlecone trees. The last known flight path was identified to pass near the summit of Pearl Peak at about 11,000ft. There was a 3-4ft base of snow on the slope when the accident occurred.

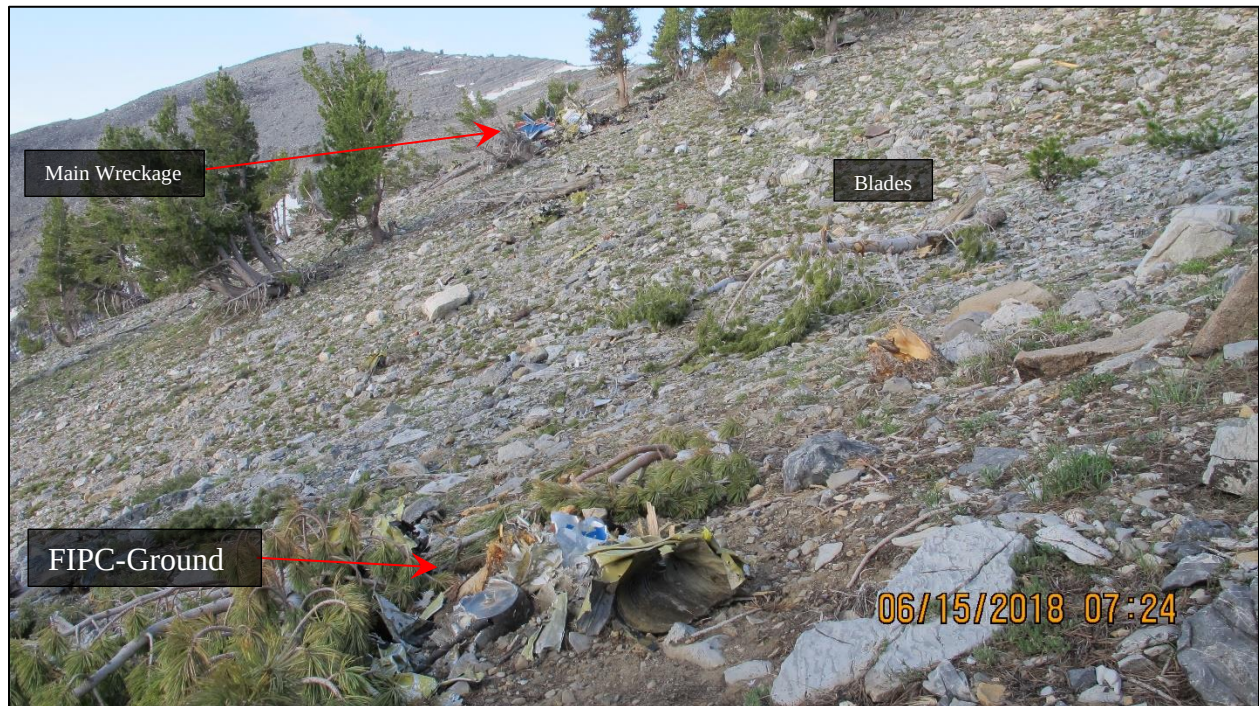
Figure 2-First Identified Point of Contact with the Ground

The first identified point of contact (FIPC) was from the top of a 25ft bristlecone pine tree about 60ft from the FIPC with the ground. The FIPC with the ground was on a small broken tree trunk and contained bent aluminum sheet metal and hub components from a propeller assembly. Broken branches were in the area of the FIPC. The next 40ft of the debris field contained small broken engine components, bent aluminum and three propeller blades broken from their hub. The blades revealed rotational scoring and impact damage consistent with an undetermined amount of power during the impact sequence. Over the next 100ft, the wing spars were found in several 3-4ft sections. Also, oil saturated ground was found in several areas.

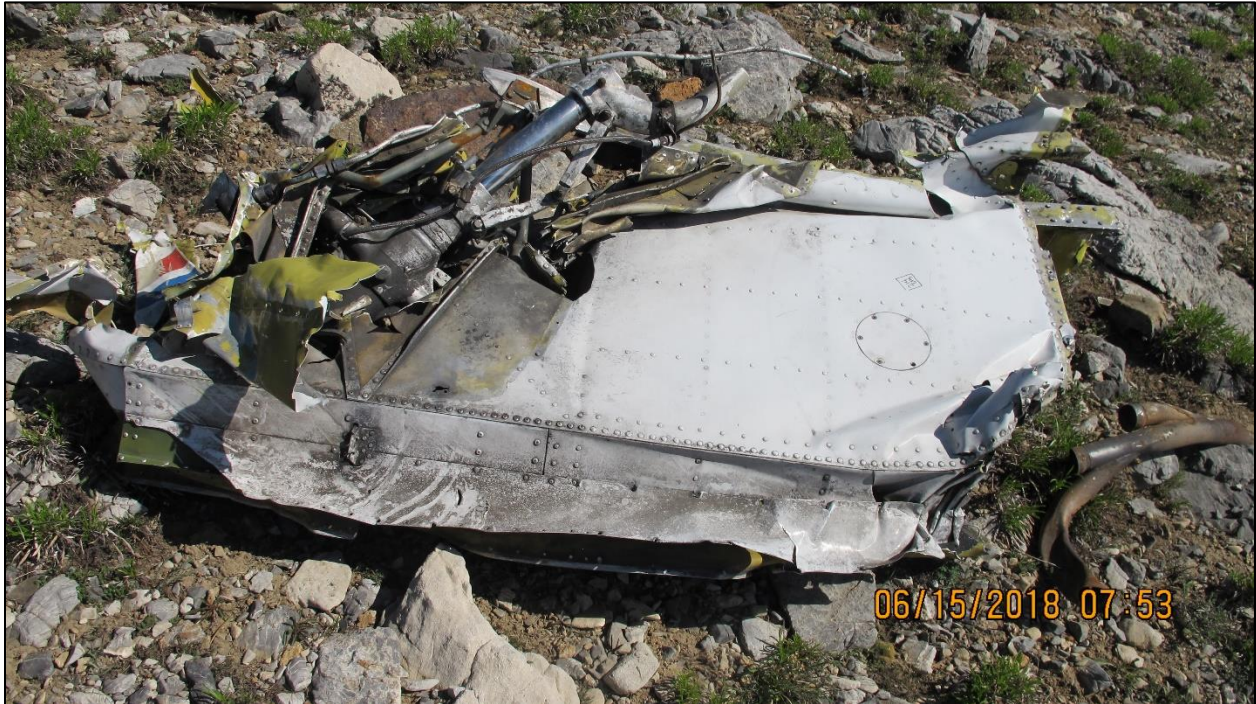
**Figure 3-Inboard Right-Wing Section**

The inboard right-wing section, including the landing gear strut was found half way down the debris field. The outboard side of the right-wing section and landing gear strut was crushed inboard.

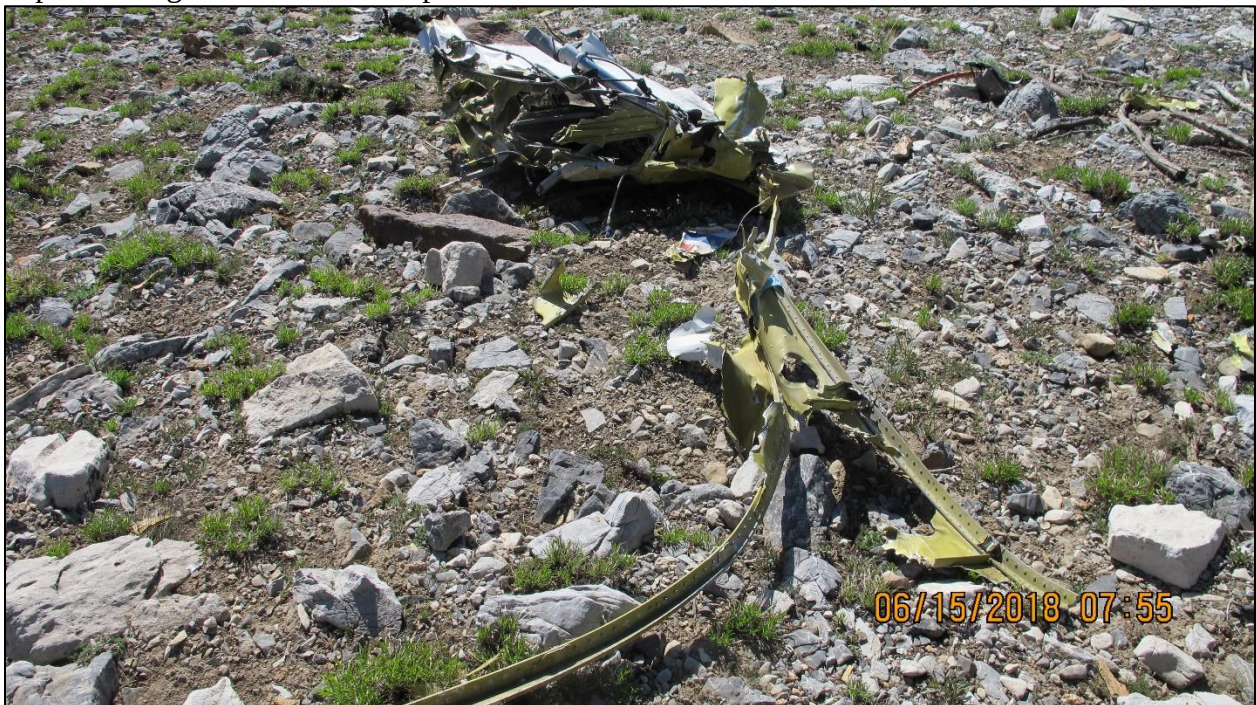
**Figure 4-Inboard Right-Wing Section and Wing Spar Section**

A long section (7ft) of wing spar was found near the inboard right-wing section. The spar had impact damage and bent in multiple directions.

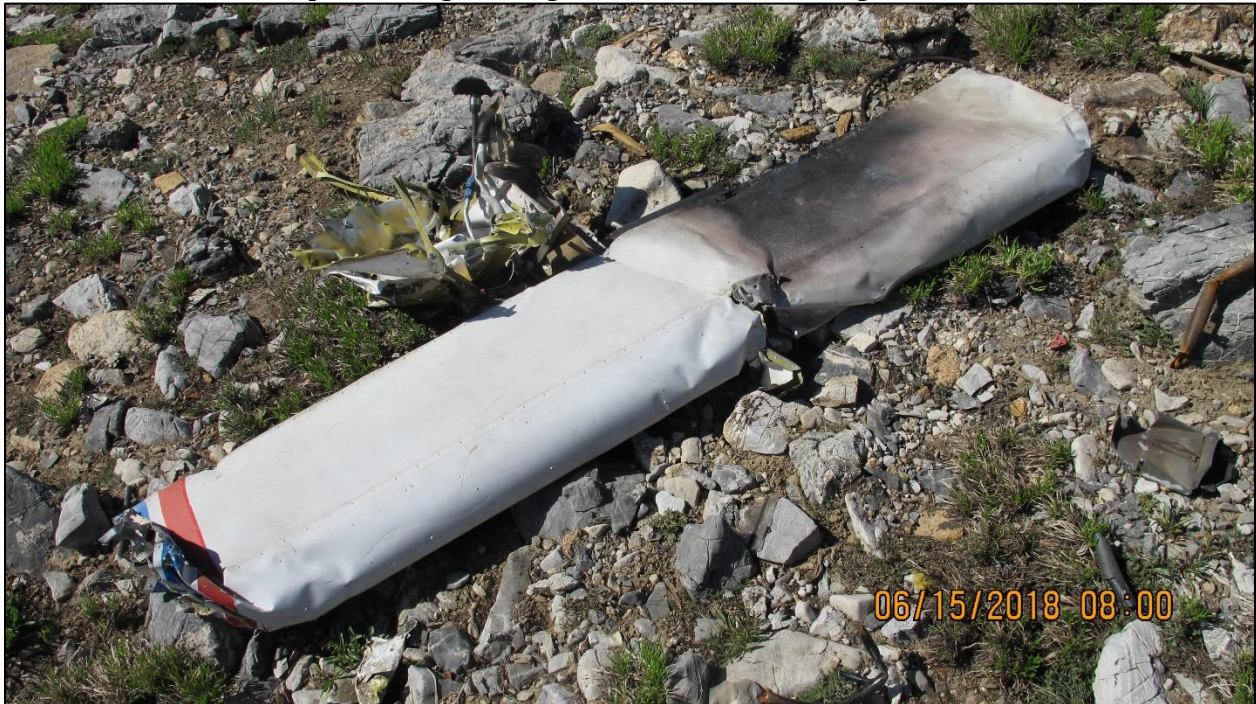
**Figure 5-Right Aileron**

The right aileron was found next in the debris field and was about 160ft from the FIPC with the tree. The aileron had impact damage throughout and thermal damage on its inboard side.

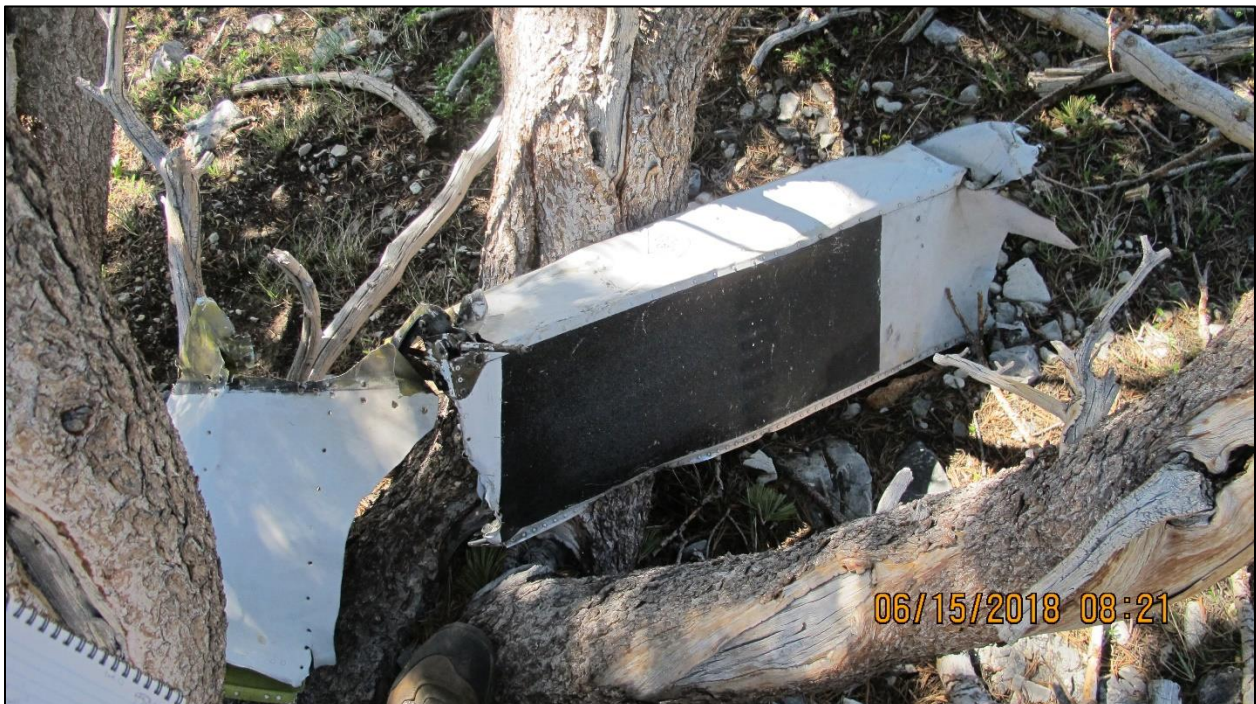
**Figure 6-Right Flap**

The right flap was found near the right aileron at the base of a tree. The flap had impact damage on both inboard and outboard ends.

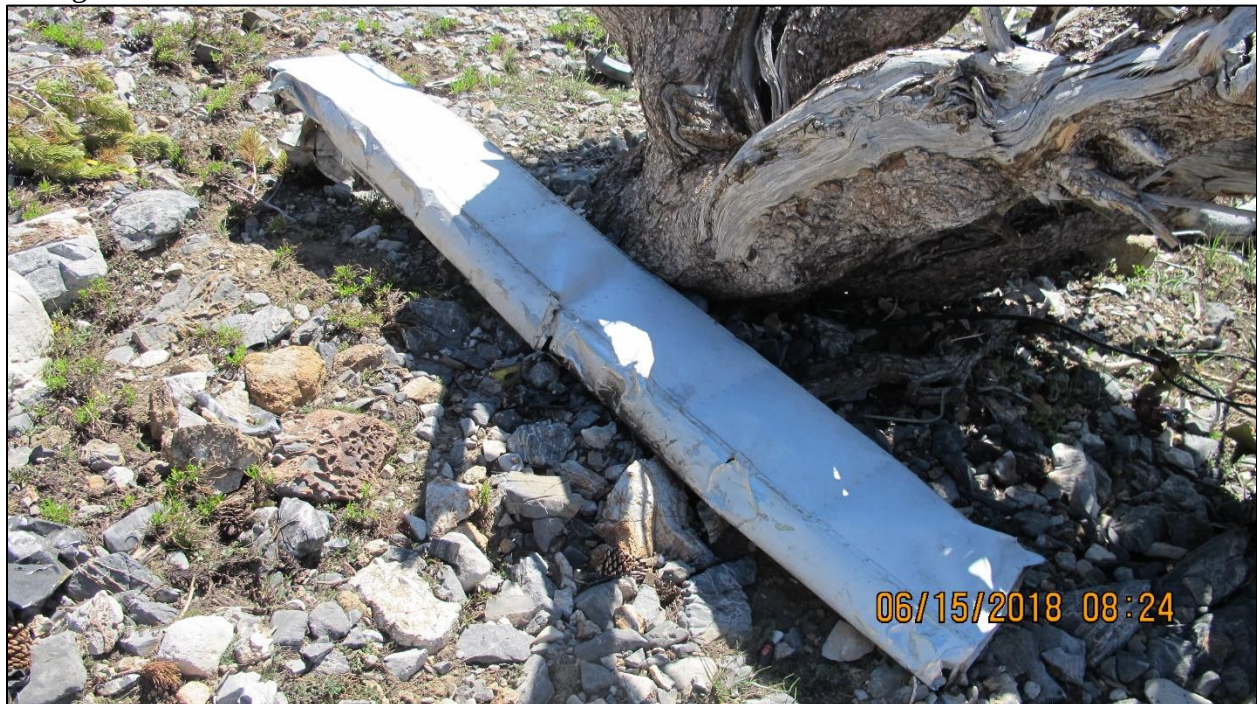
**Figure 7-Left Aileron**

The left aileron was found near the main wreckage. The aileron was intact and buckled throughout its structure.

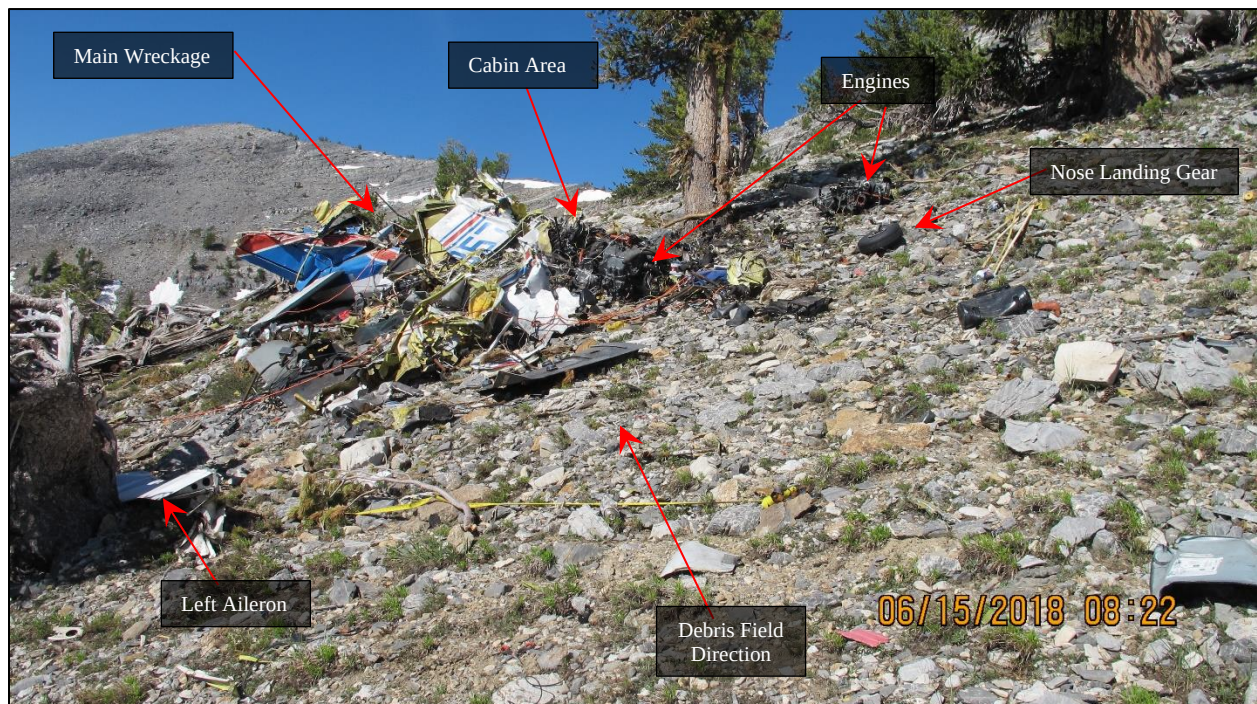
**Figure 8-Main Wreckage**

The main wreckage consisted of the cabin area and the empennage. The cabin area was heavily disfigured. First responders who were onsite in January 2018, cut open several areas of the fuselage. Two seats were found further down the debris field and the pilots seat was found in the ravine at the end of the debris field. The fourth seat was not identified.

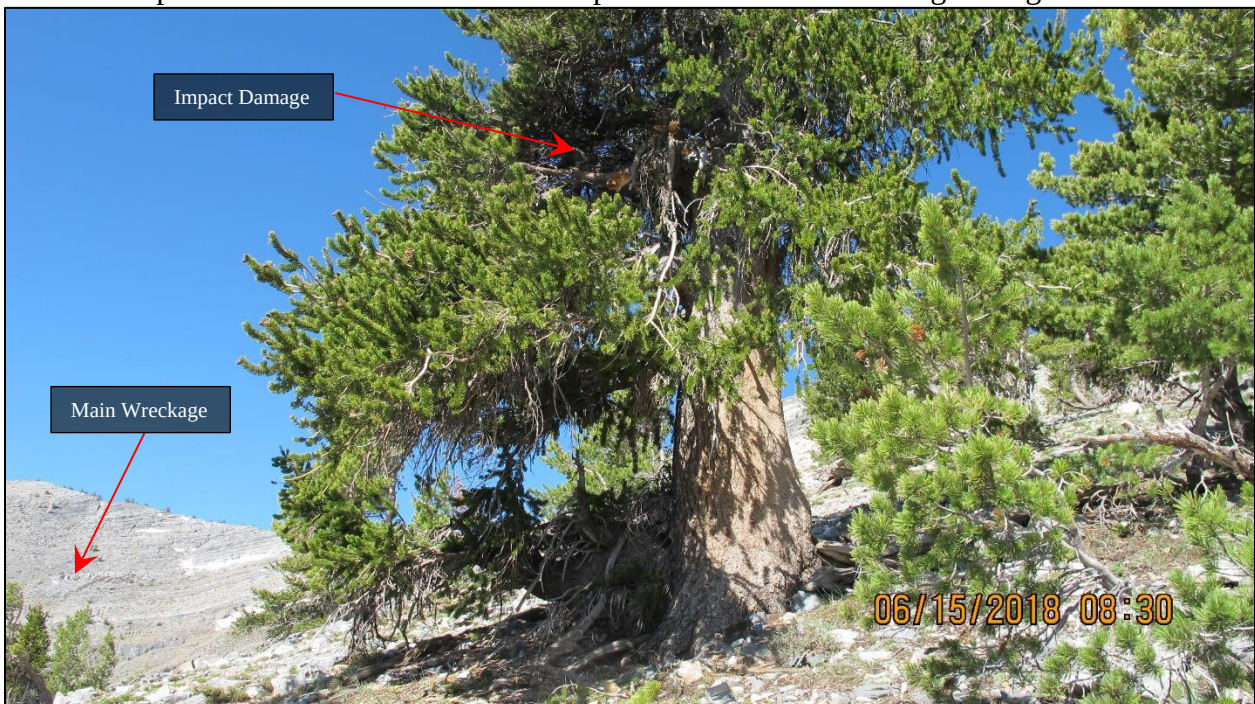
Figure 10-Impact Damage on a Tree

Impact damage was noted on a tree just up hill from the main wreckage. The impact damage was about 10ft up from the base of the bristlecone pine tree where several large branches were broken.

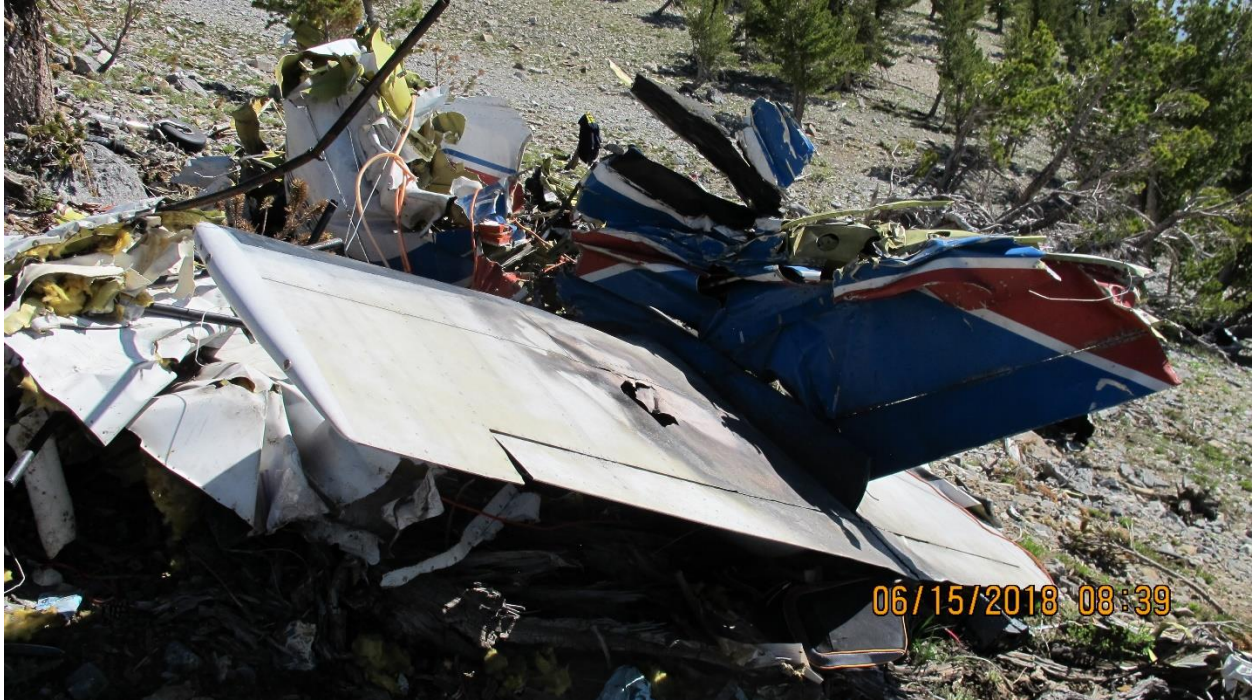
**Figure 11-Stabilator, Vertical Stabilizer and Rudder**

The empennage had impact damage to the forward and top sides of the vertical stabilizer and rudder. The stabilator and trim tab remained attached to the empennage. The upper skin of the left side of the stabilator had thermal damage and discoloration.

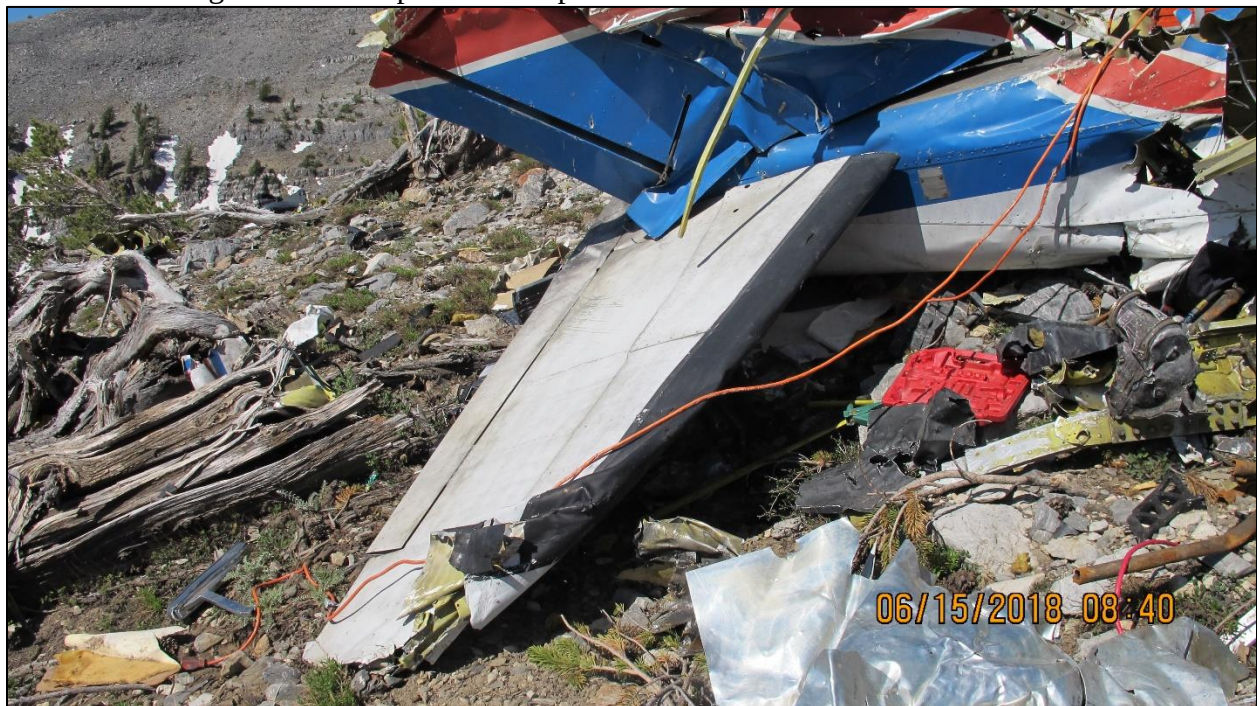
**Figure 12-Right Stabilator**

The stabilator right outboard tip was bent up and aft.

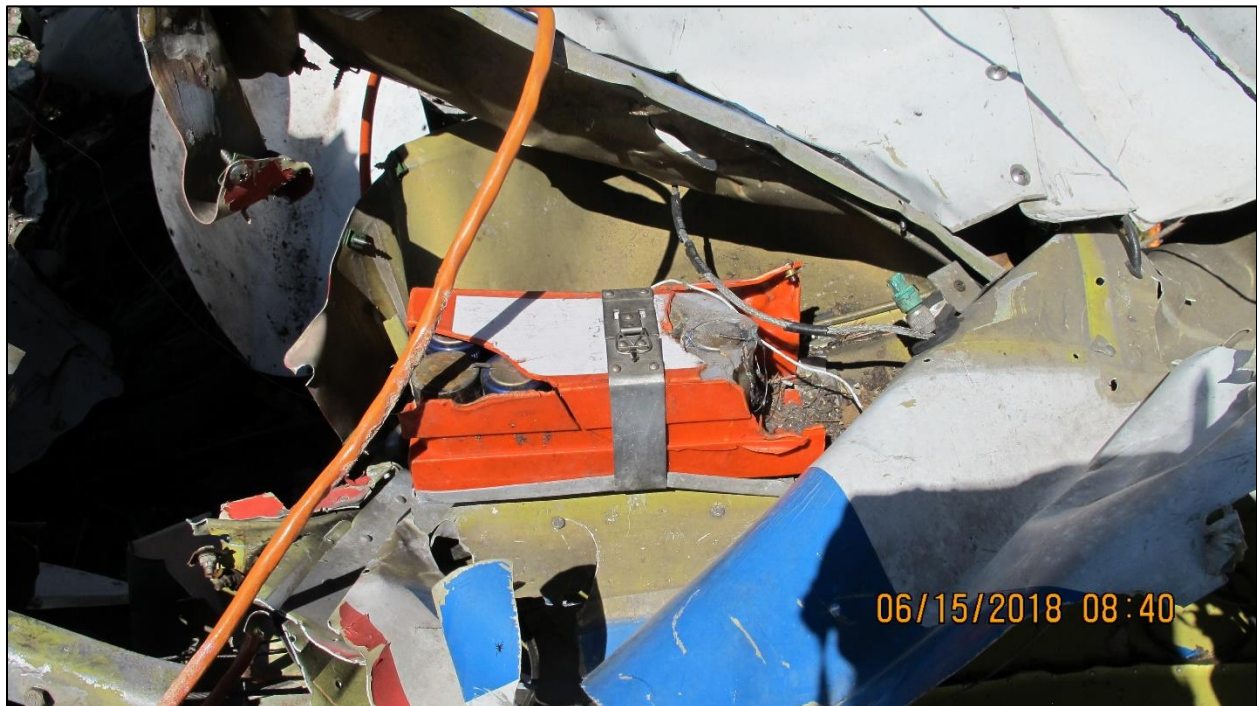
**Figure 13-ELT**

The ELT was found mounted in the aft fuselage. The ELT had impact damage to its housing revealing internal components.

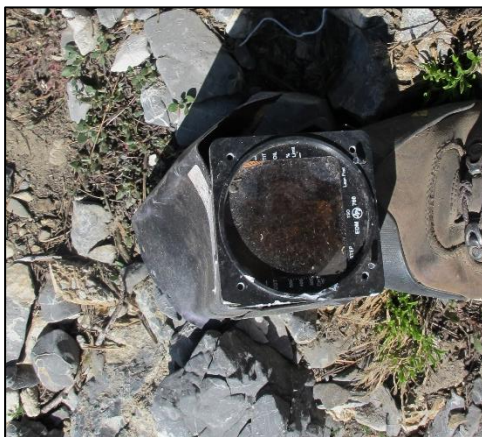
**Figure 144-JPI Instruments**

A JPI Instruments EDM 760 instrument separated from the instrument panel and was found near the main wreckage. A garmin panel mounted GPS was found near the main wreckage. Model number unknown.
