# NATIONAL TRANSPORTATION SAFETY BOARD

## MATERIALS LABORATORY FACTUAL REPORT

Report No. 18-035

Place : Pomeroy, Washington  
Date : January 27, 2018  
Vehicle : Hughes 369D  
NTSB No. : WPR18FA074  
Investigator : Samantha Link

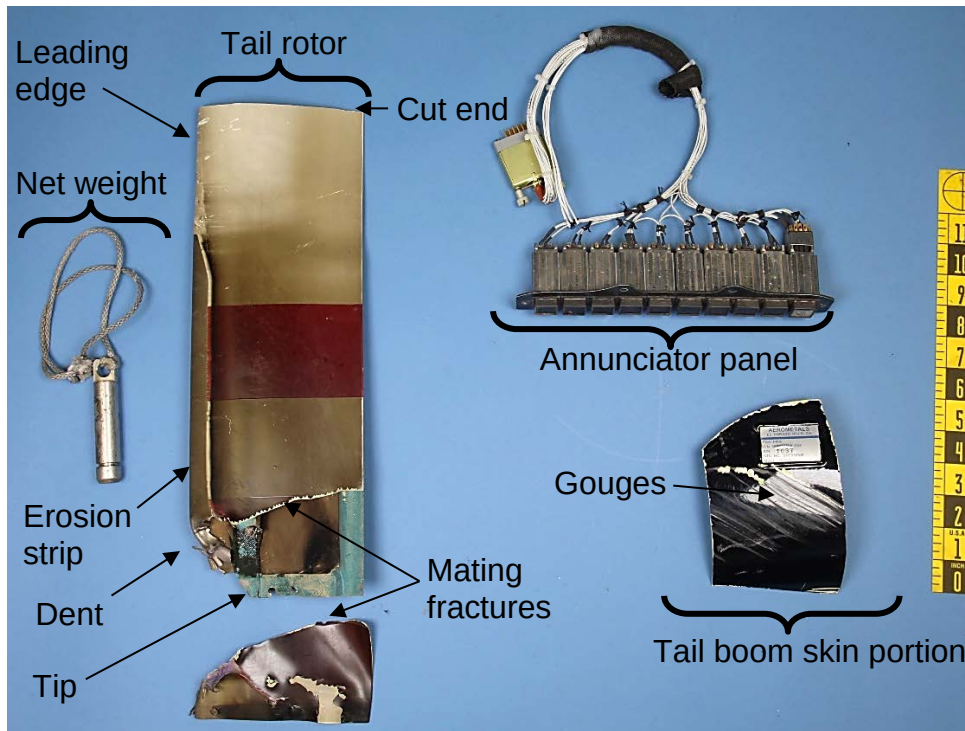
Figure 1 shows a photograph of the as-received parts from the helicopter. Visual examination of the tail rotor blade revealed a skin portion fractured from the outer tip, and the mating fractured skin piece is displayed next to the blade. The other end was cut to facilitate transportation and handling. The submitted net weight was intact and was attached to a rope. The skin portion from the tail boom was cut-out onsite to facilitate transportation and handling and the outer face contained several gouge marks.

Figure 1. Photograph of the as-received a portion of the tail rotor blade, torn skin portion from the tip end of the tail rotor blade, net weight, cut-out piece of the tail boom, and annunciator panel.

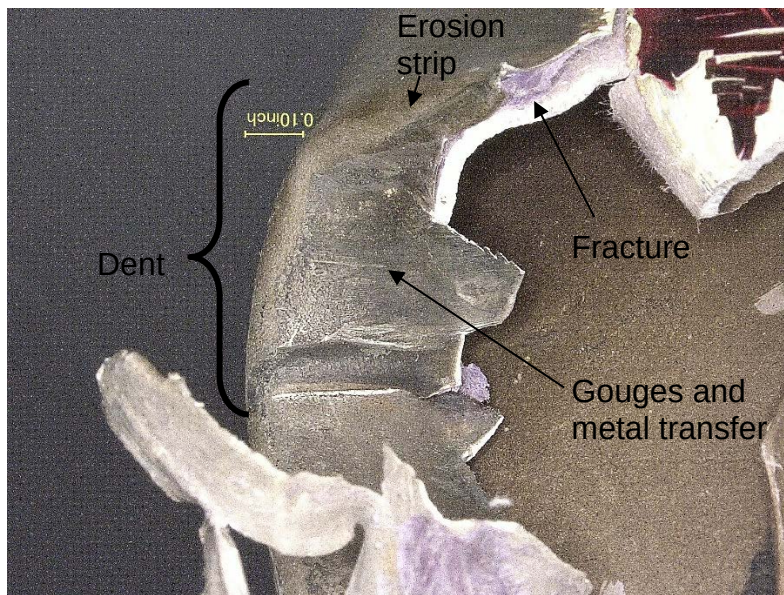
The leading edge of the tail rotor blade contained an erosion strip that was bonded to the blade. A dent was located at the leading edge near the tip end, and this dent contained gouge marks, see figure 2. The fracture at the outer tip of the blade intersected the dent.

Bench binocular microscope examination of the tail rotor blade revealed the fracture faces exhibited a rough texture and on a slant plane consistent with overstress separation, with no evidence of a pre-existing crack. The dent was cut from the tail rotor at the NTSB Materials Laboratory to facilitate examination. Scanning electron microscope examination of the dent revealed gouge marks and evidence of metal transfer on the outer surface. Energy dispersive spectroscopy (EDS) analysis of the erosion strip at the saw-cut portion (representing the base metal) produced a spectrum that contained major elemental peaks of nickel and a minor elemental peak of carbon, see Appendix 1. The gouge marks and metal transfer areas produced a spectrum that contained major

Figure 2. Close-up photograph of a portion of the erosion strip at the leading edge of the tail rotor blade in the area of the dent showing a gouges and metal transfer on the outer face.

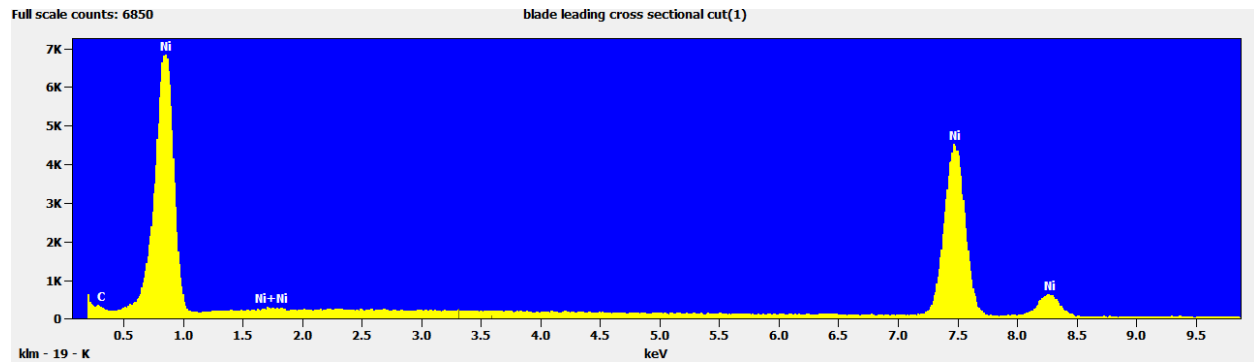
Appendix 1. EDS spectrum of the erosion strip base metal (saw cut area that exposed the base metal) showing major elemental peaks of nickel and a minor elemental peak of carbon.

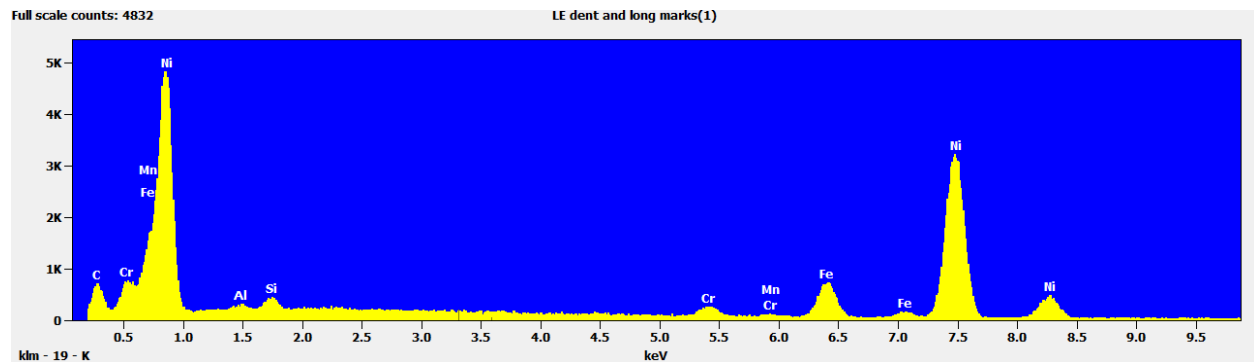
elemental peaks of iron, nickel and chromium, and minor elemental peaks of silicon, aluminum, and manganese, see Appendix 2.

Appendix 2. EDS spectrum of gouge marks and metal transfer found in the dent of the tail rotor blade showing major elemental peaks of iron, nickel and chromium, and minor elemental peaks of silicon, aluminum, and manganese.

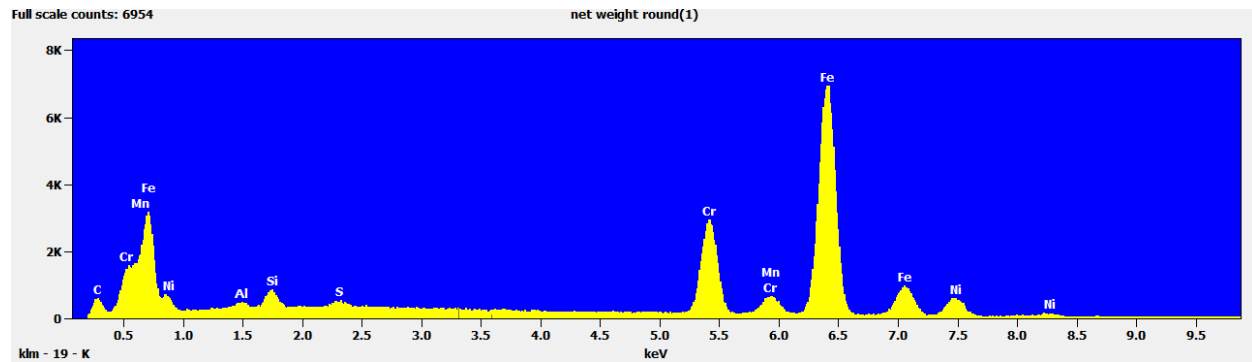
Appendix 3. EDS spectrum of the net weight showing major elemental peaks of iron, nickel and chromium, and minor elemental peaks of carbon, silicon, aluminum, sulfur, and manganese.

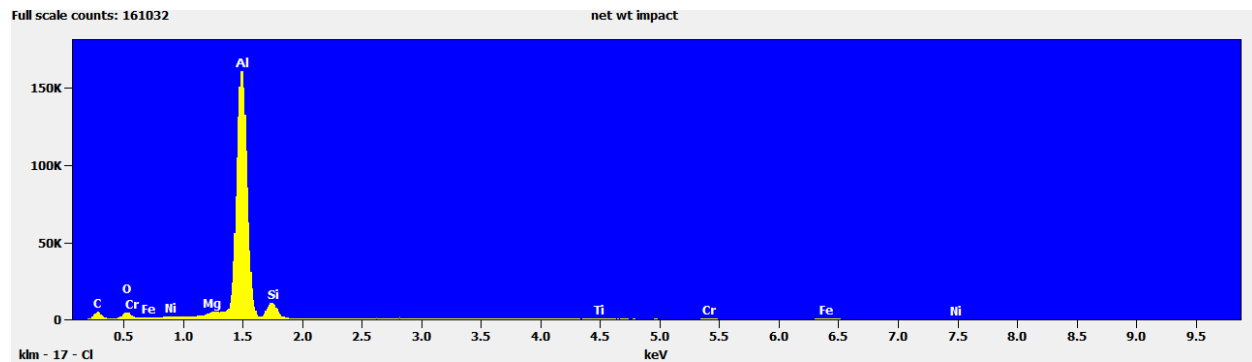
The surface of the net weight contained a tinted area on one side midway between the ends that was slightly darker compared to the other areas. EDS analysis of the outer surface produced an EDS spectrum that contained major elemental peaks of iron, nickel and chromium, consistent with stainless steel, and minor elemental peaks of carbon, silicon, aluminum, sulfur, and manganese, see Appendix 3. The net weight was weakly attracted to a magnet consistent with a ferrous alloy. The area that exhibited a dark tint produced a spectrum that contained major elemental peaks of aluminum and silicon and minor elemental peaks of iron, carbon, chromium, nickel, titanium and oxygen, see Appendix 4.

Appendix 4. EDS spectrum of the net weight in the area that exhibited a darker tint relative to other areas showing a major elemental peak of aluminum and silicon and minor elemental peaks of iron, carbon, chromium, nickel, titanium and oxygen.

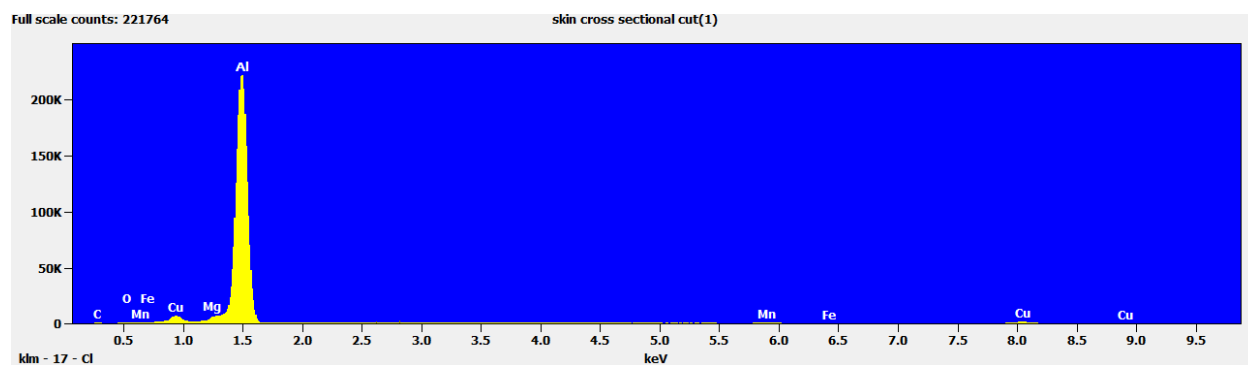
Appendix 5. EDS spectrum of the tail boom outer surface in the saw cut area (base metal) showing a major elemental peak of aluminum and minor elemental peaks of magnesium, manganese, iron, copper, carbon, and oxygen.

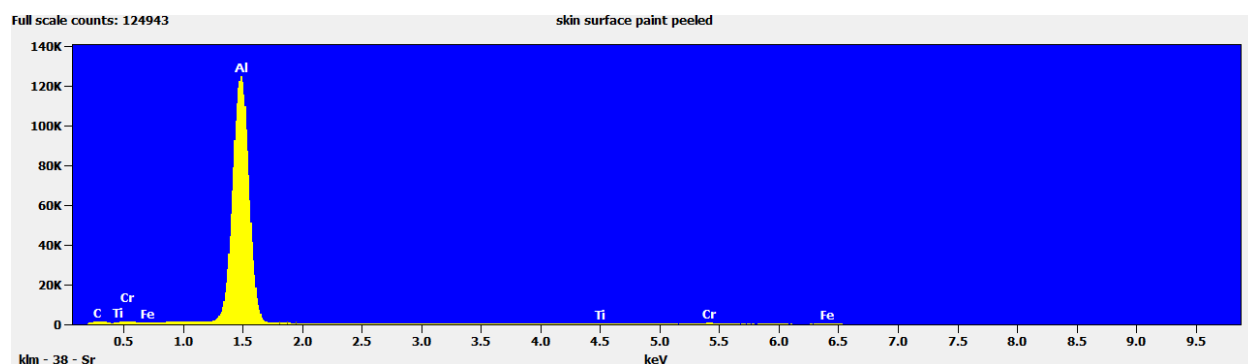
Appendix 6. EDS spectrum of the tail boom from an area where paint was intentionally peeled at the NTSB materials laboratory to expose the bare metal outer face showing a major elemental peak of aluminum and minor elemental peaks of iron, chromium, titanium, and carbon.

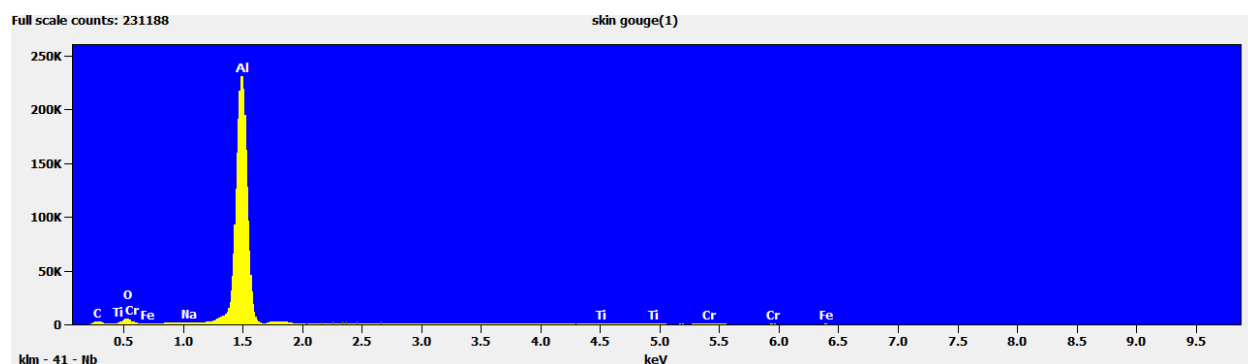
The outer face of the cut-out skin piece from the tail boom contained several gouge marks that penetrated and exposed bare metal. EDS spectrum from the saw cut area (base metal) contained a major elemental peak of aluminum and minor elemental peaks of magnesium, manganese, iron, copper, carbon, and oxygen, see Appendix 5. EDS spectrum of exposed metal from an area where paint was intentionally peeled at the NTSB materials laboratory to expose the bare metal outer face contained a major elemental peak of aluminum and minor elemental peaks of iron, chromium, titanium, and carbon, see Appendix 6. EDS spectrum of exposed metal within the largest gouge mark contained a major elemental peak of aluminum and minor elemental peaks of iron, chromium, titanium, chromium, sodium, carbon, and oxygen, see Appendix 7.

Appendix 7. EDS spectrum of the tail boom at the gouge mark showing a major elemental peak of aluminum and minor elemental peaks of iron, chromium, titanium, chromium, sodium, carbon, and oxygen.
