## **NATIONAL TRANSPORTATION SAFETY BOARD**

# **AIRFRAME AND ENGINE EXAMINATION**

**WPR18FA074**

Location: Pomeroy, WA  
Date: January 27, 2018  
Aircraft: Hughes 369D, Registration N369TH, Serial #1000830D  
NTSB IIC: Samantha Link

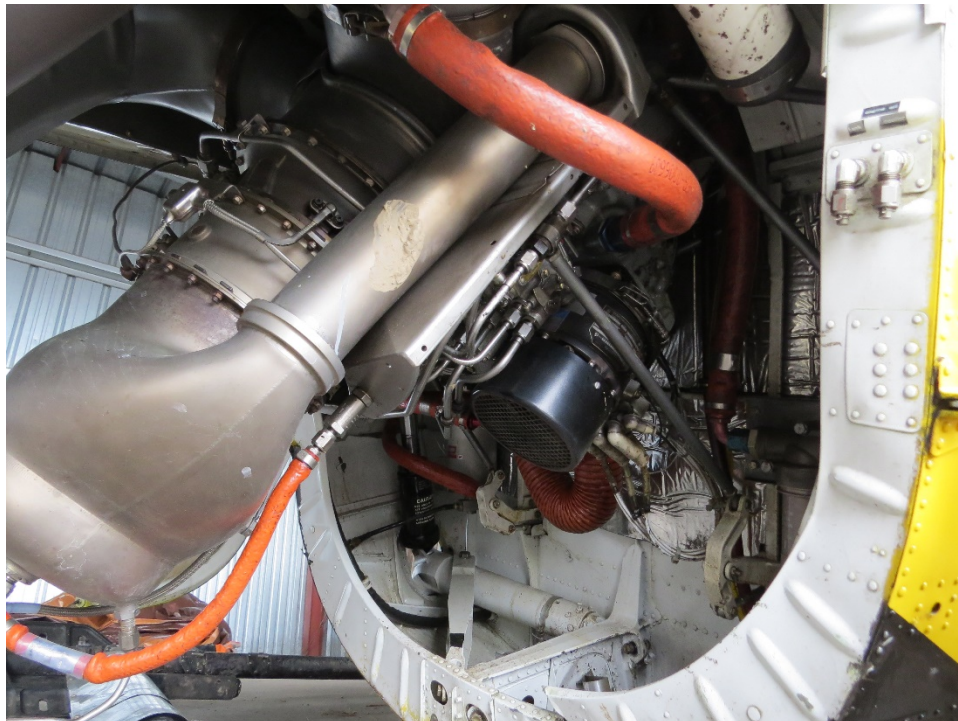
- The engine remained in position and was securely attached to the airframe
  - No significant impact damage was noted to the engine
  - No obvious catastrophic anomalies were noted
- Ample oil was present in the engine oil reservoir
  - Oil was clean and bright, with no abnormal odors noted
- Control continuity from the cockpit to the engine could not be established due to deformation of the fuselage and cabin area
- Exhaust ducts were removed to facilitate access to the power turbine
  - No evidence of damage
  - When rotated by hand, the power turbine rotated smoothly, and continuity was established to the main rotor and tail rotor drive shafts
- The gas generator turbine was boroscoped

Figure 1: Overall View of Engine

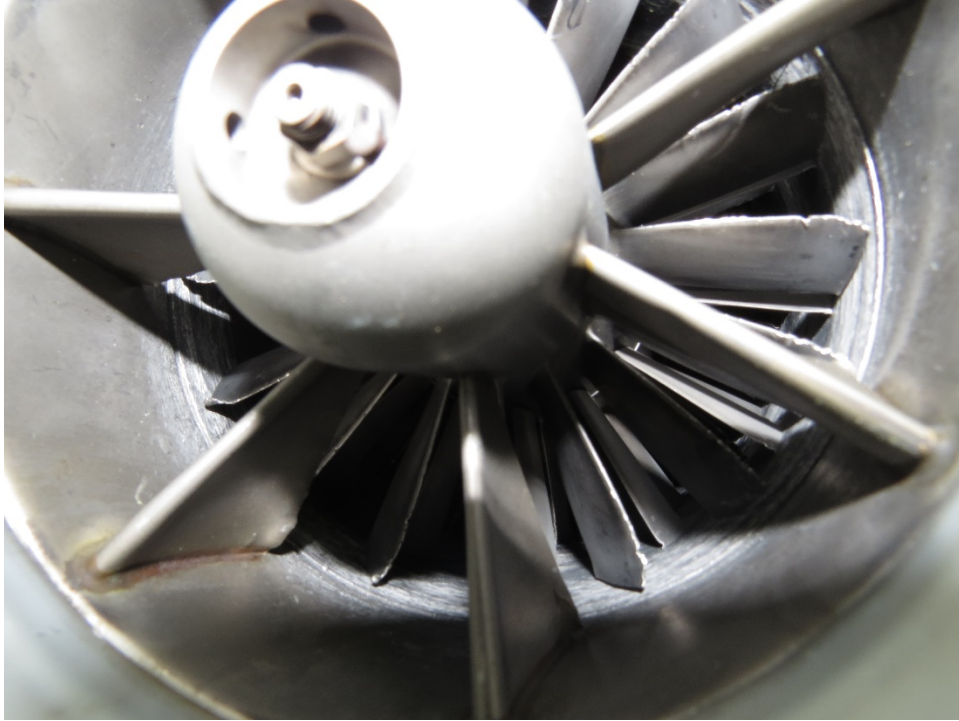
- Inlet plenum was accessed to inspect the compressor
  - o Tail rotor drive shaft was broken within the plenum
  - o Compressor was damaged consistent with foreign debris

- o When rotated the compressor moved freely
- The fuel supply line to the fuel spray nozzle was removed
  - o About one teaspoon of clean, clear liquid that smelled of 'Jet A' fuel was present

Figure 2: Compressor

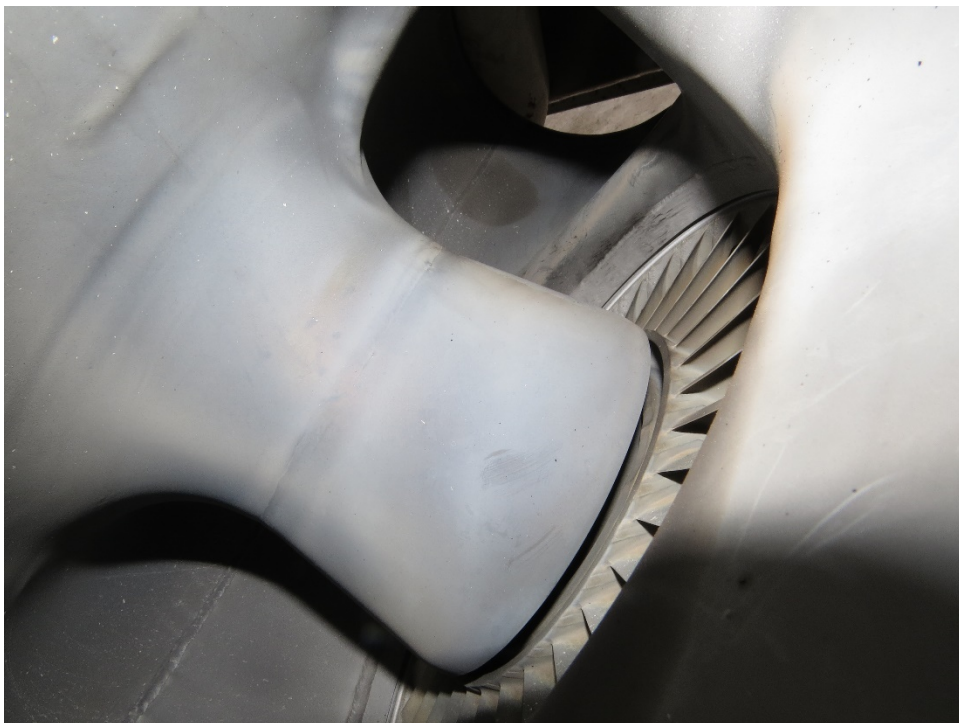
- o Displayed no evidence of operational damage, thermal discoloration, or damage consistent with an abnormal combustion.
  - o Metal splatter was noted on the 1<sup>st</sup> stage turbine nozzle shield

Figure 3: The Power Turbine

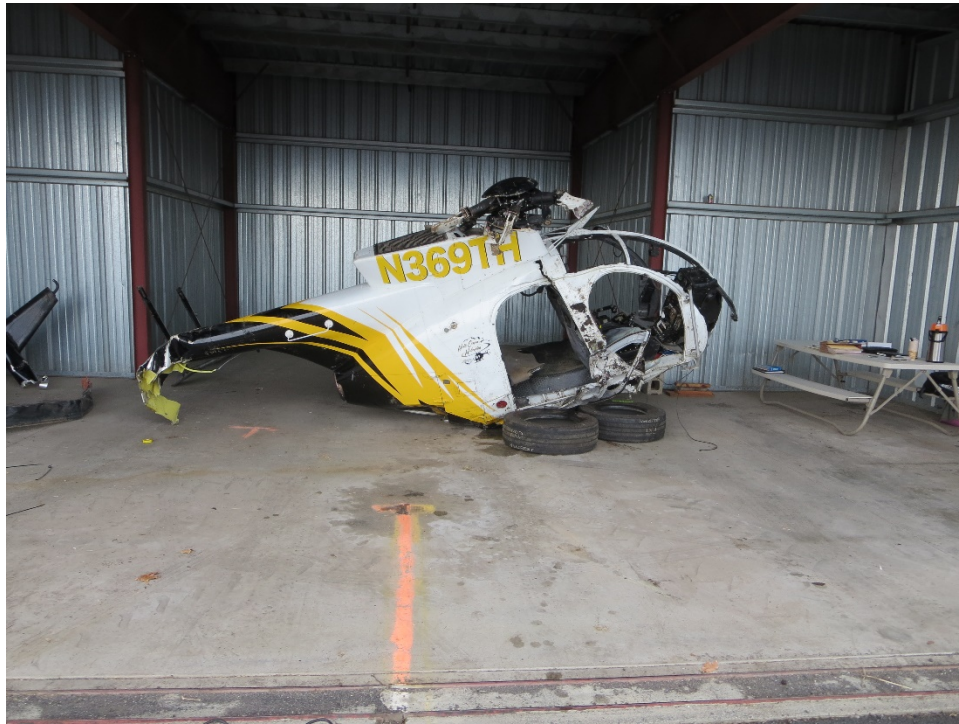
- The forward fuselage exhibited substantial impact damage
  - The right side was crushed inward
  - The bottom of the fuselage was bent and deformed on both the left and right sides

- Most doors were removed prior to the accident flight.
    - The right-side passenger door was observed attached, but was crushed and damaged.
- The lower fuselage exhibited upward and inward crushing on the right side

- The pilot floor support bulkhead and floor were bent and distorted
  - The right seat support structure exhibited downward and sideward crushing; the left seat support exhibited slight crushing of the seat pan

- The canted frame and lower bulkhead behind the pilot/copilot seats were bent and distorted
  - The lower strike protection assembly was fracture separated, but was otherwise undamaged

Figure 4: Fuselage

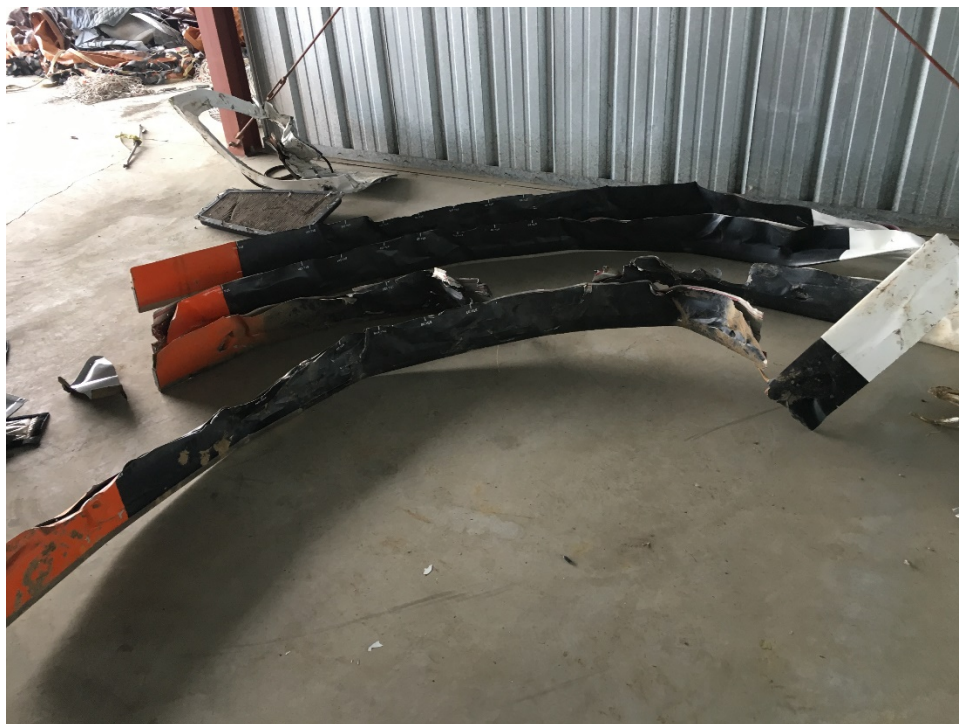
- The main rotor blades exhibited extensive damage consistent with being driven under power
  - All five main rotor blades were fracture separated and appeared to be bent and warped in a similar manner

- Two blades were mostly whole, however, warped
    - One blade was warped; however, the tip was fracture separated
    - One blade sustained extensive trailing edge damage, was warped, and separated into several pieces

Figure 5: Four of the Five Main Rotor Blades

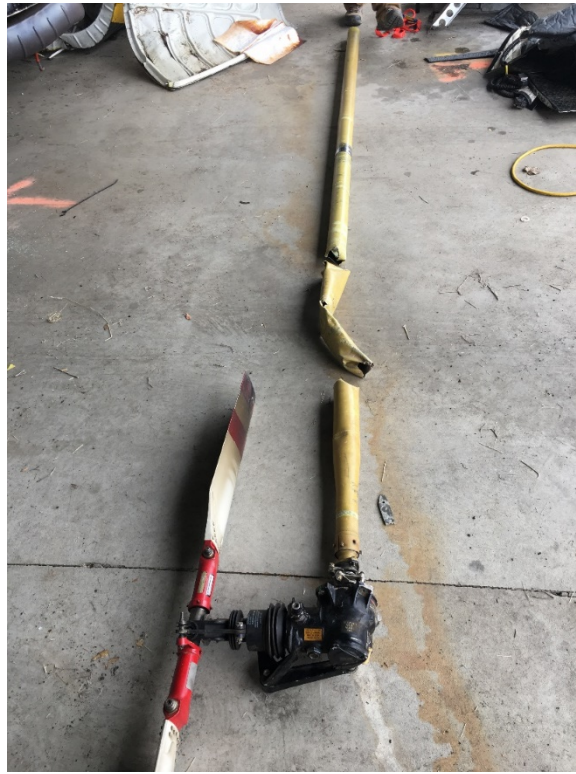
- The tail rotor drive shaft was fracture separated into three pieces and exhibited extensive rotational scoring particularly towards the aft end of the drive shaft

- The fractures were just aft of the main transmission output pinion, at the tailboom fracture, forward of the tail rotor transmission, and at the tail rotor transmission.

- The tail rotor assembly and transmission were mostly intact and fracture separated from the end of the tailboom
  - Flex couplings on the tail rotor transmission coupling were fractured

- Tail rotor stop and tail rotor hub exhibited contact marks and dents consistent with excessive tail rotor blade flapping
  - The tail rotor blades remained attached to the hub

**Figure 6: Tail Rotor Drive Shaft and Tail Rotor Assembly**

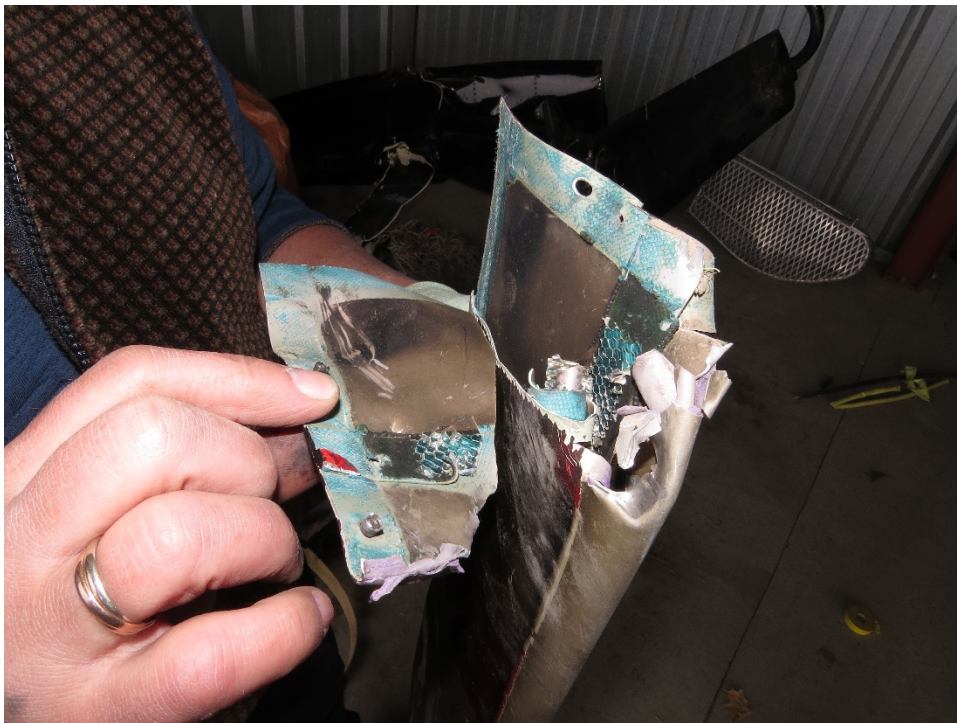
- One blade appeared undamaged
    - The second blade sustained damage to the outboard most two inches
      - One side of the tail rotor skin was fracture separated.

- The weight and blade endcap were fracture separated and unable to be located
      - The damaged section of the blade was bent and curled

**Figure 7: Outboard End of Tail Rotor Blade**

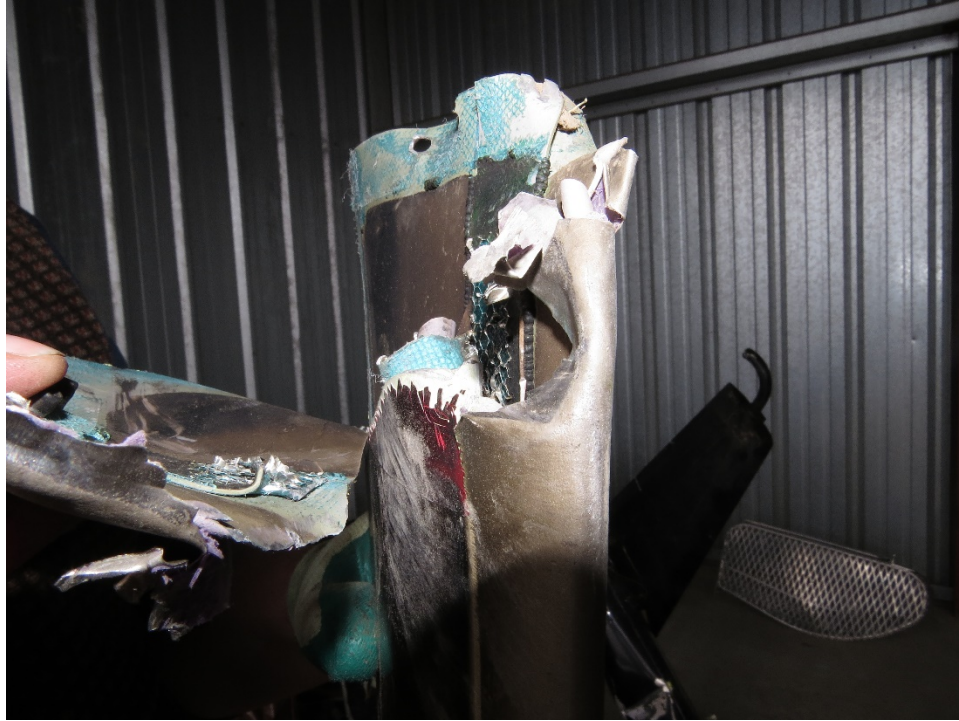
**Figure 8: Leading Edge of Outboard Tail Rotor Blade**

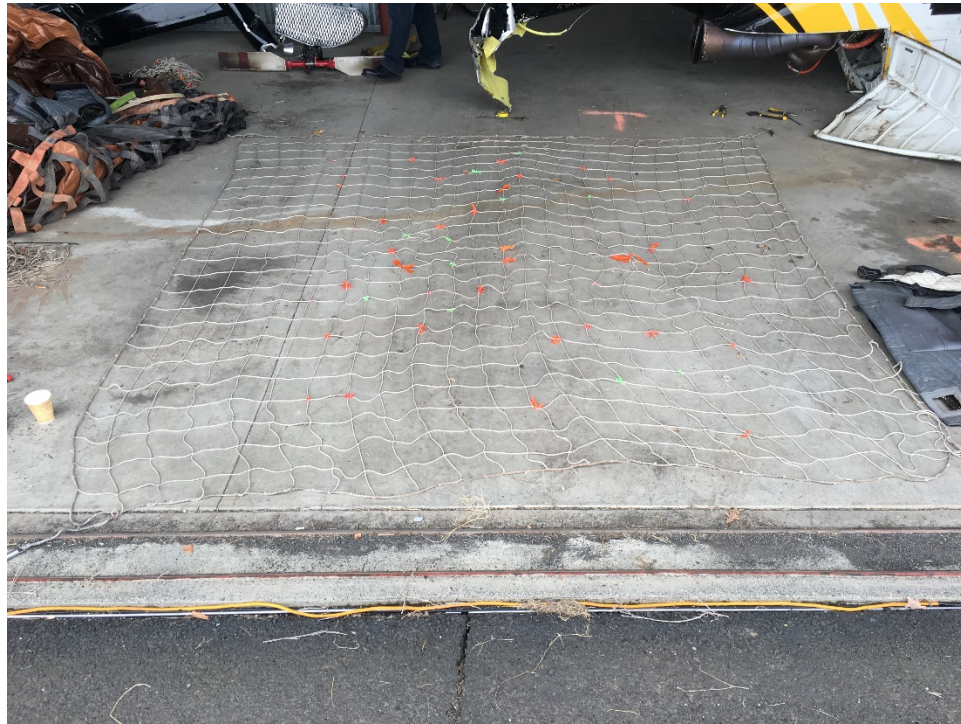
- The two nets found on scene were located just north of the main wreckage. One net was mostly closed just north of the main wreckage. A second, half opened, net was found further north and slightly up the western ravine wall.
  - The northern most net, which was found about half open, was laid out
    - No damage was present to the netting
    - The four corner weights were present and undamaged
  - The net found just north of the main wreckage, which was found mostly closed except for one weight extended outward, was laid out and examined
    - The netting was undamaged.
    - Three of the weights appeared to be undamaged
    - The fourth weight (which was the one found extended from the rest of the net) exhibited heavy scratch marks, and the rubber ring was missing.

Figure 9: Northern Most Net

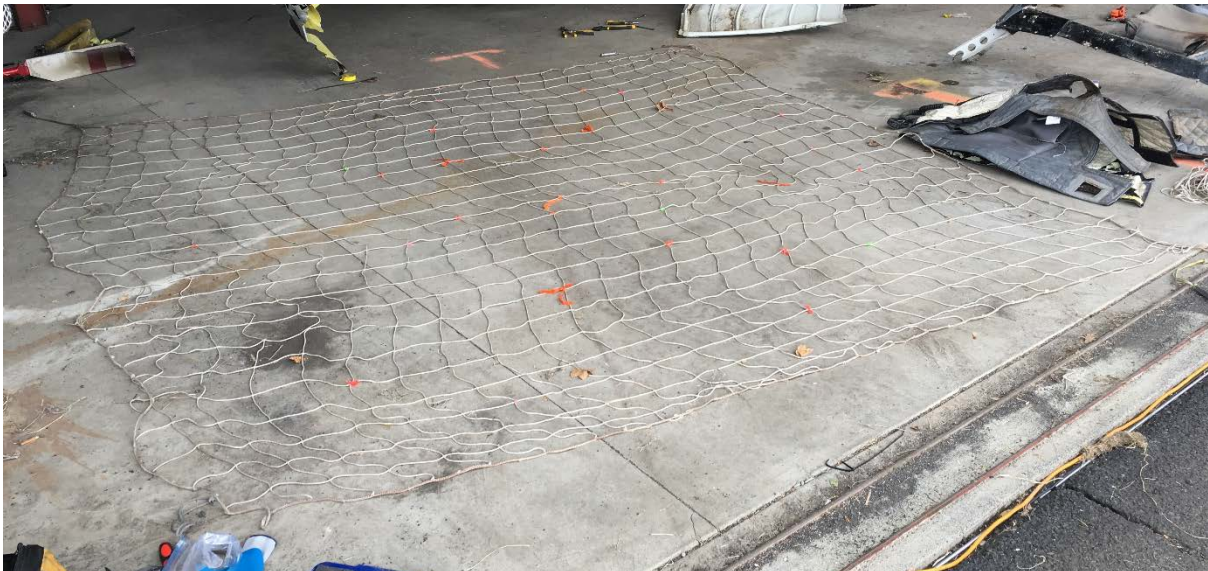
Figure 10: Net Closest to Main Wreckage

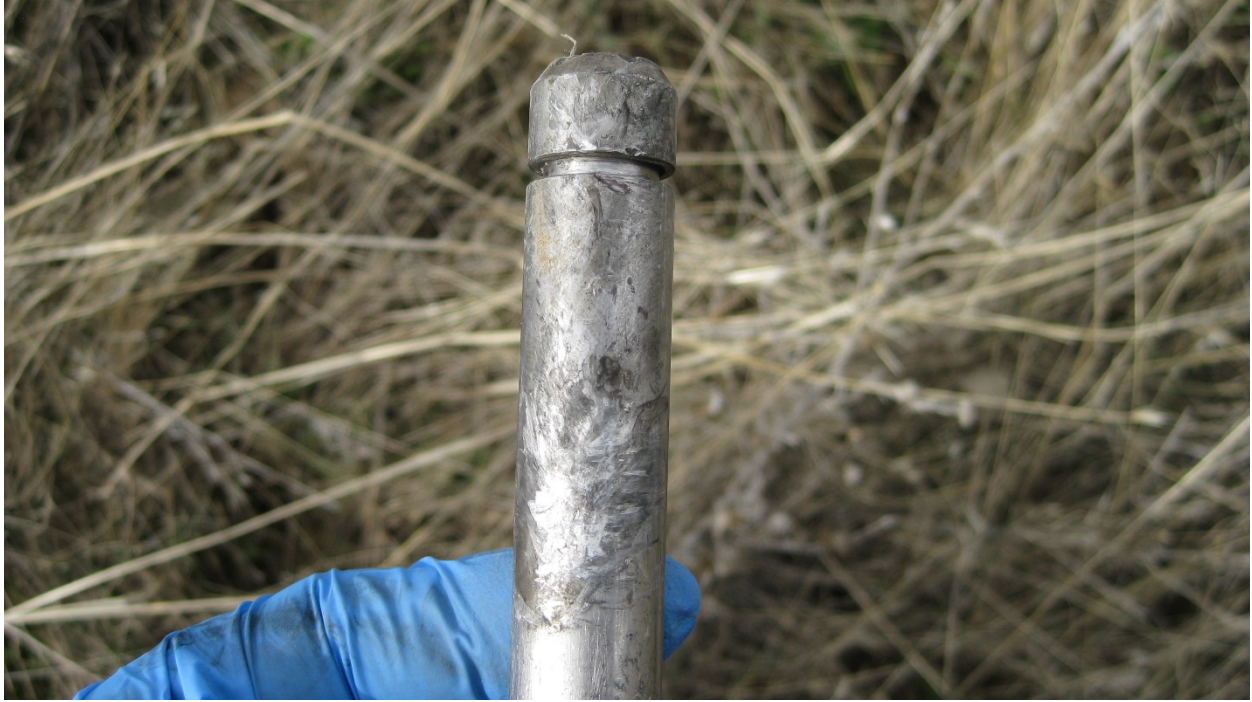
Figure 11: The Damaged Weight
