## **NATIONAL TRANSPORTATION SAFETY BOARD**

### **ONSITE EXAMINATION NOTES**

**WPR18FA075**

Location: Concord, CA  
Date: January 29, 2018  
Aircraft: N93316  
NTSB IIC: Albert Nixon

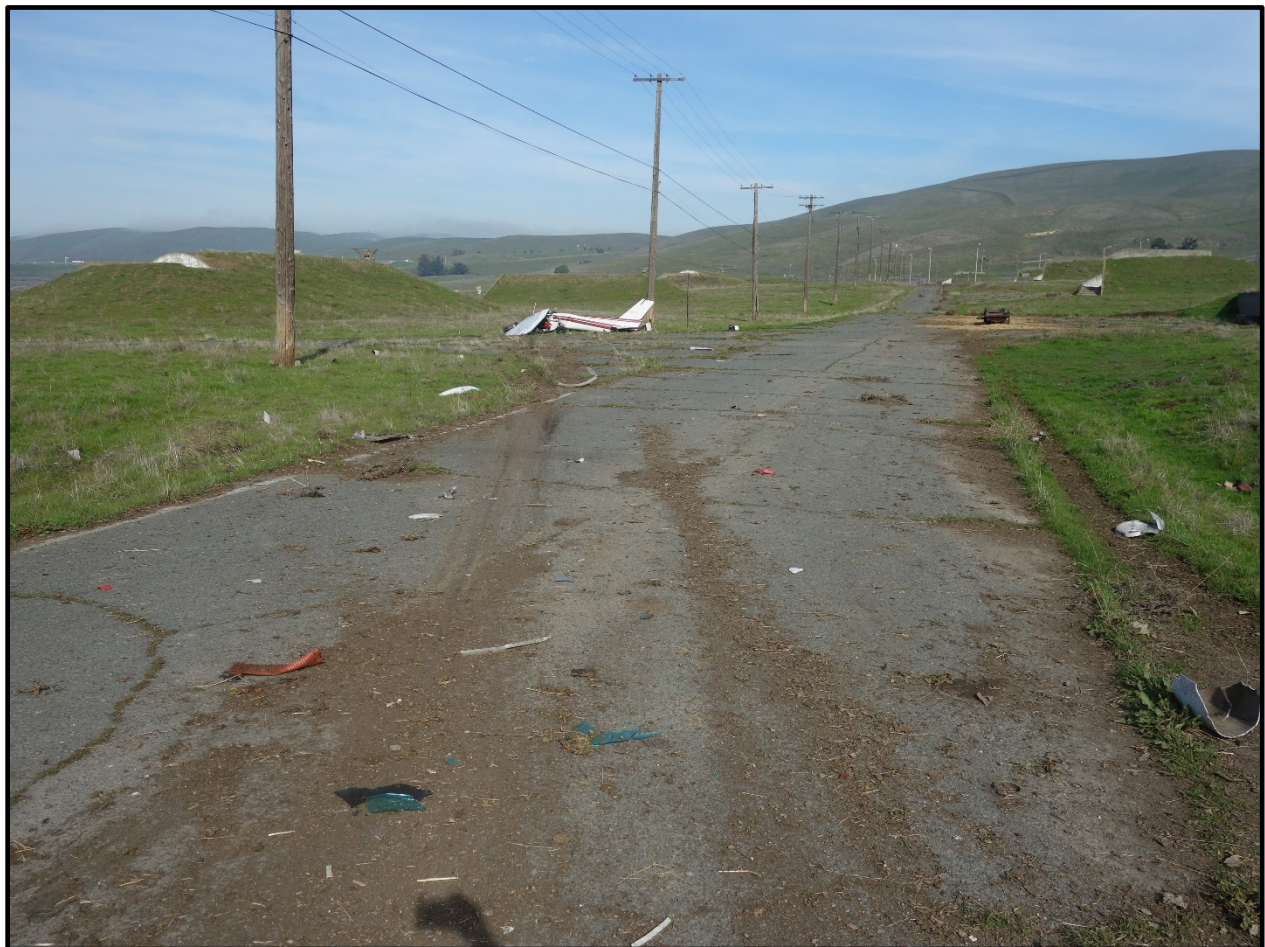
The wreckage was located near the Military Ocean Terminal Concord facility, on the Navy Base Realignment and Closure (BRAC), property, at an elevation of about 156 ft mean sea level. The airplane impacted the ground in a near wings levels and about a 45° nose down pitch attitude. The airplane fuselage was oriented on a heading of about 270°.

The first point of impact was an impression in the dirt and asphalt where the three landing gear imprints could be identified. The right wing's impression in the dirt could also be identified. A propeller blade tip was located in the disturbed area of the dirt and asphalt, about 2 inches long, 1 inch wide, and ½ inch in depth, just forward of the gear impressions. From the initial point of impact, the airplane began to skid for about 290 ft. After coming to rest upright, the carburetor, propeller, battery, and a fire extinguisher, separated from the main wreckage and were located

Figure 1: Airplane wreckage and ground scars as viewed from the left.
