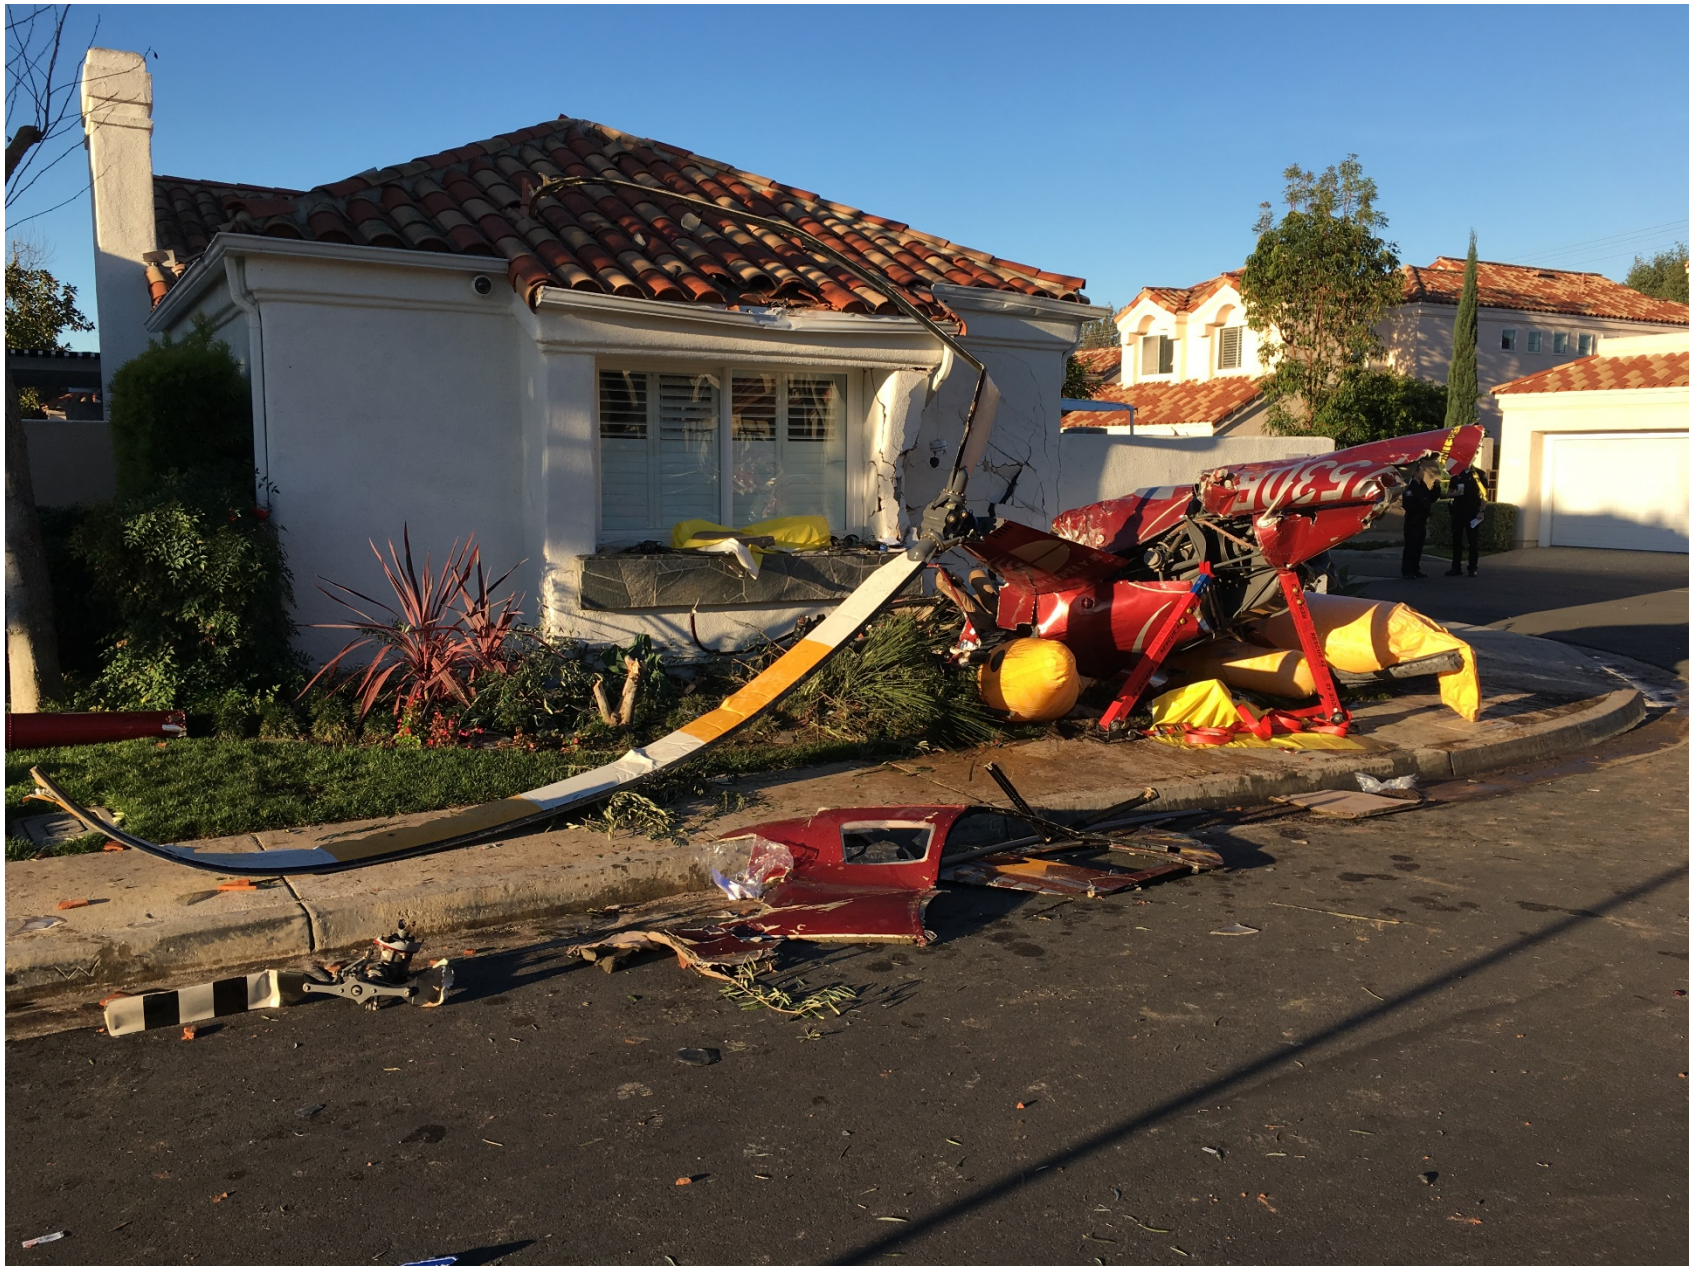
**Photo 1 – View of the main wreckage.**

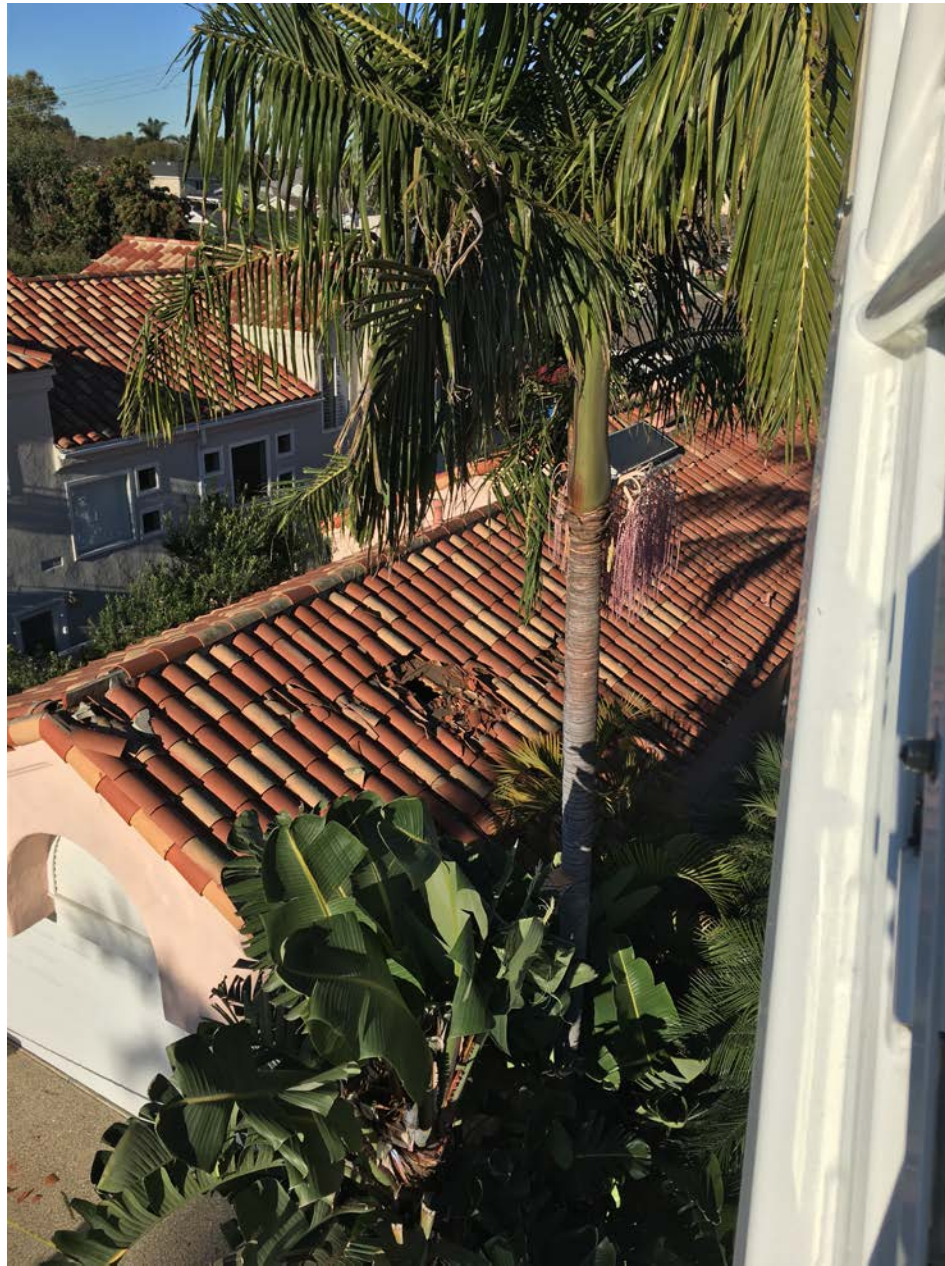
**Photo 2 - Area where the tail rotor was located.**

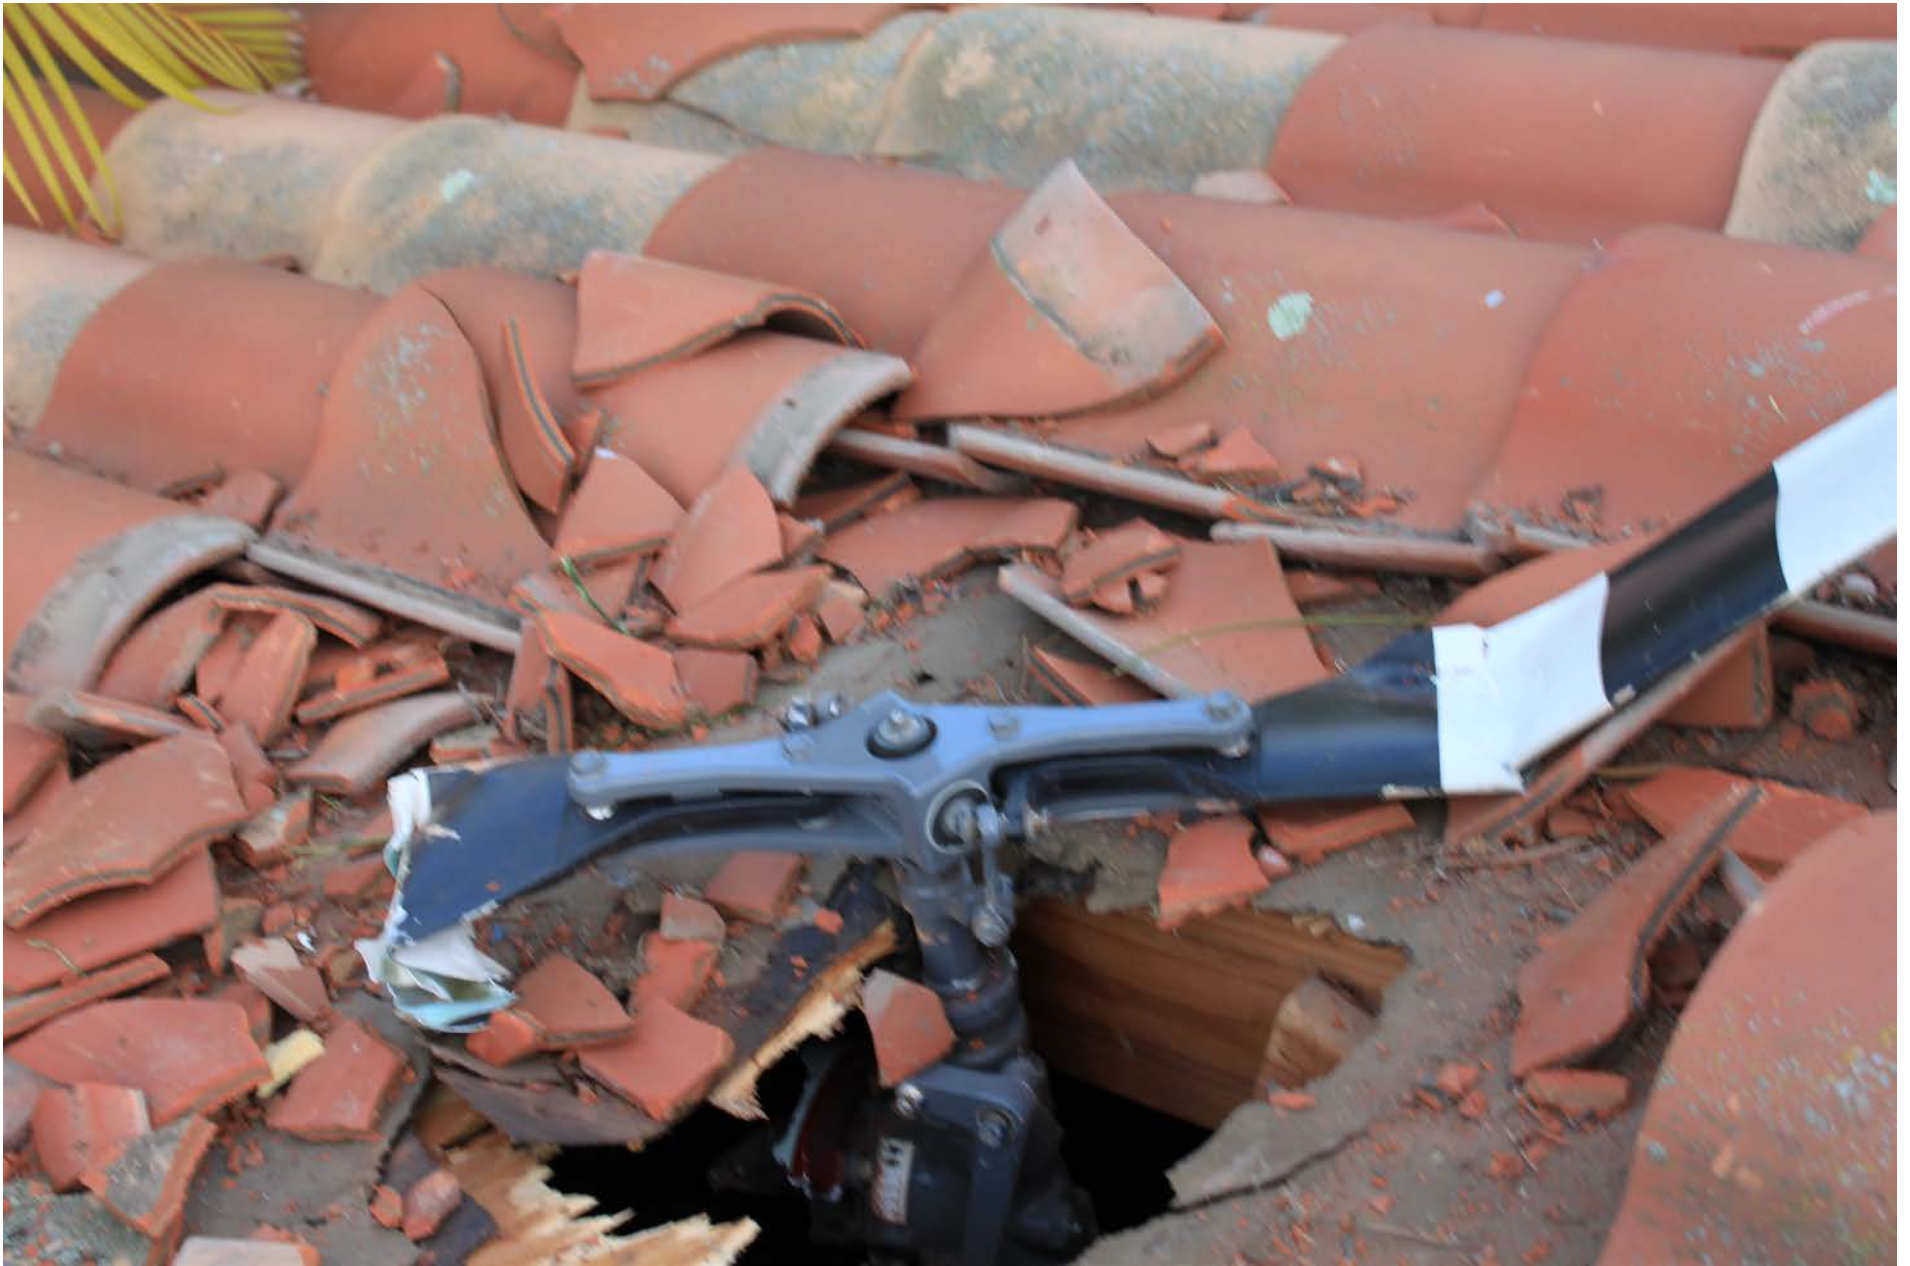
**Photo 3 - Tail rotor as located.**

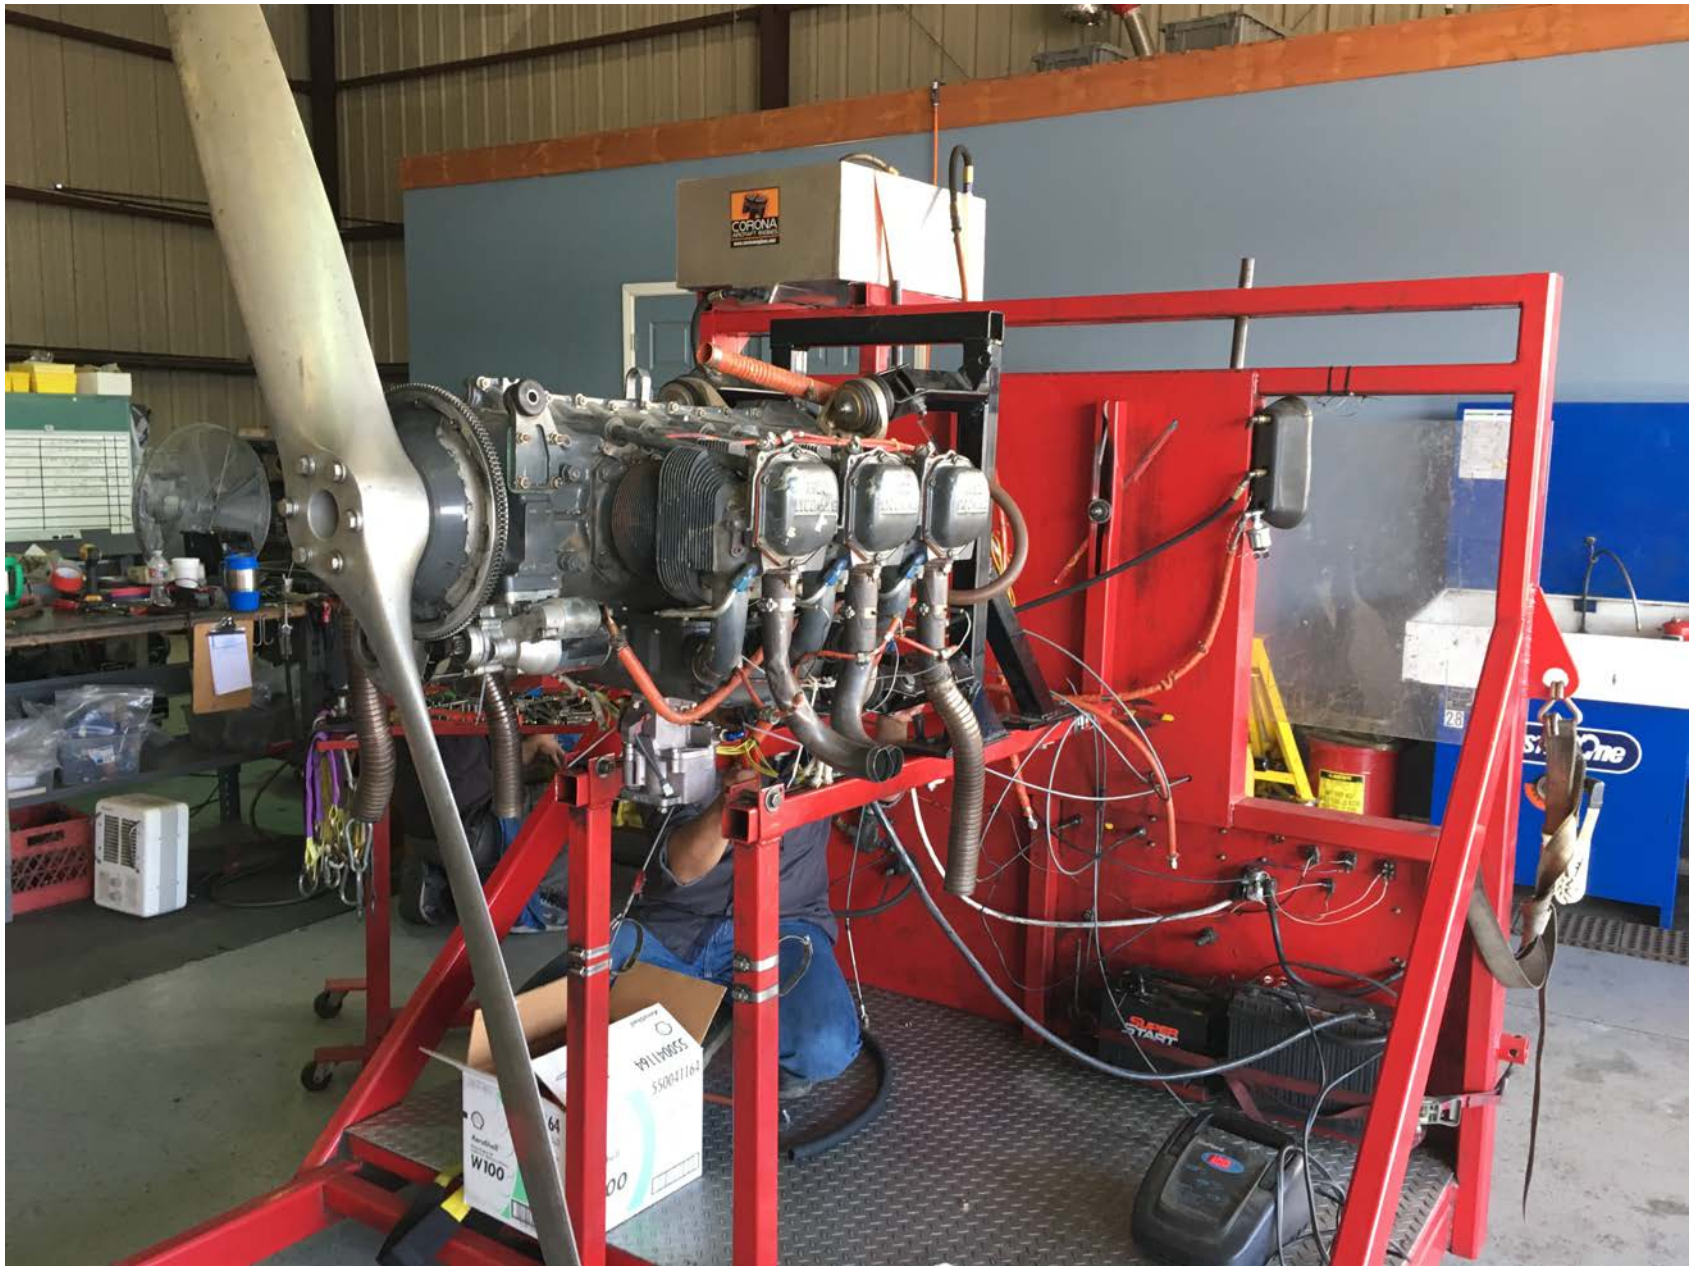
**Photo 4 - The engine prepared for an engine run.**

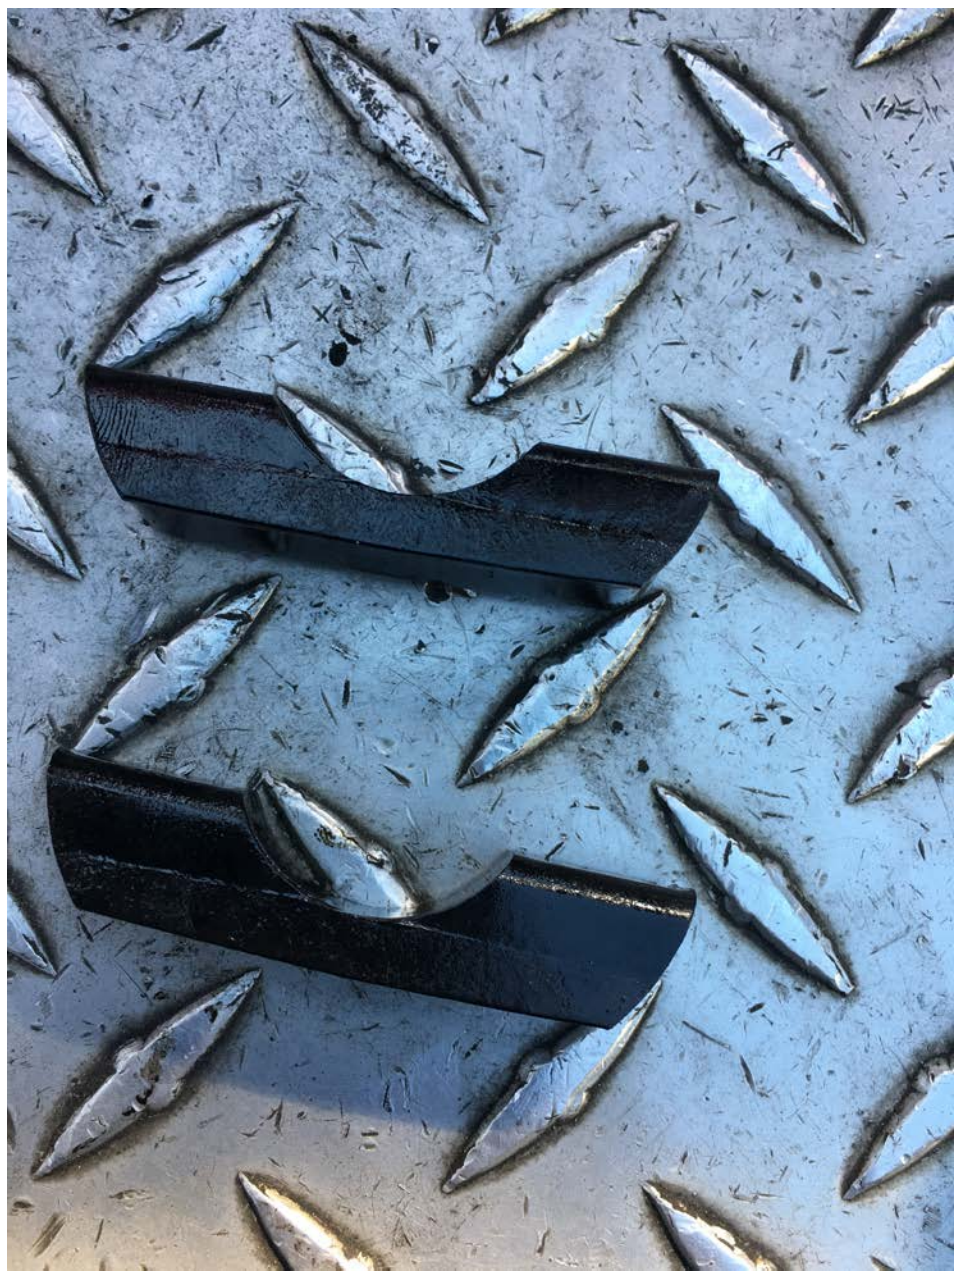
**Photo 5 - Magneto bushings located in the oil screen.**
