**NATIONAL TRANSPORTATION SAFETY BOARD**

**AIRFRAME AND ENGINE EXAMINATION**

**WPR18FA084**

Aircraft: Airplane Cessna 182T, Registration Number: N3525T, Serial #: 18280965

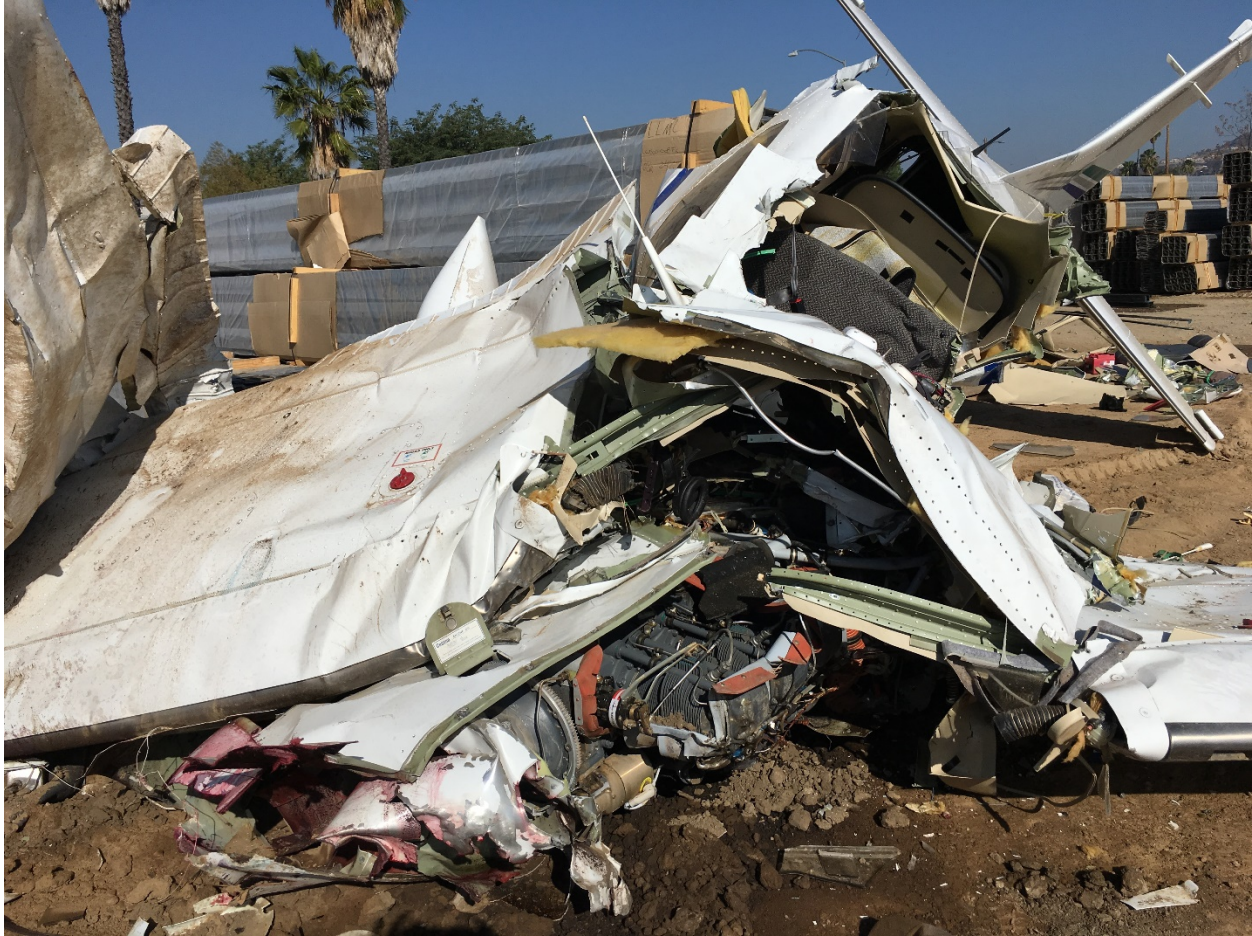
Photo 03 – Main Wreckage (NTSB)

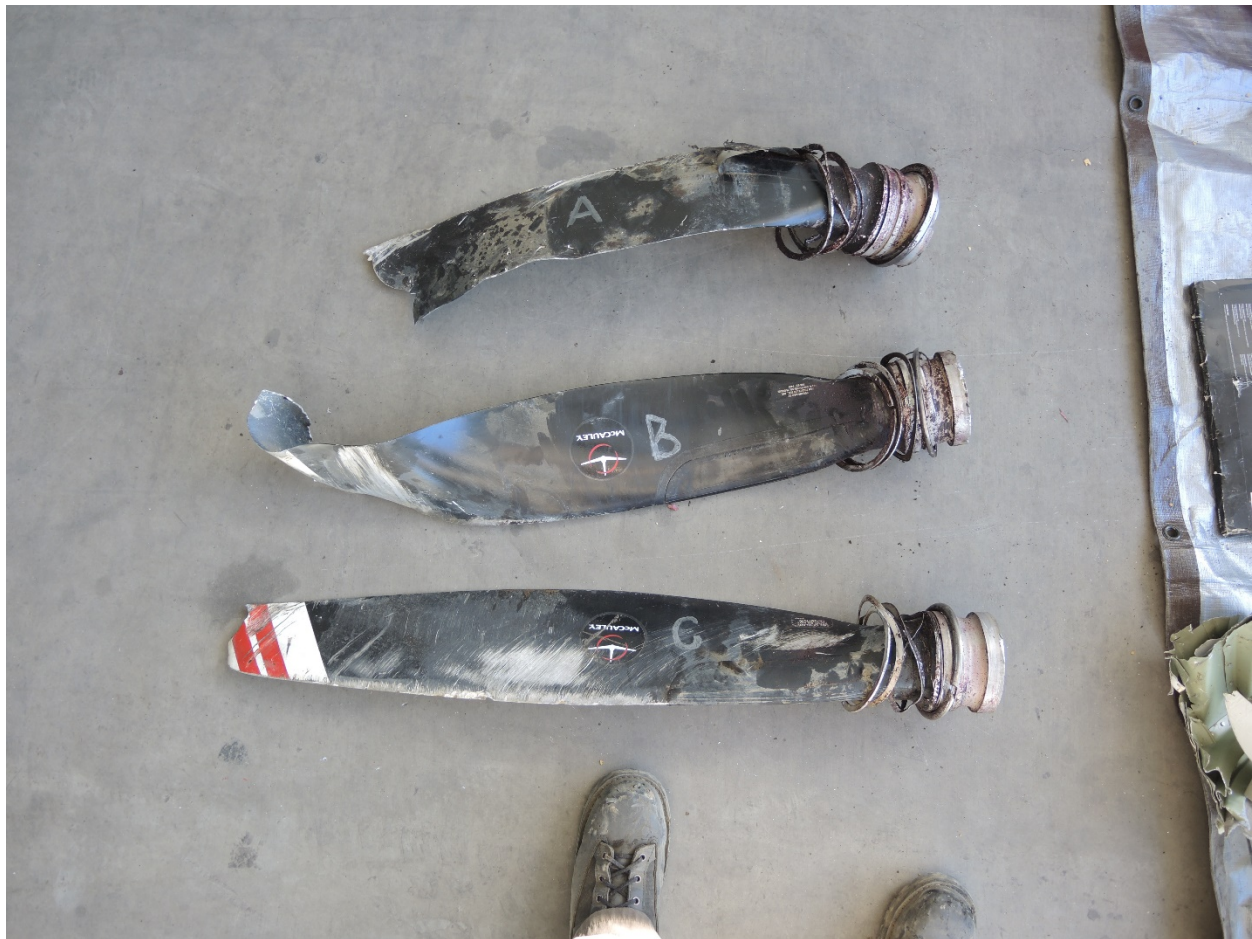
Photo 04 – Propeller Blades (NTSB)

The propeller was a McCauley 3-bladed propeller. All 3 propeller blades fully separated from the hub, and a portion of the propeller hub remained attached to the engine. All 3-propeller blades had leading and trailing edge nicks and gouge marks, torsional twisting and chordwise striations across the

cambered surface of propeller blades "B" and "C." Blade "A" was missing about 6 inches of the outboard portion of the blade. Blade "C" also was missing the tip.
