# NATIONAL TRANSPORTATION SAFETY BOARD

MATERIALS LABORATORY FACTUAL REPORT

Report No. 18-072

Place : Agua Dulce, California  
Date : February 11, 2018  
Vehicle : Cirrus Design VK-30, N52TH  
NTSB No. : WPR18FA088  
Investigator : Jack Vanover, AS-WPR

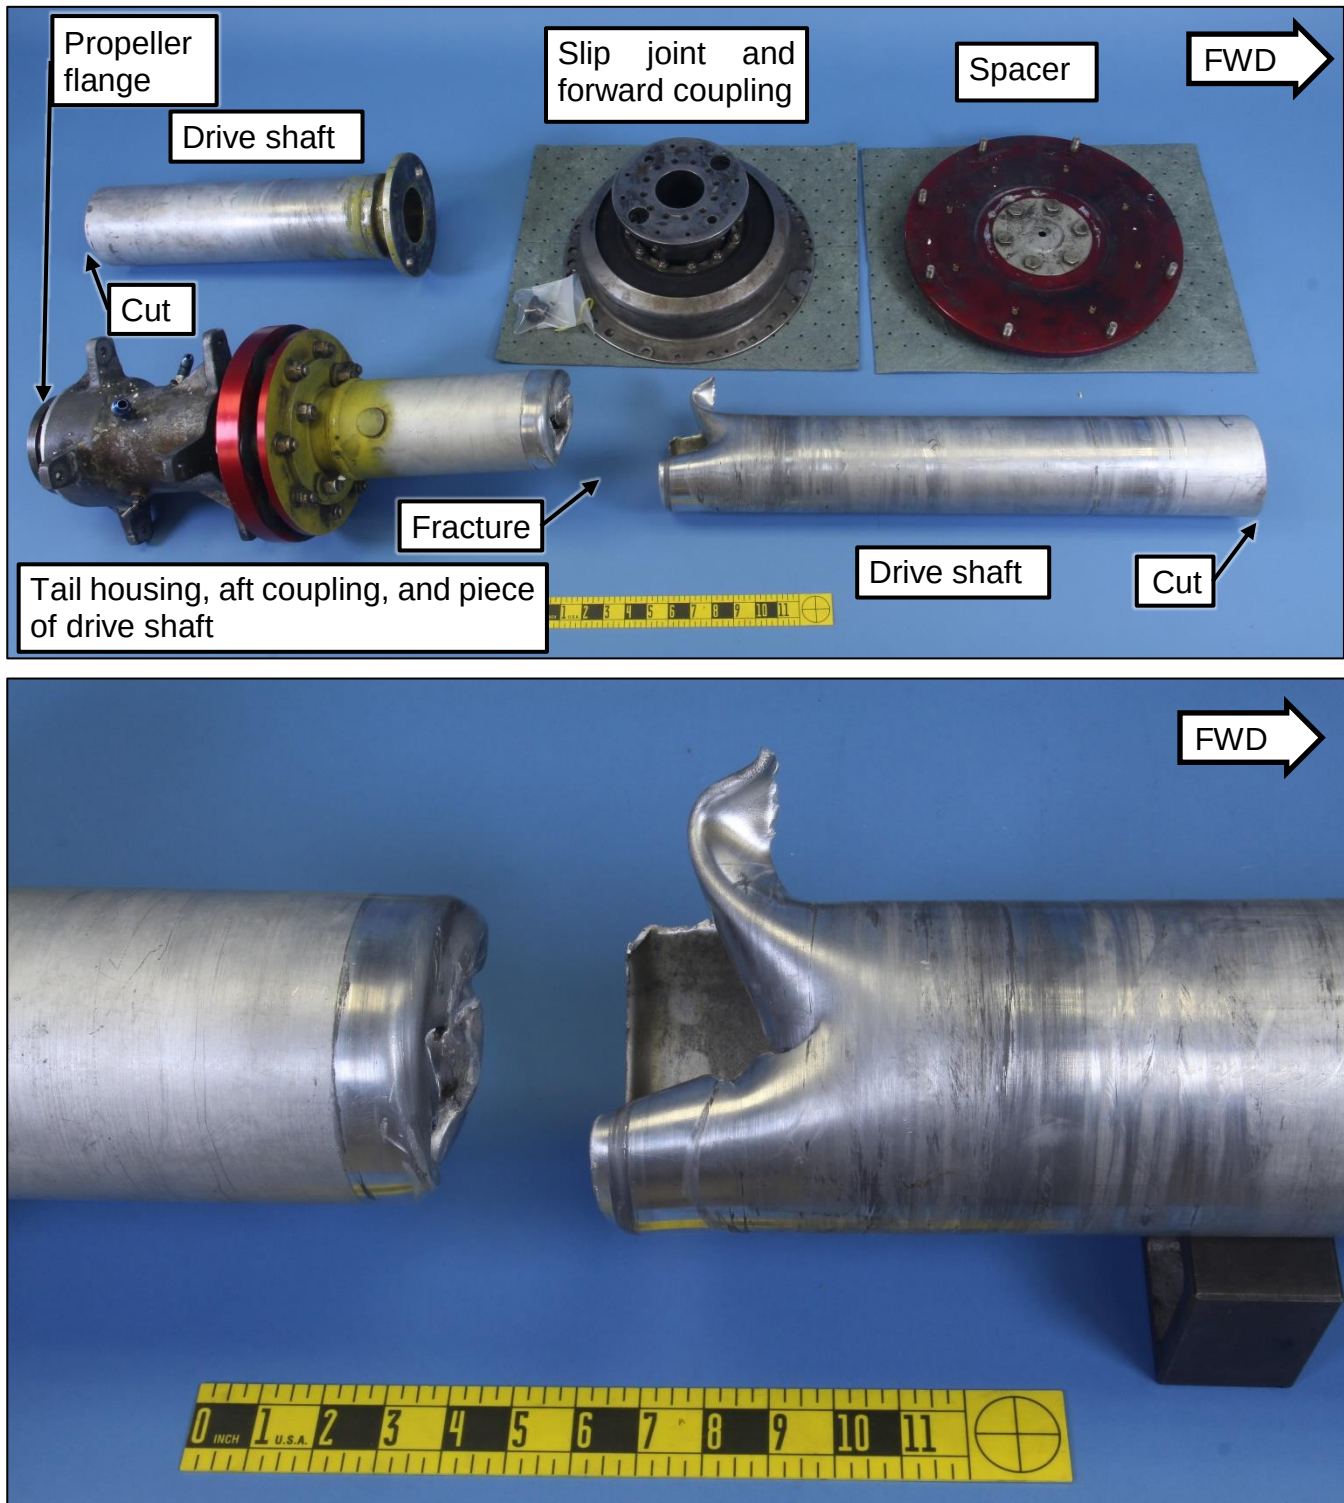
Components of the propeller drive assembly including the tail housing, aft coupling, propeller extension drive shaft, slip joint, forward coupling, and spacer were submitted for examination as shown in figure 1. The Cirrus Design VK-30 is designed with the propeller located at the aft end of the fuselage. As assembled on the airplane, the propeller flange (see figure 1) is located at the aft end of the tail housing, and the spacer attaches to an adapter ring on the engine. As indicated in figure 1, the drive shaft was fractured forward of the aft coupling, and the drive shaft had been cut at the location indicated to facilitate shipment to the NTSB Materials Laboratory.

A closer view of the fracture in the drive shaft is shown in the lower image in figure 1. The fracture around most of the circumference was in a transverse plane with secondary fractures extending longitudinally. On the forward side of the fracture, the shaft wall was bowed inward adjacent to the fracture and slightly outward within approximately  $\frac{1}{2}$  inch of the fracture. Around approximately  $\frac{1}{3}$  of the circumference, the shaft wall was folded over on itself and bent forward and outward.

Figure 1. Overall view of the submitted components (upper image) with a closer view of the drive shaft fracture (lower image).

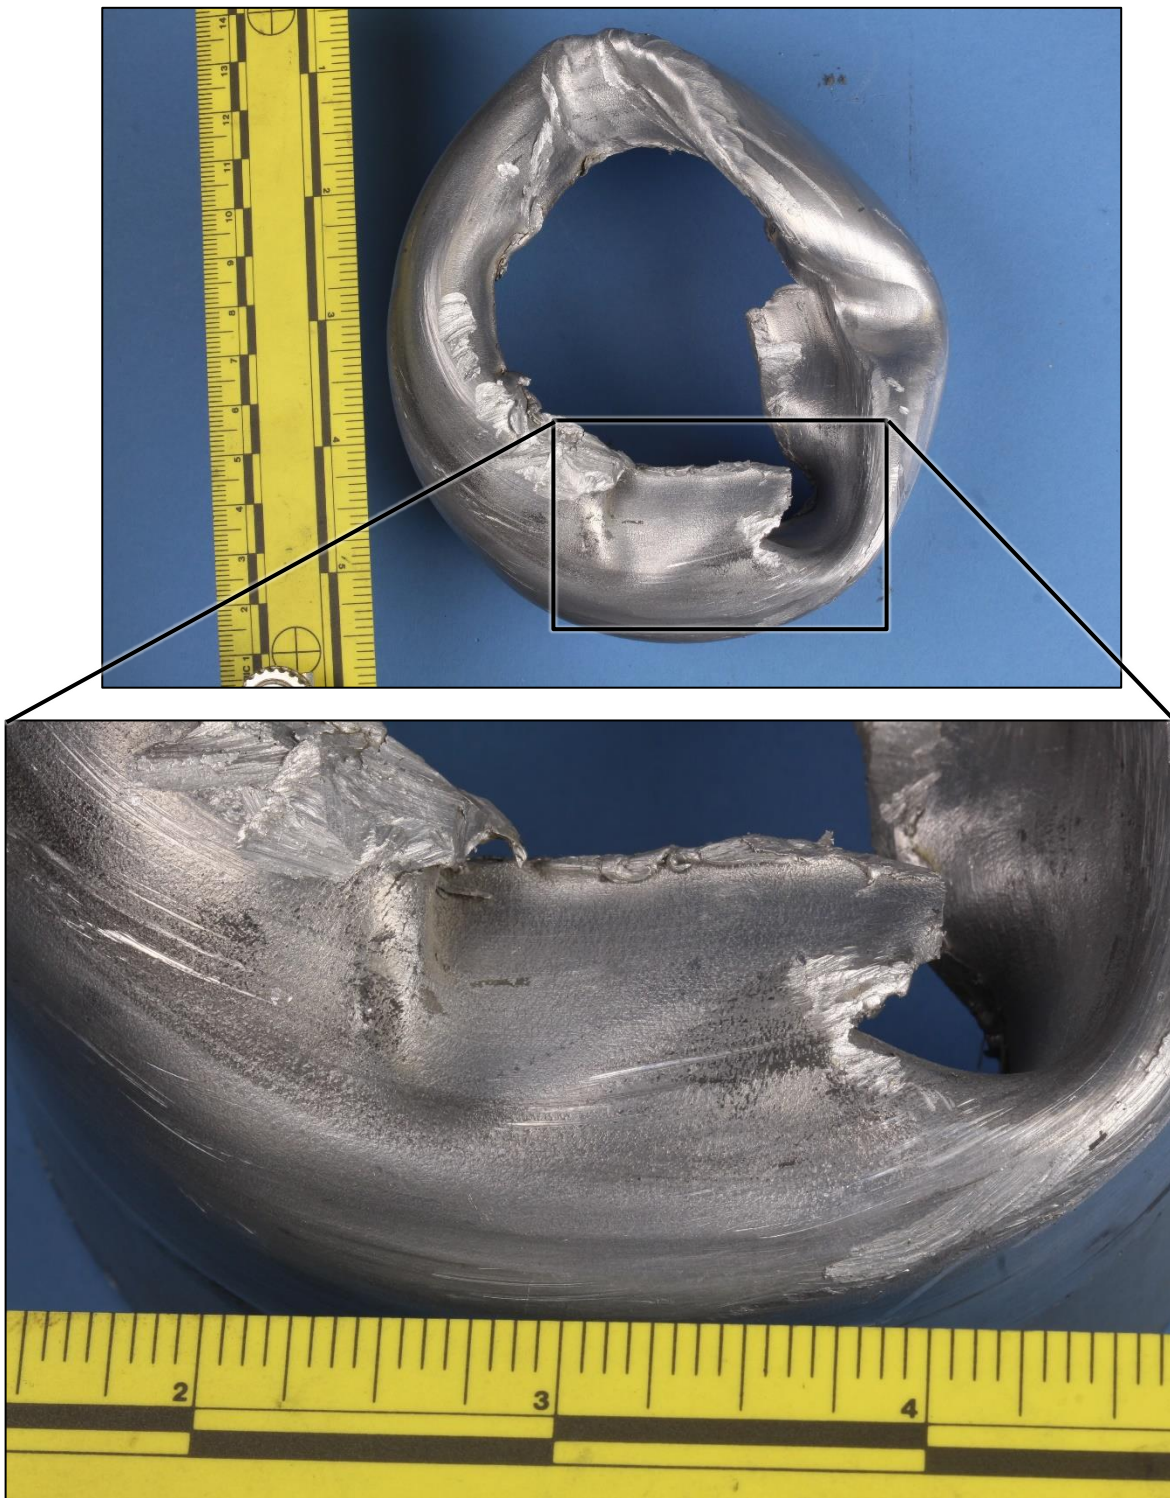
A transverse cut was made through the shaft aft of the fracture location to facilitate an examination of the aft side of the fracture, and views of the aft side of the fracture are shown in figure 2. The shaft was folded and bent inward, and multiple impacts corresponding to contact with the mating side of the fracture were observed. A closer view of a relatively protected area of the fracture is shown in the lower image in figure 2. No evidence of circumferential scoring was observed on the surface adjacent to the fracture.

Fracture surfaces on the forward and aft sides of the primary fracture in the transverse plane were examined. However, the fracture surfaces on both sides of the fracture were obliterated by smearing and post-fracture contact damage.

Figure 2. Overall view of the aft side of the fracture after sectioning from the rest of the drive shaft (upper image) with a closer view of the surface adjacent to the fracture where the wall was folded inward (lower image).

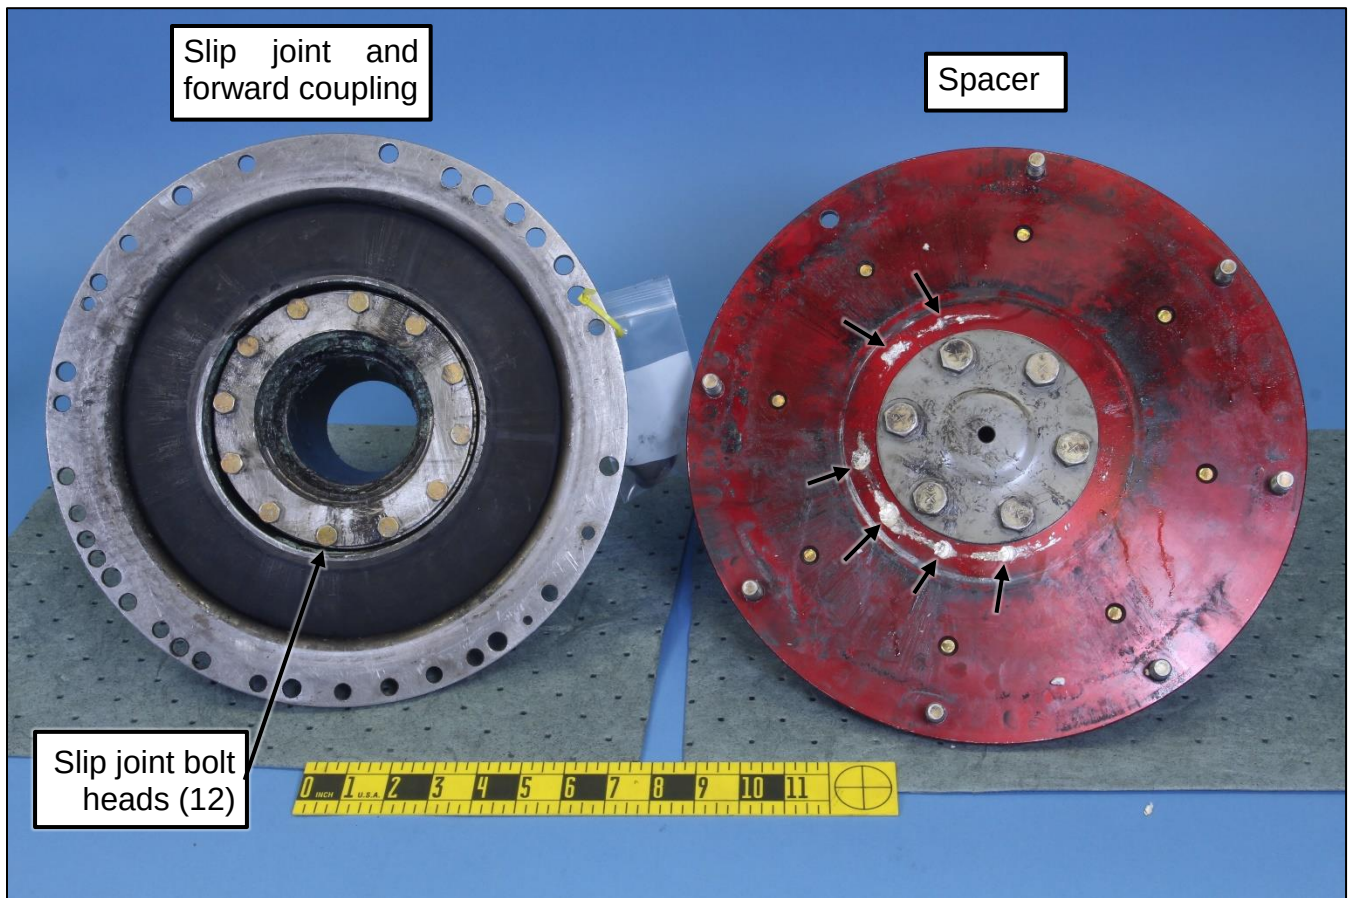
A view of the forward coupling with the attached slip joint and the mating face of the spacer is shown in figure 3. Gouges were observed on the spacer at locations indicated with unlabeled arrows in figure 3. The location and shape of the gouges was consistent with heavy impact with bolt heads on the slip joint.

Figure 3. Overall view of the aft side of the slip joint and forward coupling and mating forward side of the spacer. Unlabeled arrows indicate impact marks on the spacer corresponding to heavy contact with bolt heads on the slip joint.
