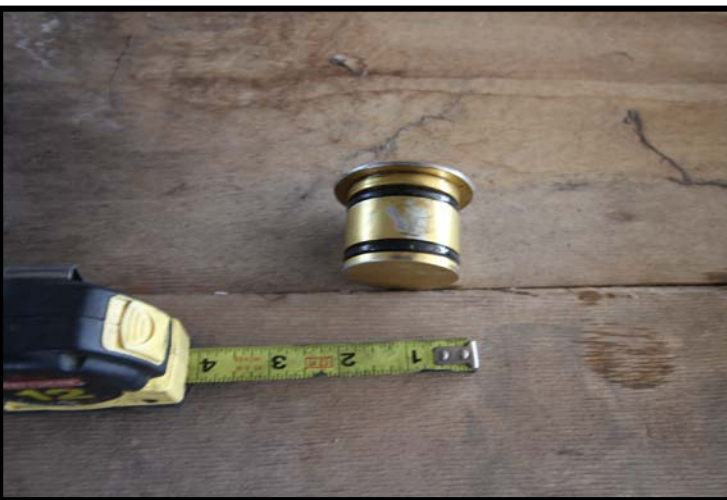
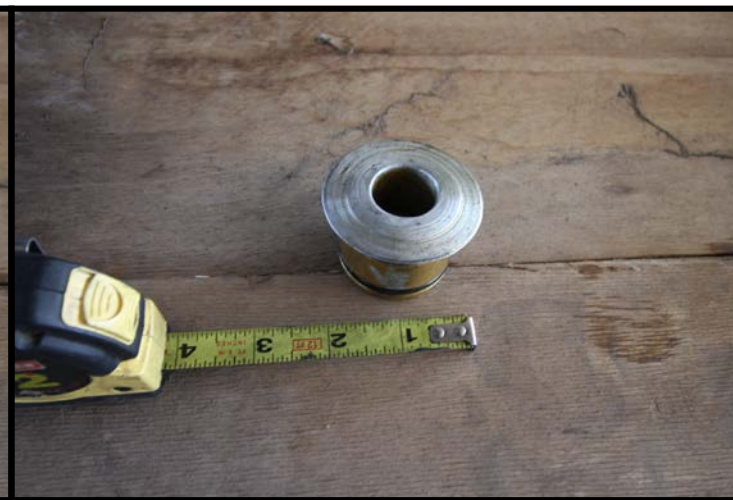
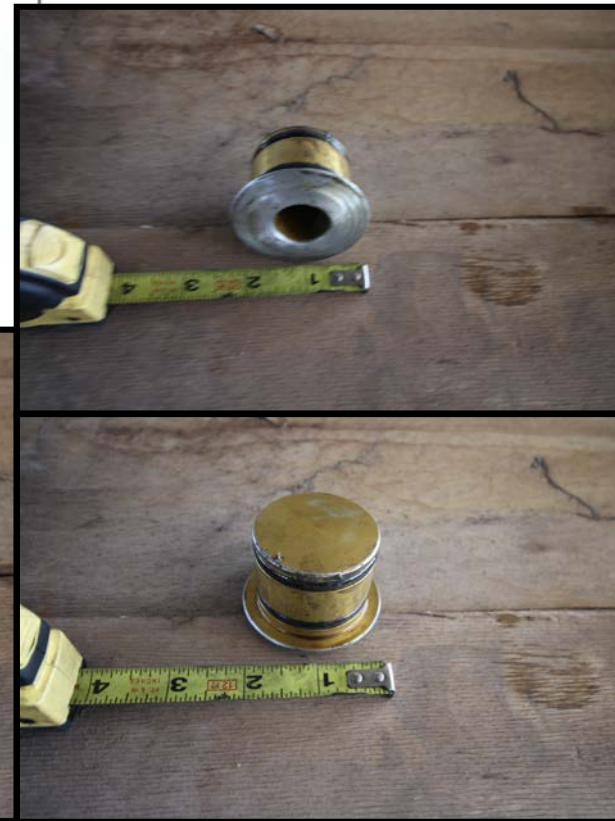
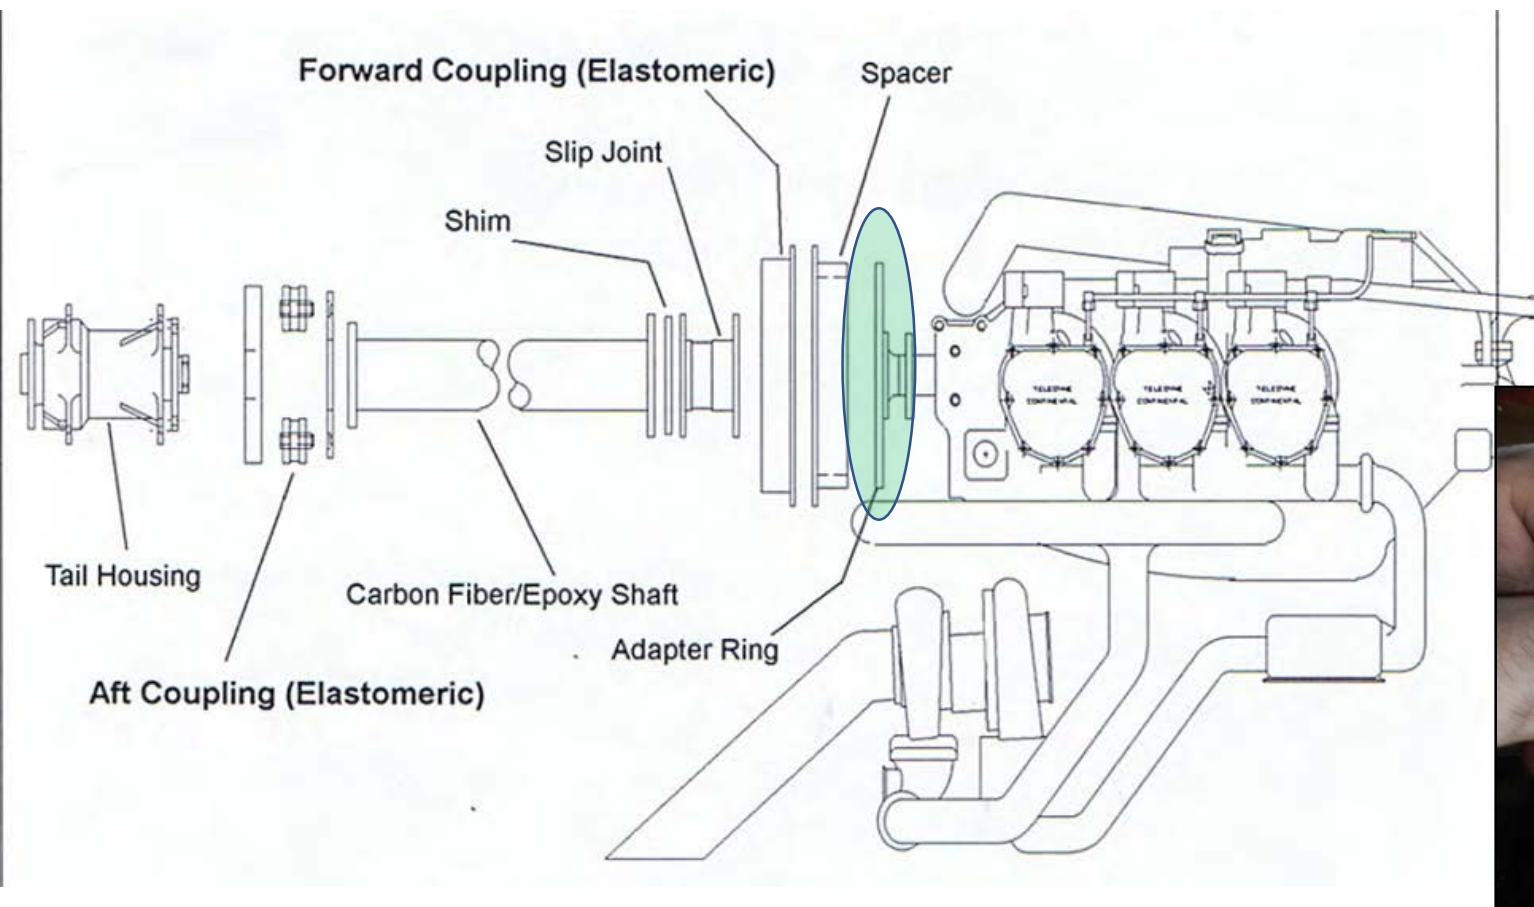
### Drive Shaft Crank Plug

The plug appeared to be intact at the time of the exam. The plug was between the engine propeller flange and the adapter ring.

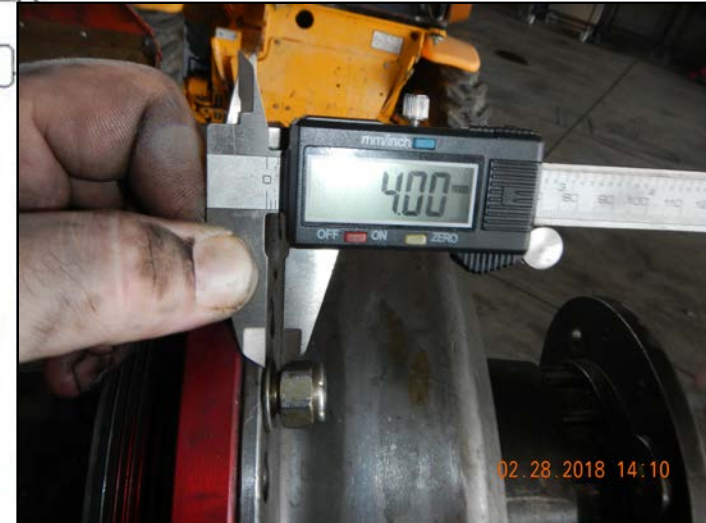
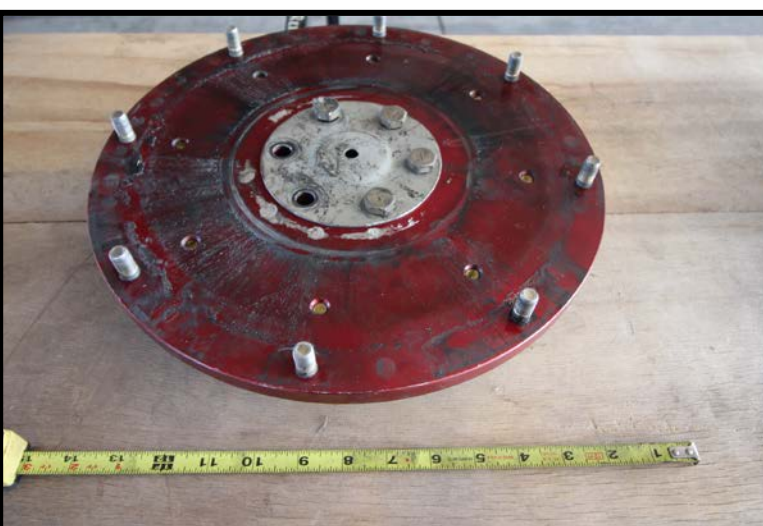
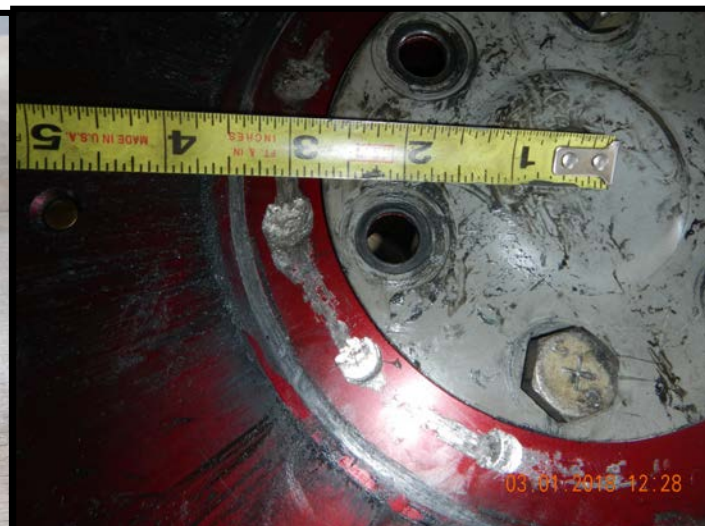
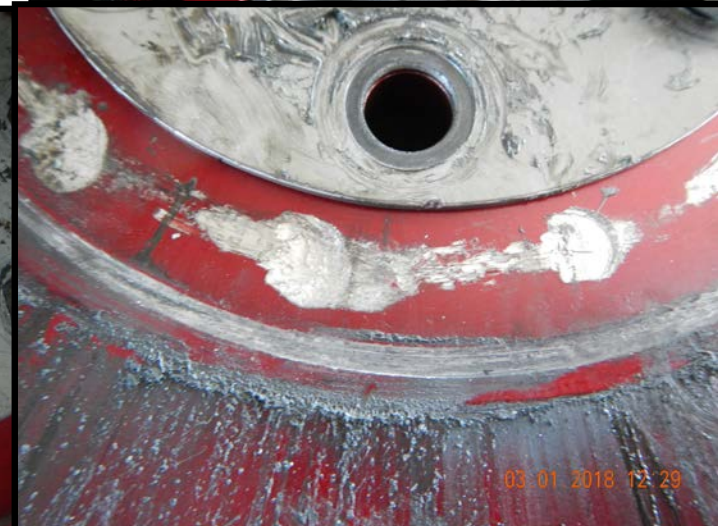
### Adapter Ring

The adapter ring, named “Adapter Plate” below was attached to the forward coupling (Elastomeric). Six bump marks about three inches out from center were noted on the aft center section of the adapter ring.

- One of the outside bolts was backed off about 4 mm. (about two threads exposed). See photo below.

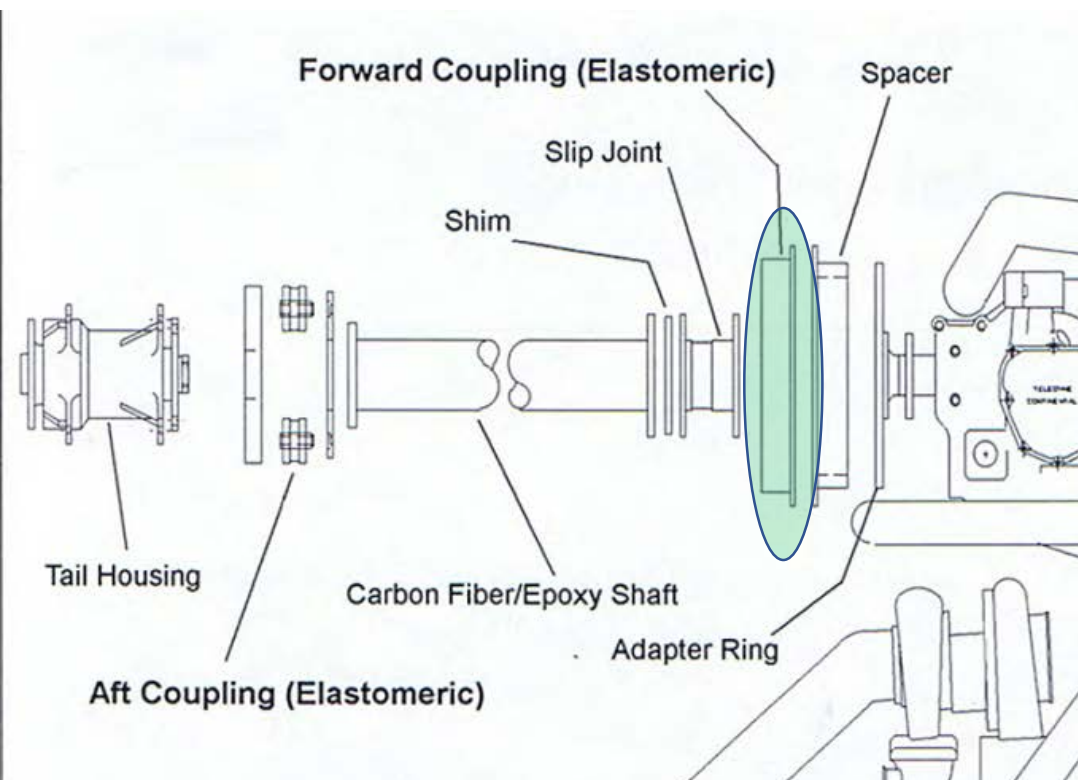
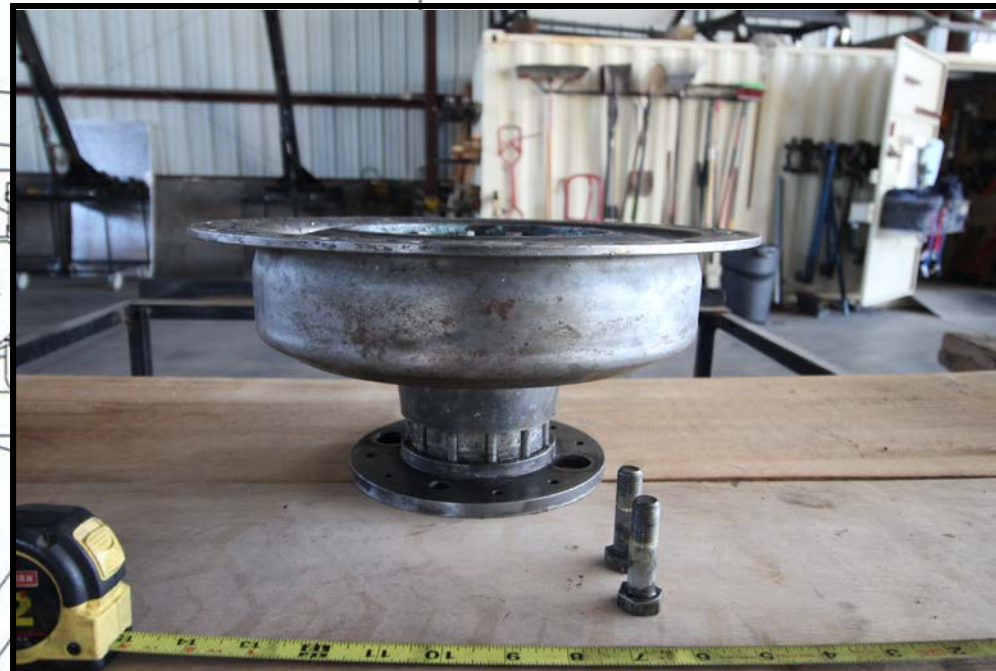
- Forward Coupling (Elastomeric)
- Dynaflex LCD Series Coupling
  - The forward bolts are about 3 inches from center.

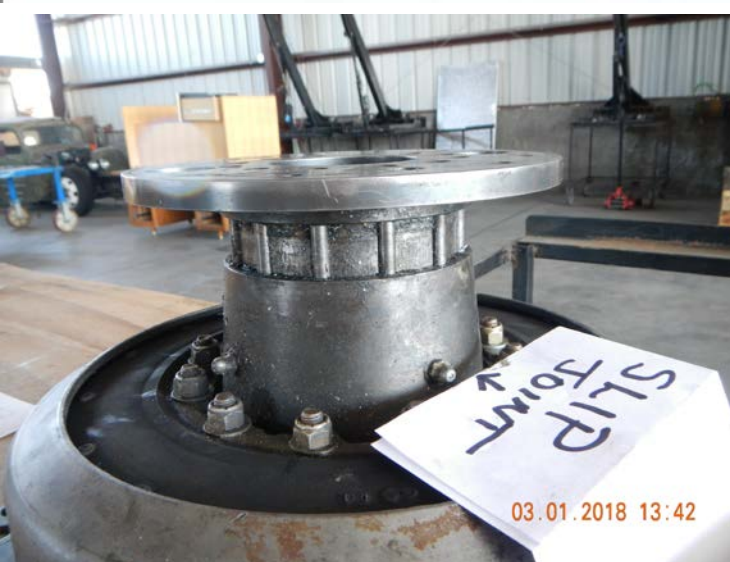
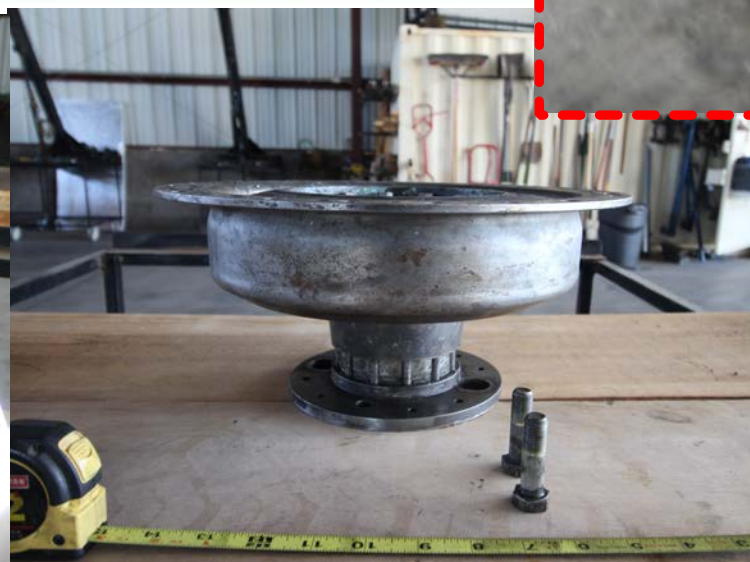
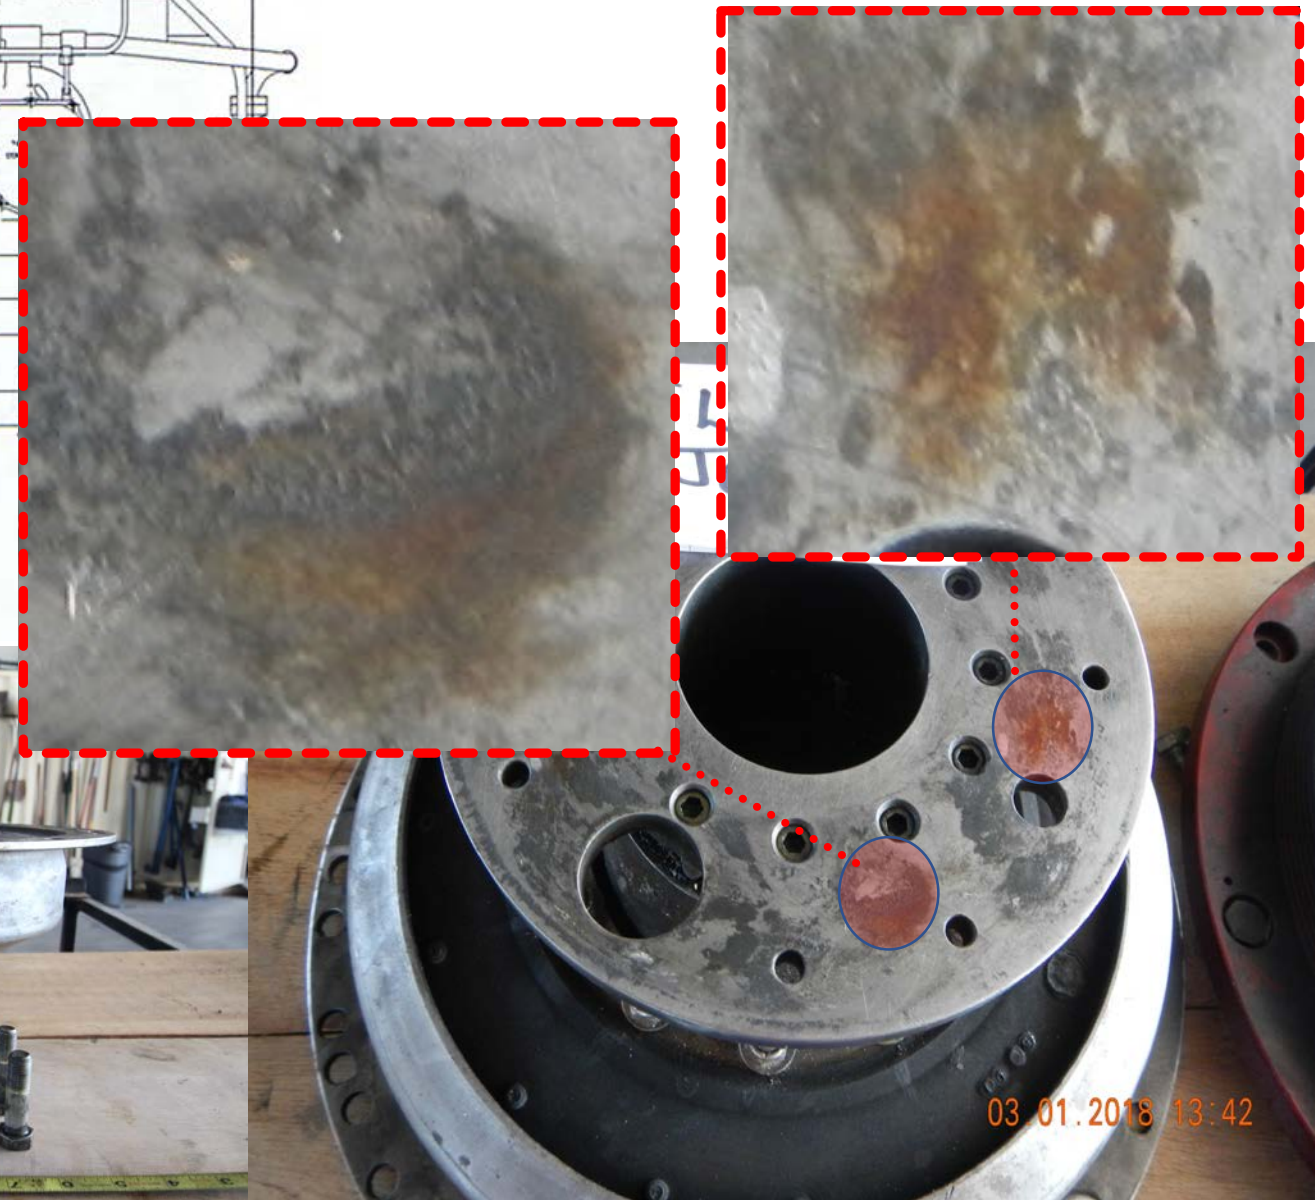
### Slip Joint

No shim was found between slip joint and drive shaft.

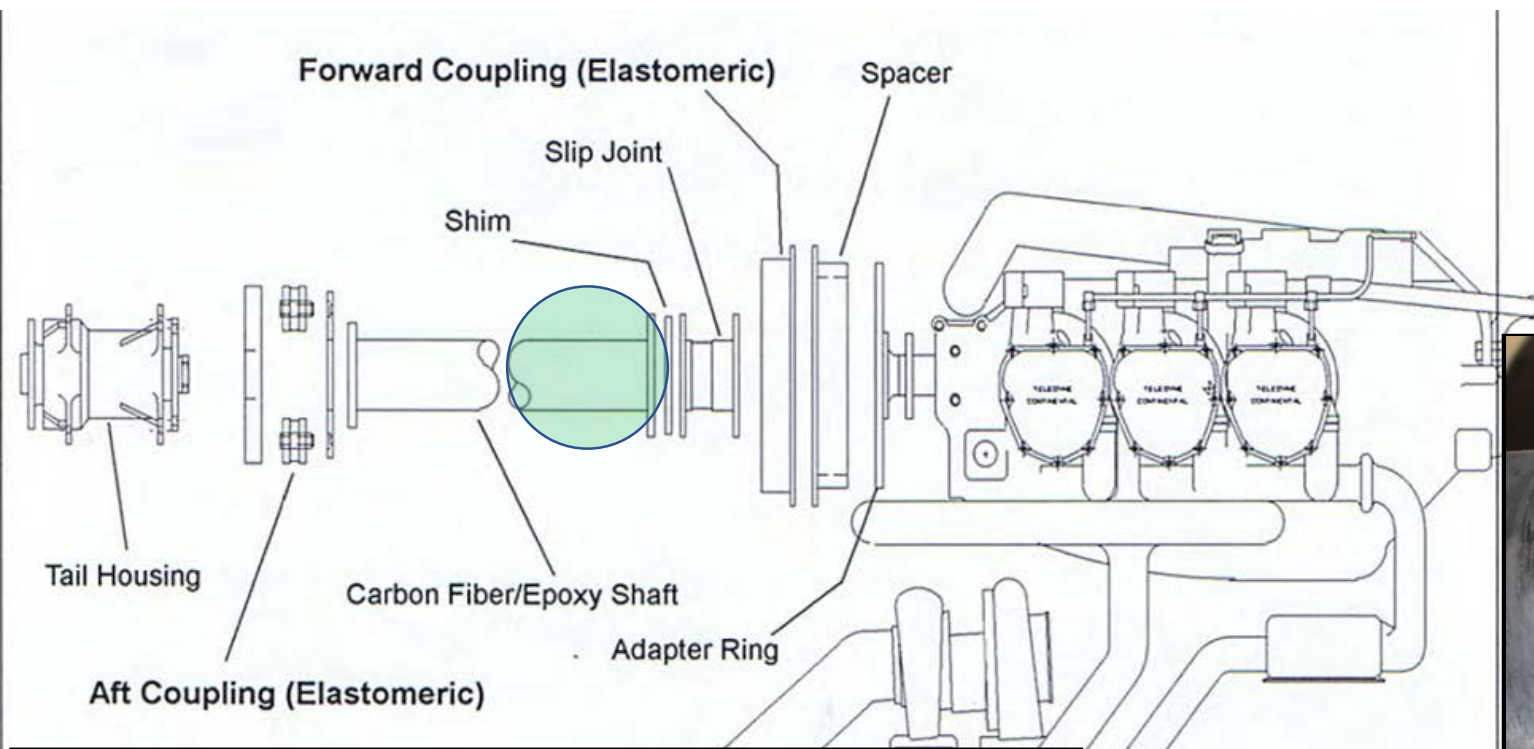
#### Shim

- According to the Cirrus Builders Association-Builders Newsletter, 10-CBA Nov. 1995, a shim was required between the drive shaft flange and the slip joint.
- There was not a shim present at the time of the exam.

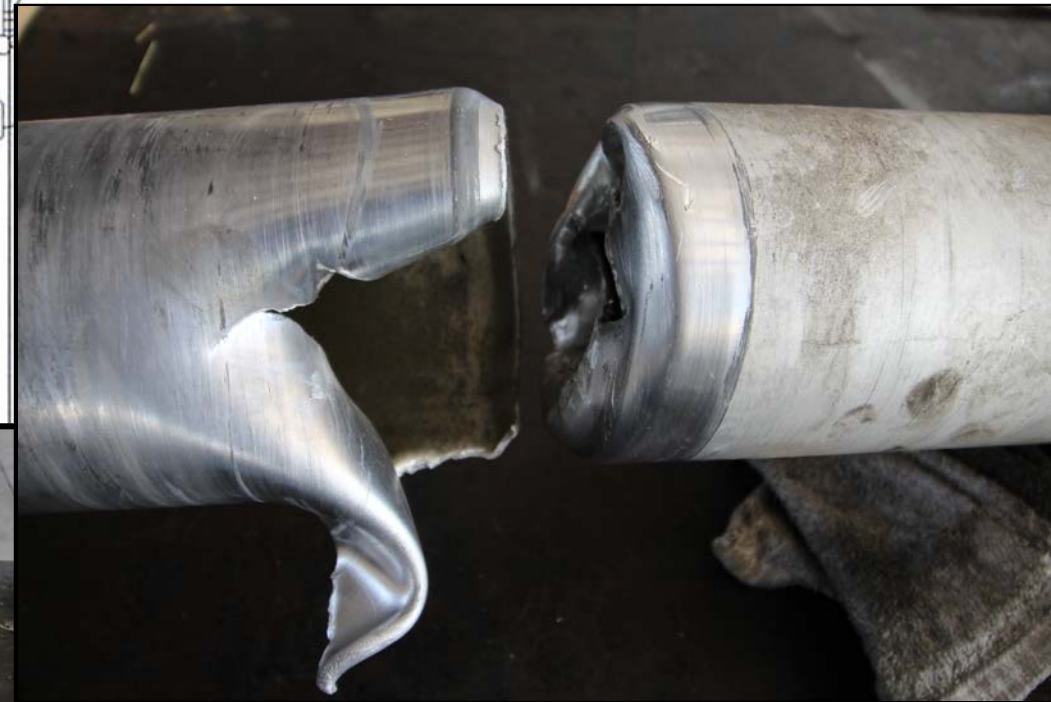
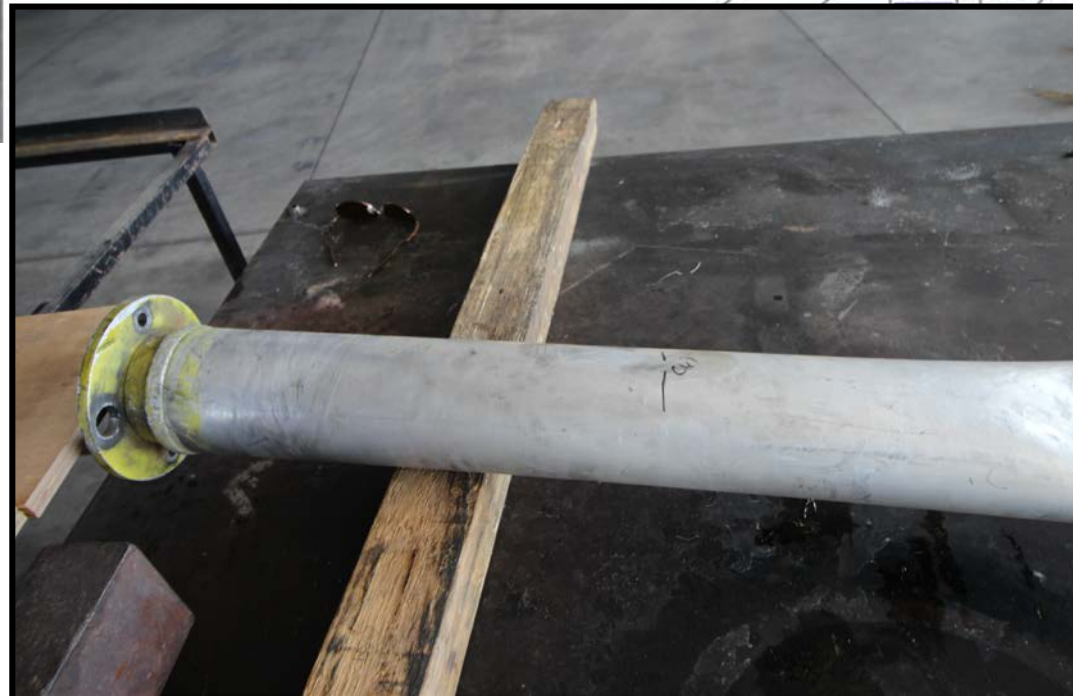
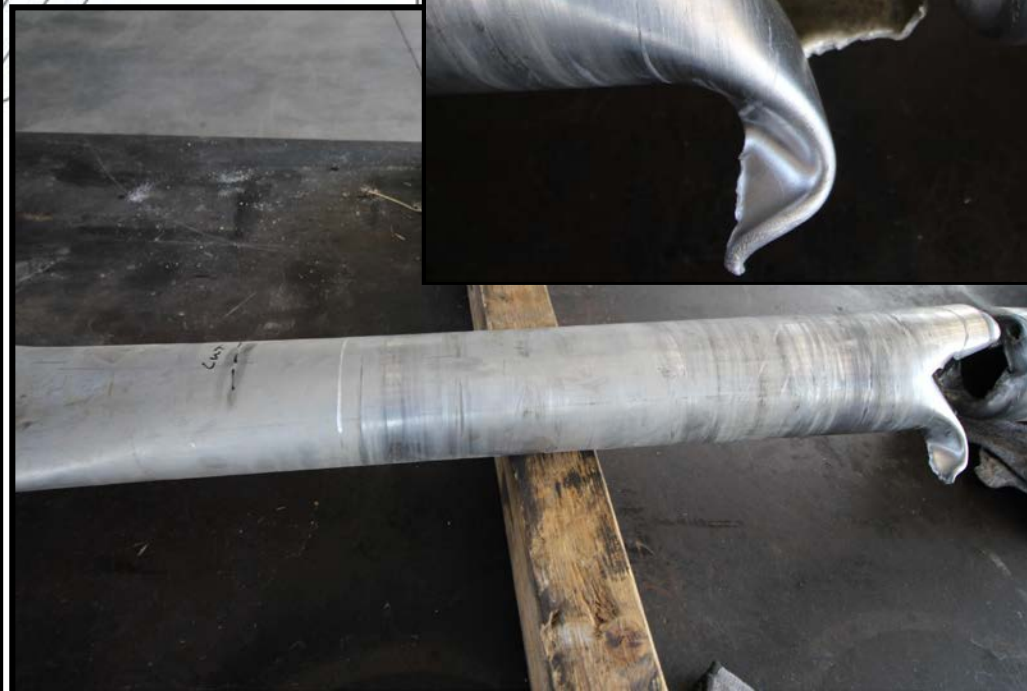
### Forward Section of the Drive Shaft

About 23 inches of the drive shaft was removed from the drive shaft and the remaining drive shaft was shipped to DC for further examination.

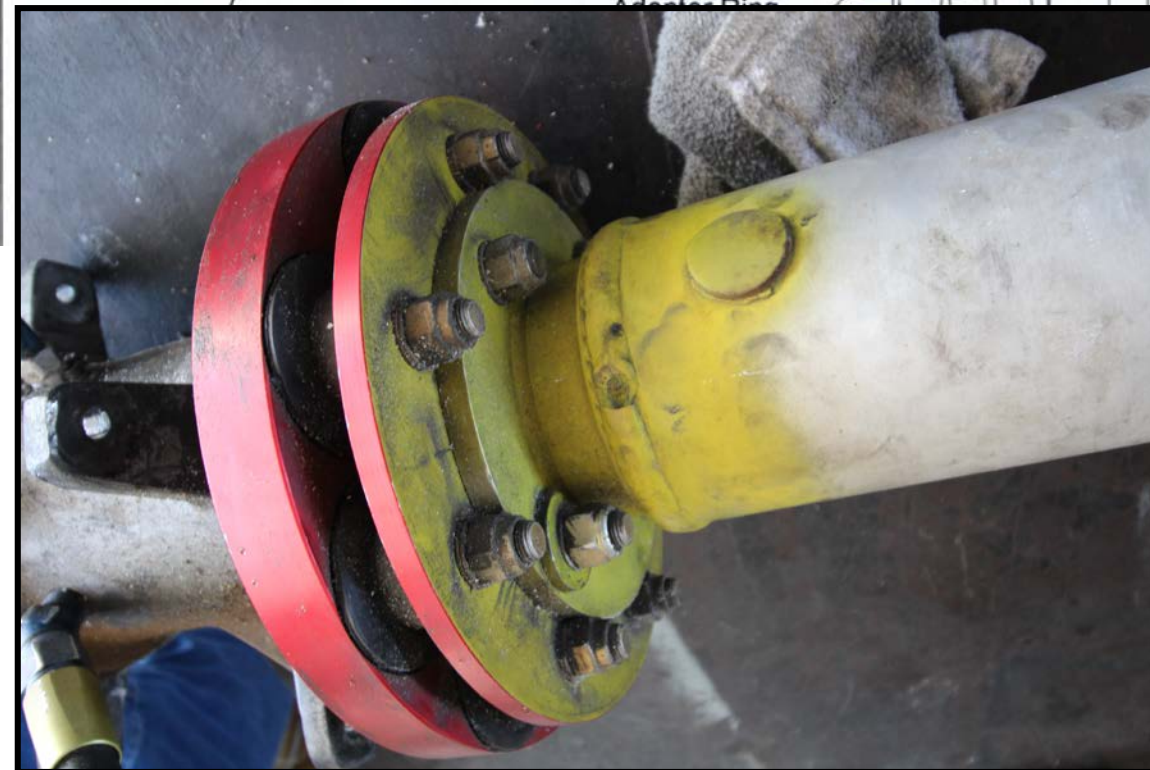
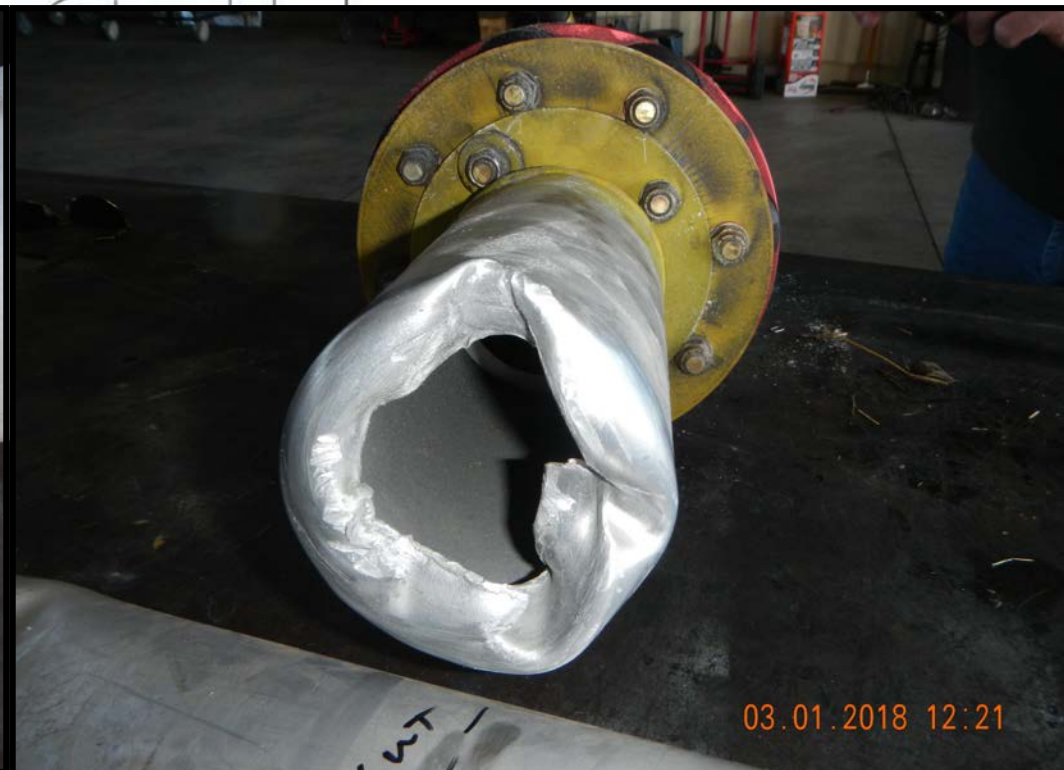
#### Aft section of Drive Shaft

About 18 inches of the drive shaft remained attached to the aft coupling. The drive shaft was shipped to DC for further examination.

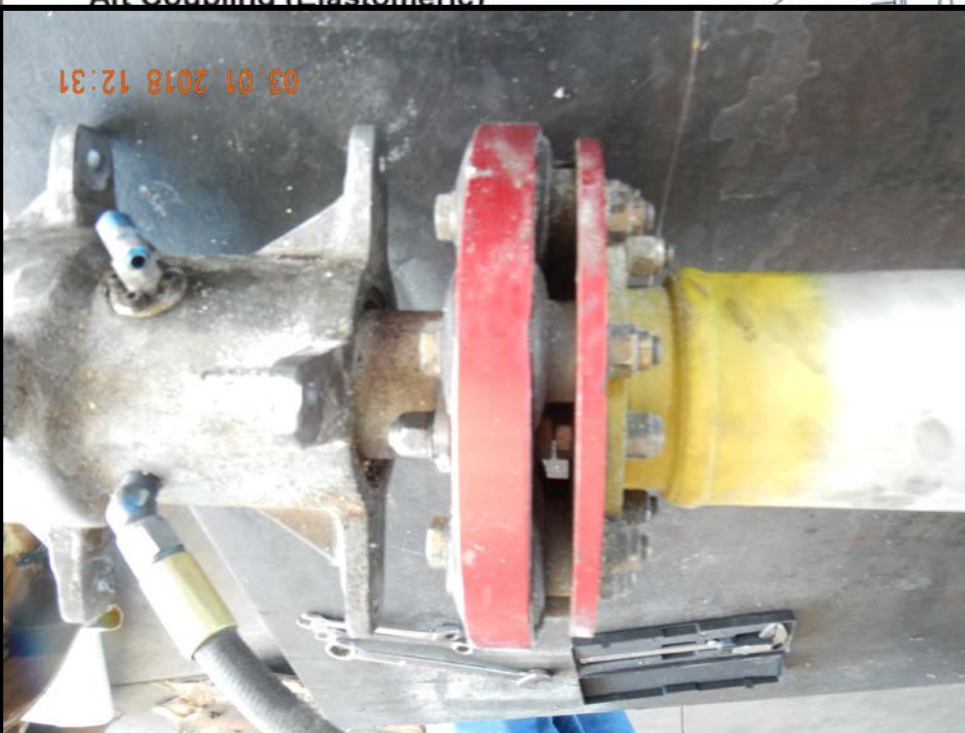
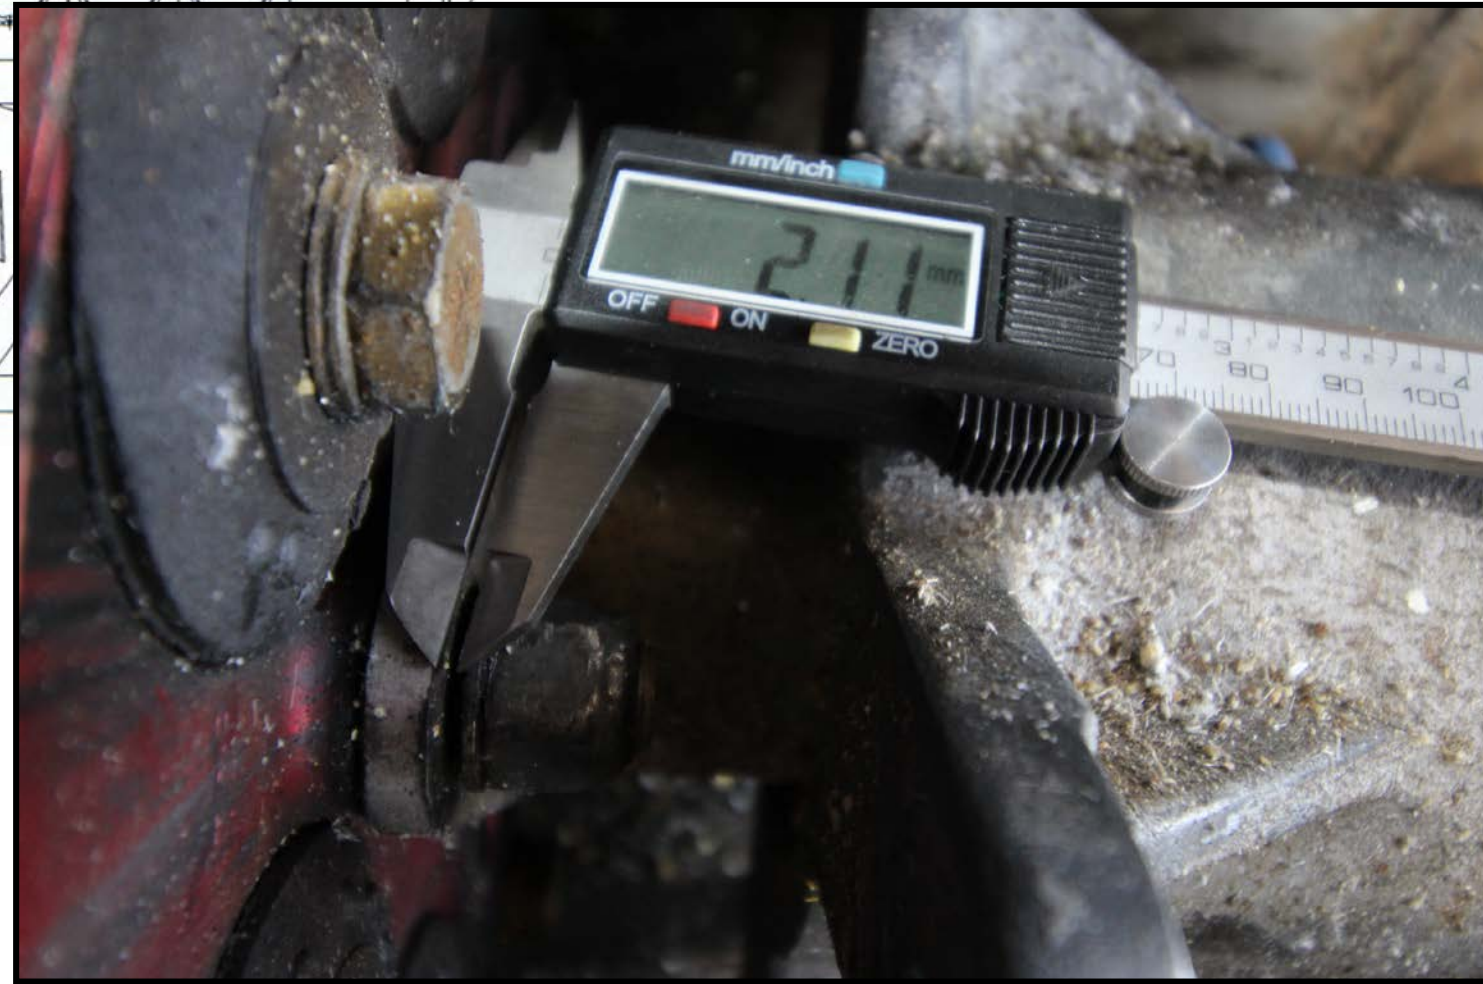
#### Aft Coupling

- The aft coupling remained attached to the tail housing and about 18 inches of the drive shaft.
- All three components were removed from the tail section as they were found. There were two bolts that connected the aft coupling to the tail housing, and one of those two bolts was backed off about 2.11mm.
- The aft coupling, tail housing, and drive shaft were shipped to DC for further examination.

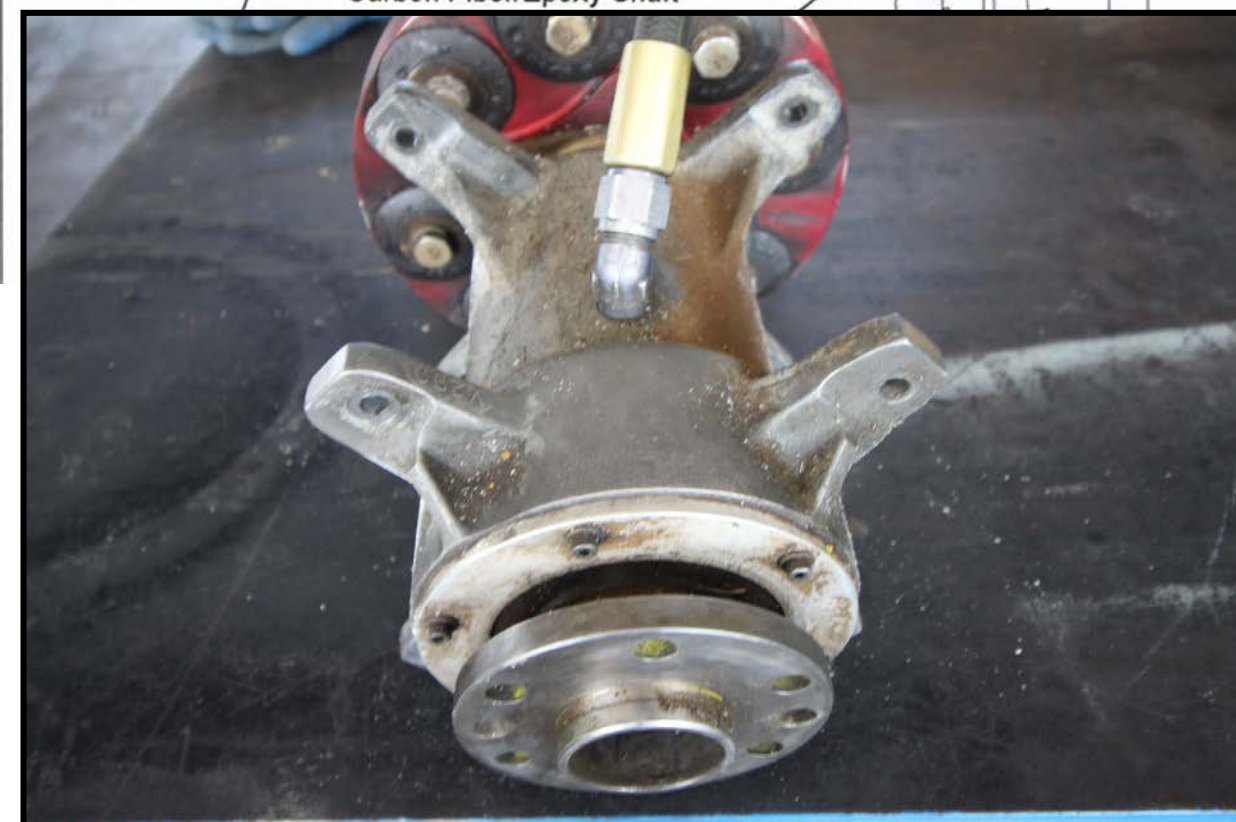
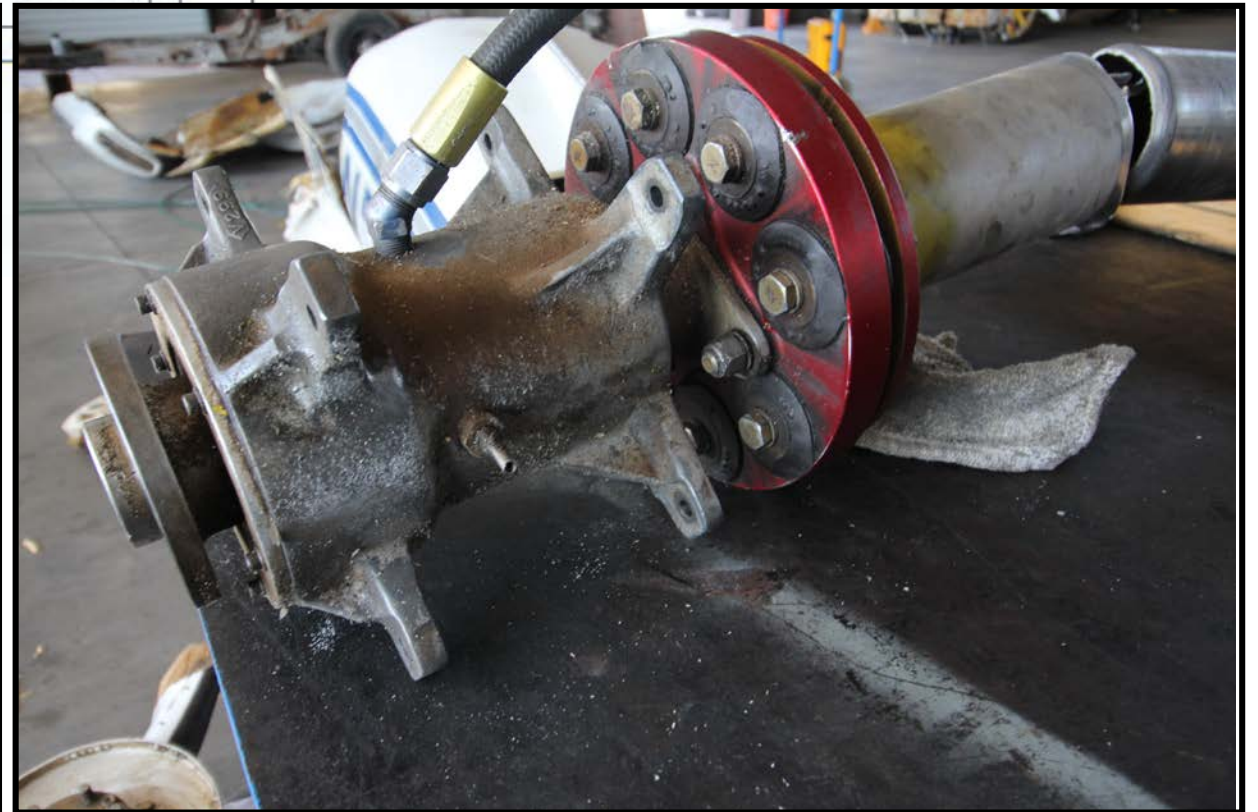
#### Tail Housing

- The tail housing was removed from the tail section.
- The aft coupling, tail housing, and drive shaft were shipped to DC for further examination.

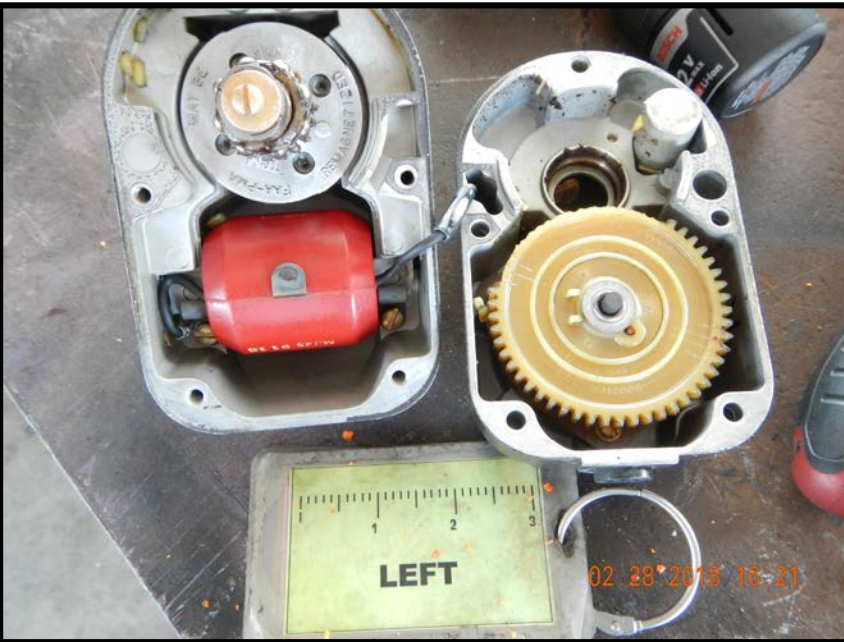
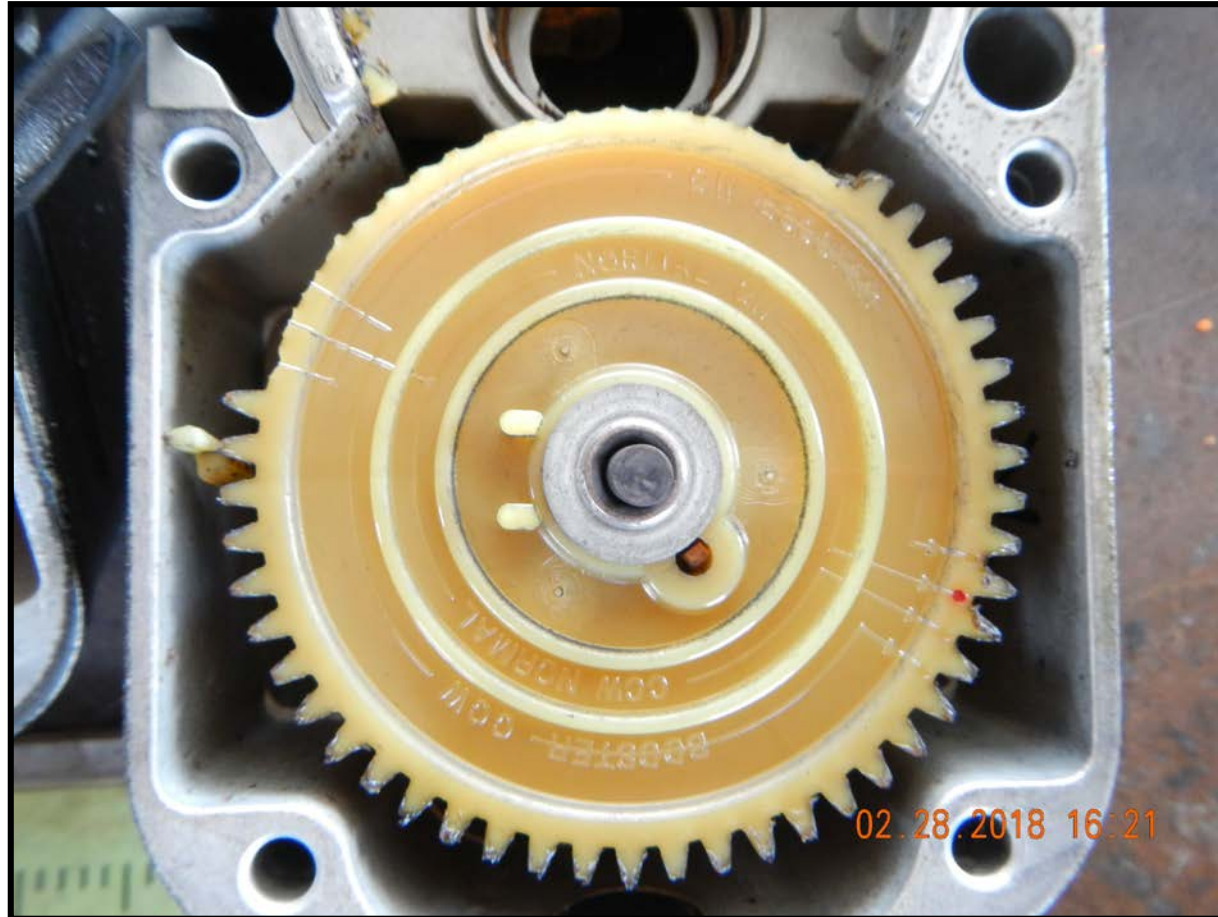
# Left Magneto

- Only one of the six primary ignition leads would spark during manual rotation. Further examination revealed about 22 teeth were broken off of the timing gear.
- Previous maintenance of the left magneto listed below.
