**National Transportation Safety Board**  
Office of Research and Engineering  
Washington, D.C. 20594

## Airplane Performance Study

| Airplane: | Piper PA-34-200T “Seneca II”, Registration N14GQ |
| NTSB Number: | WPR18FA091 |

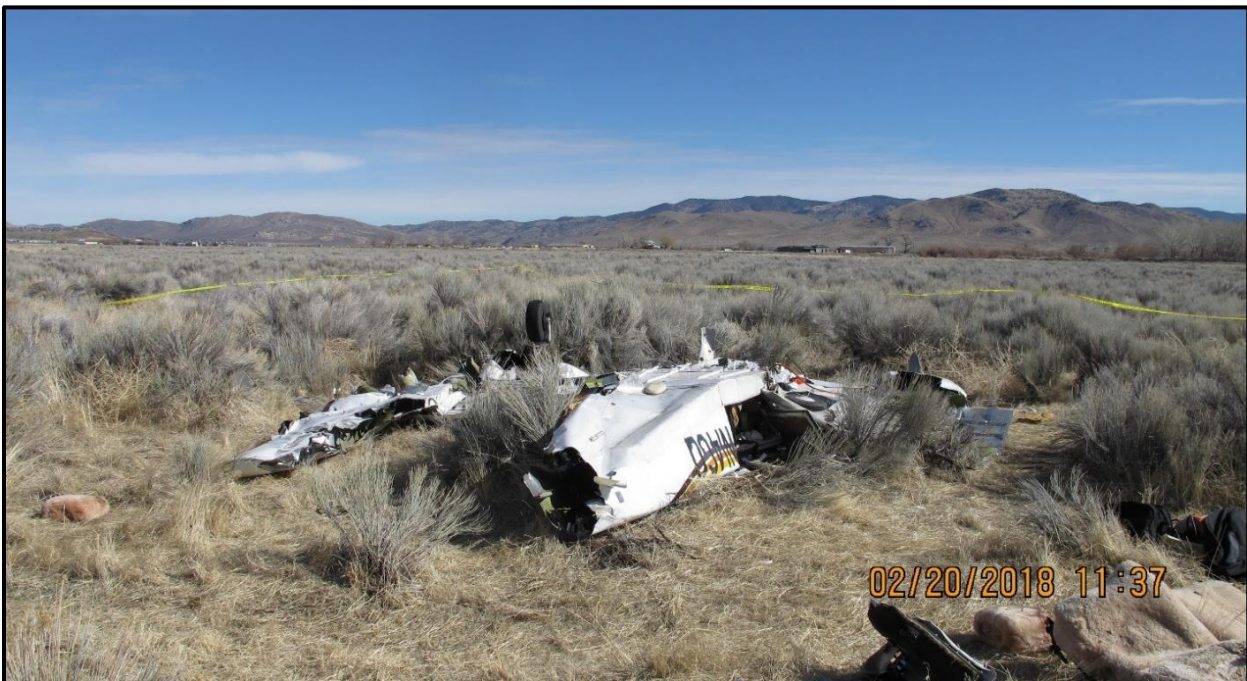
**Figure 2: Main Wreckage Site**

Initial examination of the airplane by the National Transportation Safety Board (NTSB) revealed that the airplane impacted the ground in an inverted, wings-level, slightly nose-down attitude. Additional debris was located about a half mile south of the main wreckage and contained separated airplane parts. See Figure 2 for a picture of the main wreckage site.

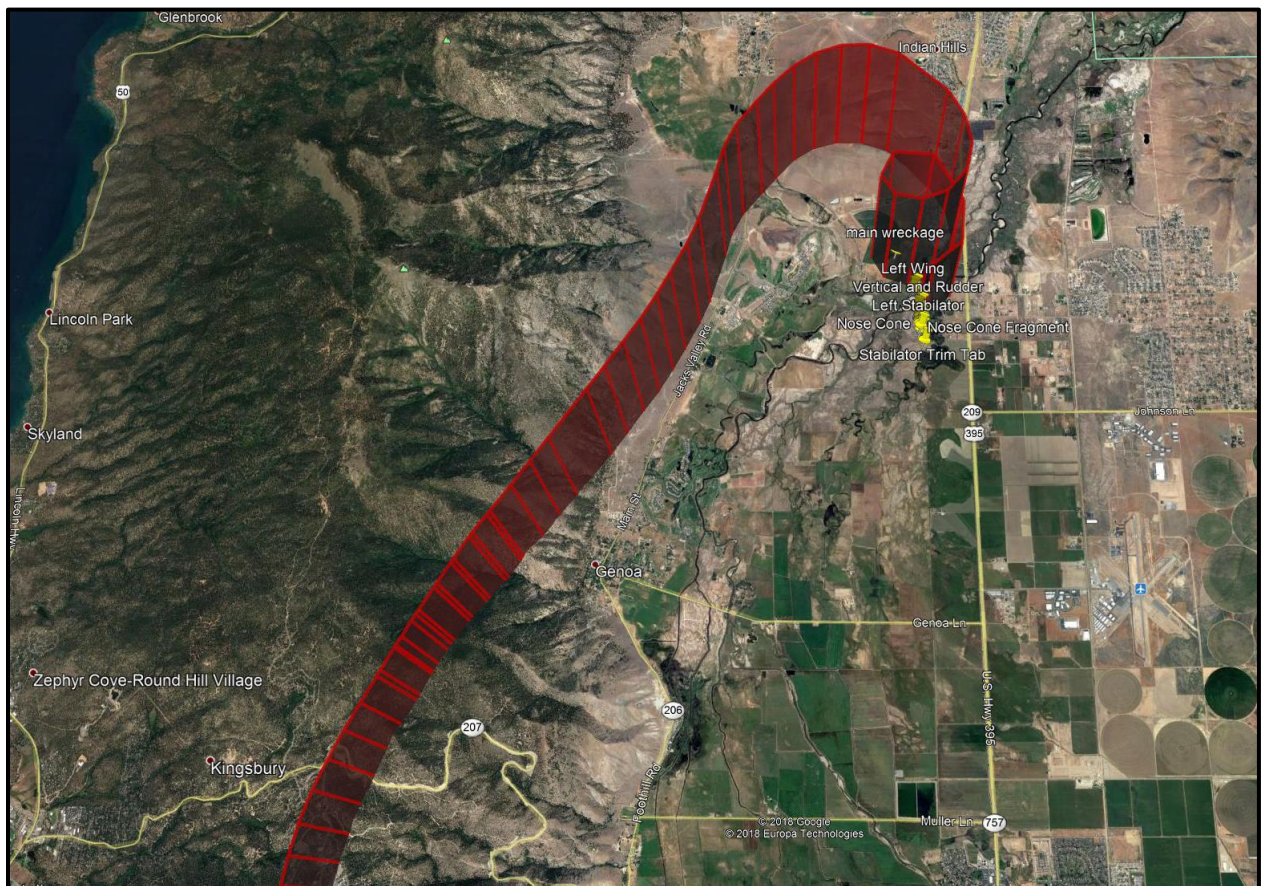
**Figure 4: Last Five Minutes of Appareo Stratus Ground Track Near the Accident Site and Wreckage Location**

Figure 3 highlights the ground track for the entire flight from BFL to the accident site recovered from the Appareo Stratus receiver. Figure 4 shows approximately the last five minutes of the flight and the main wreckage site in more detail.

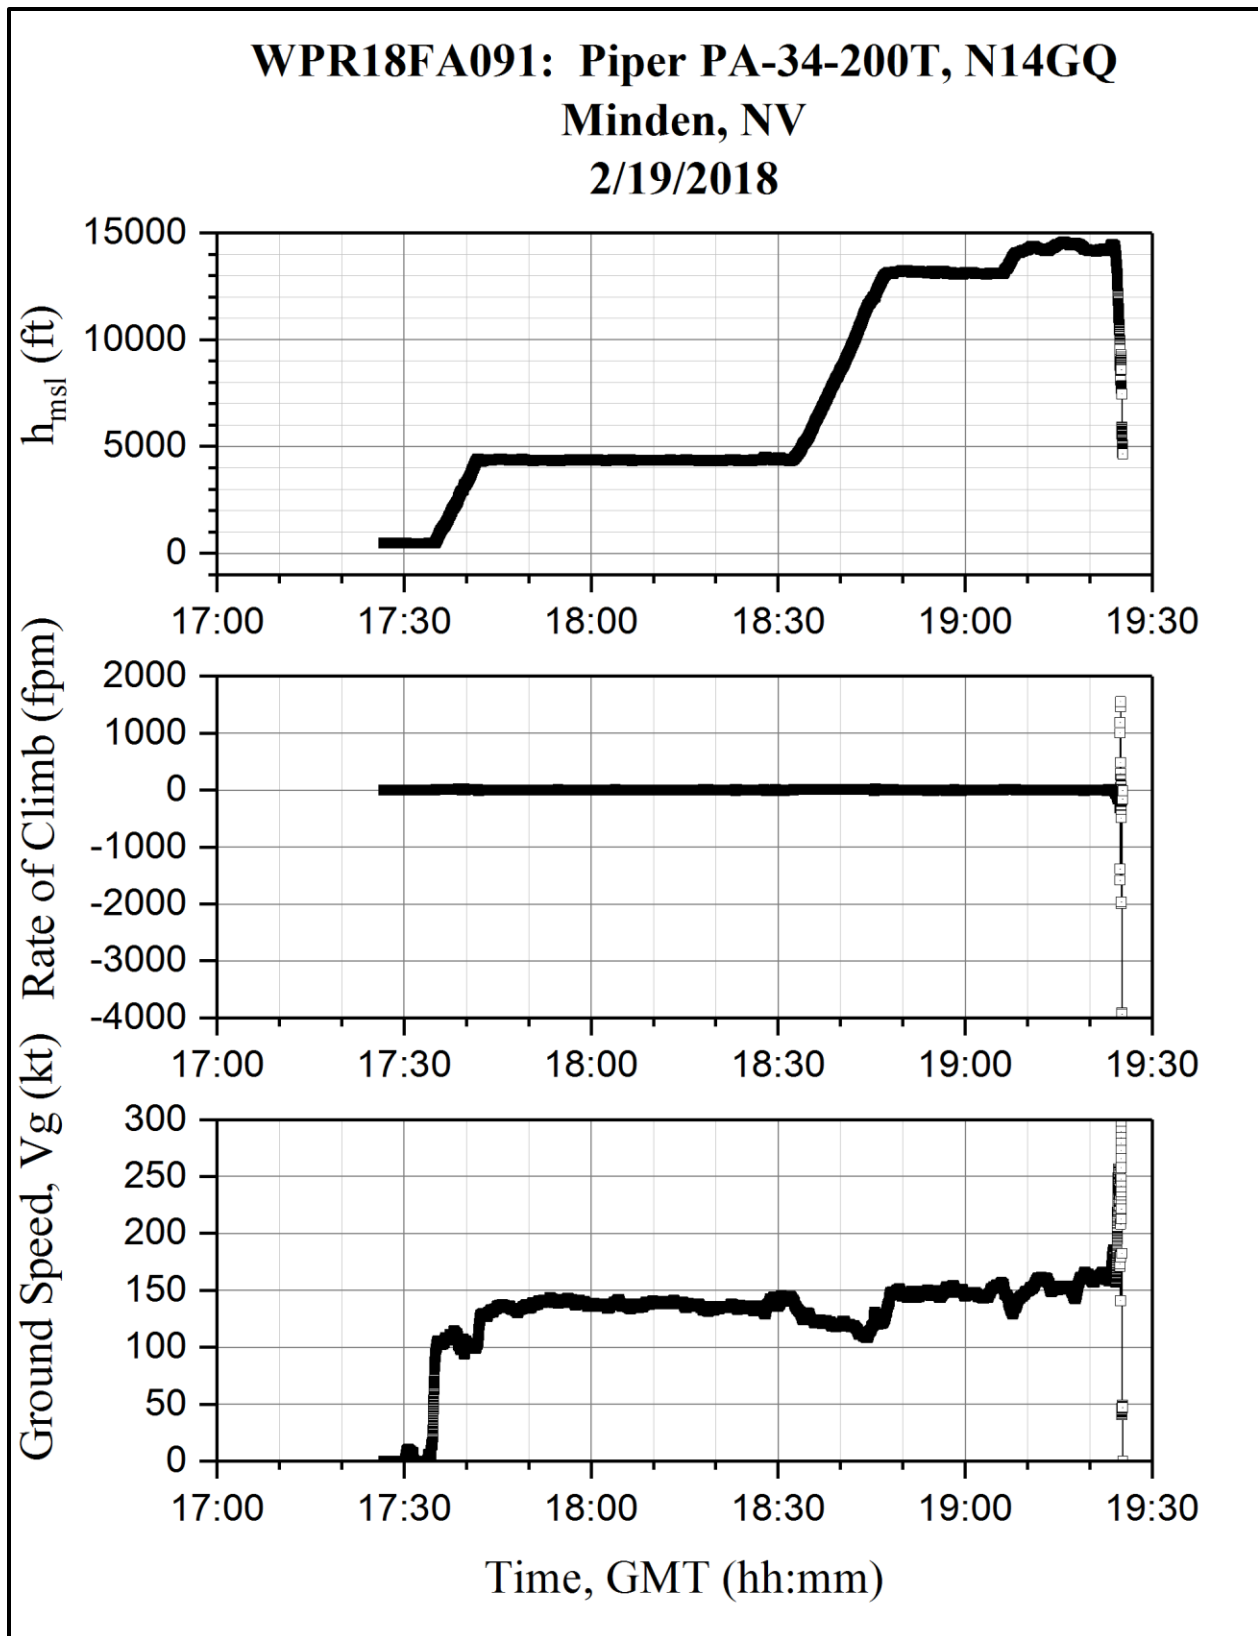
Figure 5: Altitude and Ground Speed Based on Appareo Data

Figure 5 shows the GPS altitude<sup>3</sup> and groundspeed recorded by the Appareo unit for the flight. The data show that the flight was relatively uneventful until about the last 30 seconds. Figure 6 shows the altitude, the groundspeed, and the estimated airspeed<sup>4</sup> for the last five minutes.

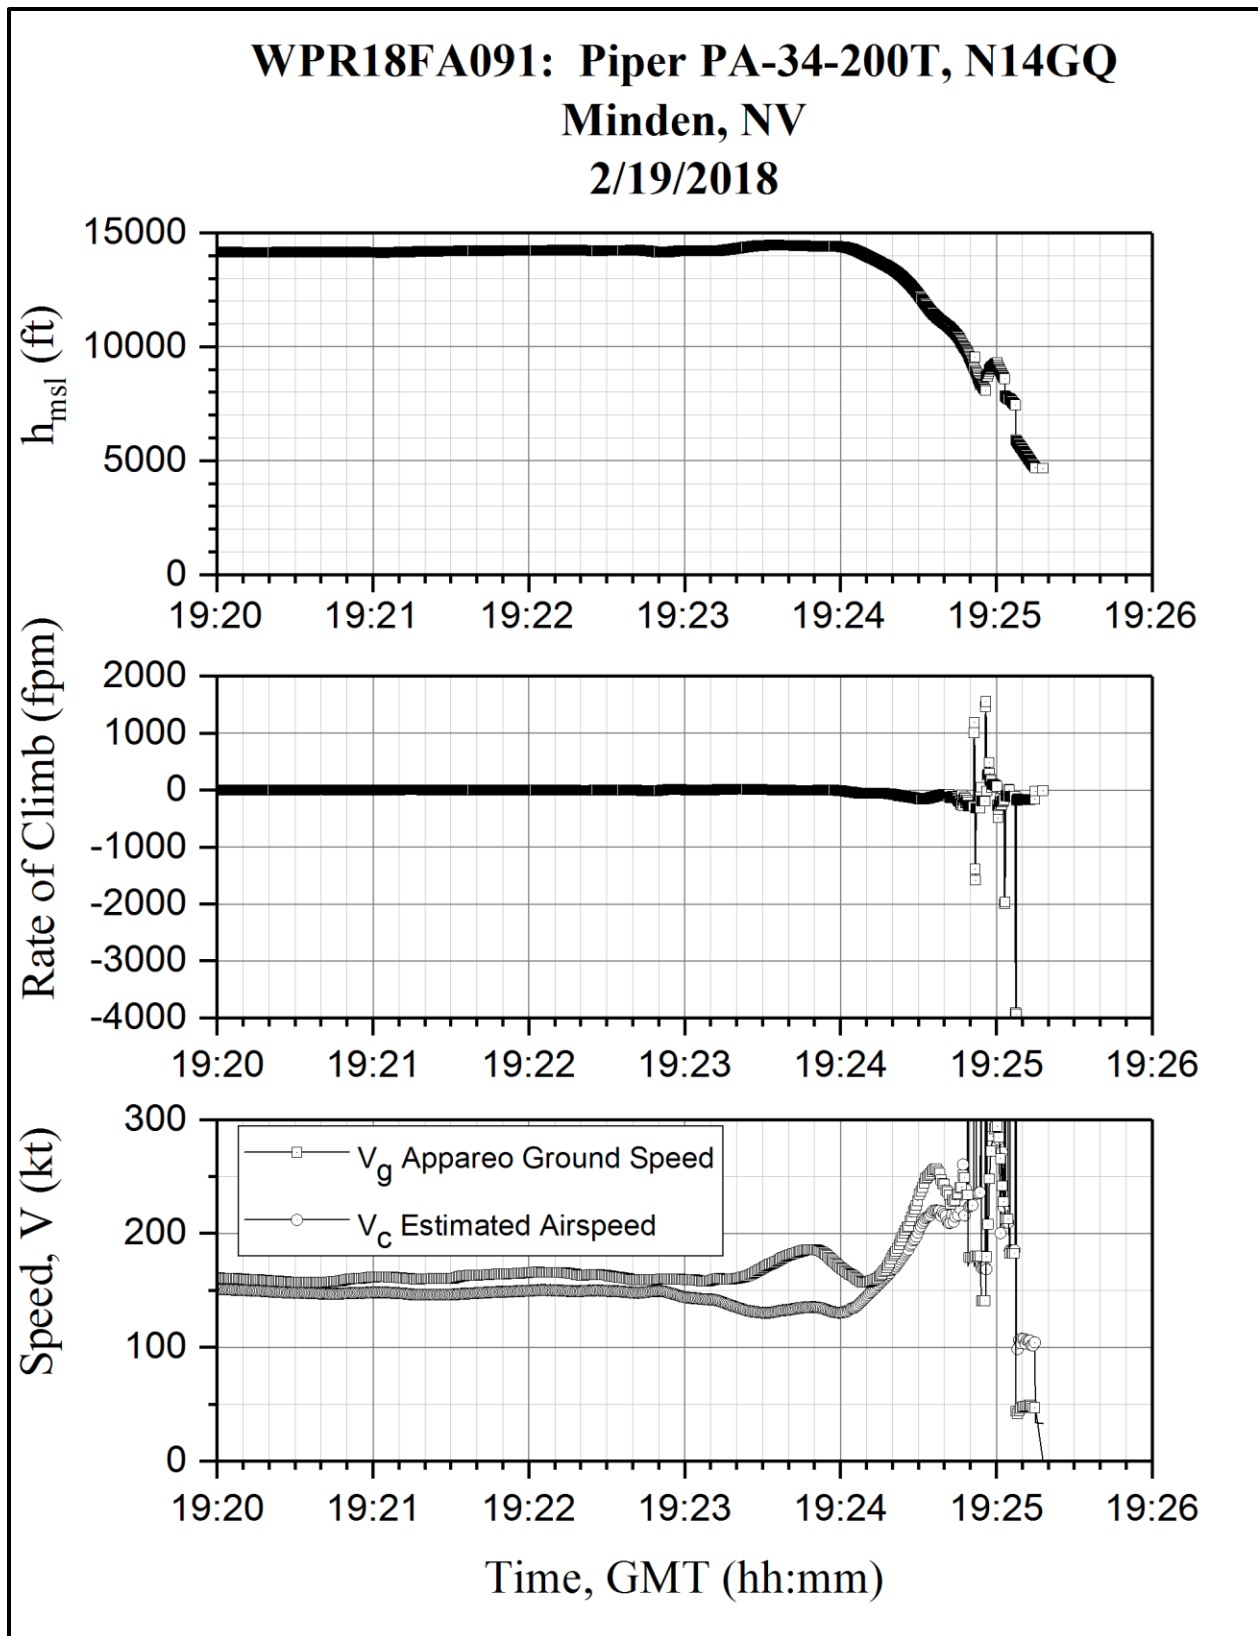
Figure 6: Altitude and Speed for Final Minutes Based on Appareo Data

At 11:24:37 the estimated airspeed peaks at 220 kt, well above the never-exceed speed of 195 kt published in the Pilot Operating Handbook (POH). The Appareo data are erratic beyond about 11:24:49. The wide-spread debris field documented during the recovery is evidence of an in-flight break-up.

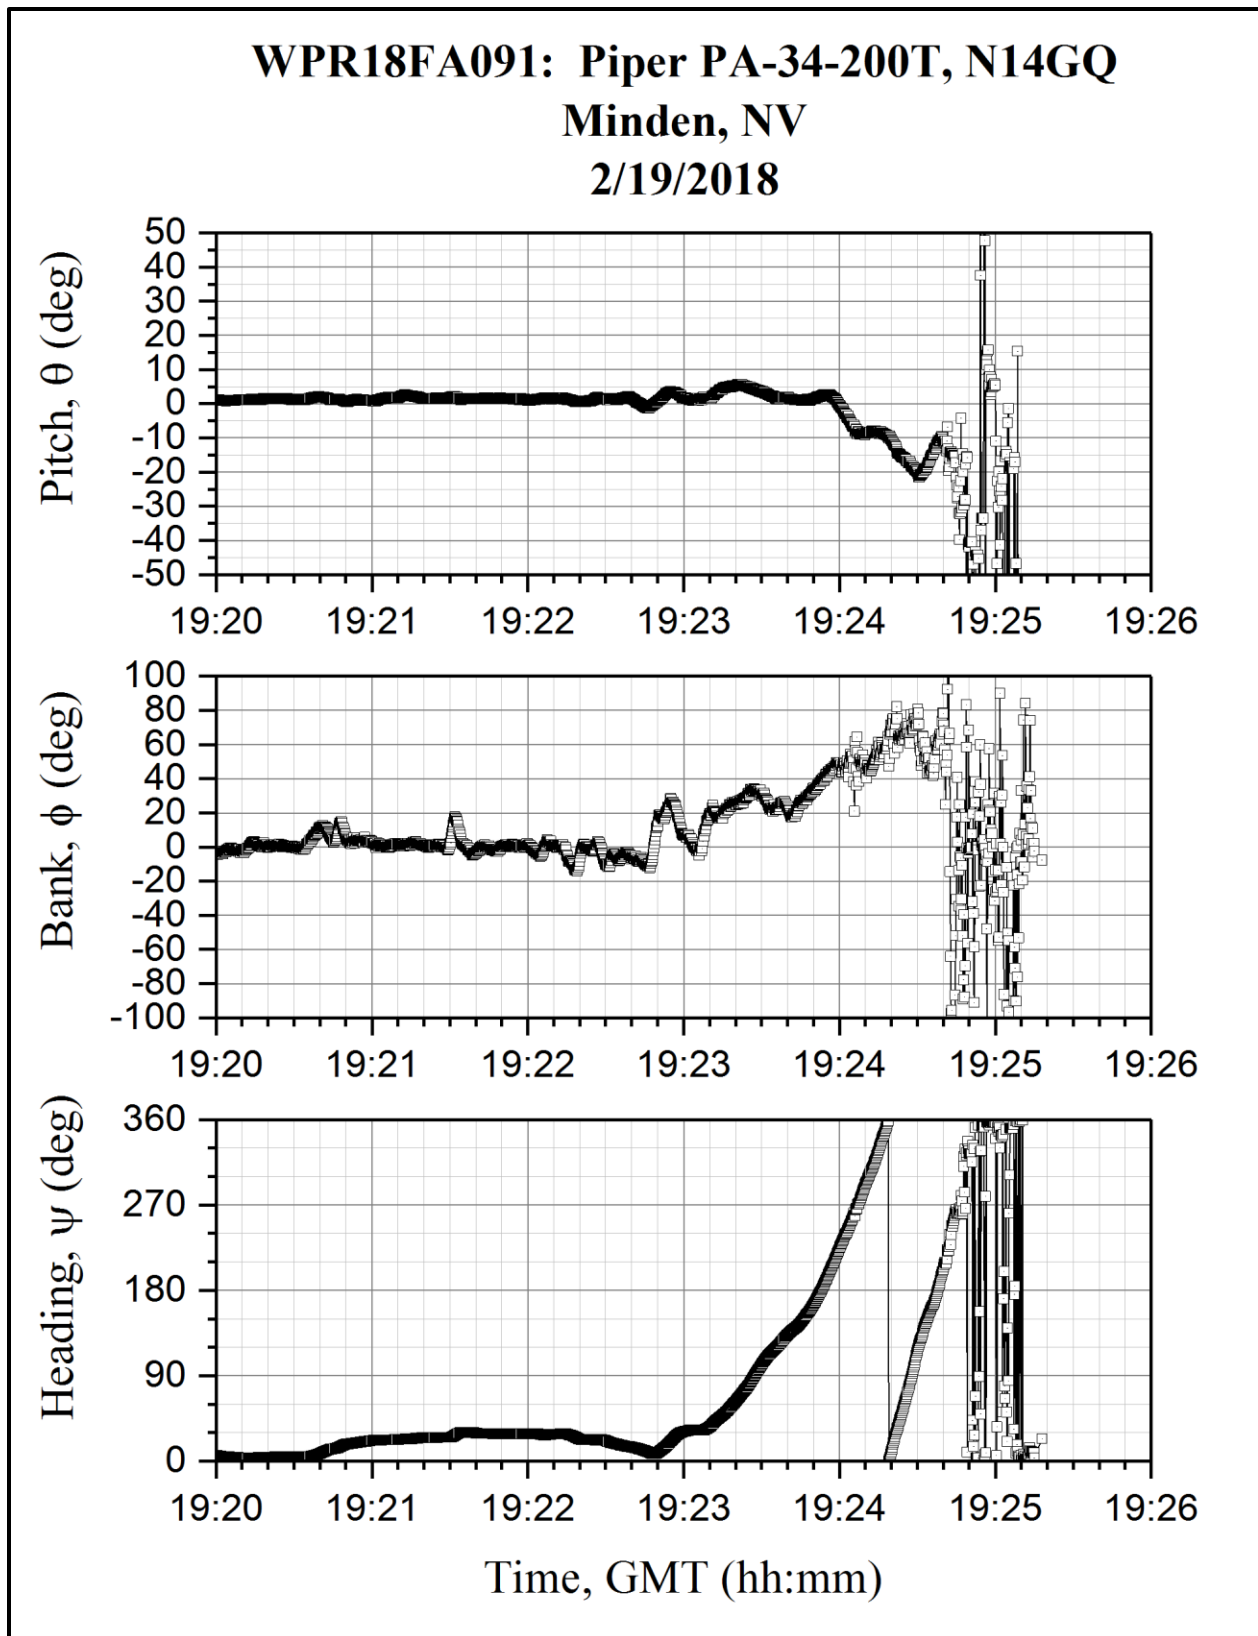
Figure 7: Calculated Pitch, Bank, and Heading for Final Minutes Based on Flight Path and Selected Appareo Data

As shown in Figure 7, the airplane began a right spiral turn beginning at about 11:23:00, with the bank angle reaching 80 degrees at about 11:24:20. The bank angle decreases to about 60 degrees, but then tightens to over 100 degrees bank angle at 11:24:42. The data then indicates a rapid roll to the left. The data in all the Appareo data channels show substantial variability after 11:24:49, and it appears that the data are unreliable beyond that time.

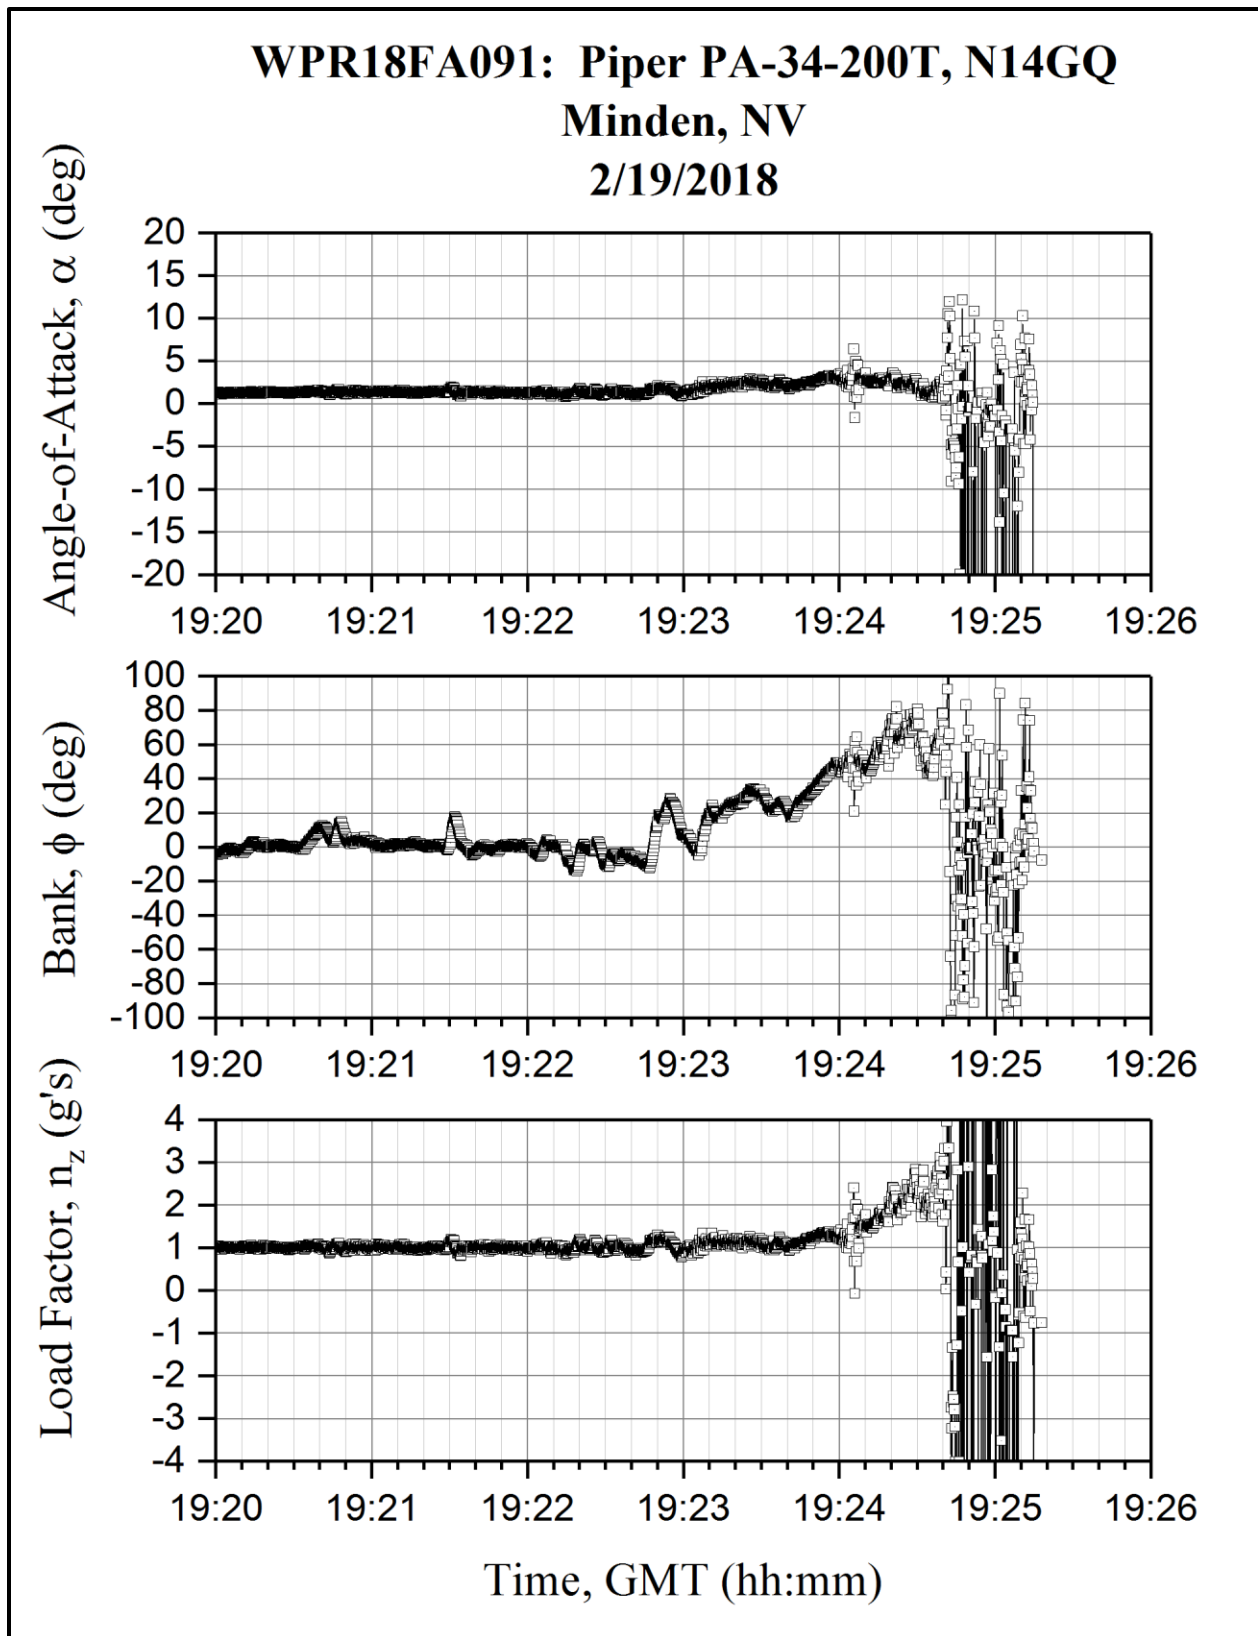
Figure 8: Calculated Angle-of-Attack and Load Factor for Final Minutes Based on Flight Path and Selected Appareo Data

Figure 8 shows that the load factor calculated from the flight path and selected Appareo parameters exceeded 4g's at 11:24:41. The POH lists the maximum positive load factor as 3.8g's. No negative load factors are approved by the manufacturer.
