# **National Transportation Safety Board**

## **Airplane Performance Study with Air Traffic Control Communications**

| Airplane: | PIPER PA34, N14GQ |
| NTSB Number: | WPR18FA091 |

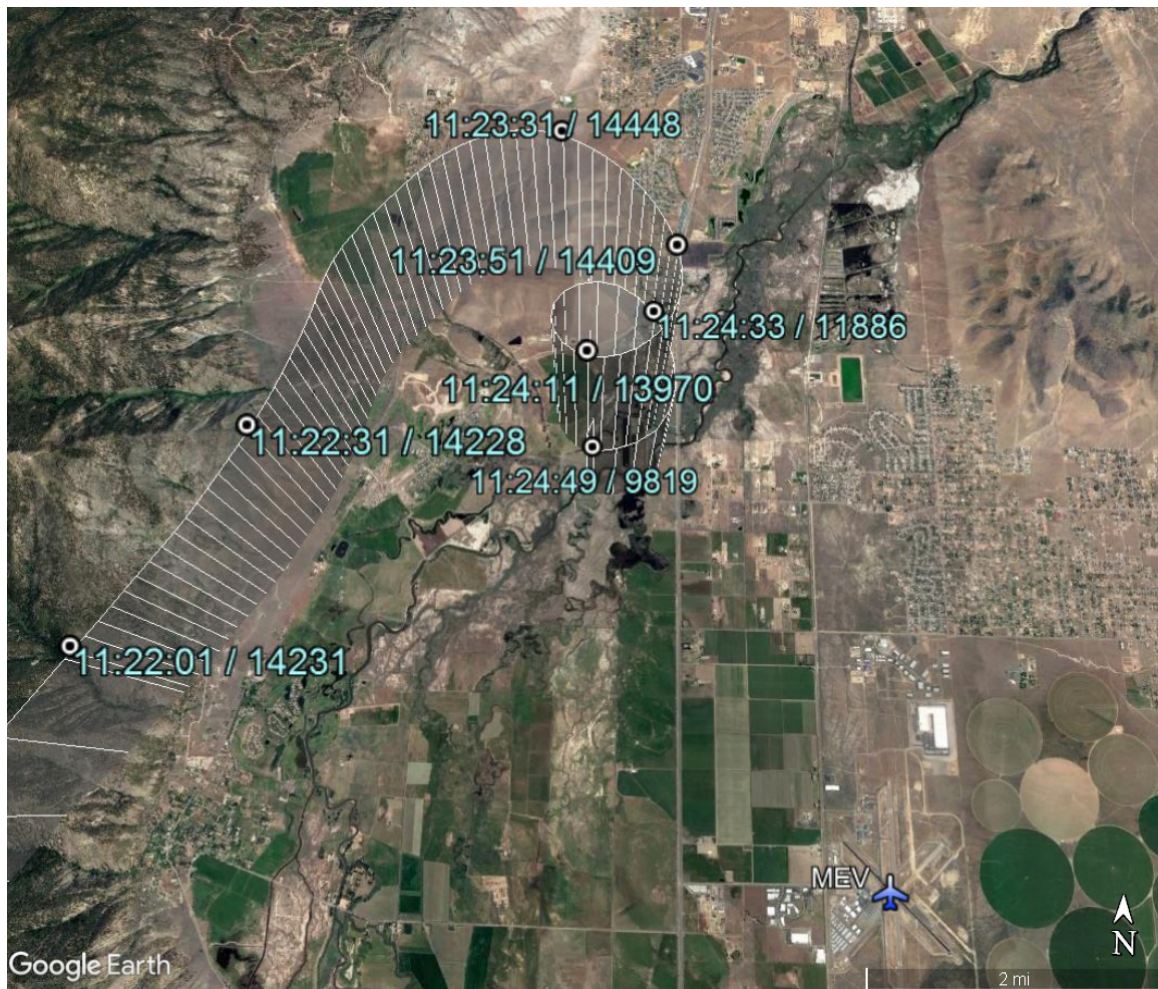
**Figure 3.** End of airplane flight path

The airplane's calibrated airspeed was calculated using the weather and winds aloft from the area and time of the accident. At about 11:23:00 the airplane began a right turn from a track of 30° to 140° while above 14,000 ft (Figure 3). At about 11:23:51 the right turn began to tighten, but the airplane maintained its altitude until 11:24:00 (Figure 4) when it began to descend. As the altitude passed below 13,500 ft, the airspeed began to increase rapidly (Figure 4 and Figure 5) and the right turn continued to tighten into a spiral. After 11:24:49, the data from the Appareo became unreliable.

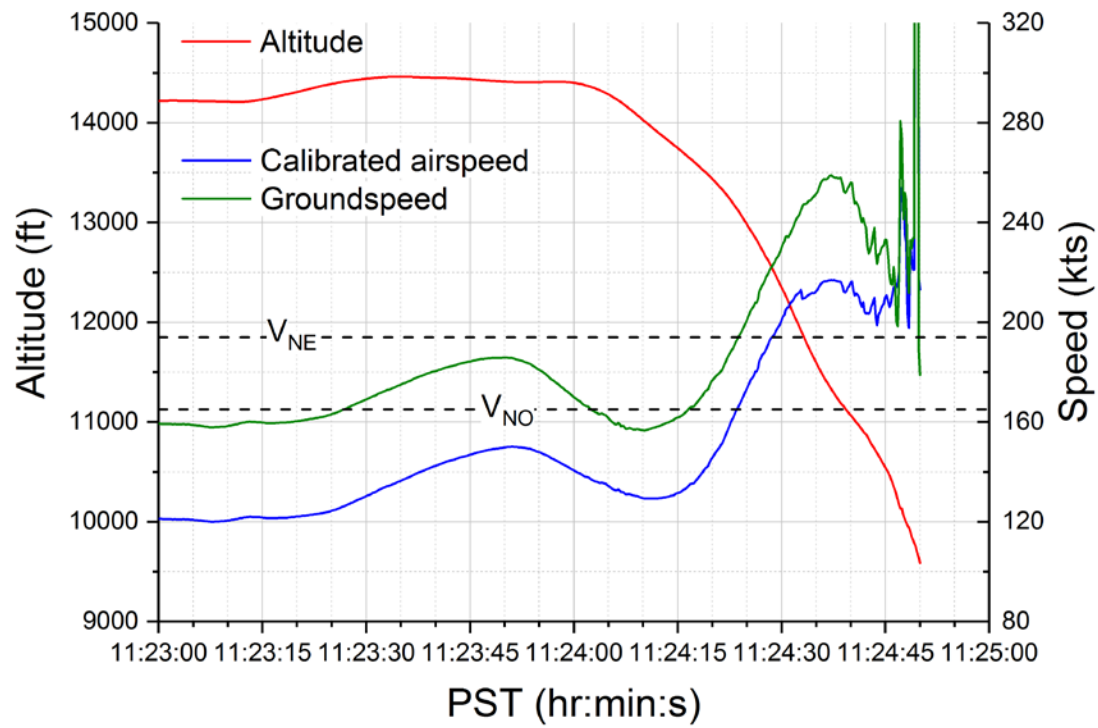
**Figure 4.** Altitude, groundspeed, and calibrated airspeed.

The airplane's maximum structural cruising speed ( $V_{NO}$ ) is listed in the Pilots Operating Manual [1] as 190 mph or 165 kts of calibrated airspeed. The never exceed speed ( $V_{NE}$ ) is 224 mph or 195 kts of calibrated airspeed. These limitations are shown on Figure 4. The airplane exceeded  $V_{NO}$  at 11:24:24 and  $V_{NE}$  at 11:24:29.

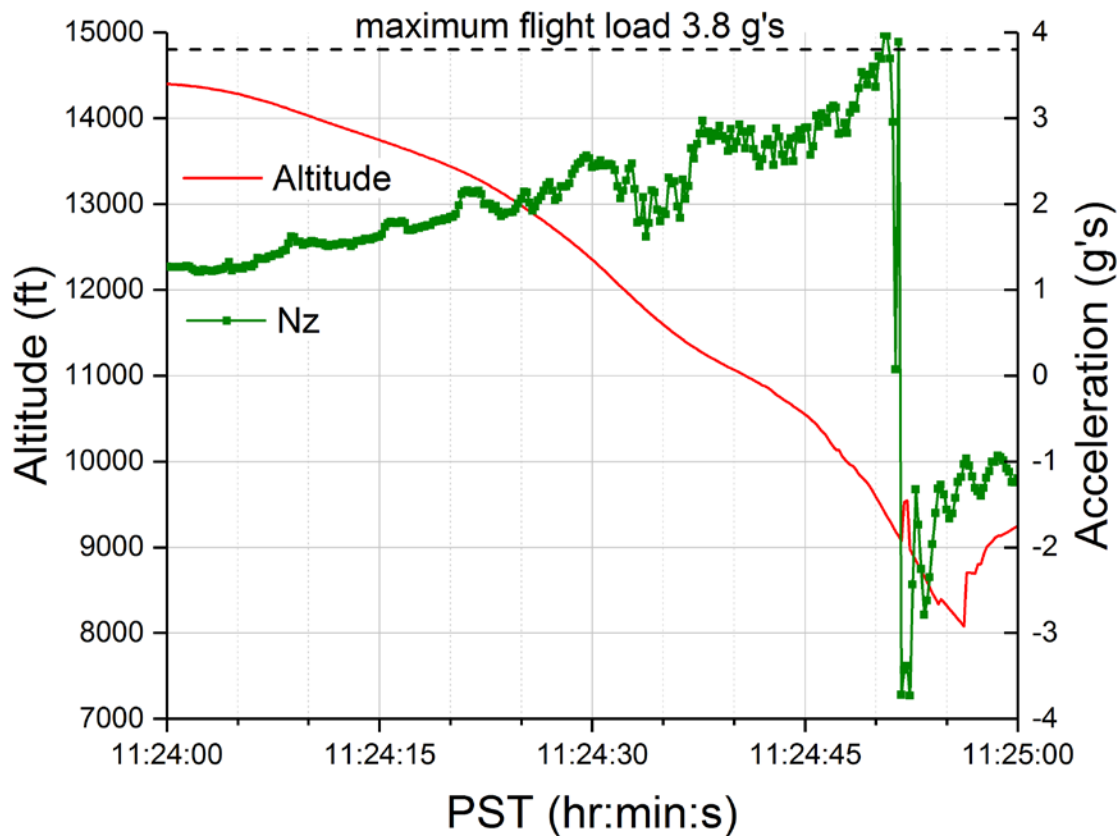
**Figure 6.** Altitude and vertical acceleration.

The airplane's maximum positive flight load factor (flaps up) is listed as 3.8 g's. The airplane's recorded flight load in the z-axis steadily increased starting at 11:23:00 when the right turn began (Figure 6). The airplane's flight load as recorded by the Appareo reached a maximum value of 3.95 at 11:24:50 at which point the Appareo data became unreliable (see also the sudden positive change in altitude) and the load factor drops significantly.

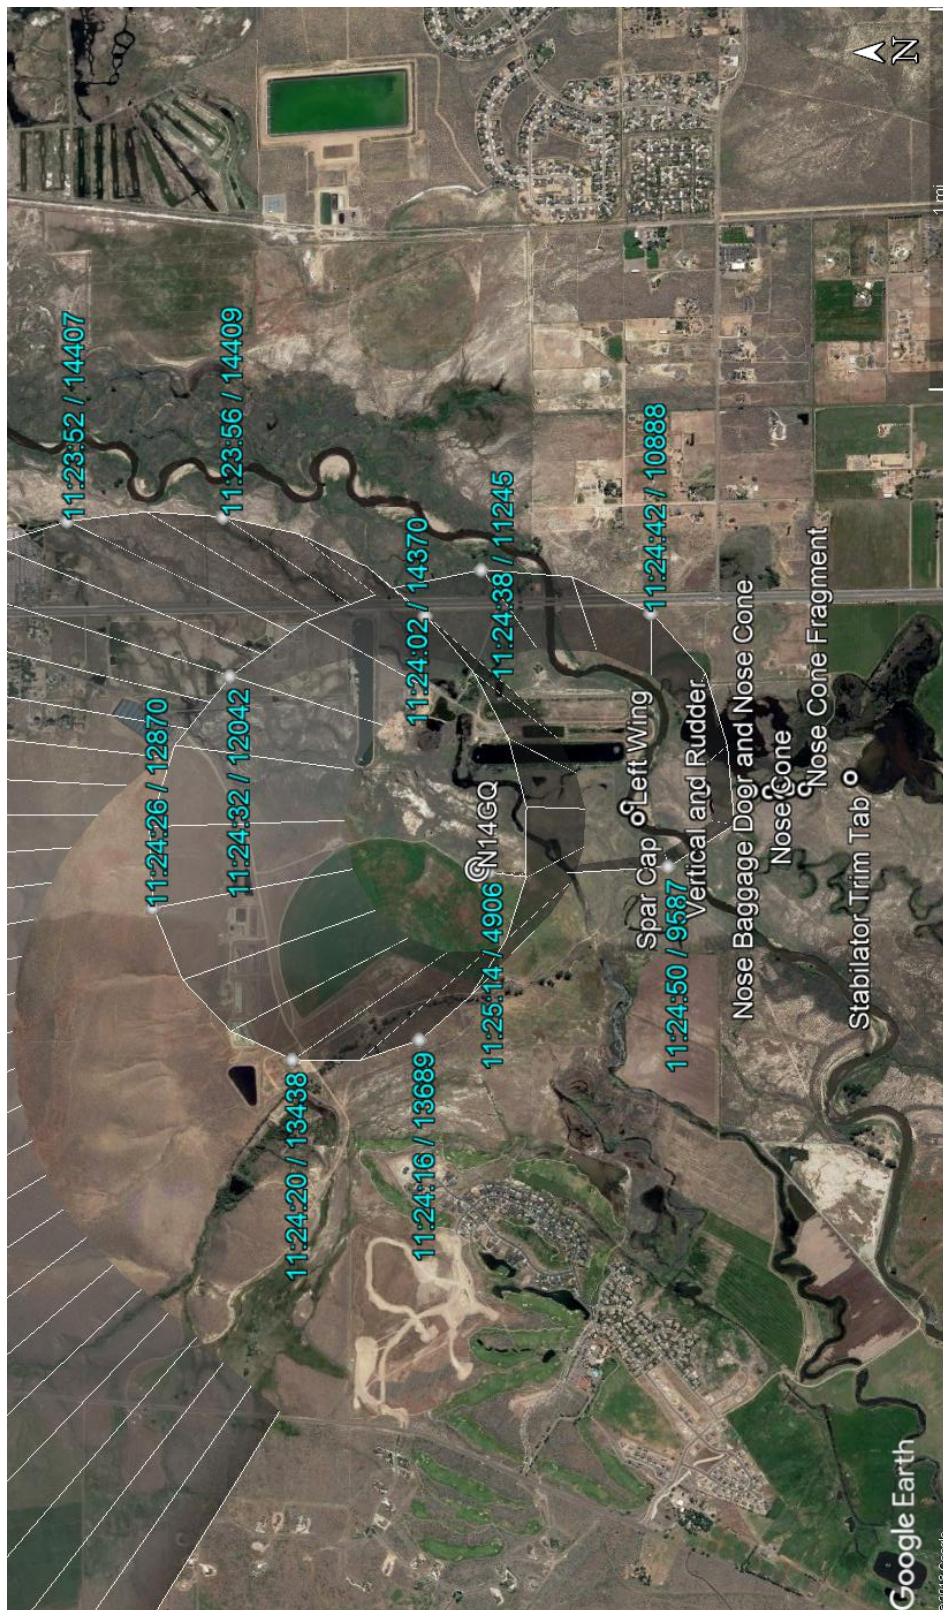
Figure 7. Airplane flight path and debris field.

Figure 7 shows the recorded flight path with data points between 11:24:50 and 11:25:08 removed. The final six seconds of data from 11:25:08 until 11:25:15 did show a flight path and altitude consistent with the airplane fuselage's final resting point (Figure 8). The elevation of the debris field was about 4,600 ft above sea level. The wreckage lay along a heading of 345° from the southern-most stabilator trim tab to the fuselage, which was a mile away.

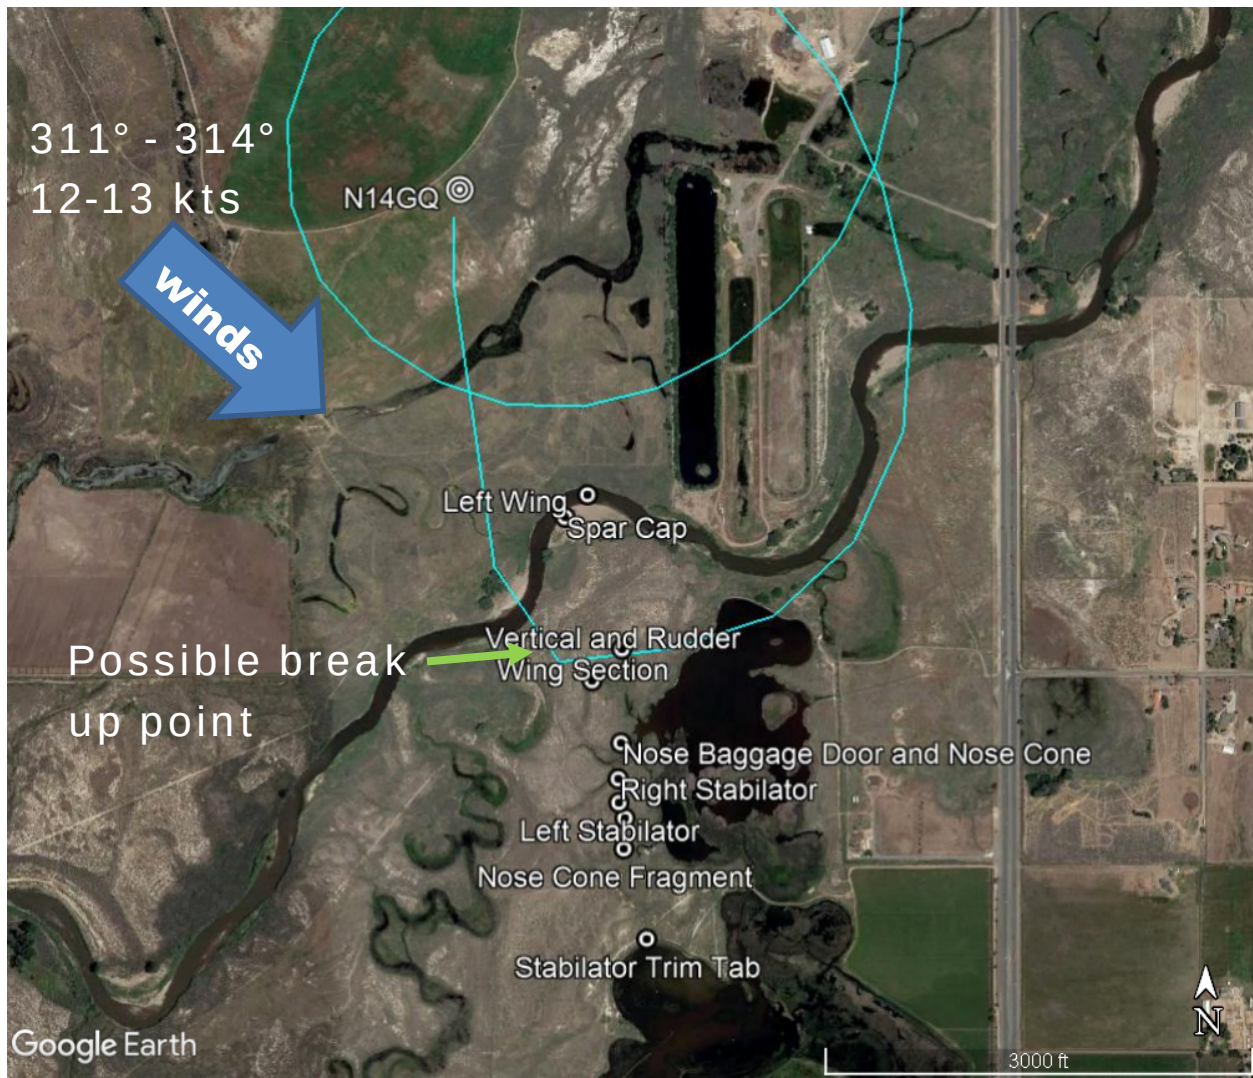
**Figure 9.** Airplane flight path and debris field.

The unreliability of the data after exceeding the maximum load suggests that the airplane broke up about 11:24:49 at an altitude of 9,500 ft MSL, 4,900 ft above the terrain below. Figure 9 shows the flight path projected onto the ground and the debris field. Also noted are the wind directions from Table 1. Winds below 10,000 ft are noted on the figure. The debris field is consistent with a break up at 9,500 ft. While the high momentum fuselage continued north, lighter pieces were carried southward and somewhat east by the wind.

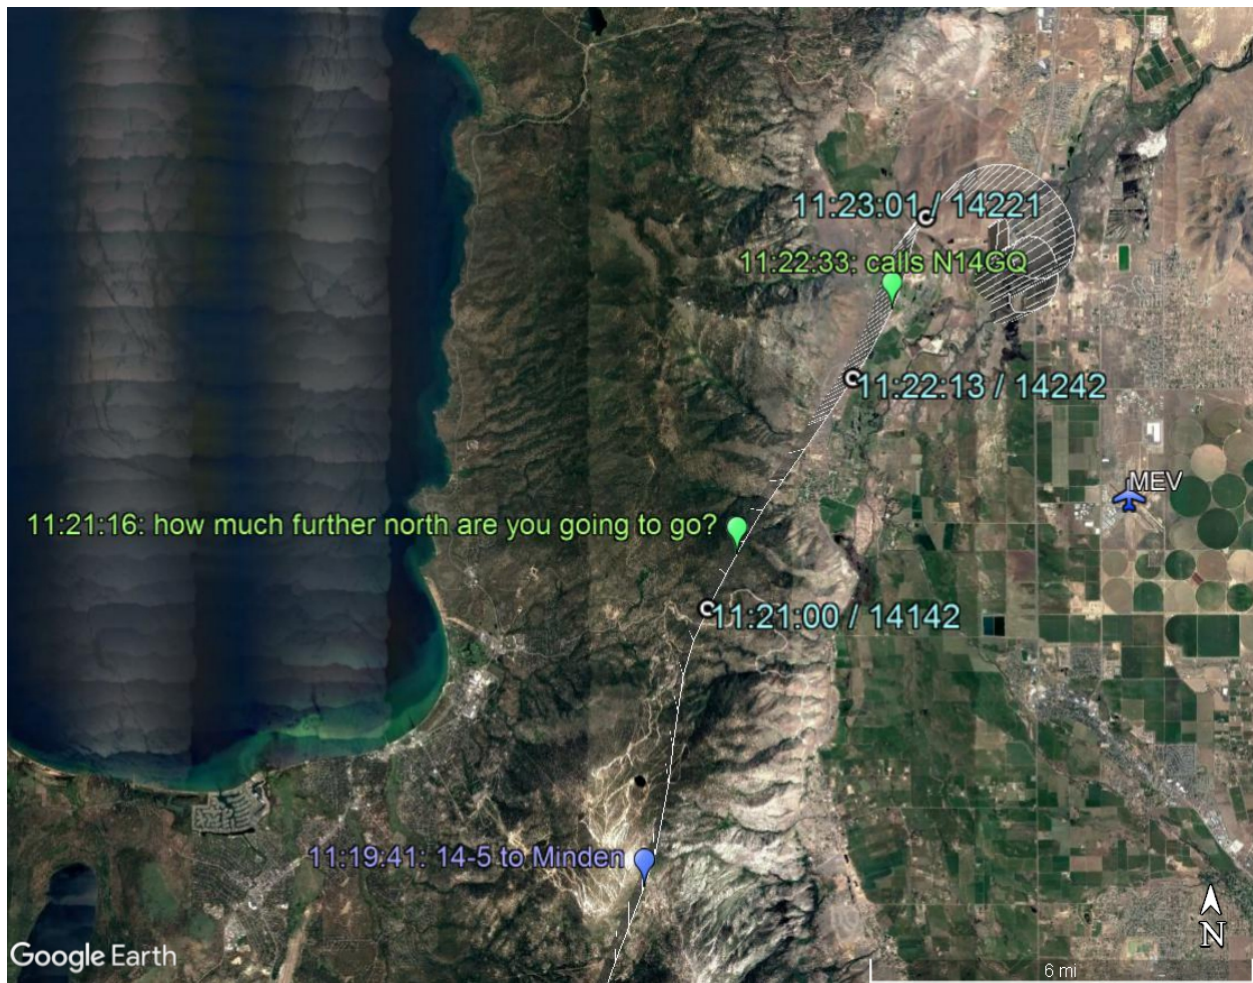
**Figure 10.** Airplane flight path and ATC communications.

At 11:21:16, ATC asked “how much further north are you going to go or is it for clouds?” and Figure 10 shows that the airplane was near the latitude of MEV. The accident pilot did not respond and the frequency was not busy. At 11:22:33 ATC called for N14GQ and again at 11:22:39. At 11:24:43 the pilot responded “ah, one four golf quebec” (Figure 11).
