## **NATIONAL TRANSPORTATION SAFETY BOARD**

# **ACCIDENT SITE EXAMINATION SUMMARY**

**WPR18FA091**

Location: Minden, Nevada  
Date: February 19, 2018  
Aircraft: N14GQ, Piper PA-34  
NTSB Investigator-in-Charge: Andrew Swick

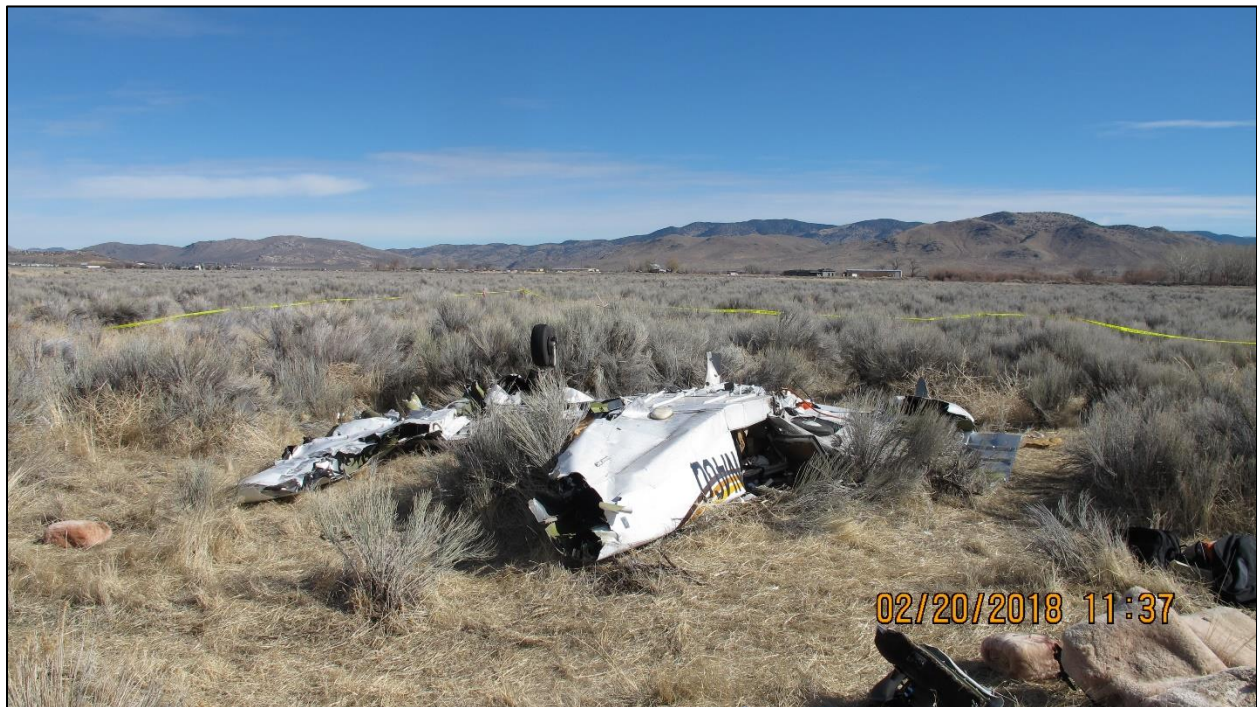
**Figure 1- Accident Site, Main Wreckage**

Examination of the accident site was conducted on February 20 and 21, 2018, by the NTSB-IIC, FAA-IIC, representatives from Piper Aircraft and Continental Motors Group, and revealed the

airplane impacted the ground in an inverted, wings level, slightly nose down attitude. There was no debris path located within the vicinity of the main wreckage. The nose cone assembly, empennage, right wing outboard full-span-flap assembly, and left outboard wing section were not located with the main wreckage. A debris field was located about .5 mile south of the main wreckage and contained the separated airplane parts. The debris field was 800 ft wide by 3,128 ft long.

Prior to the examination, first responders had cut several areas of the fuselage to facilitate the removal of the occupant.

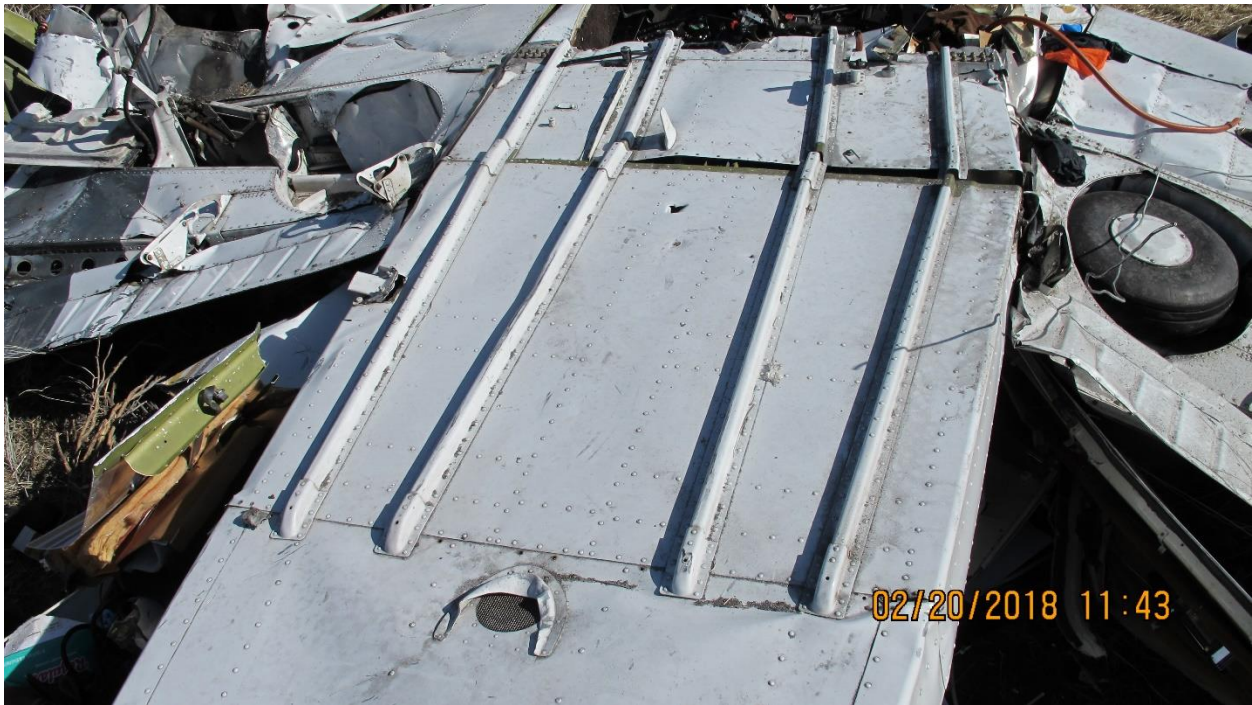
**Figure 3-Lower Fuselage**

The fuselage lower surface had several black transfer marks, impact damage and punctures. The right-side step was cut by first responders, and the mount was partially separated. The skid rails had black transfer marks and impact damage to their right facing sides. The vent fairing located aft of the skid rails was crushed.

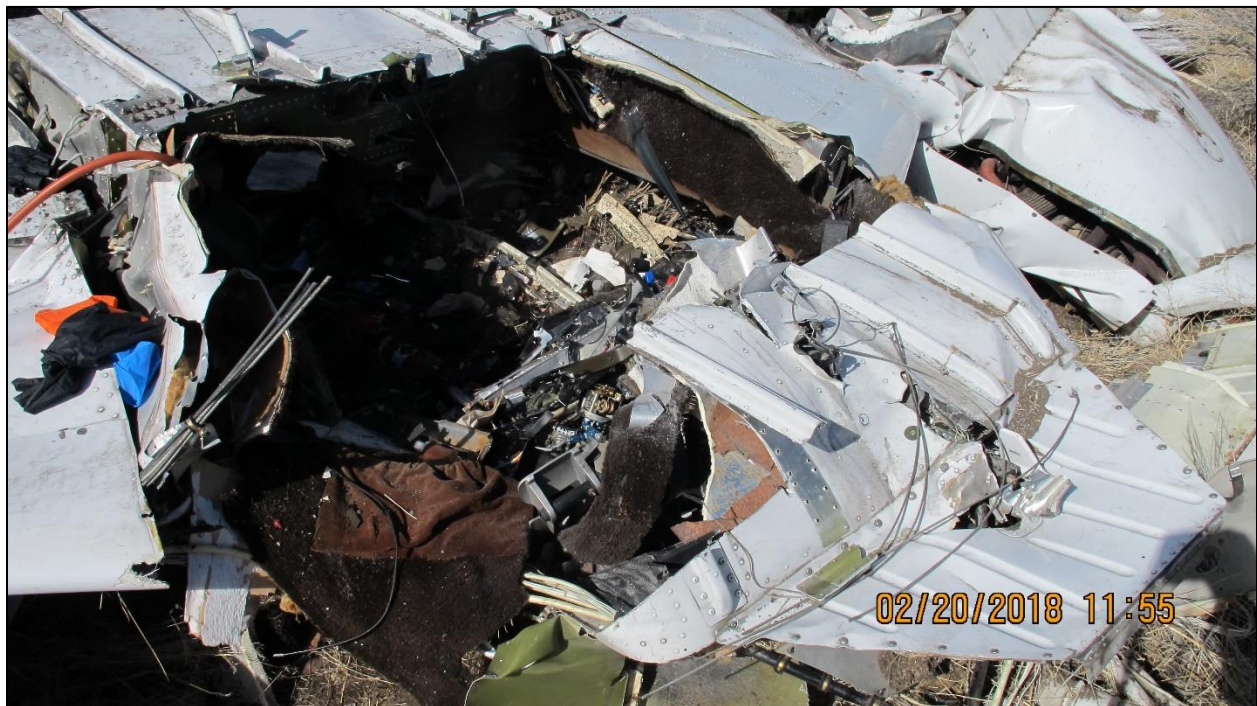
**Figure 4-Forward Fuselage, Cabin Area**

The forward lower fuselage, center console and seats were removed by first responders, exposing the cabin area. The instrument panel was crushed. The throttle quadrant remained attached to the center console, was crushed and positions unknown. Oxygen system tubing was visible in the cabin area.

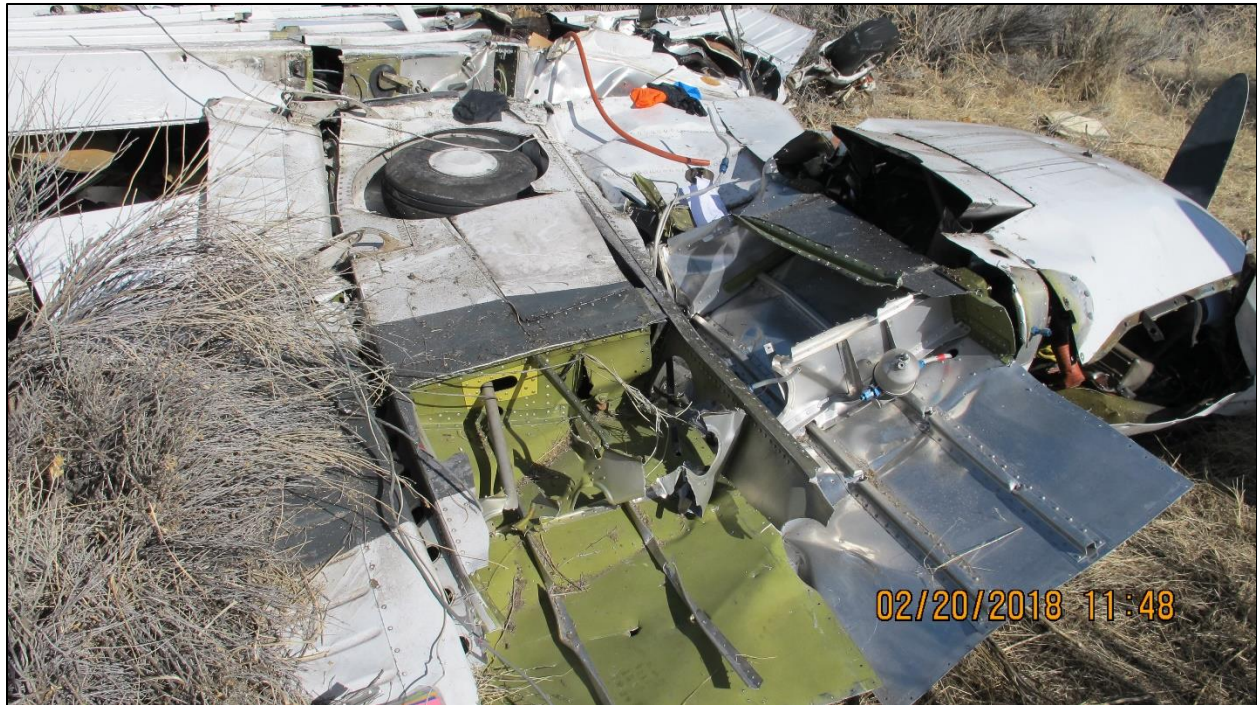
**Figure 5-Left Wing, Lower Side View**

The left wing remained partially attached to the fuselage. The forward and aft spars separated near the wing root area. The outboard section of the left wing separated about midspan. The forward and aft spars were bent downward. The upper wing skin had buckling and deformation. A section of the forward spar upper cap separated from the webbing and was not located with the main wreckage. The spar separation surfaces revealed 45-degree shearlips. The spoiler cables remained attached to the spoiler bellcrank and was continuous to the cabin controls through impact damage and cable cuts by first responders. The spoiler interconnect cable was continuous through to the right wing. The left main landing gear was found in the retracted position with damage to the trunnion and supporting pins area. The landing gear was loose but could not be removed due to the position in the damaged wheel well.

The left engine was partially attached to the wing with damage to its mounting assembly. The cowling had impact damage revealing the sides of the engine. The propeller assembly remained attached to the engine and one blade was exposed and undamaged.

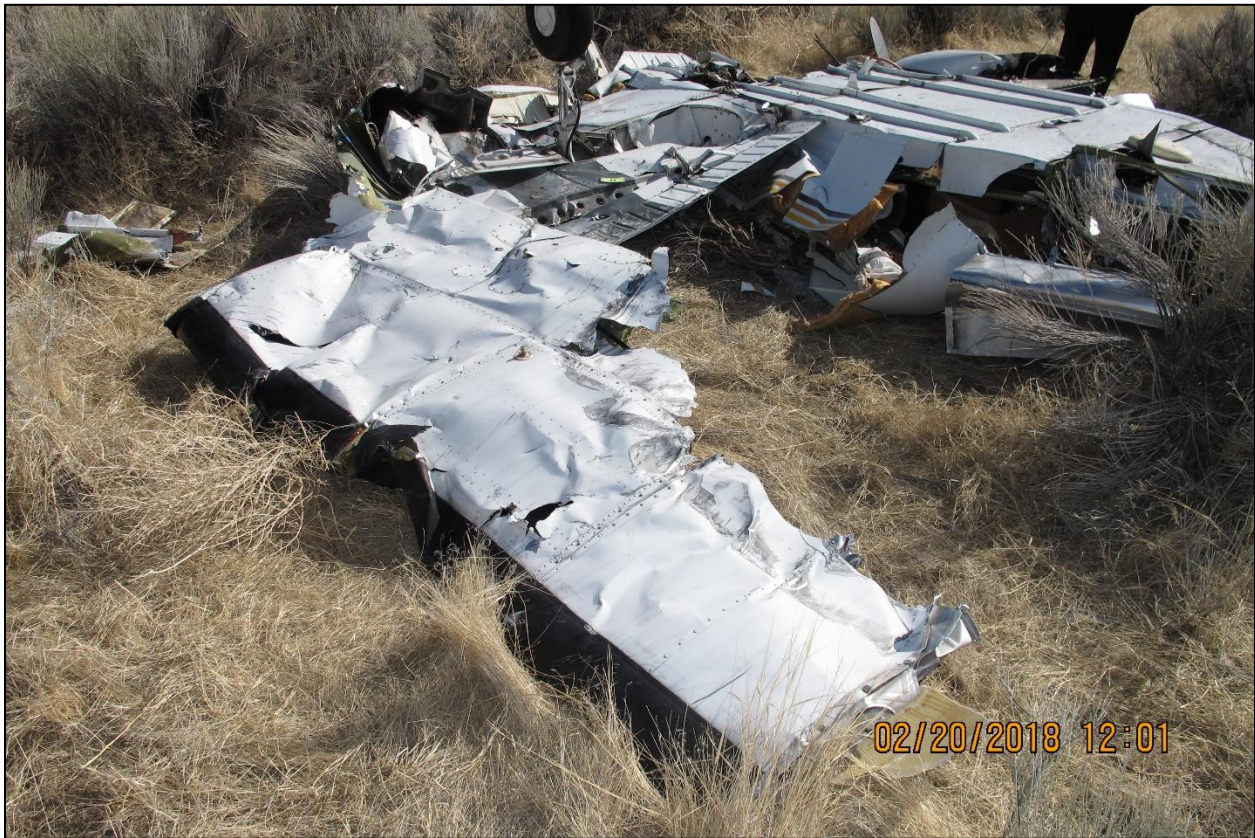
**Figure 6-Right Wing-Lower Side View**

The right wing remained attached to the main wreckage. The outboard section (from the inboard fuel tank to the tip) of the wing remained attached by control cables and tubing. The outboard full span flaps and associated attachments separated from the outboard section of the wing. About 4 ft of black colored transfer marks were visible on the lower surface of the wing forward of the outboard full span flaps. The outboard section of wing was buckled throughout. The leading edge of the wing had impact damage. The spar separation surfaces revealed 45-degree shearlips. The fuel tanks were breached, and a pillowing signature was visible on the inboard side of the inboard tank. A deep impression was visible aft of the right engine and is consistent in size with the pillowing signature of the inboard fuel tank. The right main landing gear was in the down position, and impact damage was noted in the wheel well area. The upper side of the outboard wing section had slight buckling and marking, compared to the lower surface. The fuel cap was removed and was unremarkable.

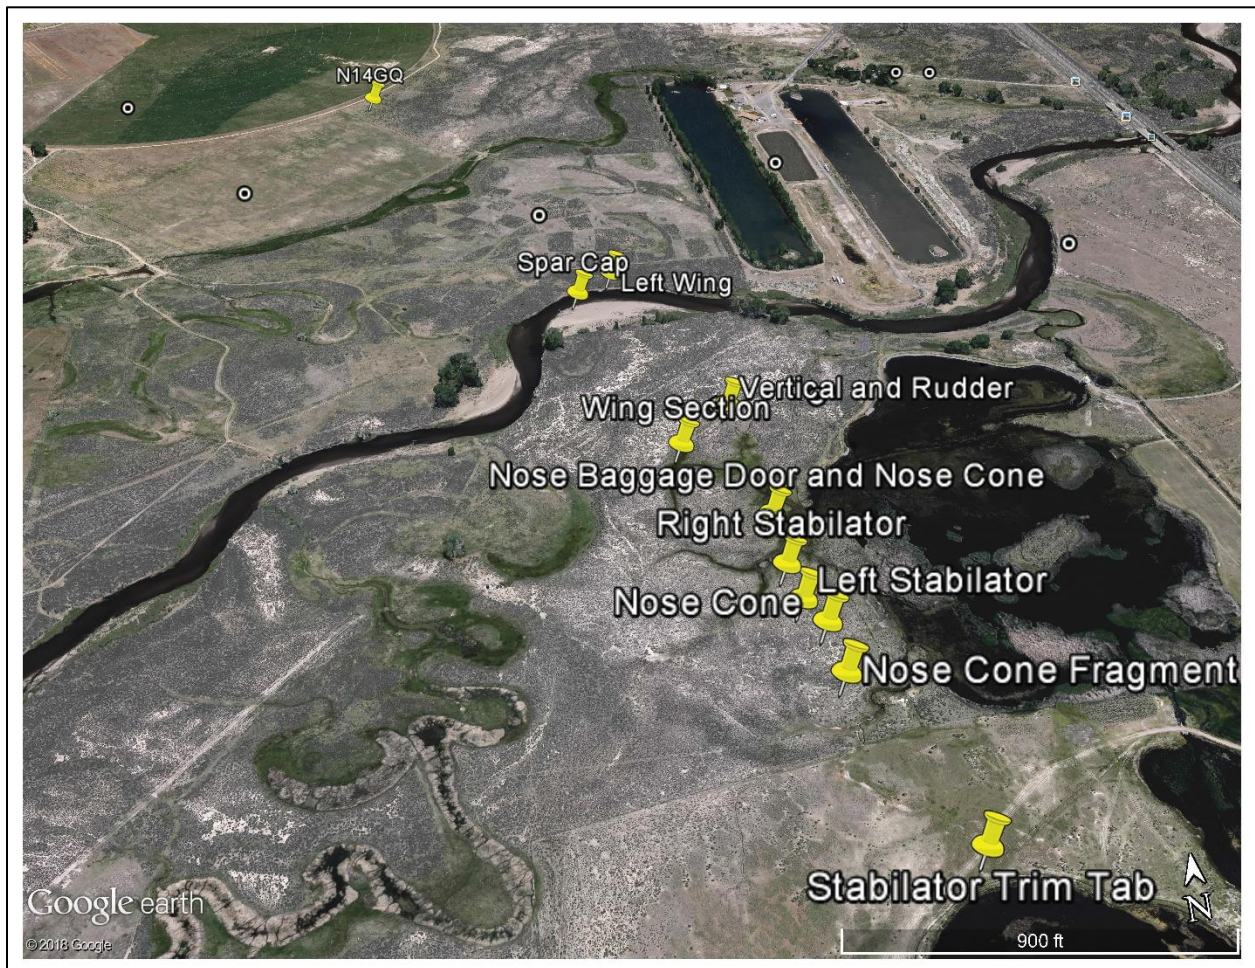
**Figure 7-Debris Field, Aerial View**

A debris field was located about .5 mile south of the main wreckage and contained the separated airplane parts. The parts were found in a linear pattern. The debris field was 3,128 ft in length and on a 172° magnetic heading from the main wreckage.

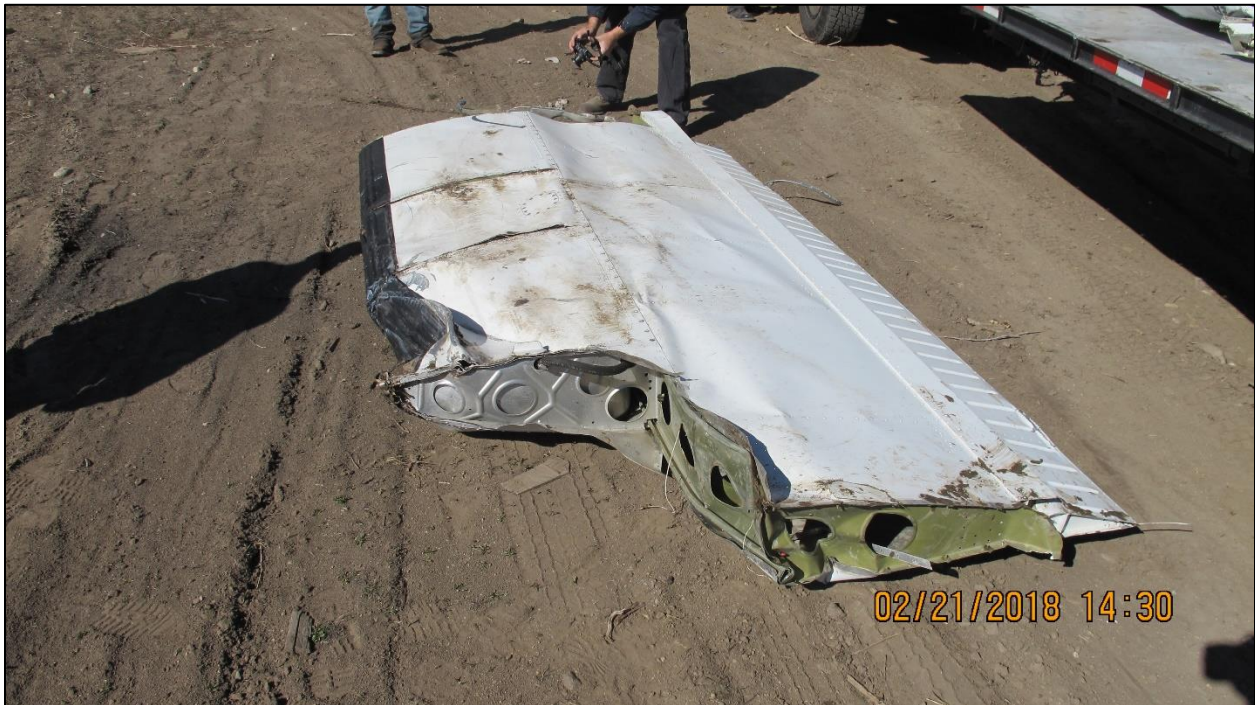
**Figure 8-Left Wing**

The left wing was located on the bank of Carson River and was the first item in the debris field. The outboard flap section and spoiler remained attached. The leading edge had impact damage and paint transfer marks. The outboard fuel tank and wing tip separated from the wing. The main spar was bent downward near the mid-span separation.

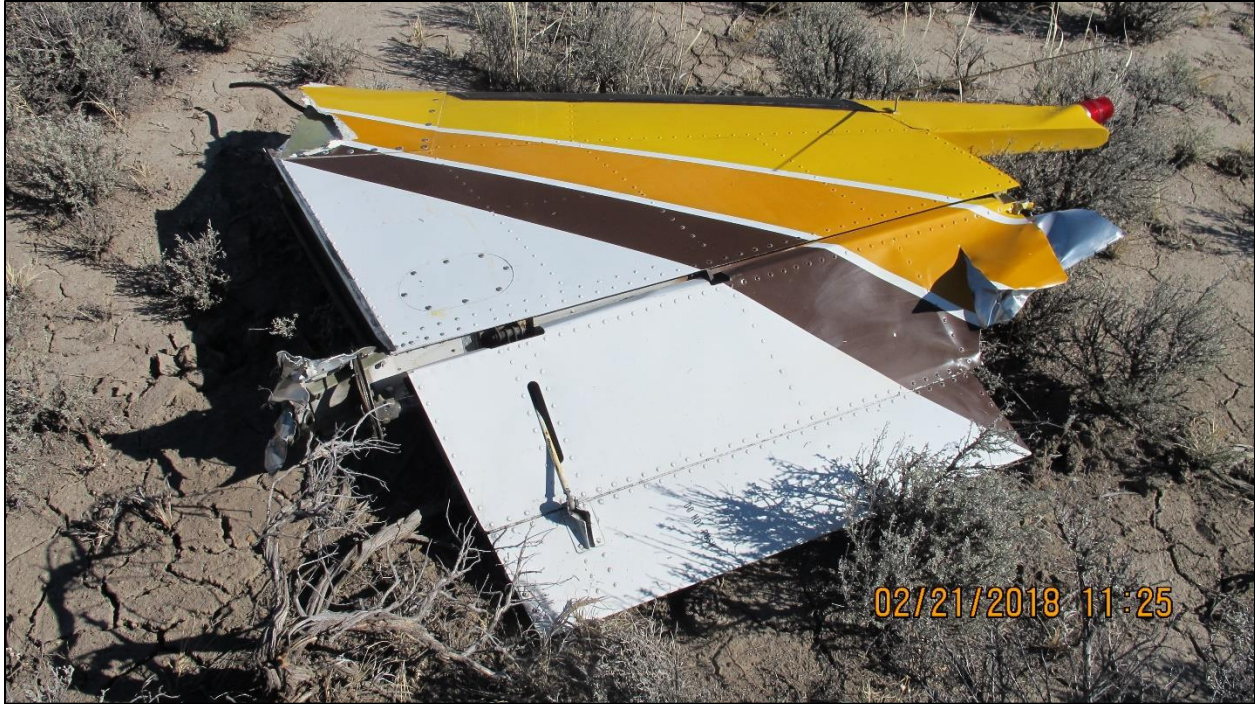
**Figure 10-Vertical Stabilizer and Rudder**

The vertical stabilizer and rudder were found about 1,000 ft down the debris field. The upper portion of the rudder, including the rudder balance weight, separated from the rudder and were not found. Rudder cables remained attached to the bellcrank and the cable ends had overload signatures. The rudder stops showed normal contact.

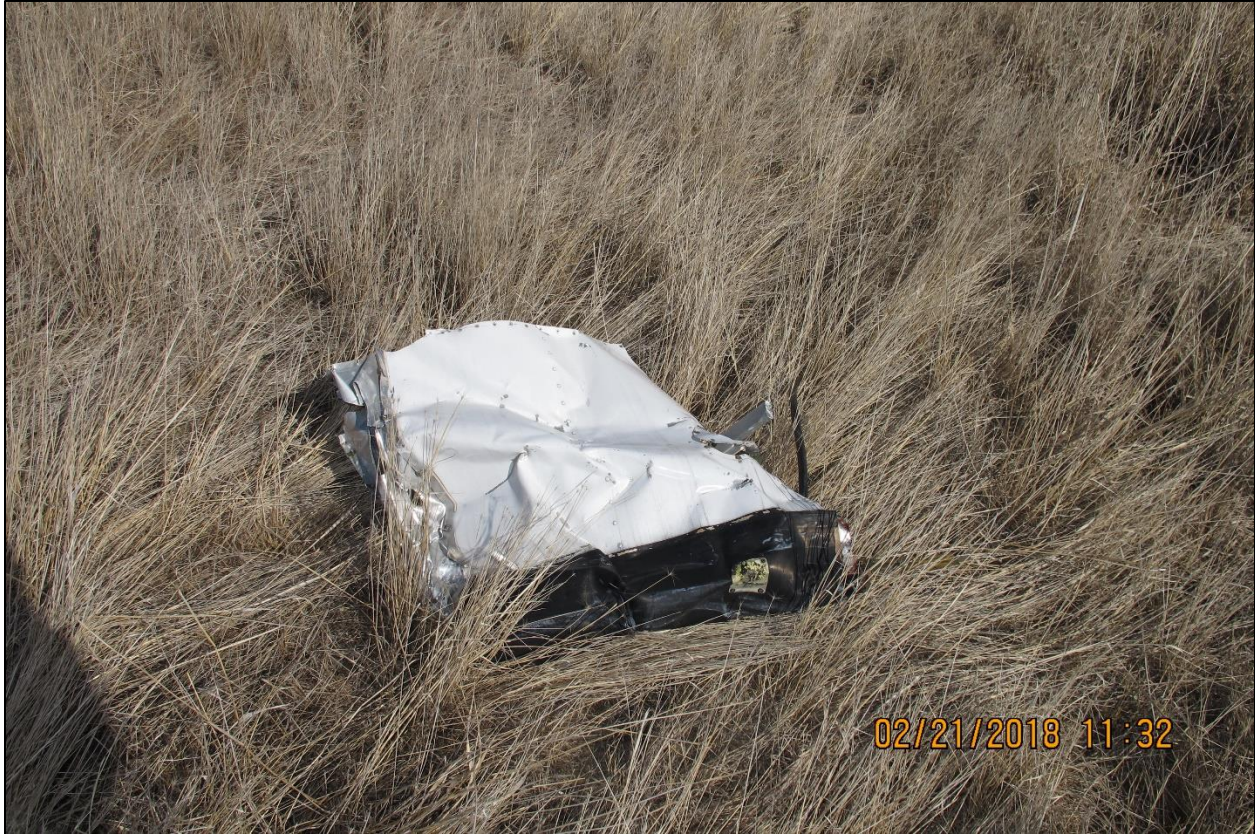
**Figure 11-Left Wing, Outboard Fuel Tank**

The left wing outboard fuel tank was found about 300 ft further down the debris field. The fuel tank was buckled and breached.

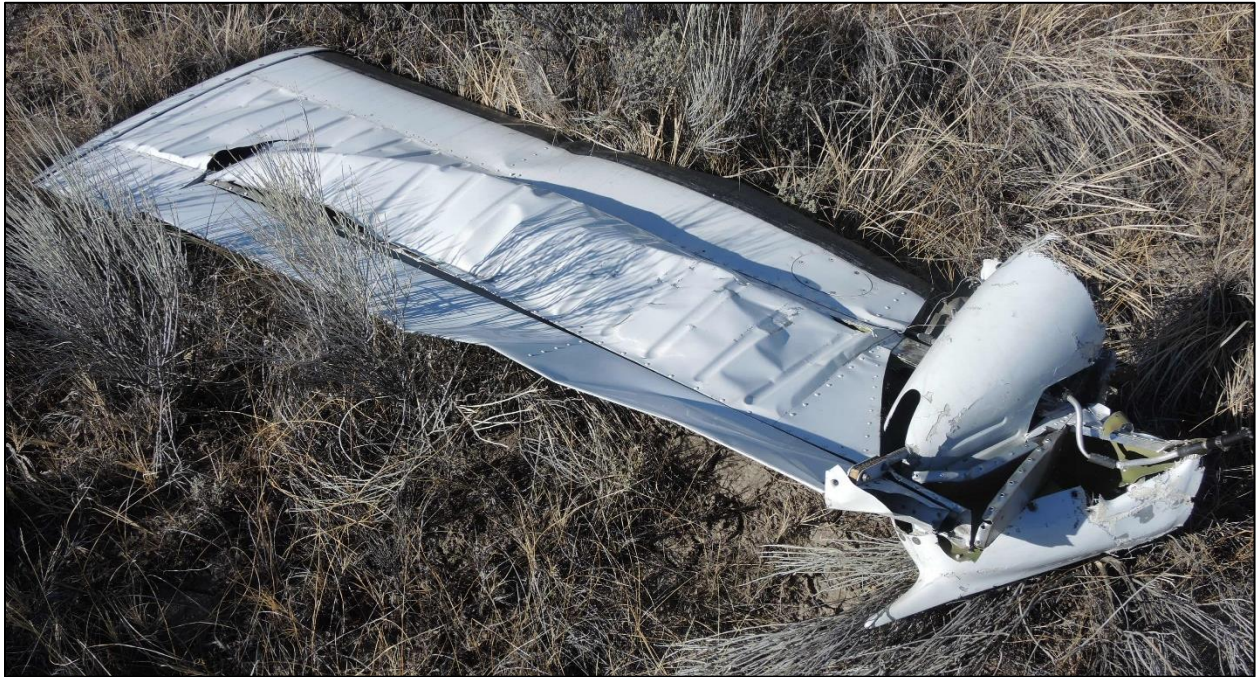
**Figure 12-Right Stabilator**

The right stabilator was found about 700 ft further down the debris field and was partially attached to a section of the tailcone. The trim tab control linkage was partially attached to the trim tab. The stabilator was buckled downward on both upper and lower sides.

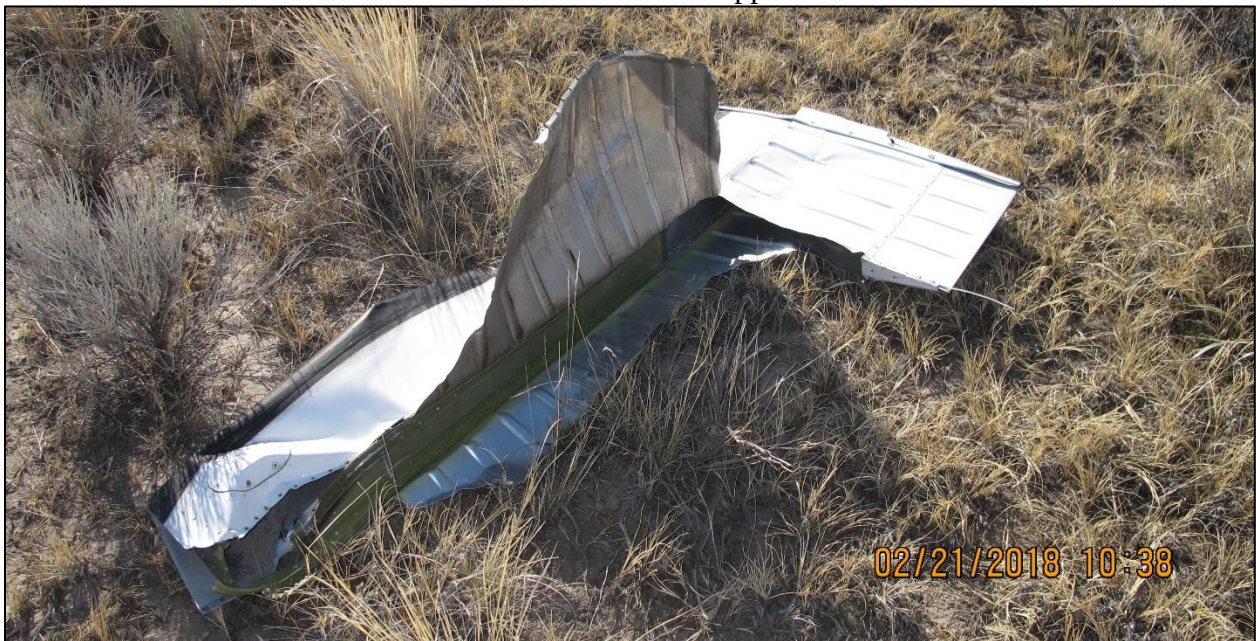
**Figure 13-Left Stabilator**

The left stabilator was found 160 ft further down the debris field and was torn open from the trailing edge. The leading edge had impact damage.

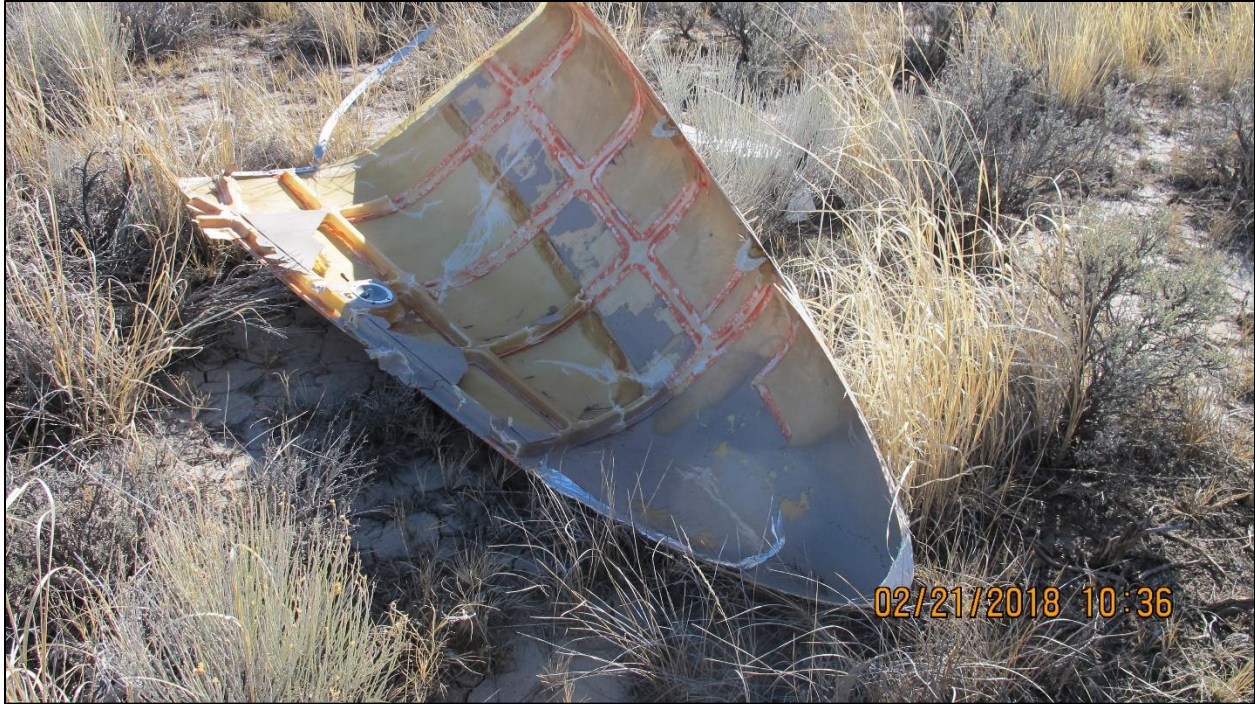
**Figure 14-Nose Cone Section**

A large section of the nose cone was found about 100 ft further down the debris field. Several other smaller sections of the nose cone were found throughout the debris field.

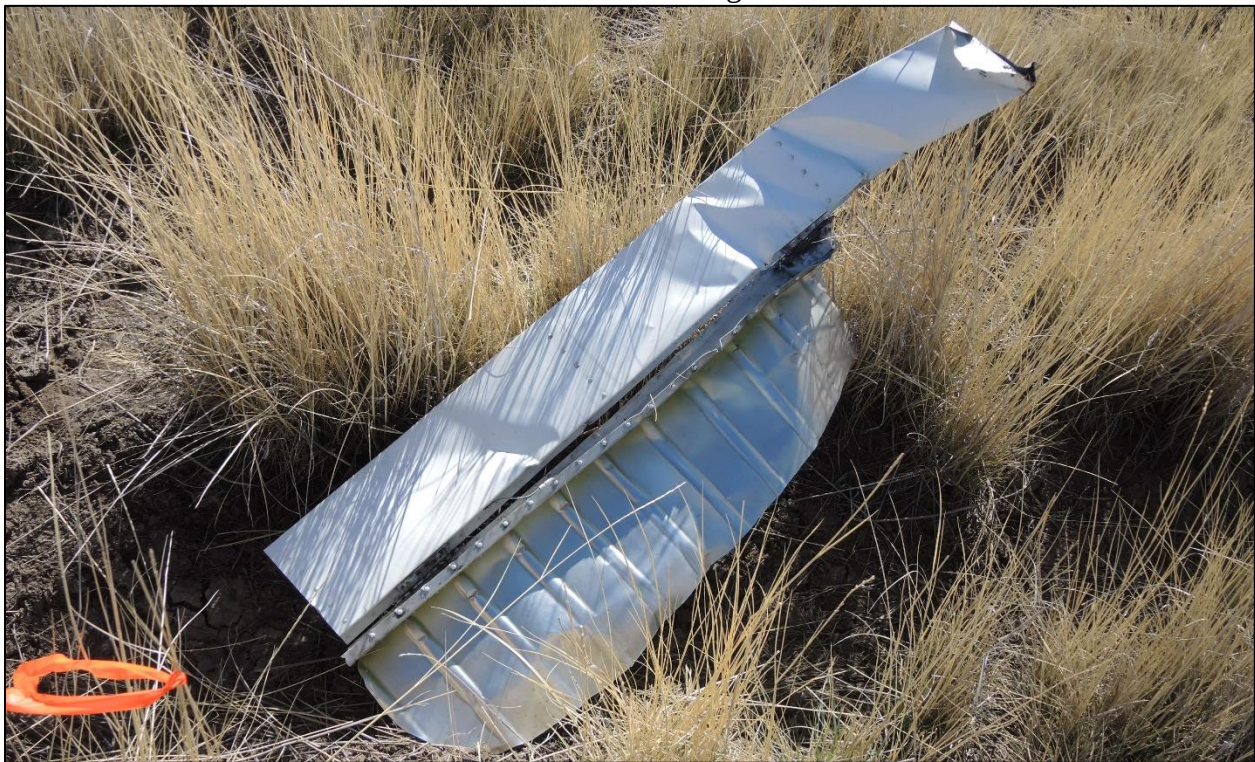
**Figure 15-Stabilator Trim Tab**

About 900 ft further, a section of the left stabilator trim tab remained attached to a small section of stabilator. This was the furthest piece of wreckage found in the debris field.

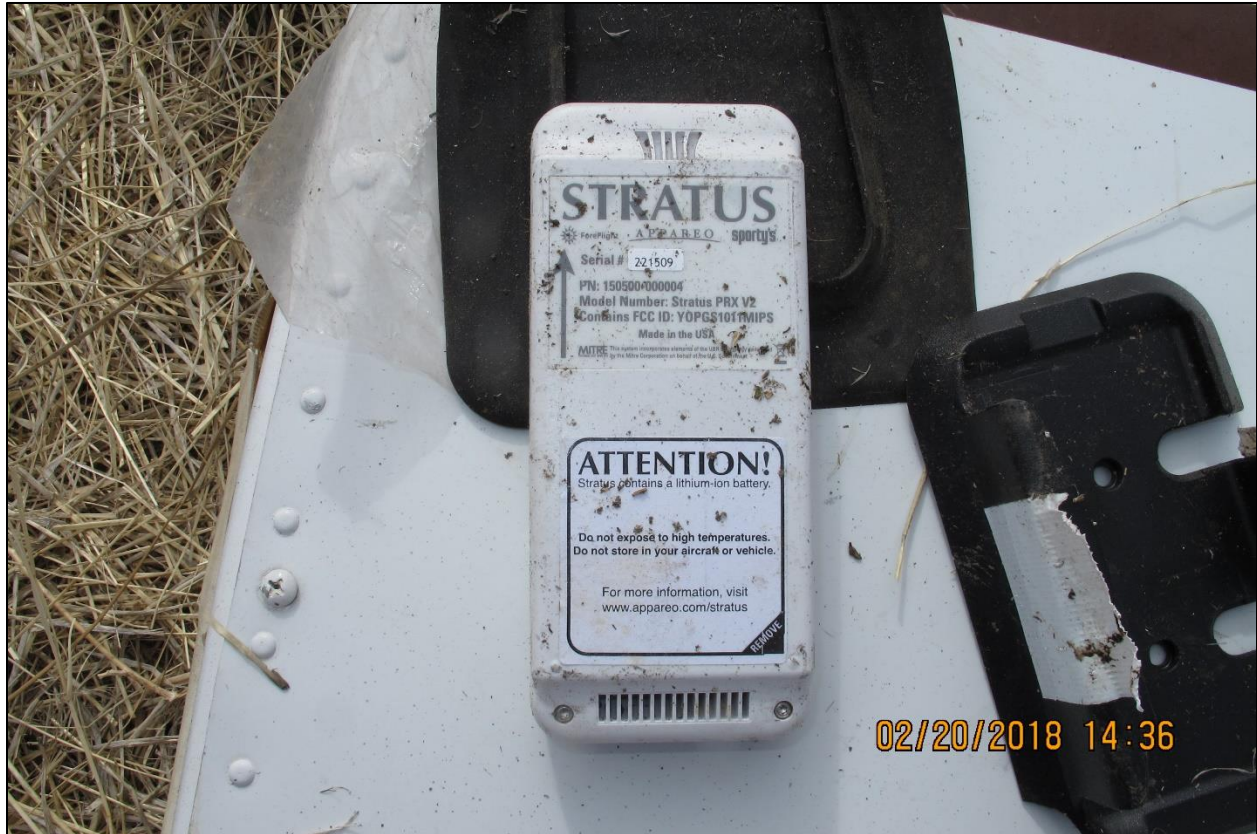
**Figure 16-Appareo Status Unit**

An Appareo Stratus unit, a flight data monitoring device, was found near the right engine and remained attached to power cables from the glare shield cabin area. The device was obtained by the NTSB IIC, for download of possible flight data.
