## **NATIONAL TRANSPORTATION SAFETY BOARD**

# **ON SCENE OBSERVATIONS**

**WPR18FA093**

Location: San Diego, CA  
Date: February 21, 2018  
Aircraft: Cirrus SR22T, Registration N707DF, Serial #1621  
NTSB IIC: Samantha Link

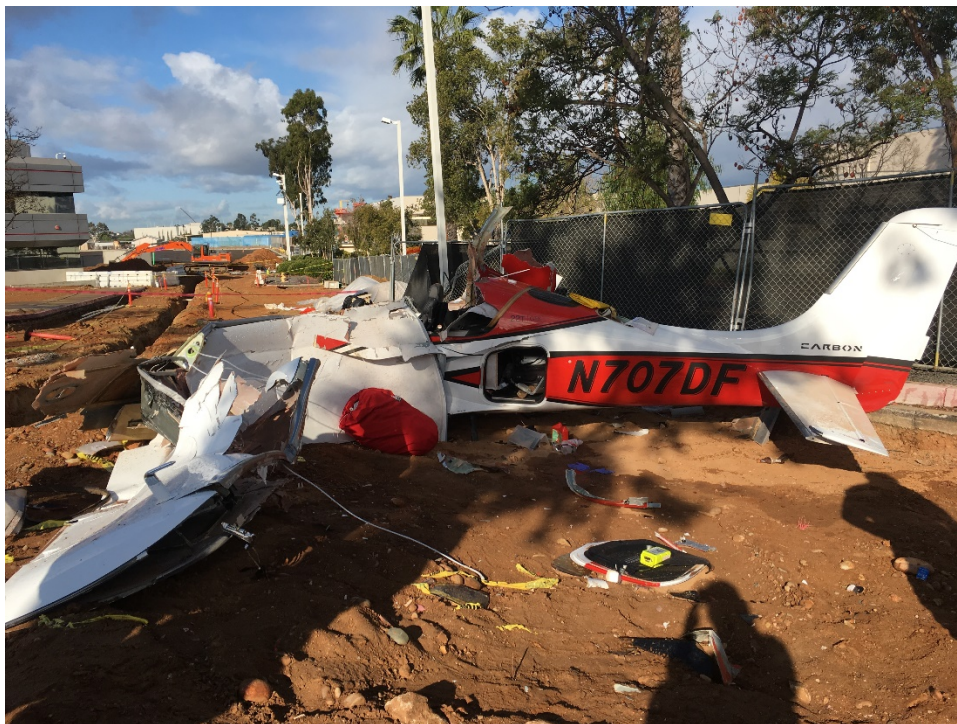
Figure 1: Left Side of Airplane

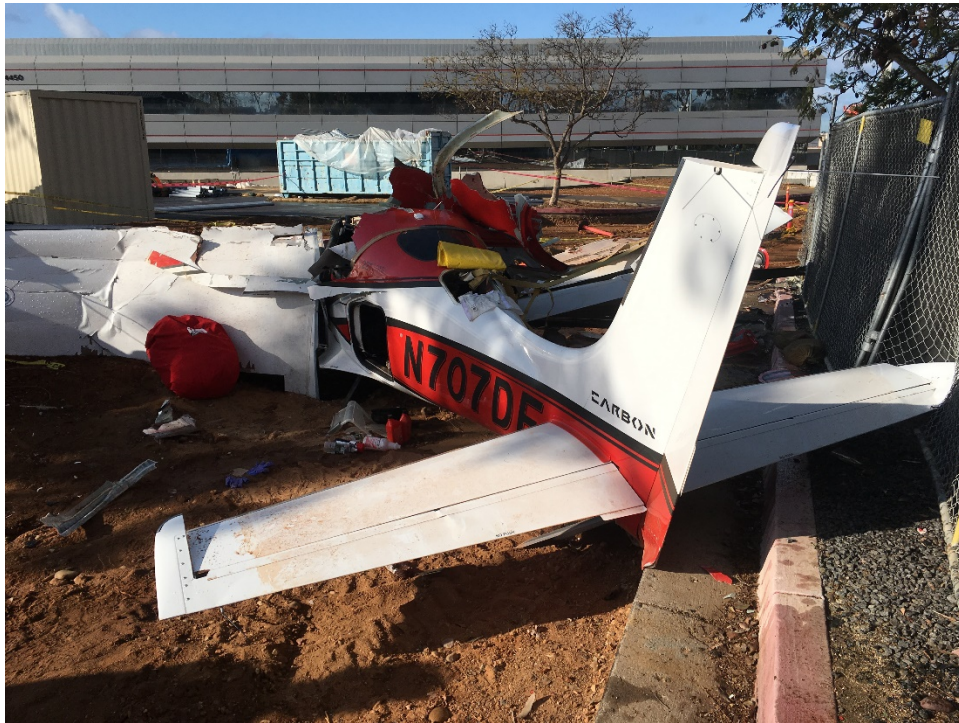
Figure 2: Empennage

- The remaining four seats remained secured to the airframe with the seat belts secured in place.
- The aft fuselage and empennage were mostly intact and sustained minimal damage.

- The parachute handle within the cockpit was found in the stowed position with the pin still installed.
  - The right horizontal stabilizer outboard edge came to rest against the fence and sustained upward crush damage.

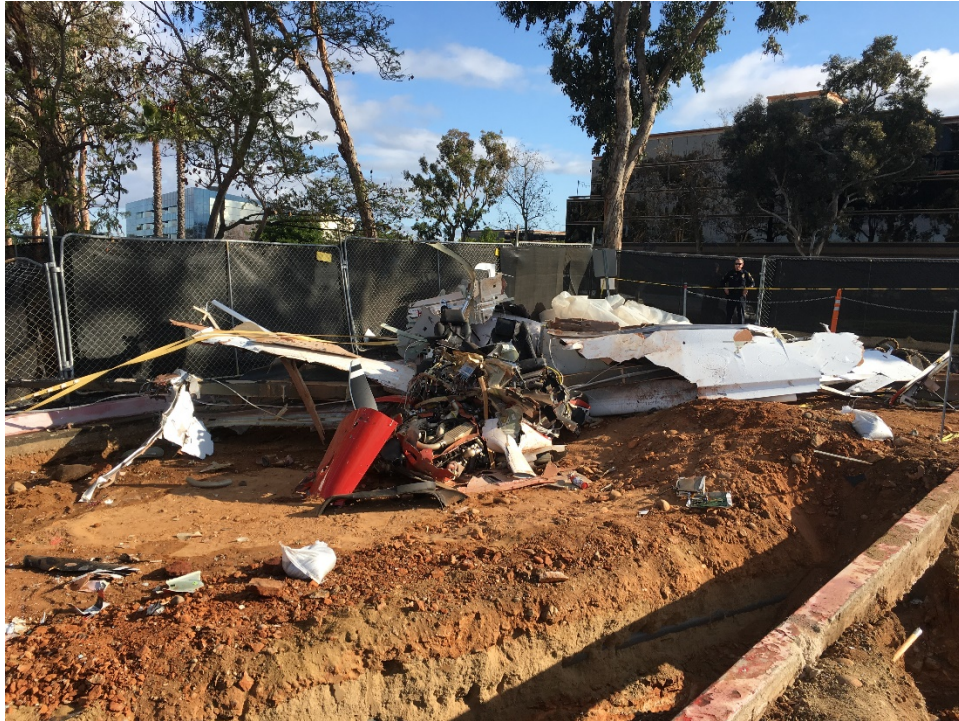
Figure 3: Forward View of Airplane

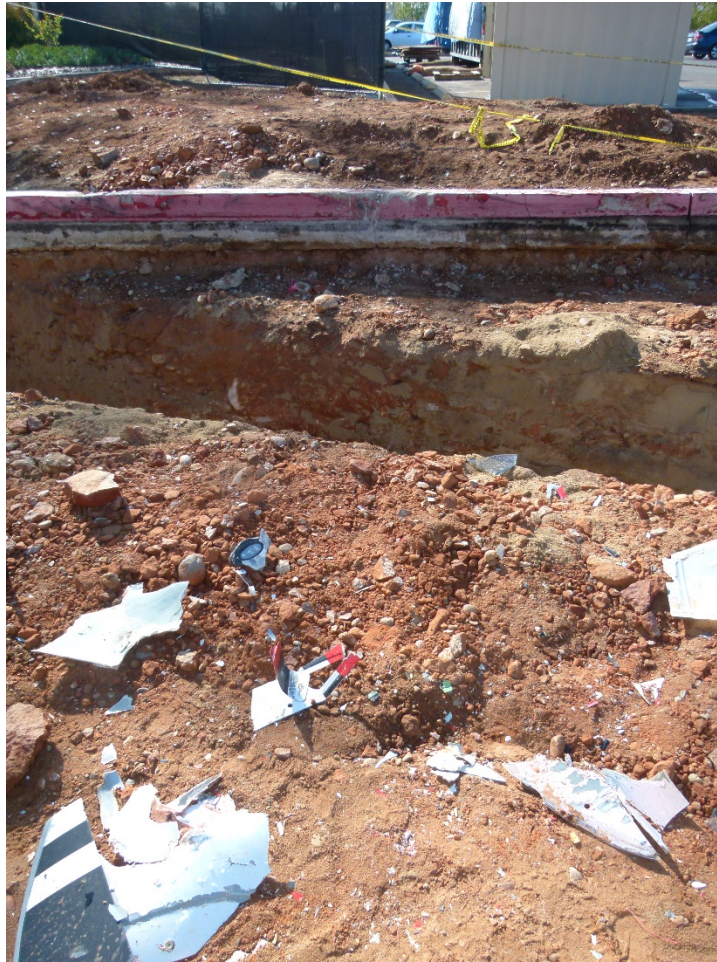
- A small impact crater was observed about 7 feet in front of the nose of the main wreckage, extending from the crater were two narrow impact marks extending from it, consistent with propeller blade leading edges. In this area were small pieces of unknown airframe debris, and a propeller blade.

- To the south of the small impact crater was the curb that extended along the trench. The curb sustained damaged and small fragments of unknown airframe components were embedded in the crack, and around the immediate area.

**Figure 4: Impact Crater and Curb Damage from Left Wing**

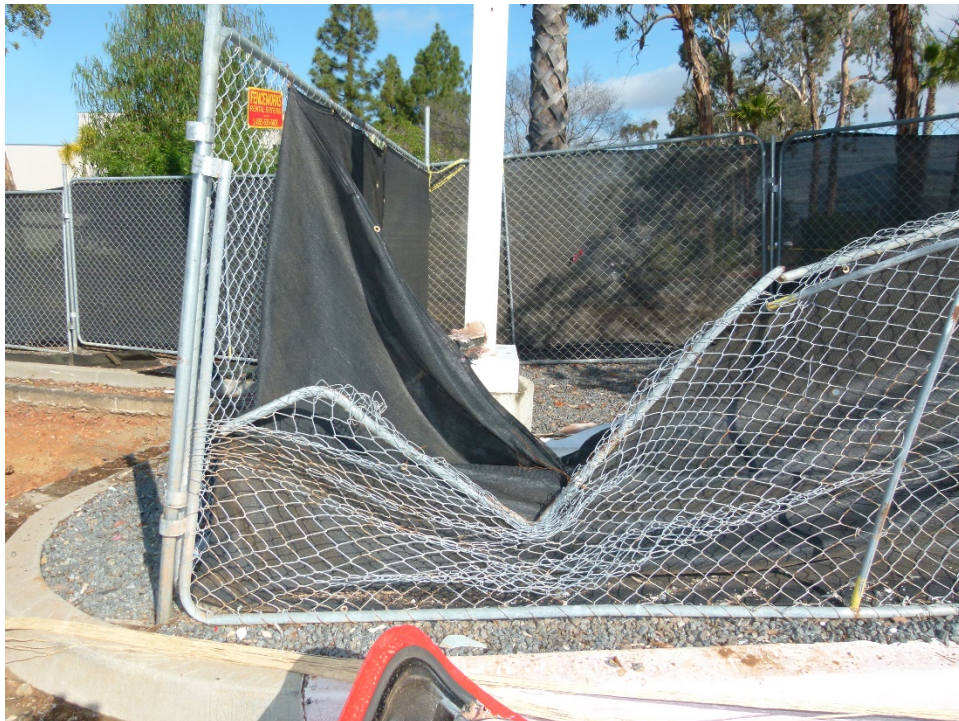
- To the north of the impact mark was a fence that was damaged downward, in the shape consistent with the leading edge a wing, the outboard right wing components came to rest on the other side of this fence.

**Figure 5: Damaged Fence Consistent with Right Wing Impact**

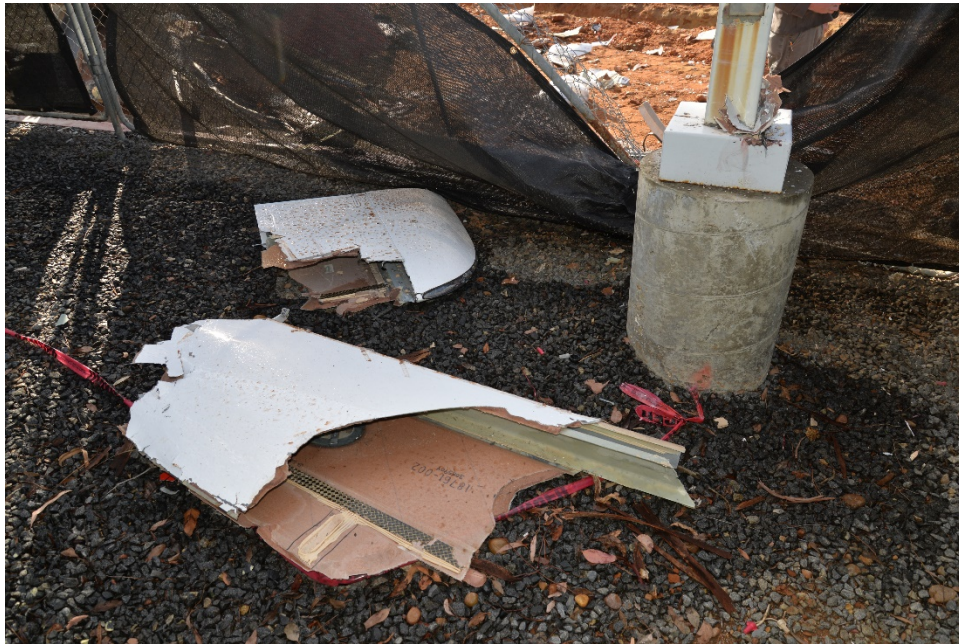
- The wing spar was mostly whole and sustained damage throughout
  - No fuel was present in the wing
- The inboard right wing remained attached to the airframe. The upper and lower wing skins were separated from the wing spar.

- The outboard wing spar was fracture separated; the inboard wing spar was mostly whole and sustained damage throughout
  - No fuel was present in the wing

Figure 6: Right Wing

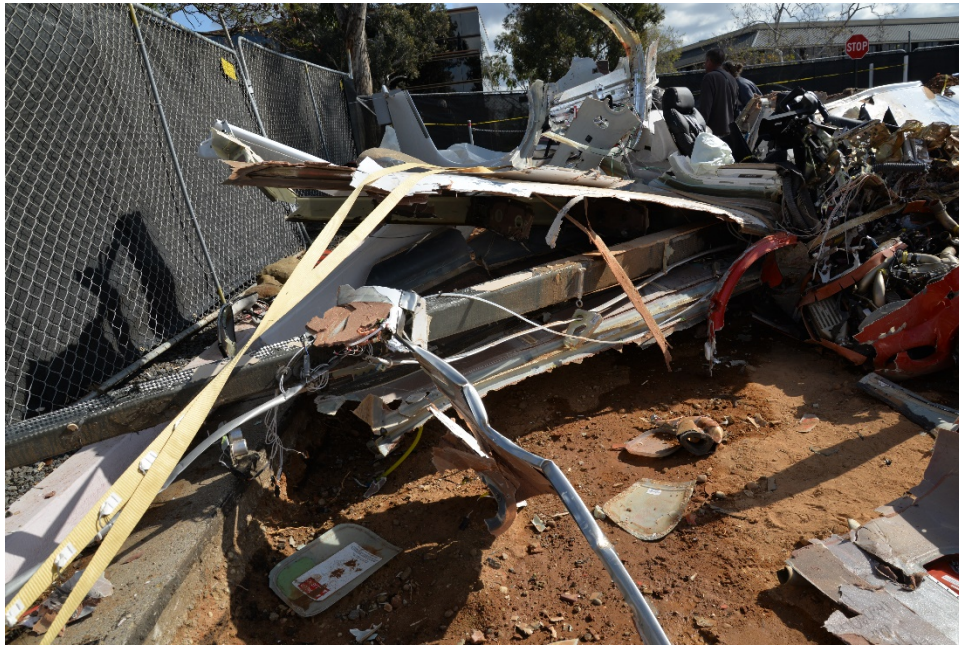
Figure 7: Right Wing Damage

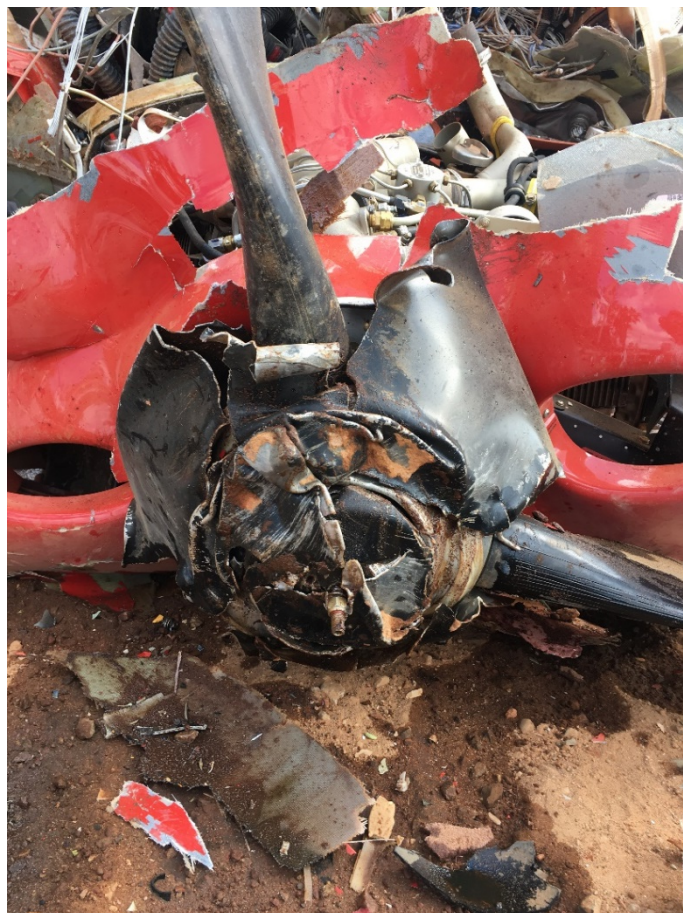
- The engine was nose low in the dirt and initial visual inspection revealed no obvious catastrophic anomalies.
  - The spinner was crushed flush against the propeller hub

Figure 8: Spinner Damage

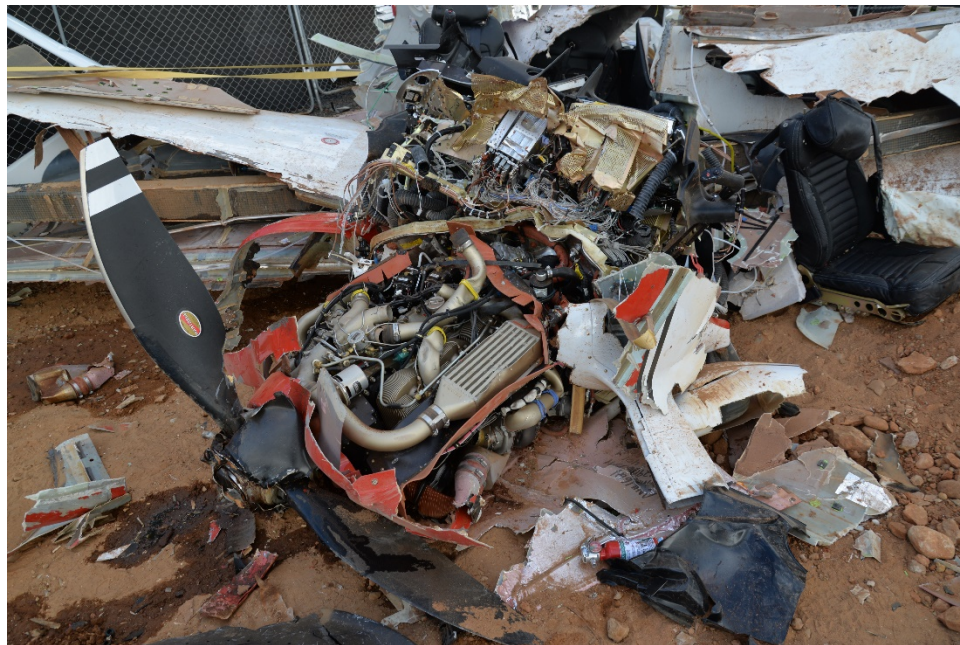
- The engine was mostly intact with no obvious visual anomalies.
- The induction system was heavily damaged and disconnected
- The right magneto was fracture separated from its mounting pad

- Three of six leads on both magnetos were pulled out of the ignition harness cap
- Fittings for the upper deck pressure reference lines were broken
  - Some lines were completely loose because they were broken on both ends

Figure 9: Top of Engine

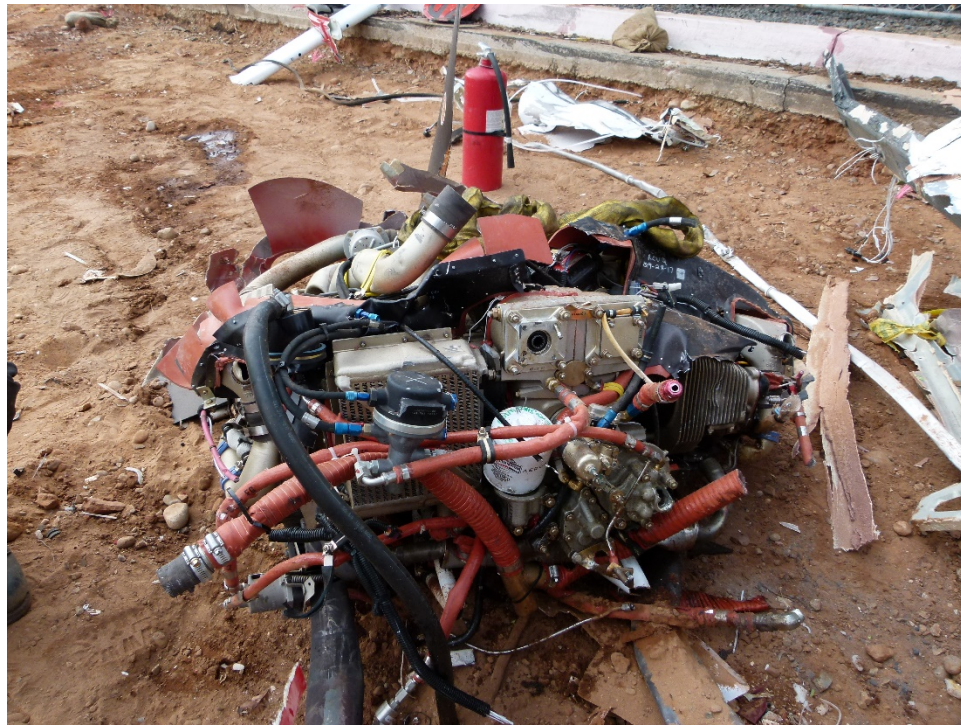
- Throttle arm moved freely from stop to stop
- The drive coupling remained intact
- The starter and part of the adapter were fracture separated

Figure 10: Accessory Section of Engine

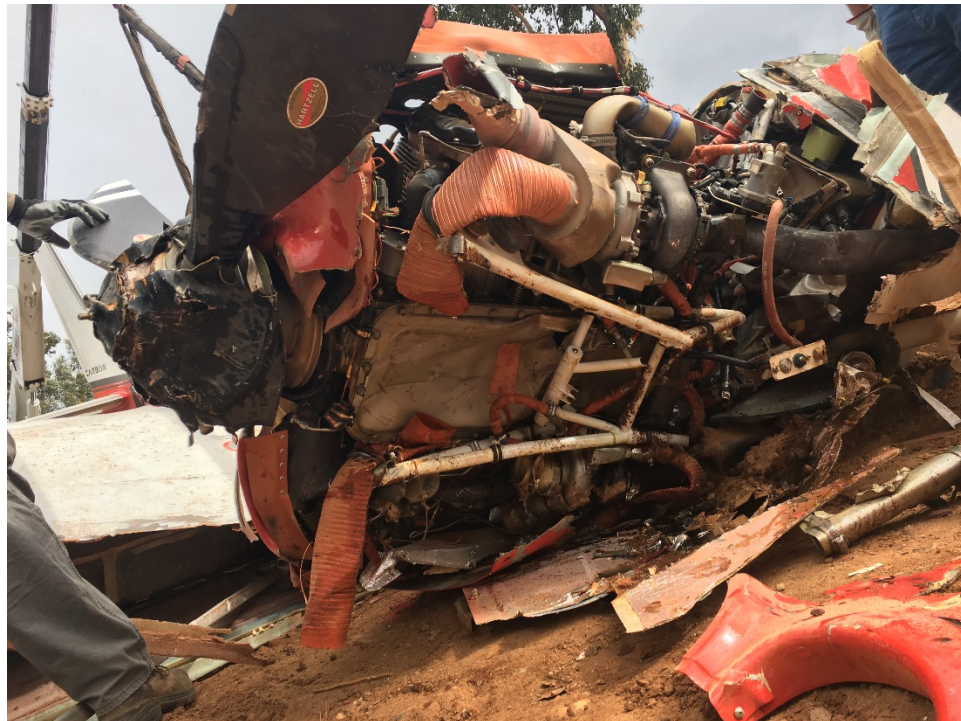
- The oil sump was crushed upwards into the crankcase
  - Hole in the bottom of the sump
  - Oil on the ground below the engine
- Then engine did not rotate when it was manipulated by hand.

Figure 11: Bottom of Engine
