## **NATIONAL TRANSPORTATION SAFETY BOARD**

# **ENGINE EXAMINATION/RUN AND PROPELLER EXAMINATION**

**WPR18FA093**

Location: San Diego, CA  
Date: February 21, 2018  
Aircraft: Cirrus SR22T, Registration N707DF, Serial #1621  
NTSB IIC: Samantha Link

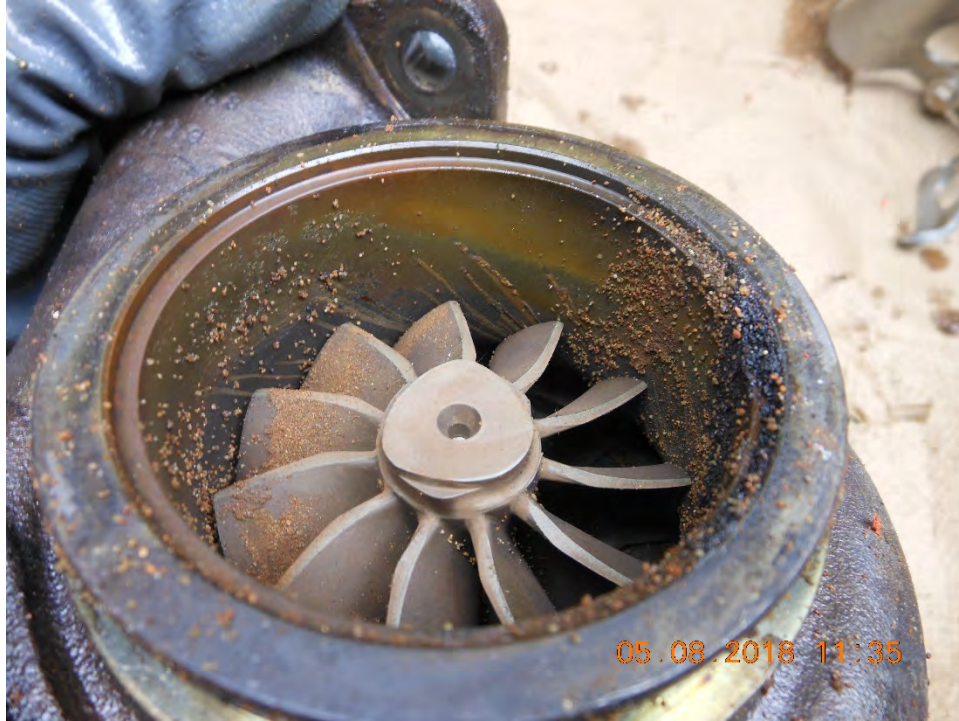
- o The turbine housing outlet exhibited spiral streaking which appeared to be from a fluid
- o Both the turbine and compressor wheels were rotated by hand

Figure 1: Spiral Streaking on the Right Turbine Housing

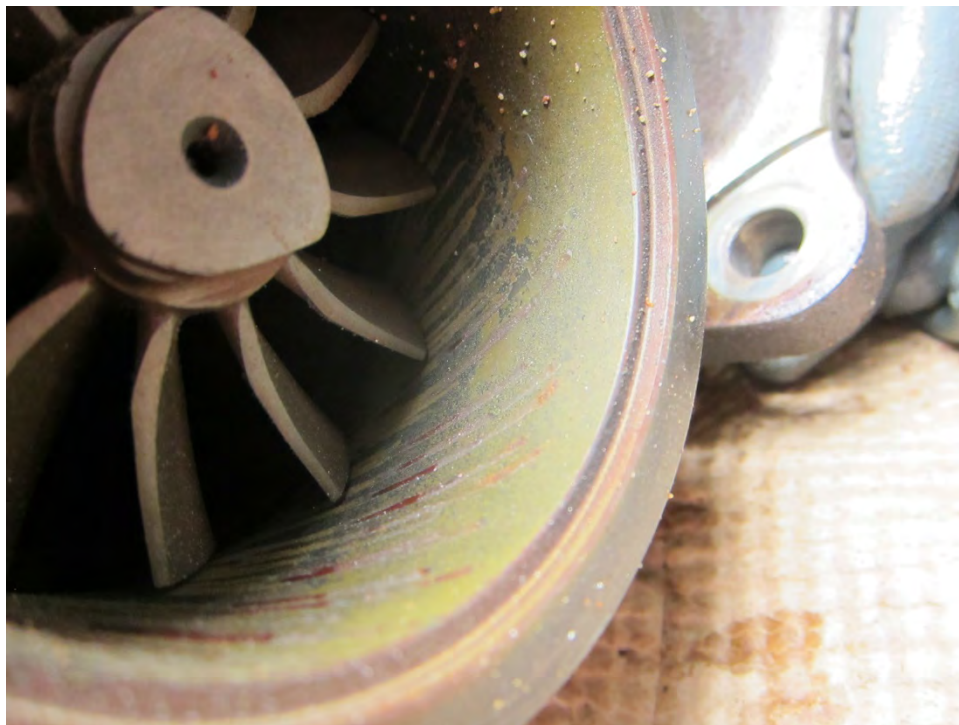
- o The turbine housing outlet exhibited spiral streaking which appeared to be from a fluid
  - o The turbine and compressor wheels were rotated by hand and rotated freely

Figure 2: Spiral Streaking on the Left Turbine Housing

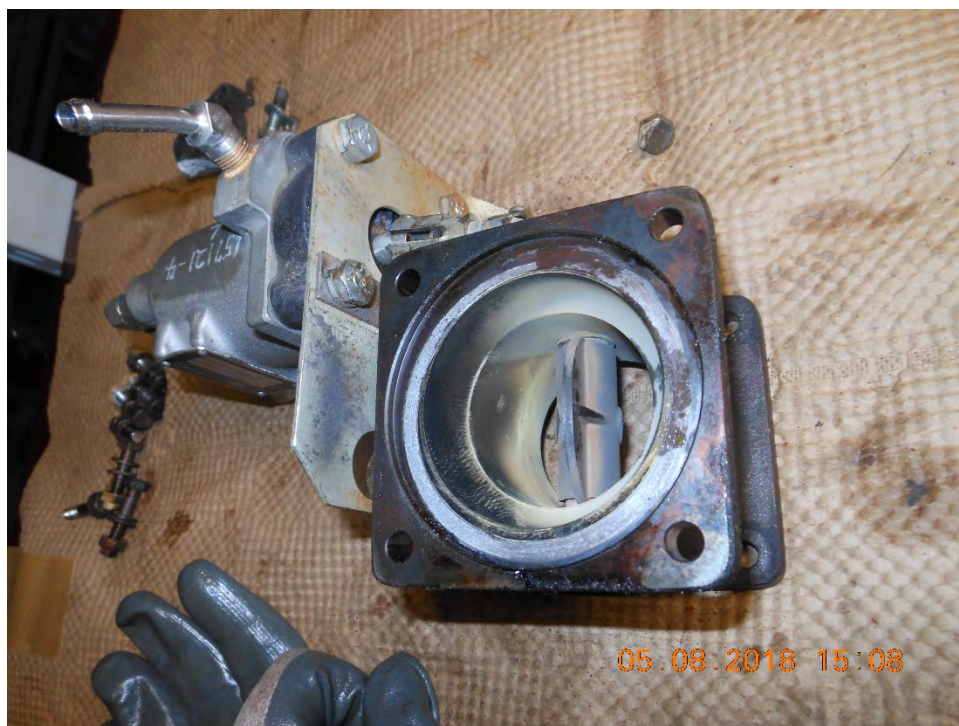
- The waste gate sustained impact damage and was removed from the engine
  - o Sooting was noted on both sides of the waste gate body duct; however, it was mostly on the downstream side of the valve.

- It was noted that the actuator mounting base was fractured and the control arm was bent consistent with impact damage
- The induction system was removed from the engine

Figure 3: Waste Gate

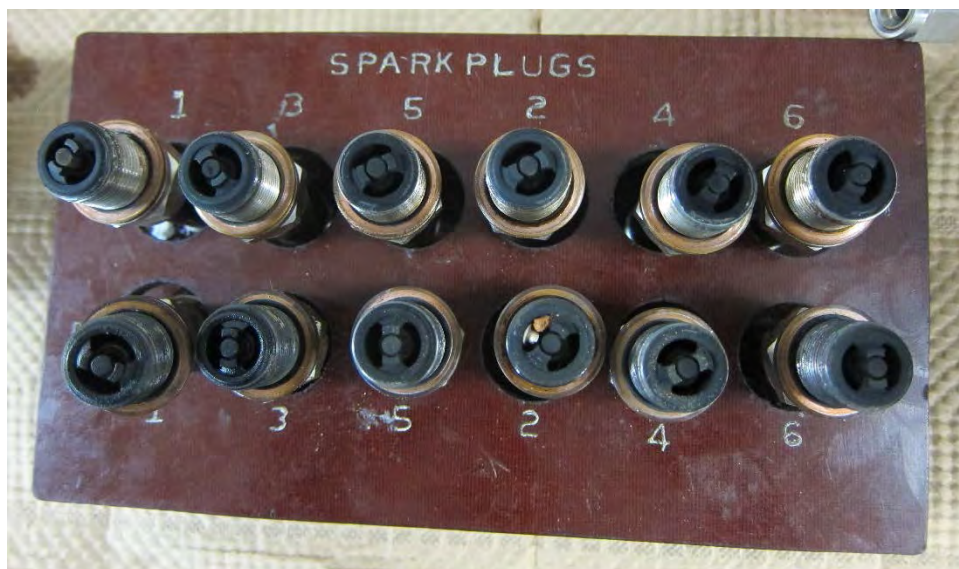
- It sustained heavy impact damaged and was fractured and separated throughout
- The baffling exhibited heavy crush damage and it was removed
- All of the spark plugs were removed from the engine and exhibited “RICH” operating signatures

- All of the massive electrodes were circular
  - All of the spark plugs were very sooty and black in color
- The starter was removed
  - The starter adapter sustained impact damage.

Figure 4: Spark Plugs

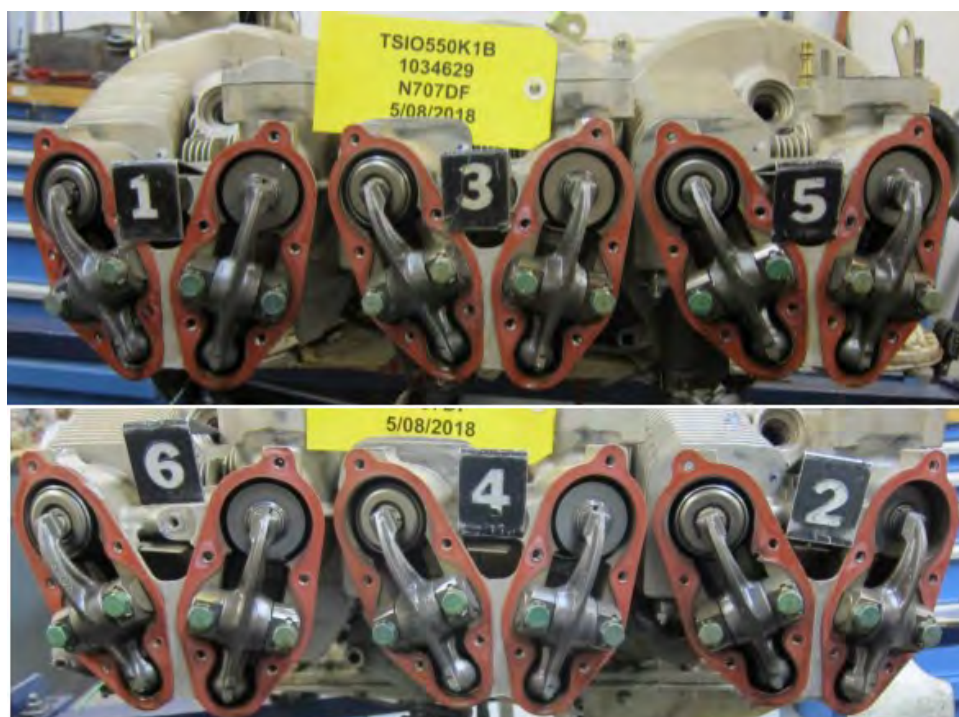
- o The internal components of all six cylinders were extremely sooty consistent with an overly rich condition.
  - o The intake and exhaust valve heads in all six cylinders were extremely sooty

Figure 5: Valves

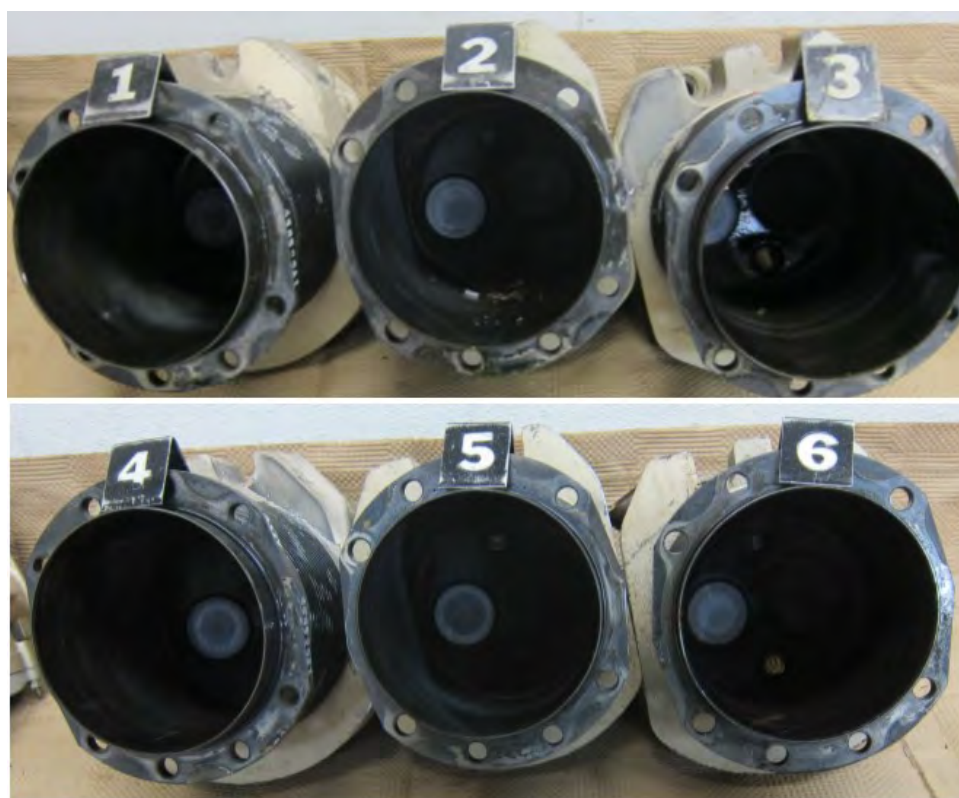
- The pistons:
  - o All six piston heads were extremely sooty and exhibited combustion deposits consistent with an overly rich operating condition
  - o The piston rings on all six pistons exhibited normal wear signatures and the ring gaps were spaced properly

Figure 6: Cylinders

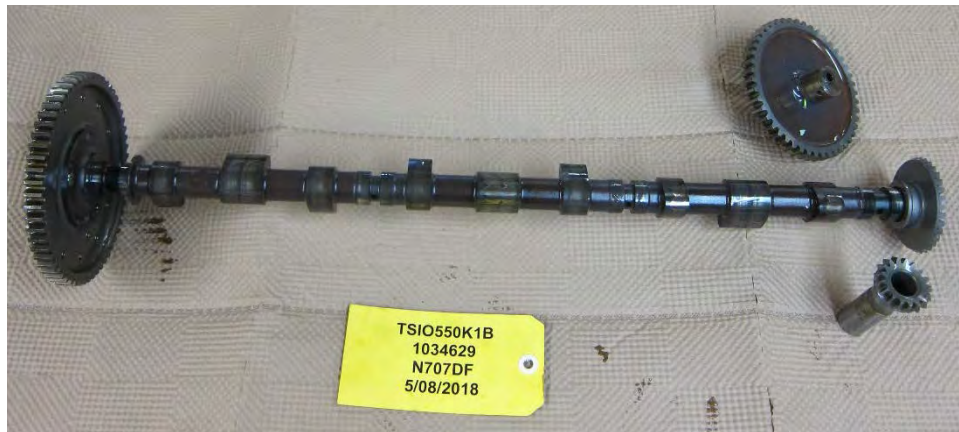
- The camshaft was removed from the crankcase
  - o The cam lobes exhibited normal wear signatures
- The crankshaft was removed from the crankcase
  - o The slinger/thrust washer was fracture separated from the crankshaft

Figure 7: Camshaft

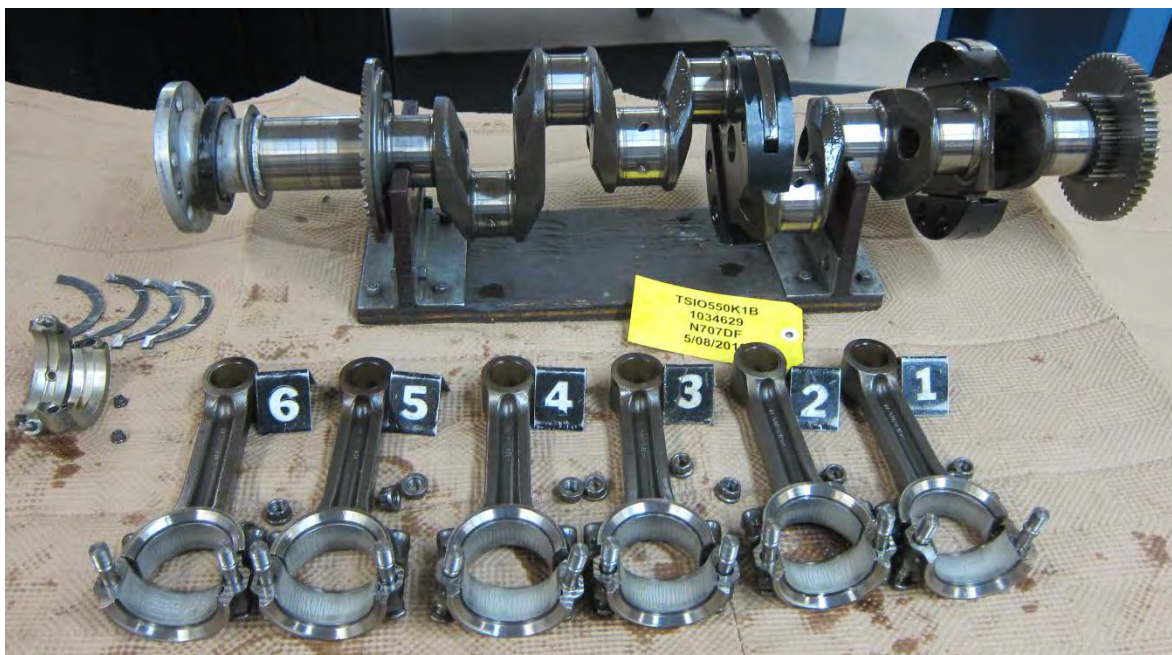
- Both halves of the fourth main bearing support were cracked
    - The crankshaft was found pushed aft against the back of the crankcase
    - The bearings exhibited normal operating wear signatures

Figure 8: Crankshaft and Connecting Rods

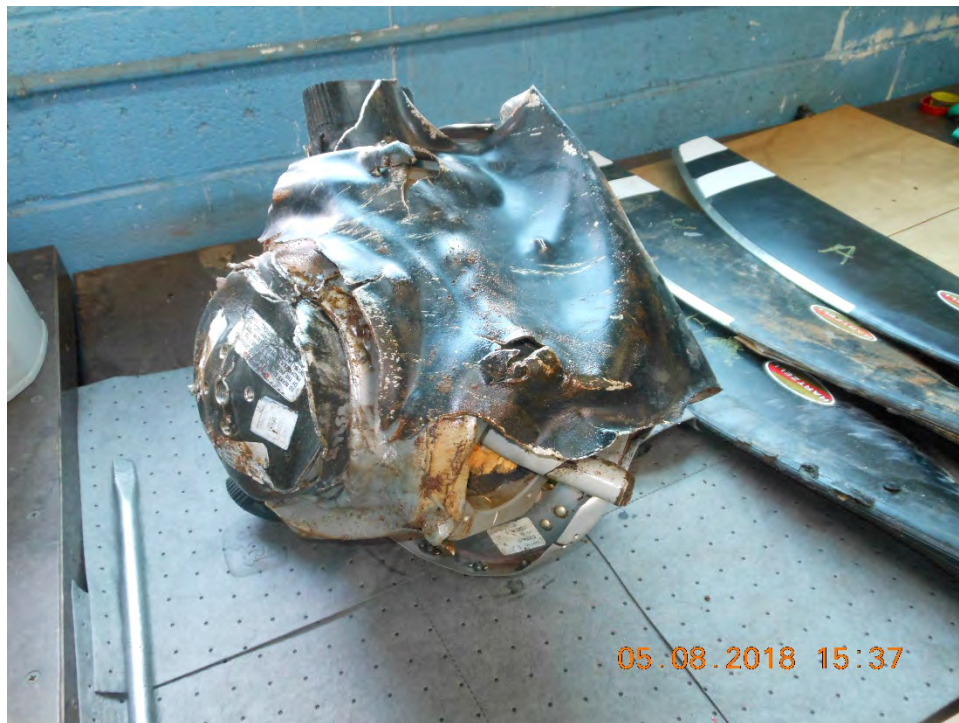
- The propeller assembly was removed from the engine
  - Spinner dome was torn and crushed aft into the propeller hub.
    - The spinner forward bulkhead was crushed against the propeller hub
  - The cylinder was crushed and fragmented
  - The pitch change rod was bent and jammed into the high pitch position
    - Pitch change rod was fractured aft of the piston
  - The propeller mounting flange was intact and undamaged (on the hub)
  - The forward hub half wall was compressed aft and fractured.
  - The inside of the aft hub half was compressed aft and fractured
  - Preload plates

Figure 9: Spinner

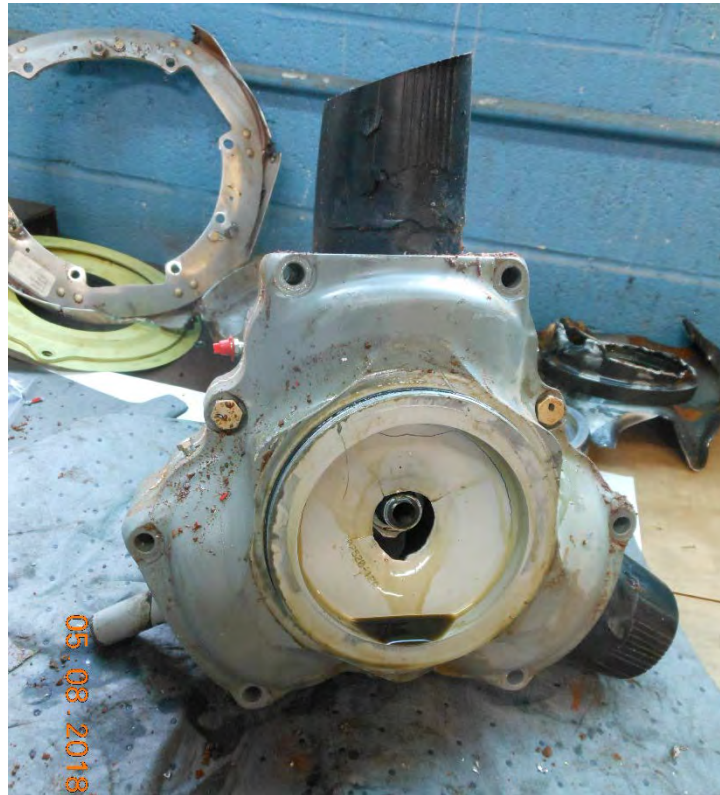
Figure 10: Propeller Hub

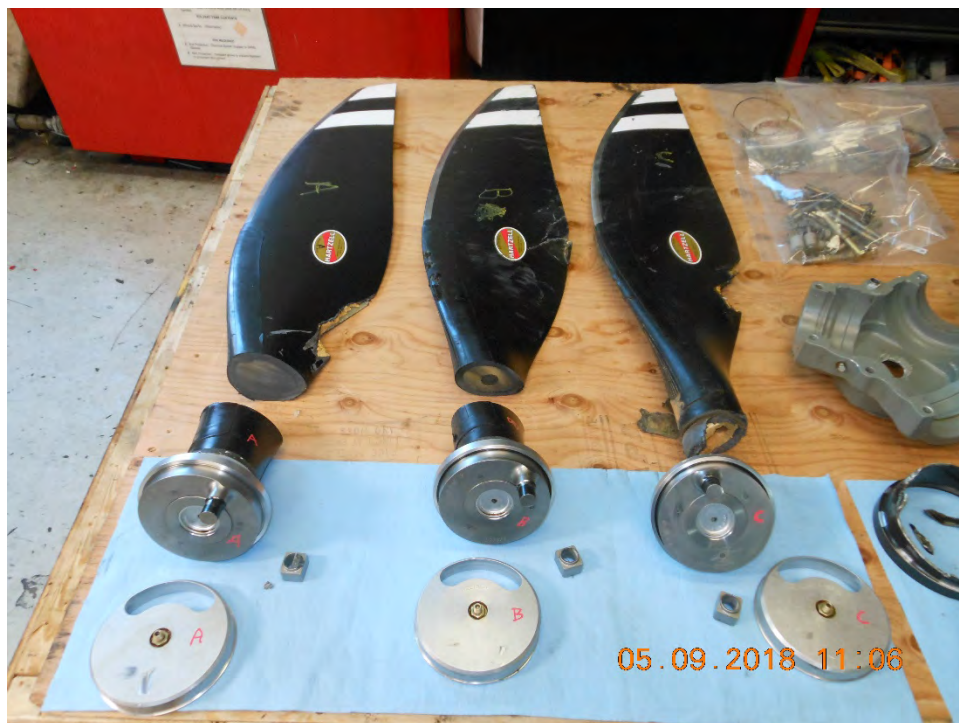
- Preload plates showed pitch change fork damage
- 2 preload plate pockets showed impact damage
- Preload plate B retention lip was found sheared consistent with impact forces in the aft direction.
- Propeller Blades were removed and disassembled:
  - Blade C was fractured from the assembly
  - Blades A and B were cut to facilitate shipping
  - Blade A and C exhibited chordwise scoring on the face side
  - All blades exhibited gouging on the trailing edge consistent with contact with the airplane's cowl.
- The propeller governor
  - Oil was present
  - Gasket screen was clear of debris
  - The shaft rotated freely when rotated by hand
    - Oil was pumped out
- All damage was consistent with high impact forces.
- No discrepancies were noted that would precluded normal operations.

Figure 11: Propeller Blades

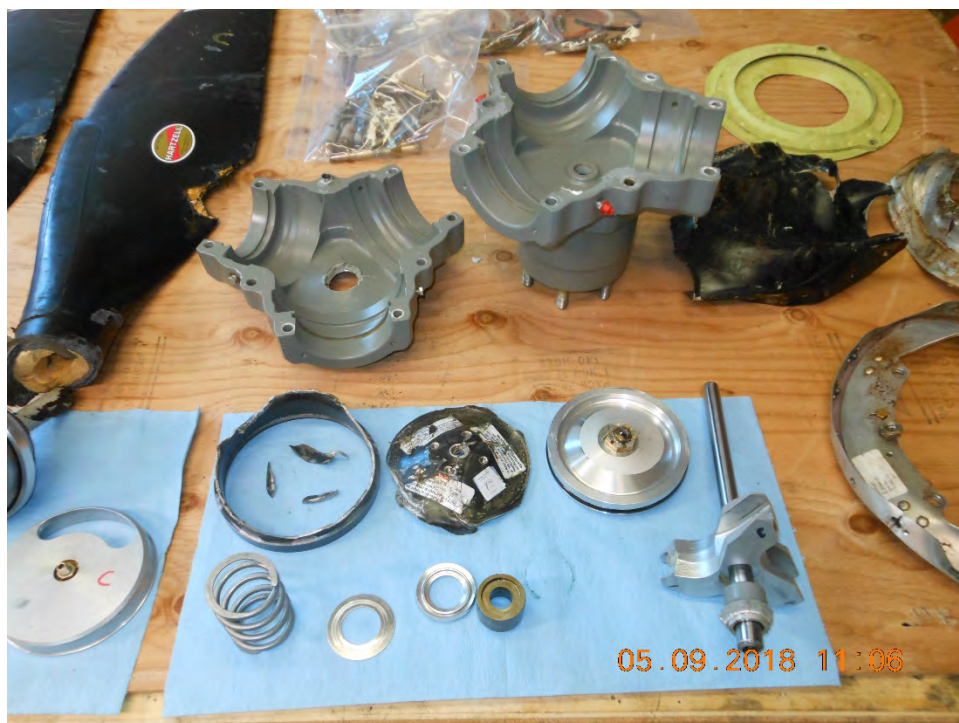
Figure 12: Disassembled Propeller Hub

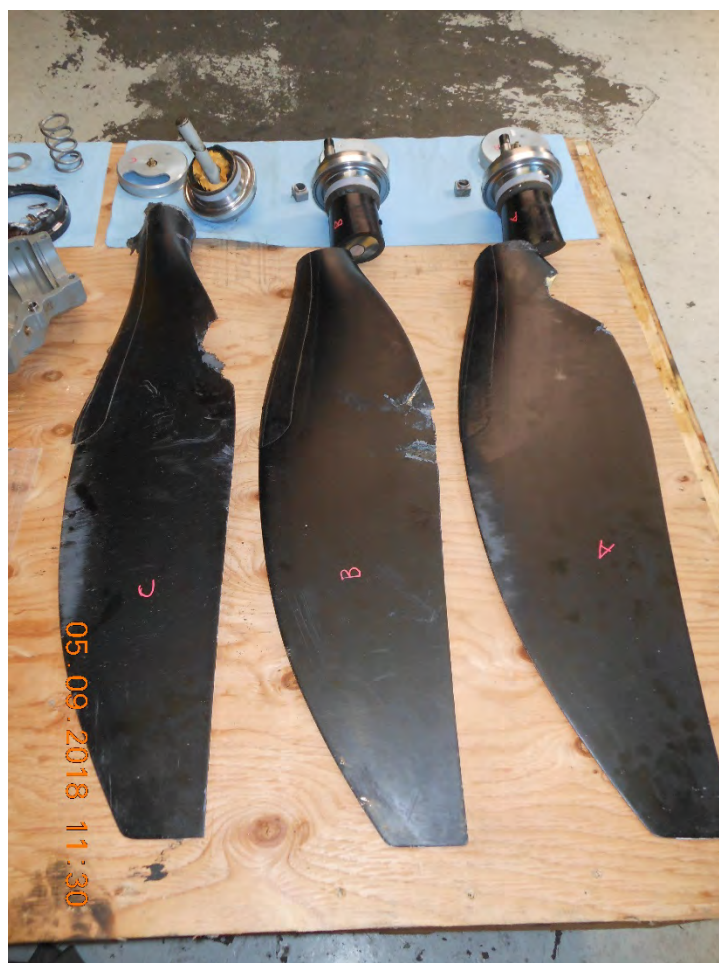
Figure 13: Face side of Propeller Blades

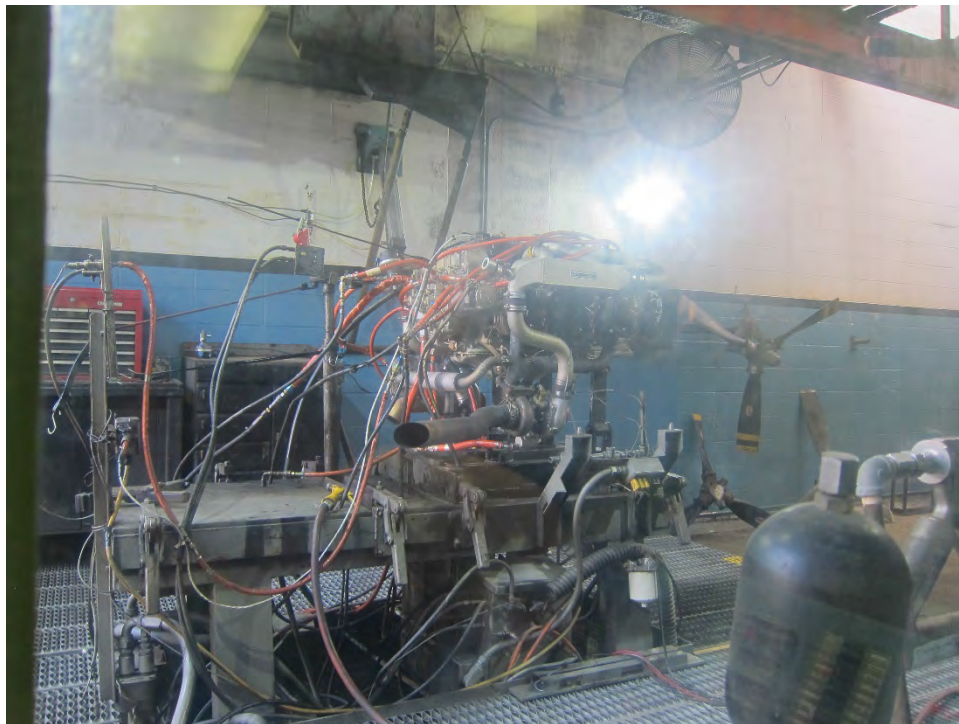
- While removing the sense line, oil came spilling out of the line indicative of damage to the internal components of the slope controller.
  - The slave engine was restarted and it was noted that at about 2300 RPM the engine started to surge. It was unable to make it to full power.

- The fuel pressure reading indicated 234 PSI, which is consistent with 39 gallons per hour.
    - Specifications indicated the fuel pressure should be between 210-220 PSI

- Note: the slave engine was surging because the fuel flow became too high, therefore, the fuel pump would adjust to decrease the fuel, but the fuel flow would slowly increase again, etc.

Figure 14: Slave Engine Running in Test Cell

- The accident engine driven fuel pump adjustment screw was measured with a caliper and it was extended 0.4725 inches. The pump was adjusted one and a half turns in the lean direction.
