## **NATIONAL TRANSPORTATION SAFETY BOARD**

### **ACCIDENT SITE EXAMINATION**

**WPR18FA095**

Location: Monticello, Utah  
Date: February 26, 2018  
Aircraft: Piper 32R-300, C-GYGY Serial 32R-7680182  
NTSB IIC: Michael Huhn

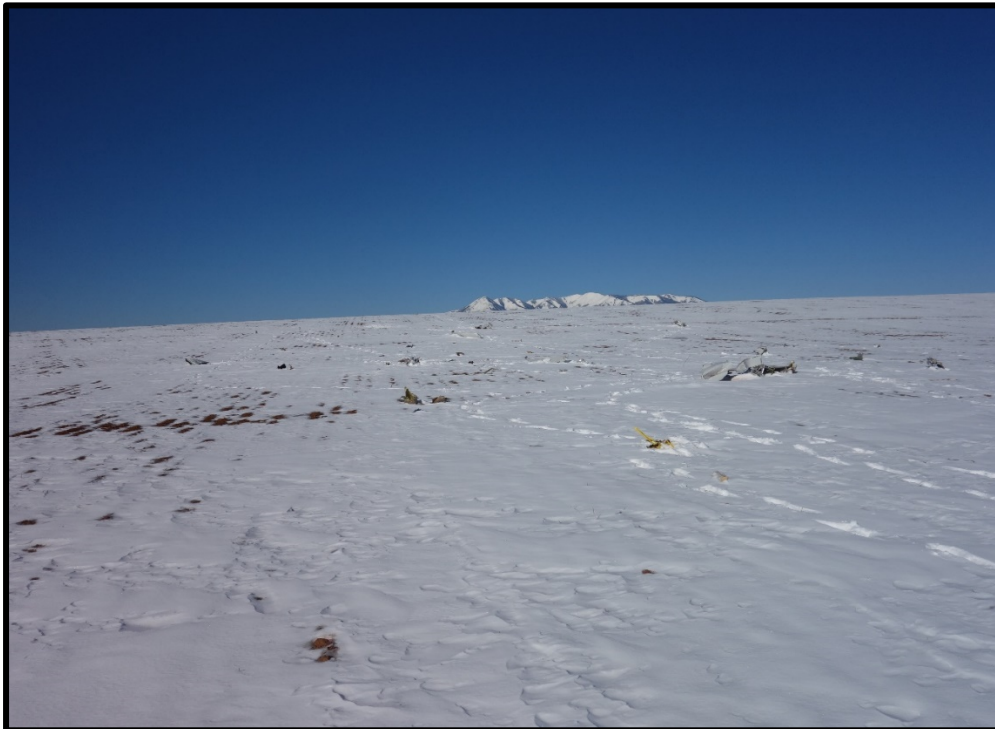
The debris path was about 483 ft long on a heading of 085° magnetic, and began with an initial impact point at a disturbed portion of dirt that measured about 2 ft diameter by 6 inches in depth. Just beyond the initial point of impact there was another area of disturbed area of dirt that was observed to be about 4 ft in length, 2 ft wide, and 6 inches in depth, that contained several small fragments of the airplane's fiberglass wingtip debris. Flight control continuity was established from the cockpit controls to each respective flight control surface. However, multiple impact separations and cuts made by the recovery personnel were observed in the flight control cables. There was no evidence of a pre or post impact fire. No personal electronic devices were recovered from the wreckage.

**Figure 1: View of Airplane Debris Trail looking Towards The Initial Impact Point.**

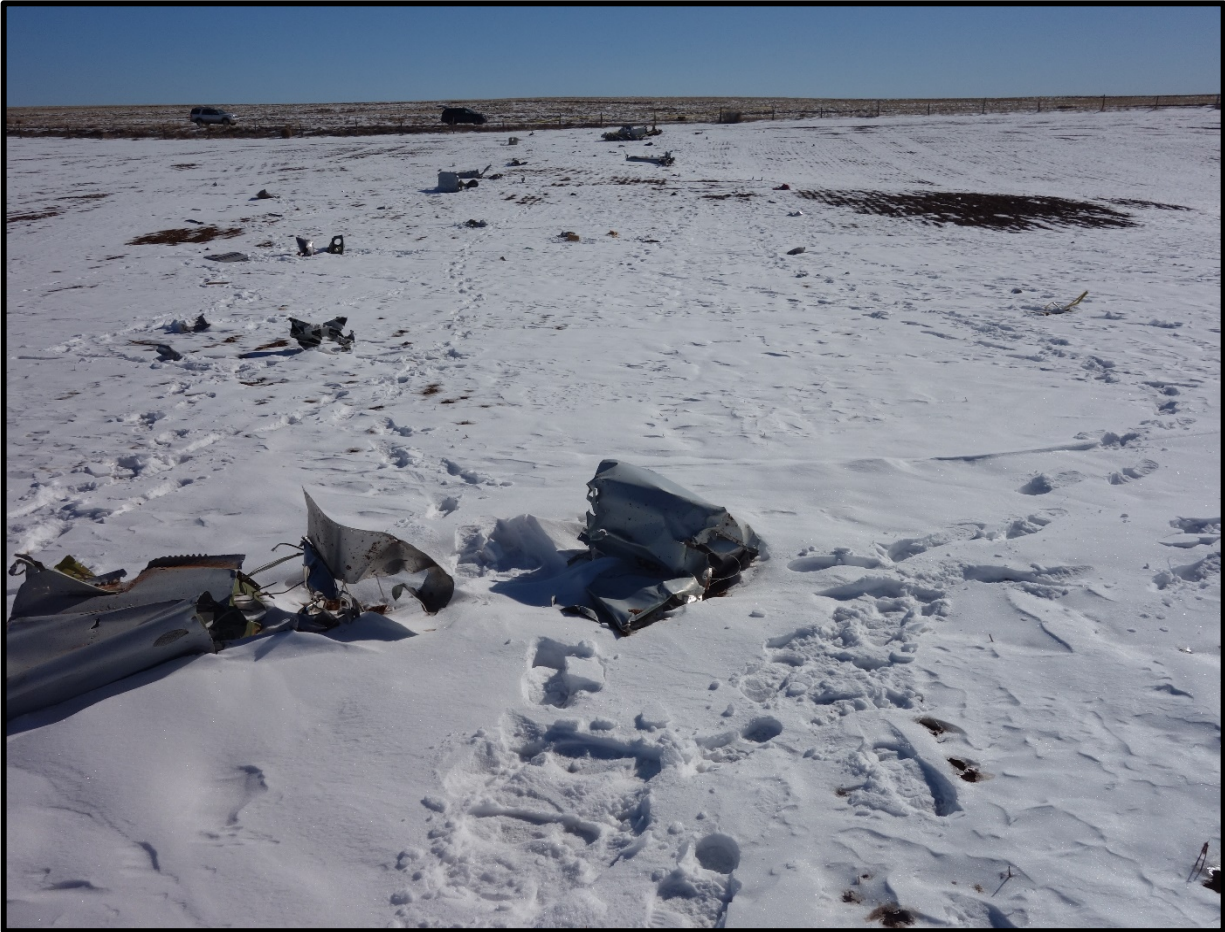
**Figure 2: View of Debris Trail with Main Fuselage in Background.**
