## **NATIONAL TRANSPORTATION SAFETY BOARD**

# **AIRFRAME AND ENGINE EXAMINATION**

**WPR18FA095**

Location: Monticello, Utah  
Date: February 22, 2018  
Aircraft: Piper PA-32R-300, C-GYGY, Serial # 32R-7680182  
NTSB IIC: Michael Huhn

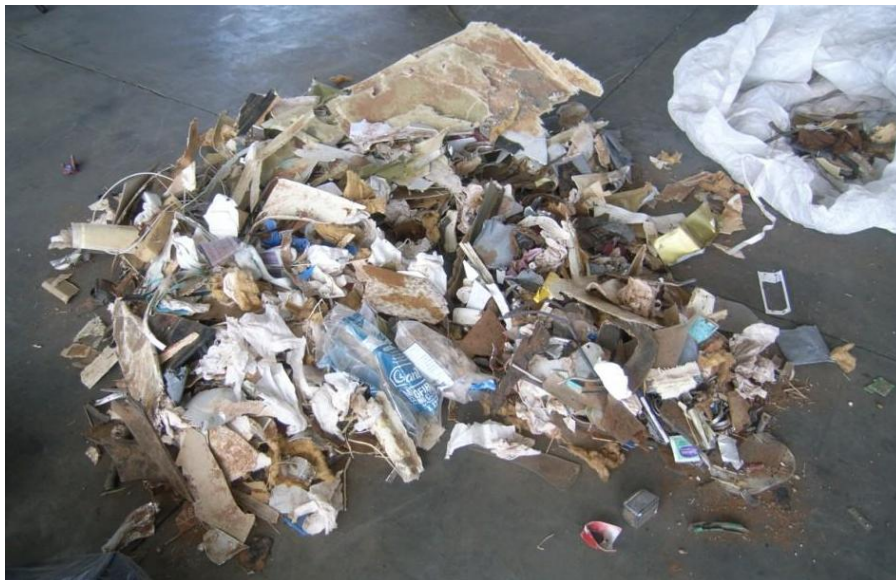
**Figure 1 - Miscellaneous Loose Debris**

The airplane was recovered and transported to Air Transport in Phoenix, AZ. The wreckage was highly fragmented. The entire wreckage was sifted through during this exam at Air Transport. A few key component groups were established for items that warranted additional documentation. These component groups included:

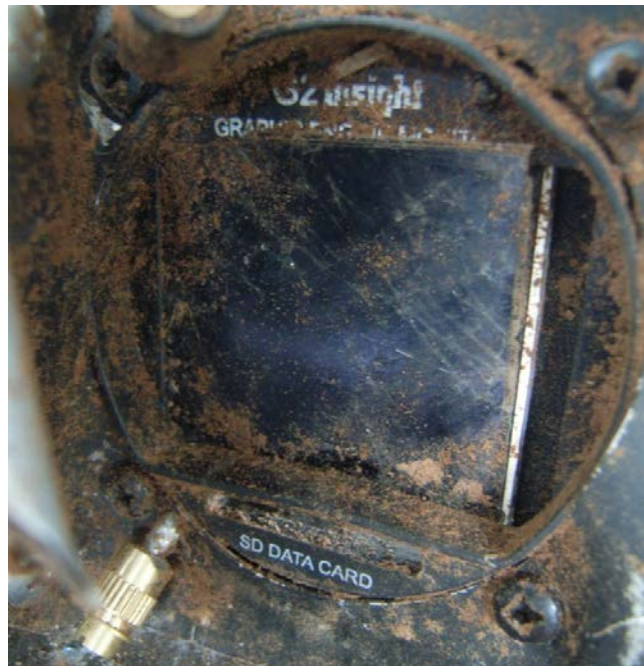
Figure 4 - Insight G2 Engine Monitor

- Engine monitor ('G2 Insight'): Internals missing, and removable SD card not located
- Airspeed Indicator: needle absent, no visible 'slap marks'
- Altimeter needles free to swing; Kollsman window set to 30.00
- Tachometer: Needle at 0, no visible 'slap marks', Hours = 3307.75
- Fuel Pressure: Midrange green
- Left Fuel qty: Full or off scale high
- Right Fuel qty: Empty or off scale low
- Oil Temperature: Off scale high
- DATCON hour meter: between 2469.5 and 2469.6
- EGT: Off scale low
- Gyro Pressure: Off scale low
- Autopilot ROLL, HDG, ALT, & PITCH rocker switches OFF
- Autopilot rotary selector switch set to NAV
- KX170B Navcom #37512 COMM = 118.52 NAV = 116.00
- KX170B Navcom #38252 COMM = 122.80 NAV = 115.95 or 115.00
- VOR Head 1 (upper) CDI = 001°
- VOR Head 2 (lower) CDI = 298°
- ELT Dorne & Margolin model ELT 6 sn 57313, switch in OFF position

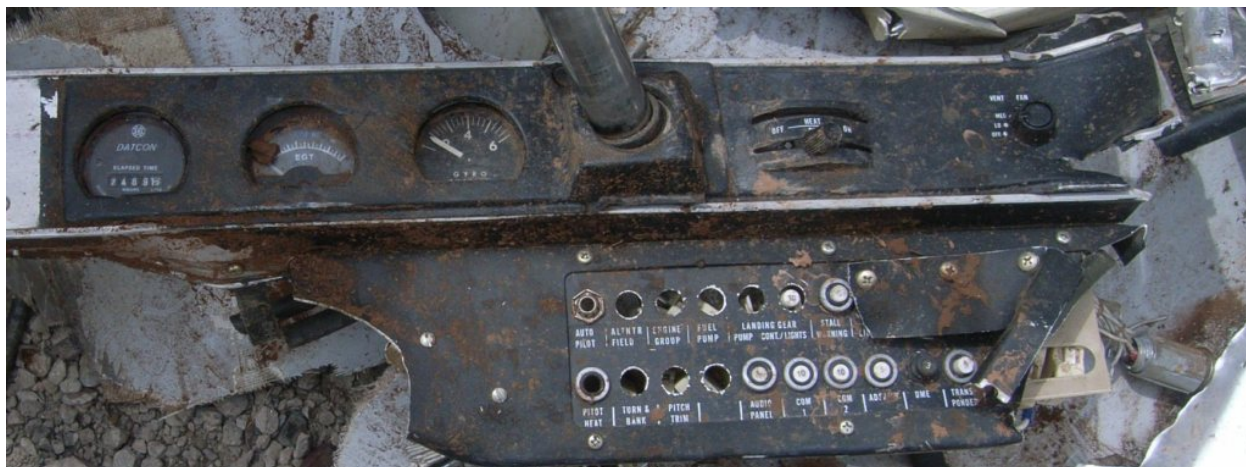
Figure 9 - Gauges and Circuit Breaker Sub-panel

Many circuit breakers were fracture-separated from their mounts/panel.

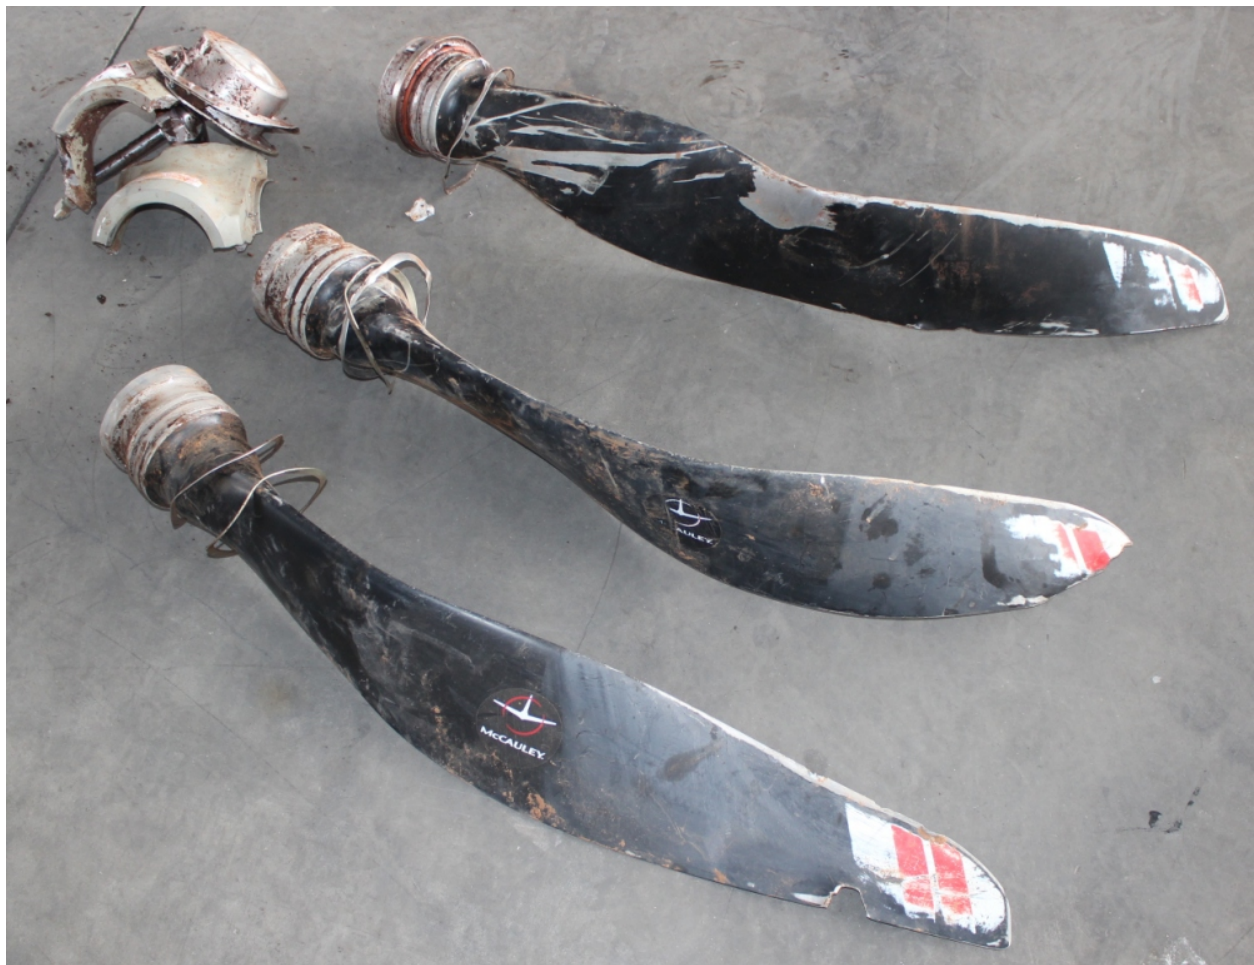
**Figure 14 - Propeller Blades and Hub Section**

The propeller hub was fracture-separated from the engine, the hub was fractured into multiple fragments, and all three propeller blades were liberated from the hub. All three blades incurred moderate aft bending at their 1/2 to 2/3 span locations. All three had multiple leading edge nicks/gouges (larger than normal or acceptable in-service nicks), and moderate scouring of their leading edge and tip paint. One blade had an approximate 1-inch square missing from its trailing edge.

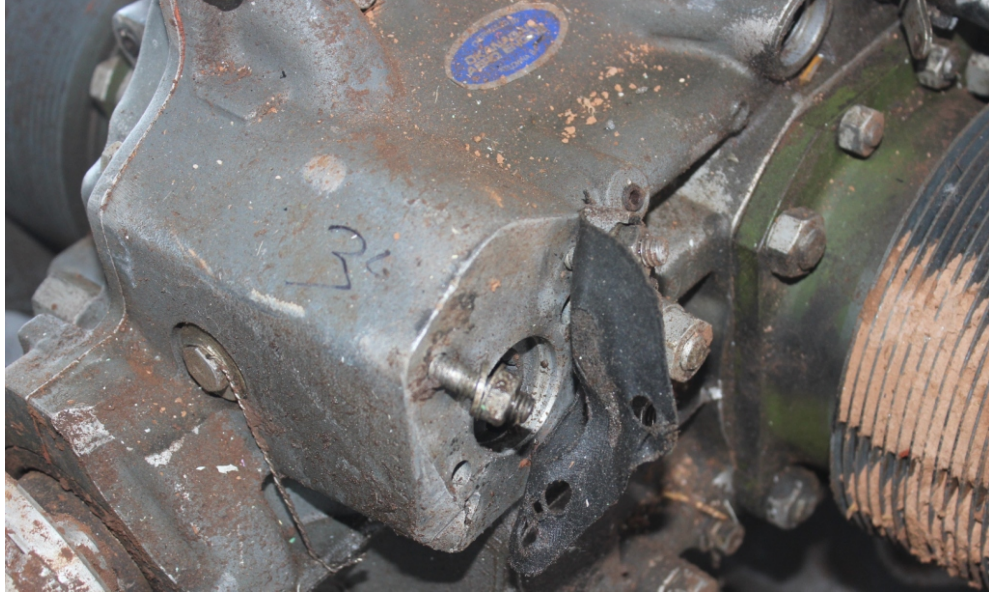
**Figure 15 - Governor Pad**

The propeller governor was fracture-separated from its mounting. The fracture surfaces of the propeller governor flange exhibited signatures consistent with overload. The gasket screen was free of visible pre-mishap contamination. The propeller governor was not available for examination. The governor control wheel was observed to have remains of the control rod end securely attached.

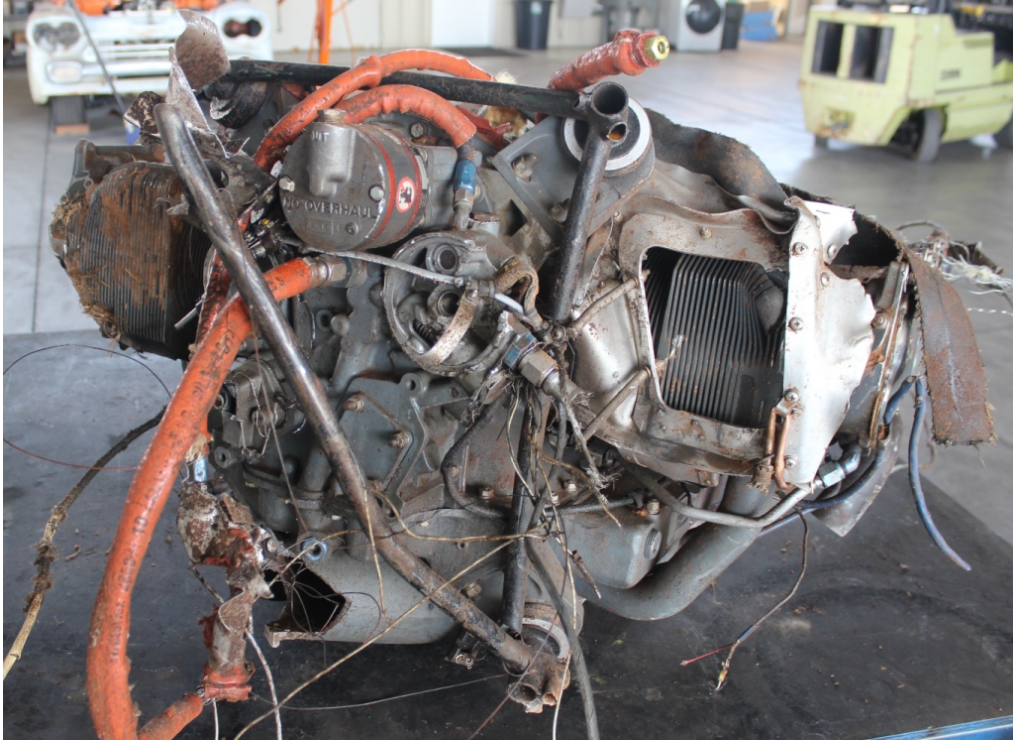
**Figure 17 - Accessory End of Engine**

The engine had been liberated from the airframe at the engine mount during the accident sequence. The engine had sustained significant impact damage, which separated the propeller assembly, starter, alternator, propeller governor, exhaust system, single drive-dual magneto, fuel pump, fuel injection servo and oil filter. The number two cylinder head had sustained significant impact damage that separated most of the rocker box casting and intake valve rocker assembly.

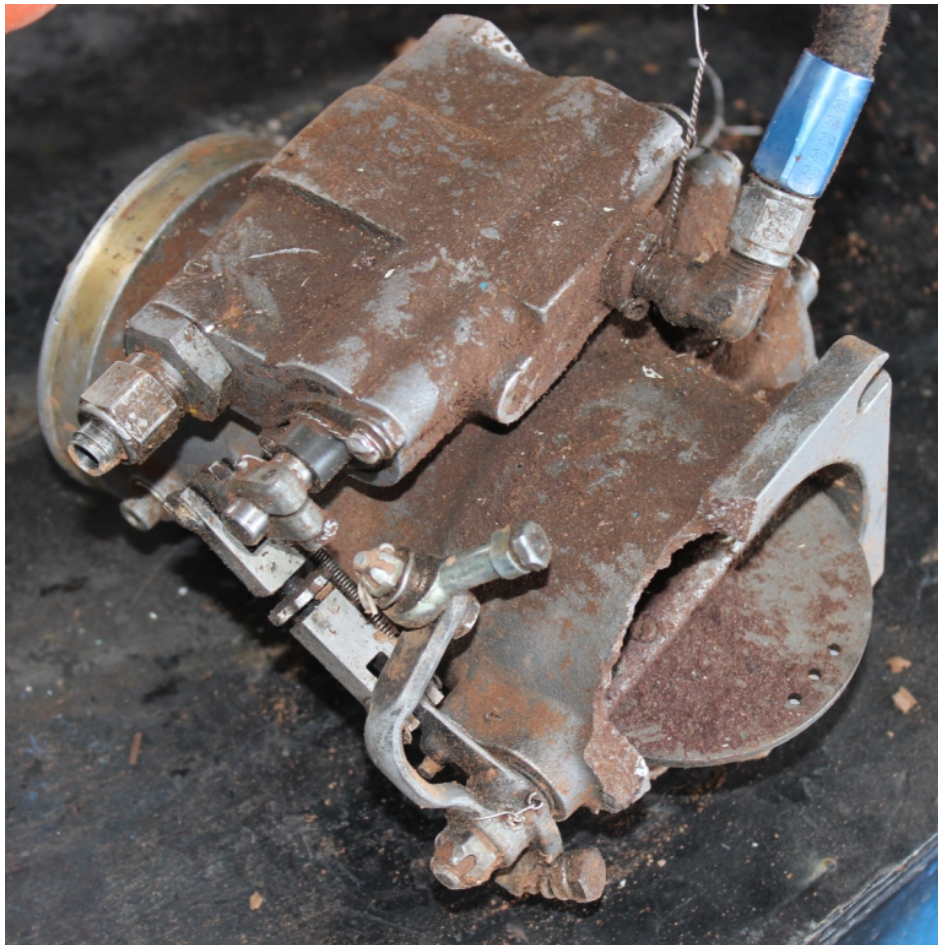
**Figure 22 - Fuel Servo**

The fuel injection servo was fracture-separated from the engine. The fracture surface signatures were consistent with overload. The throttle control rod end was found securely attached at the

control arm of the servo. The mixture control arm and attaching hardware were fracture-separated from the servo and exhibited overload. The plug on the side of the injector body was secure with the safety wire in place. The servo fuel inlet screen was found properly installed and free of contamination. The fuel injection servo was disassembled, examined and photographed. The internal diaphragms remained intact. There was no visible contaminants within the fuel cavities and passages of the servo.

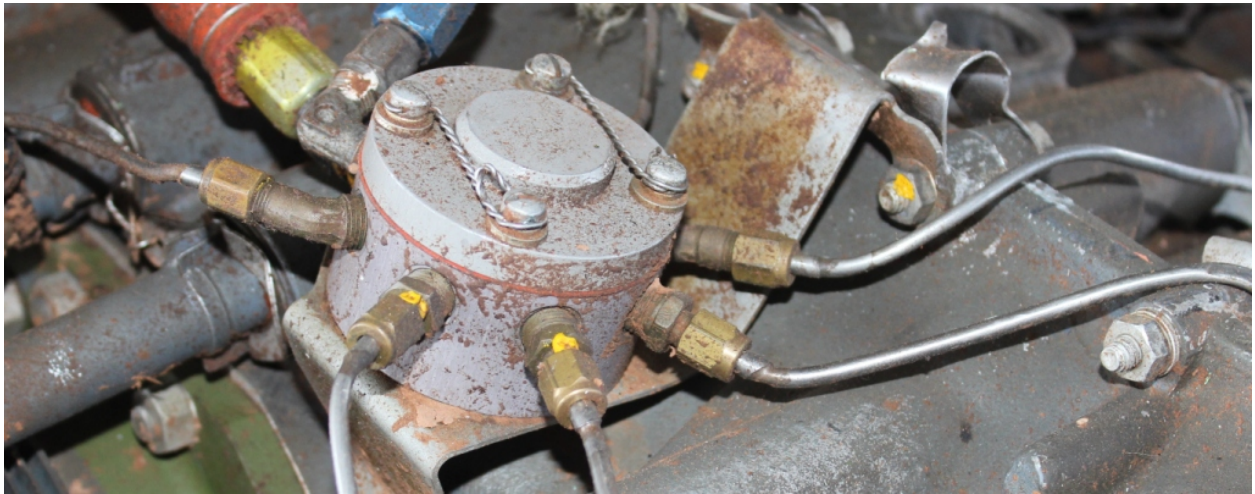
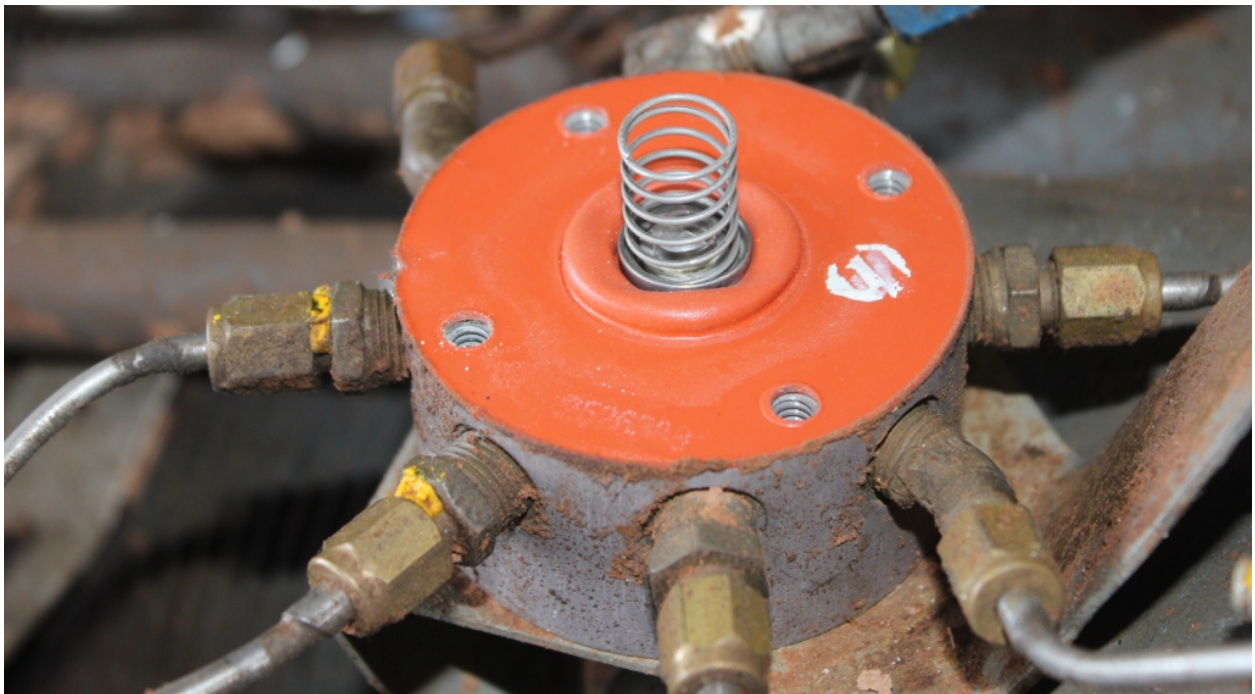
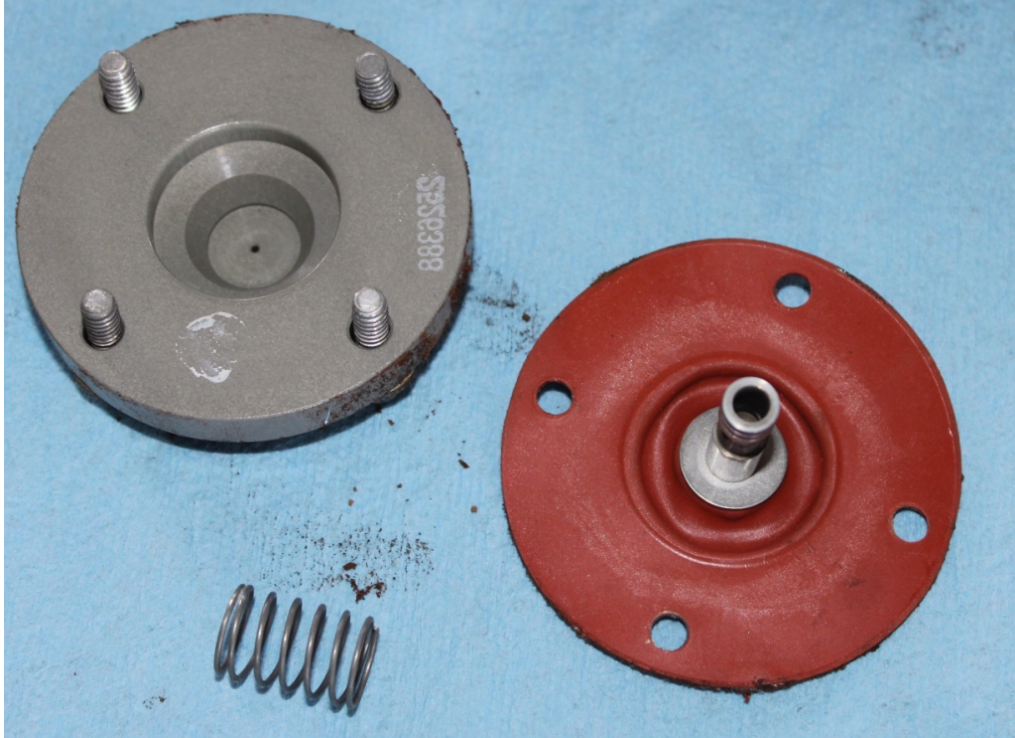
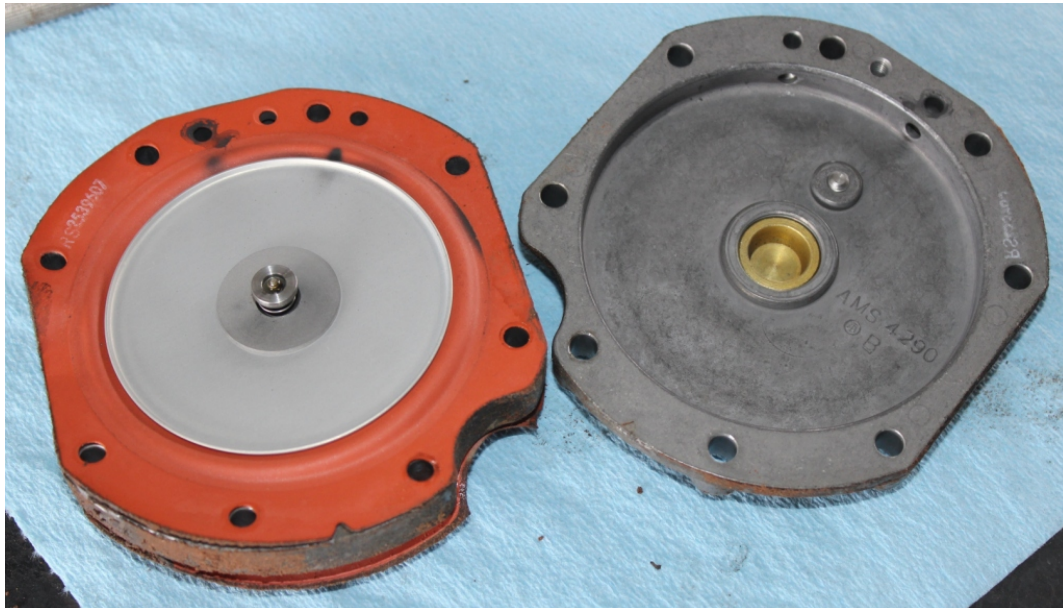
The fuel flow divider ('spider') remained secure at the mounting bracket situated at the top of the engine. The fuel lines remained secure at each flow divider fitting and fuel injector at each cylinder. The flow divider was disassembled. There was no evidence of internal mechanical malfunction or obstruction to fuel flow. The diaphragm remained intact and undamaged.

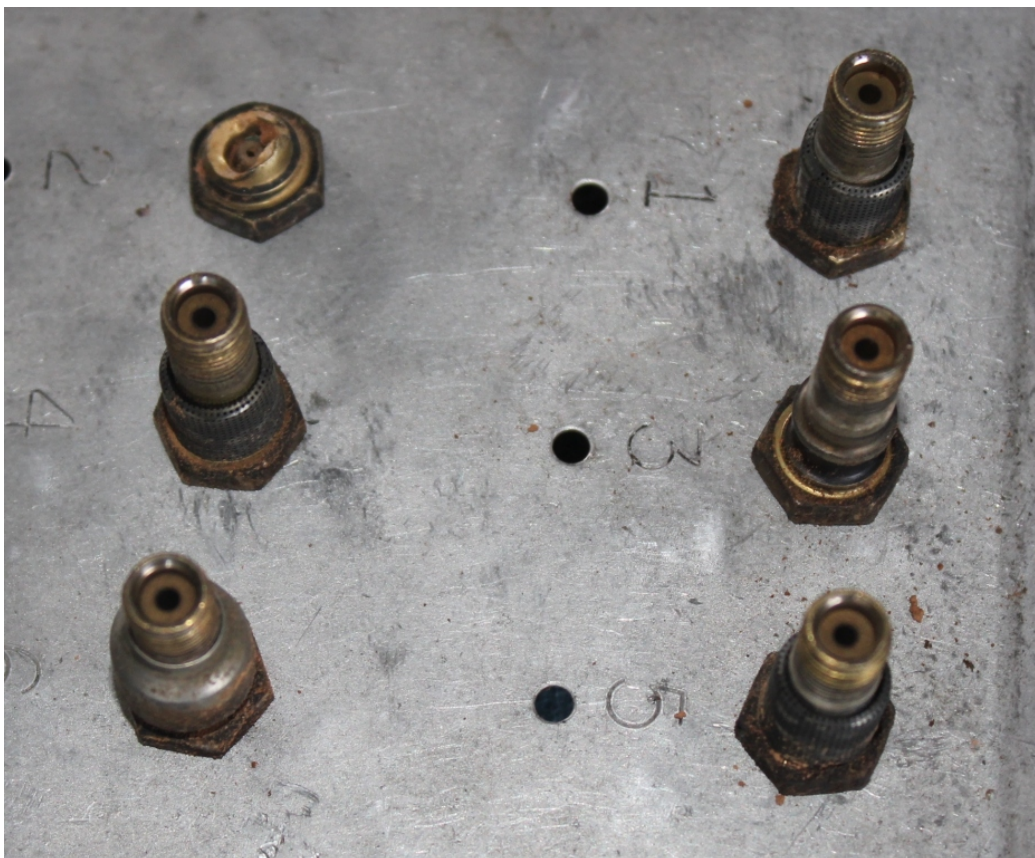
**Figure 27 - Fuel Injection Nozzles**

The fuel injection nozzles remained secure at each cylinder with the respective fuel line attached. The No 2 nozzle had sustained impact damage. The nozzles were removed and examined. The nozzles were free of visible contamination or obstruction to flow.

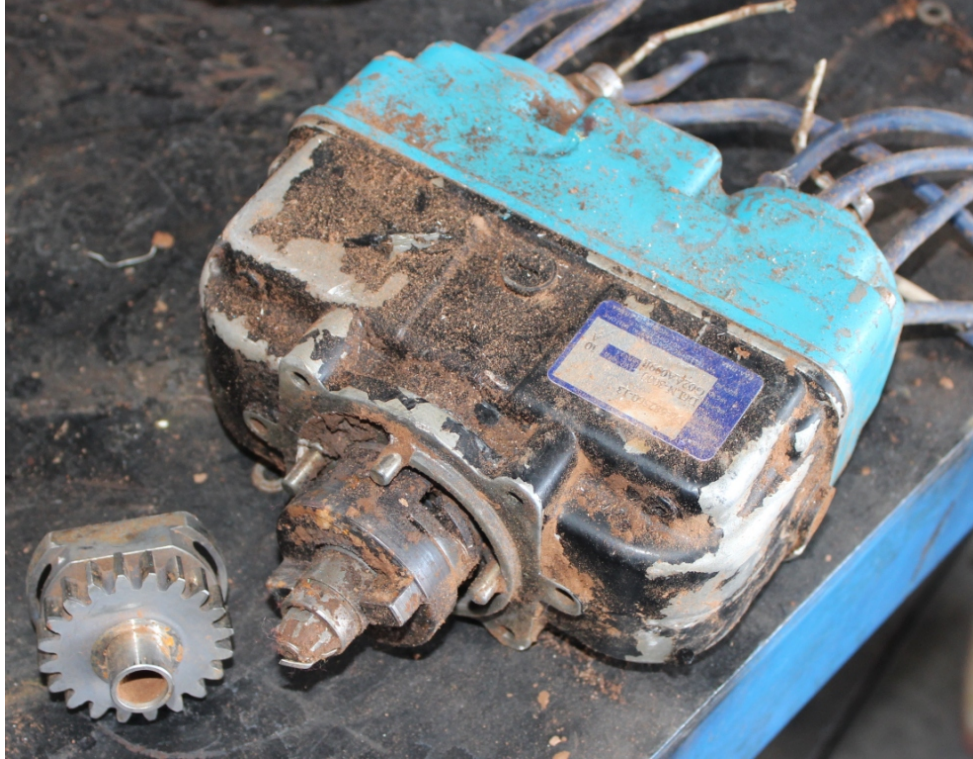
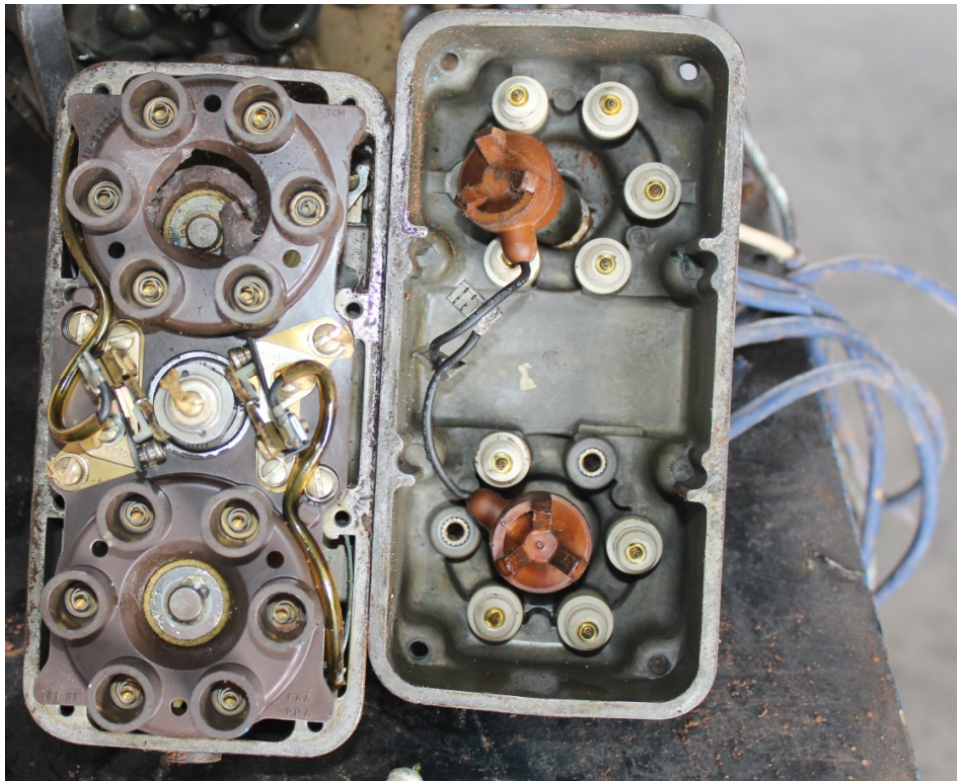
The single drive-dual magneto had sustained impact damage, and was fracture-separated from the mounting pad. The magneto clamps remained in place at the studs, and in conformance with Lycoming Service Instruction SI1508C. Magneto-to-engine timing could not be ascertained. The impulse coupler drive was found intact and secure. The drive functioned normally during hand rotation of the drive. The impact damage to the distributor block and internal components rendered the magneto unsuitable for testing. The contact assemblies were observed to open and close during hand rotation of the drive. The magneto was opened for examination. The plastic gears and distributor rotors were intact and undamaged, but the mount for one had been fracture-separated by impact.

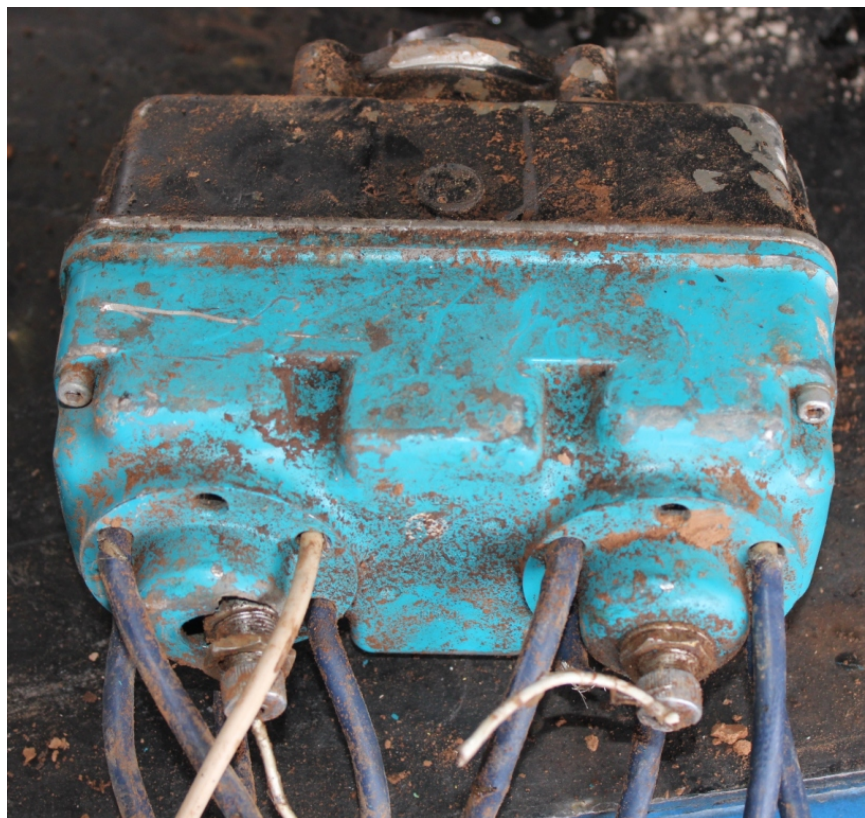
**Figure 34 - Magneto Ignition Leads**

The ignition harness leads had sustained varying degrees of impact damage, and were not tested.

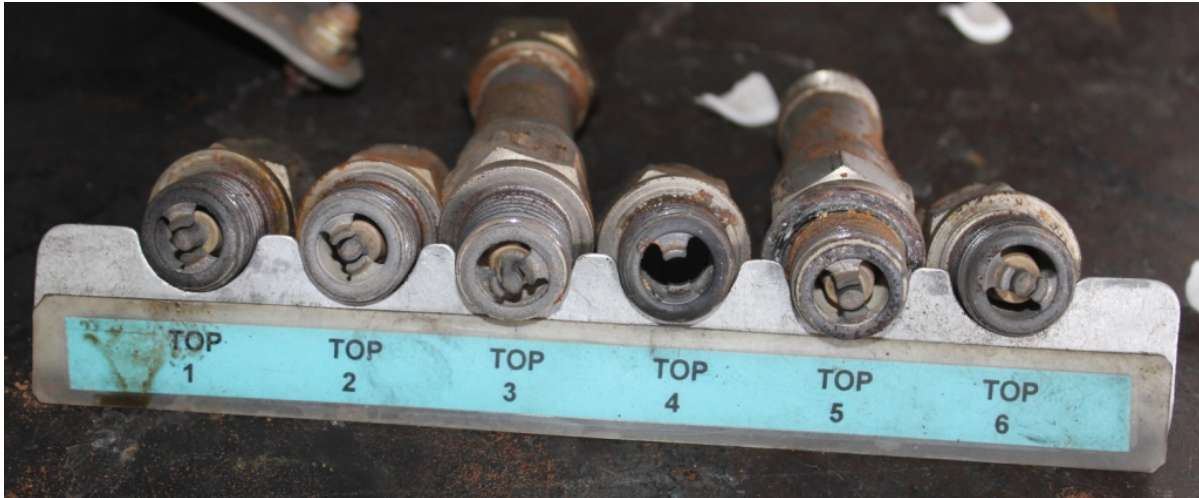
Figure 35 - Top Spark Plugs

The impact damaged spark plugs were secure at each position with their respective spark plug leads attached. Some of the spark plug barrels were impact-separated, with their respective ignition leads attached. The spark plugs were removed, examined and photographed. The spark plug electrodes remained mechanically undamaged, and according to the Champion Spark Plugs Check-A-Plug chart AV-27, the spark plug electrodes displayed coloration consistent with normal operation.

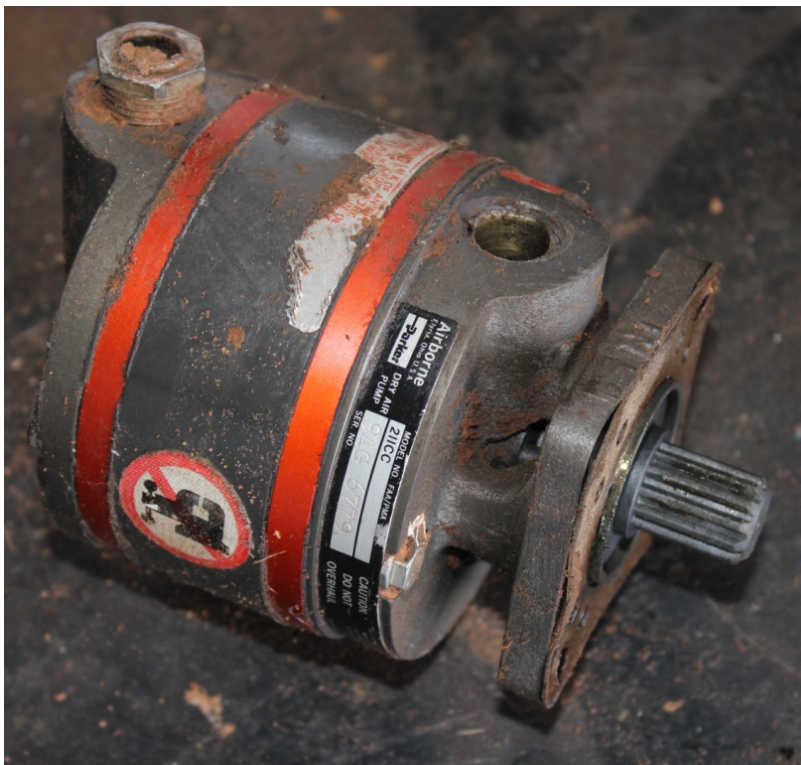
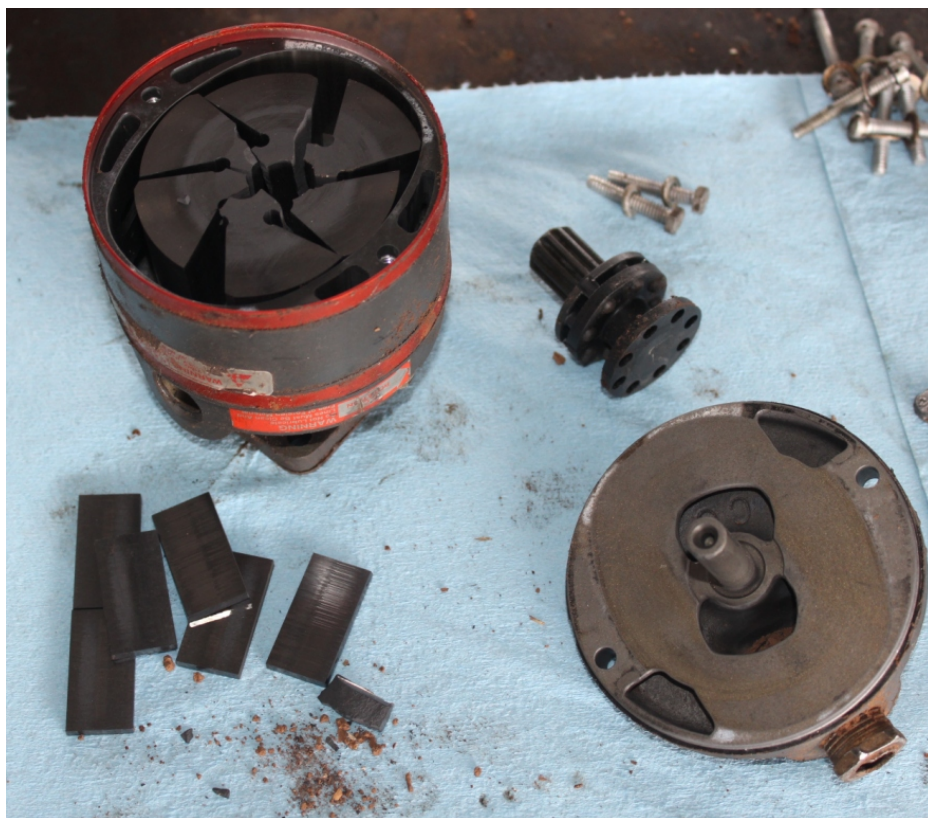
The starter and alternator were fracture-separated from the engine. Both were severely damaged and not further examined or tested. The accessory case was removed. The accessory gears including the crankshaft gear, bolt and dowel were intact and remained undamaged by any pre-impact malfunction. The vacuum pump (Airborne model 211CC, sn 9AG 6779) was secure at the mounting pad. The pump was removed, examined and photographed. The drive was intact. The rotor was fractured, but the vanes were intact.

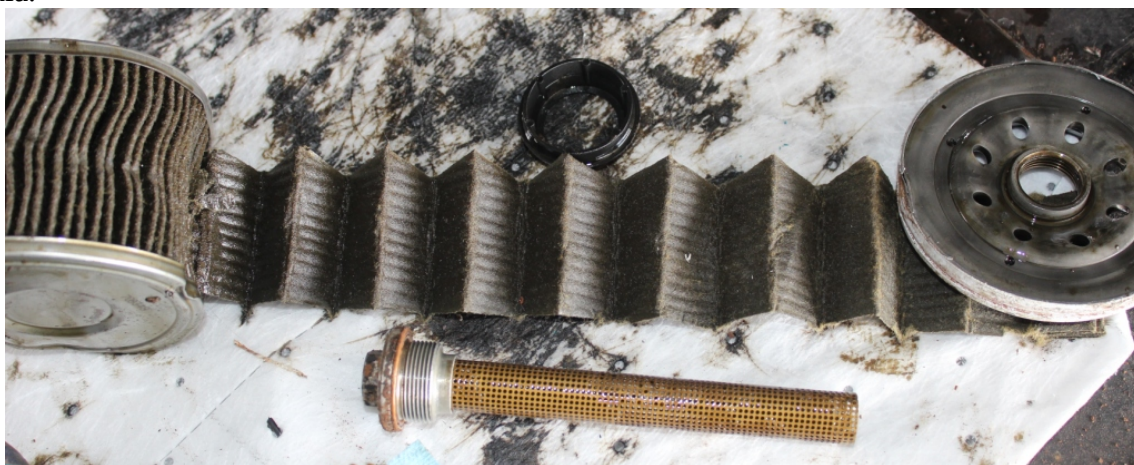
Figure 38 - Oil Filter and Screen

The oil suction screen was found secure and uncontaminated by any pre-mishap debris. The oil filter was fracture-separated from the engine. The full flow oil filter was cut open to expose the filter media. There was no evidence of pre-mishap metal contamination observed in/on the filter media.

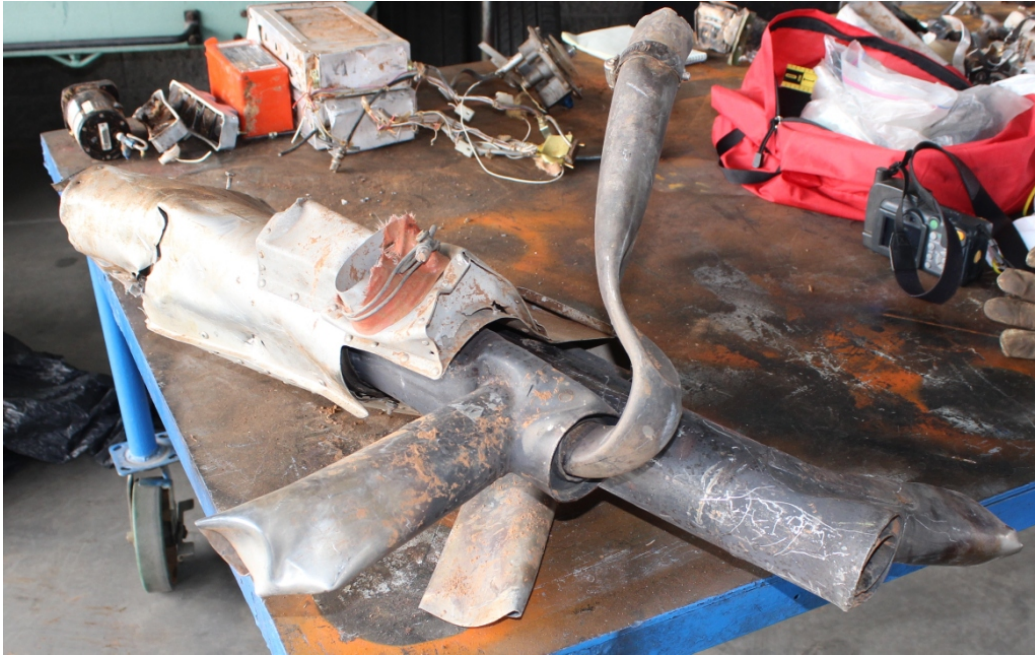
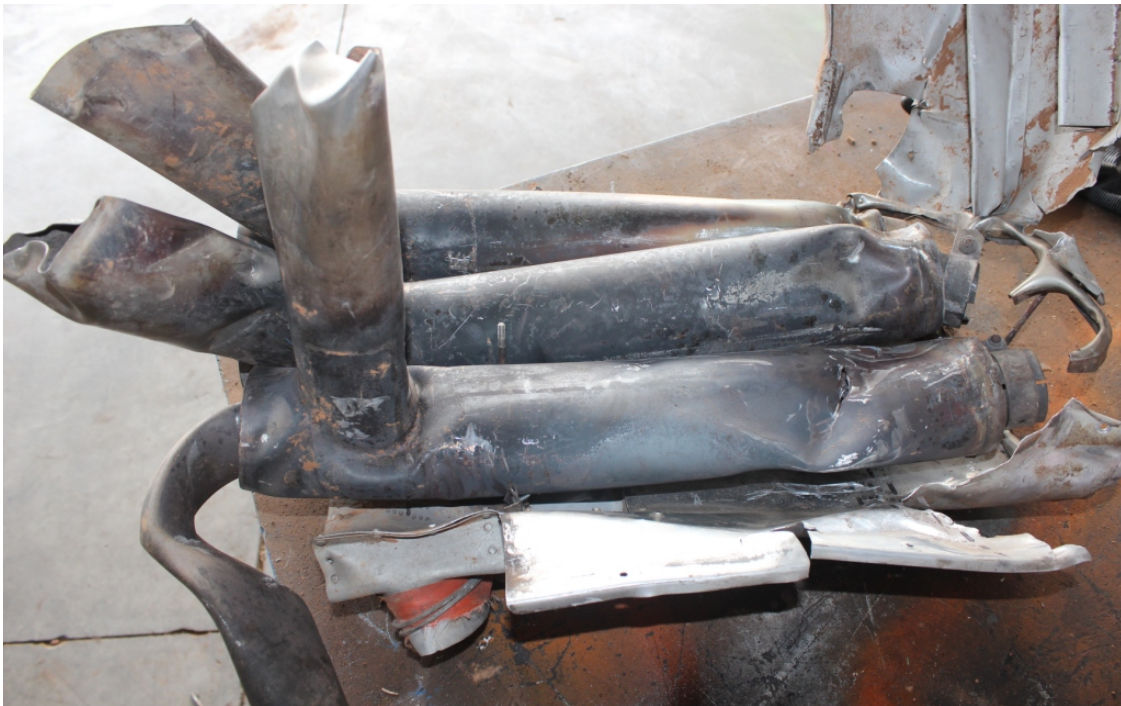
There was significant ductile bending of the exhaust system components. The exhaust system and mufflers were found free of obstructions.
