## **NATIONAL TRANSPORTATION SAFETY BOARD**

# **ACCIDENT SITE EXAMINATION SUMMARY**

**WPR18FA104**

Location: La Center, WA  
Date: March 11, 2018  
Aircraft: Piper PA-18-150, N4511Y  
NTSB Investigator-in-Charge: Maja Smith

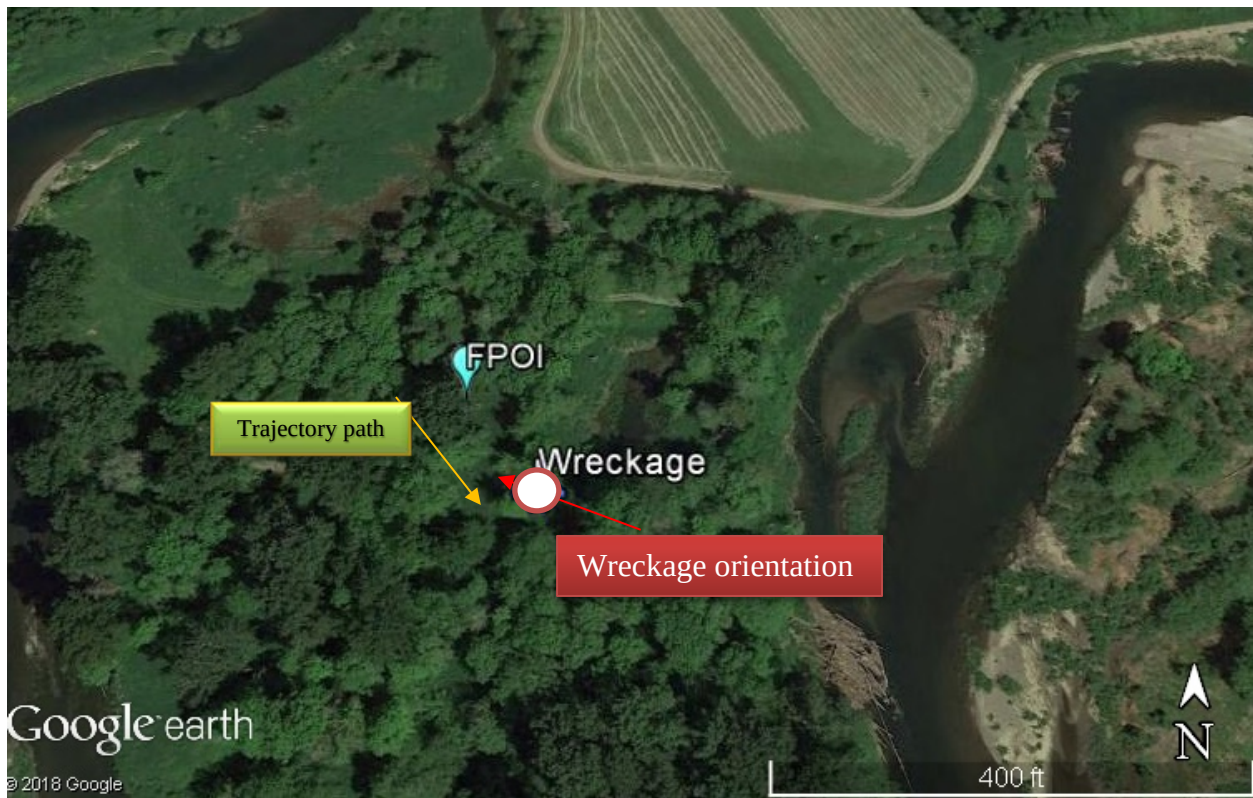
**Image 2-First point of impact and main wreckage (satellite view)**

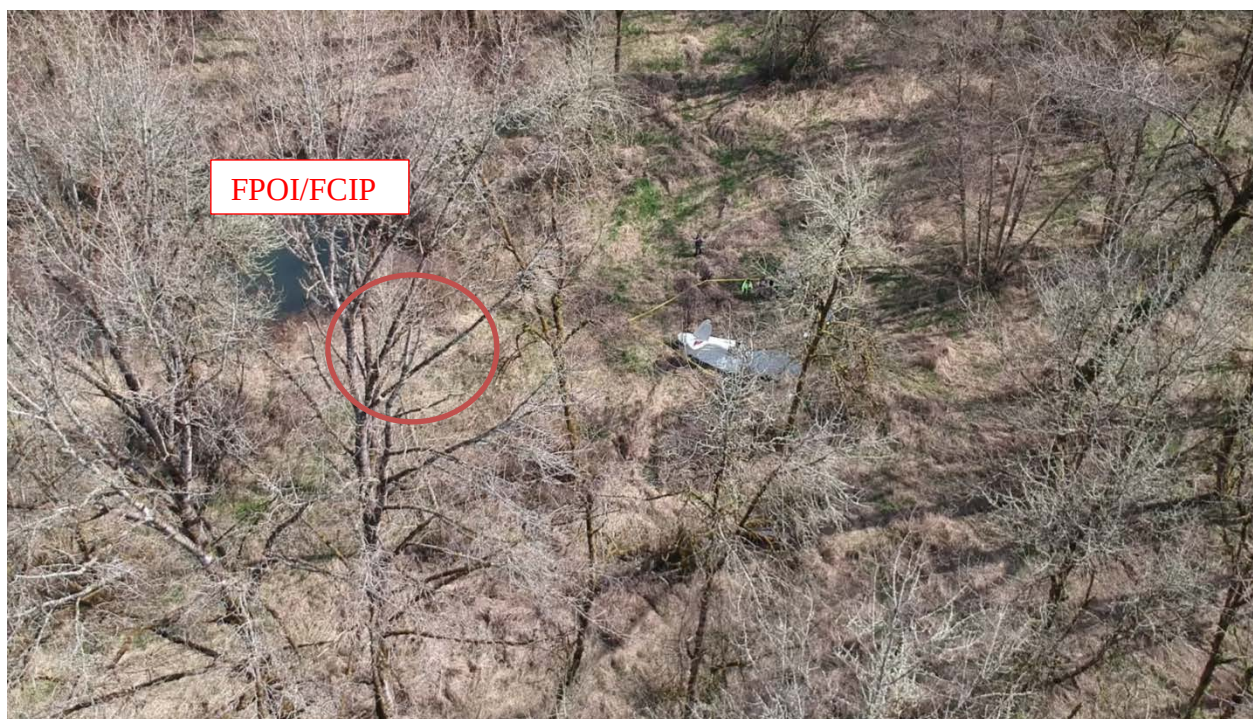
**Image 3. First point of contact and the wreckage**

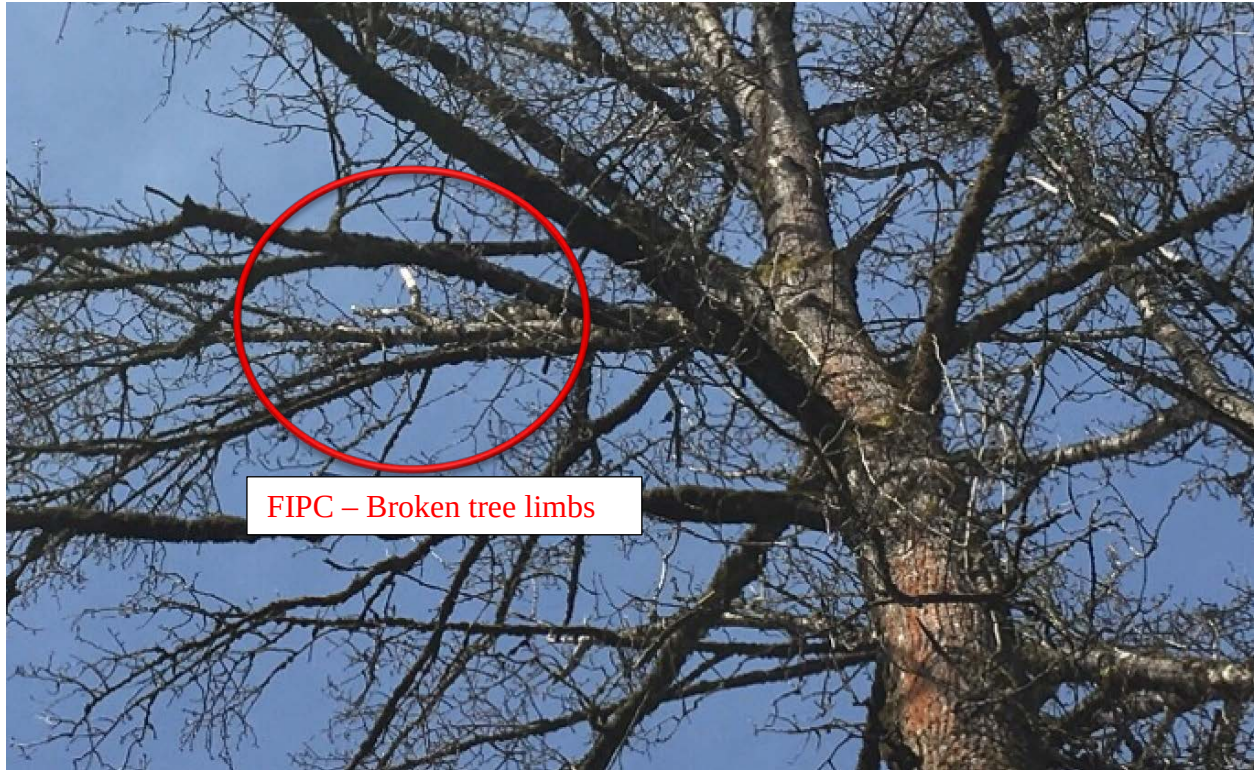
**Image 4. First point of contact – Broken tree limbs**

The first identified point of contact (FIPC) consisted of several broken tree limbs at the top of a 140-foot tall tree. A piece of the left wing landing light cover lens was found underneath the tree which was consistent with the left wing contacting the tree. A debris of broken tree limbs on the ground continued for the rest of the flight path on an approximate heading of 120°. The airplane came to rest about 142 ft from FIPC and was oriented north-west on a heading of 270°.

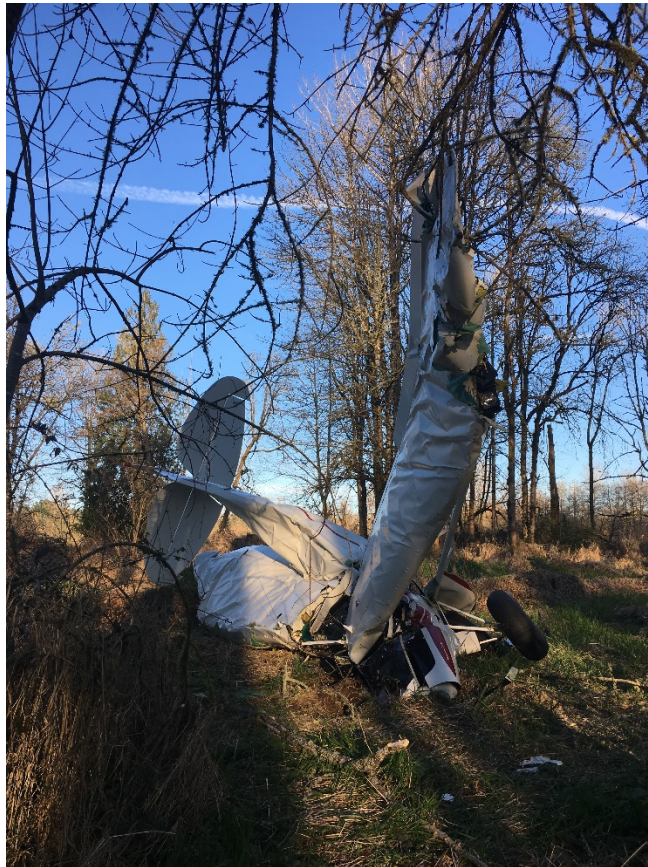
**Image 4 – airplane wreckage**

The airplane impacted terrain in a nose down attitude. The propeller hub and one blade were imbedded in the ground and created about 2 ft deep hole. The other blade extruded from the ground. Both blades remained attached to the hub. The top of the engine cowling was found crushed around the engine.

The fuselage came to rest on its right side and exhibited twisting throughout. The empennage remained attached to the fuselage and was bent upward. The vertical stabilizer, horizontal stabilizer, rudder and elevators remained attached to the empennage and were undamaged.

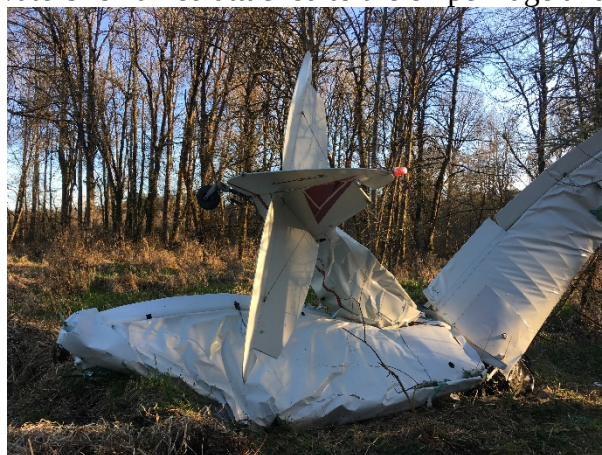
**Image 5 – Right wing**

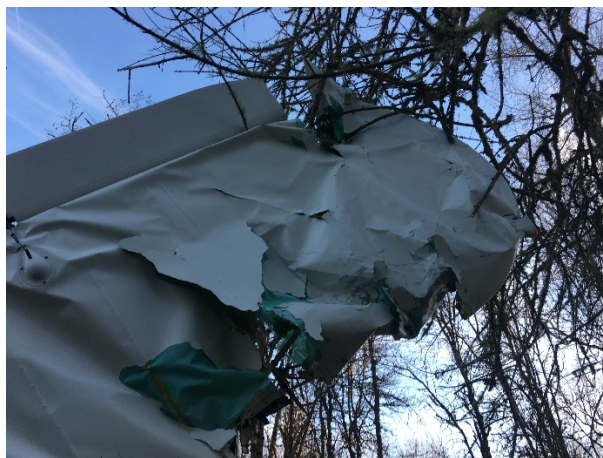
**Image 6 – Impact damage on the left wing**

Both wings remained attached to the fuselage. The outboard portion of the left wing's leading edge, around landing lights, was torn and crushed in the aft direction, consistent with the tree branches impact. Small pieces of branches were imbedded throughout the wing. The strut was still attached and connected to the lower fuselage. The right wing was slightly bent backwards and twisted. The right wing tip was crushed which was consistent with the ground impact. The inboard portion of the right wing exhibited inboard crushing. The strut was still attached and connected to the fuselage. All flight control surfaces remained attached to their respective hinges.
