## **NATIONAL TRANSPORTATION SAFETY BOARD**

### **ACCIDENT SITE / AIRFRAME / ENGINE EXAMINATION SUMMARY**

**WPR18FA116**

Location: Santa Paula, California  
Date: March 31, 2018  
Aircraft: Ragle RV6A, N820TL  
NTSB Investigator-in-Charge: Joshua Cawthra

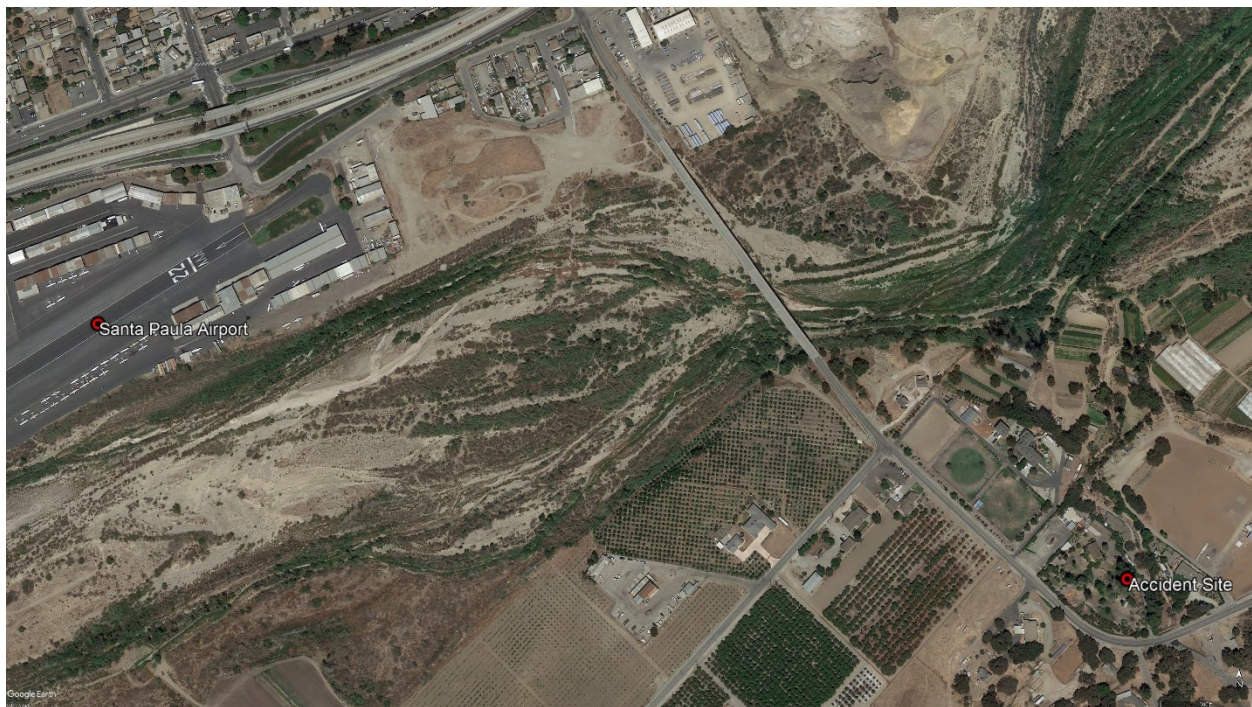
Examination of the accident site revealed that the airplane impacted trees and terrain about 0.7 miles east of SZP. The initial point of impact was separated tree limbs, about 20 feet above the ground and an adjacent brick wall, about 8 feet in height. On one side of the brick wall, the left main landing gear assembly was located and on the other side of the brick wall (opposite that of where the wreckage was), the left main landing gear wheel pant, and inboard forward portion of the left wing, including the fuel tank was found. Fire damage was noted to the surrounding structure adjacent to the wall where the inboard portion of the left wing was found. Severed tree limbs, plexi glass, canopy structure, and various debris was located throughout the debris path, which was about 30 feet in length and oriented on a heading of about 160 degrees magnetic. The main wreckage came to rest upright on a heading of about 043 degrees magnetic.

Photo 1: Overview of the accident site in relationship to the airport.
