# NATIONAL TRANSPORTATION SAFETY BOARD

MATERIALS LABORATORY FACTUAL REPORT

Report No. 18-064

Place : Reno, Nevada  
Date : May 1, 2018  
Vehicle : Thunder Mustang  
NTSB No. : WPR18FA131  
Investigator : Elliott Simpson, AS-WPR

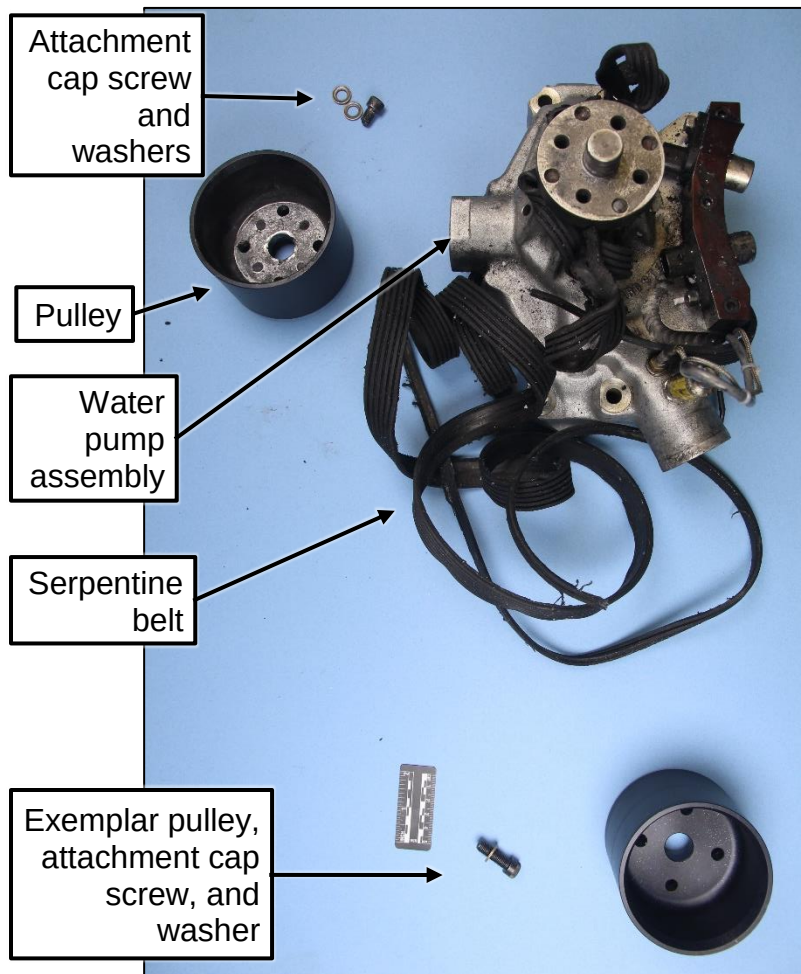
An overall view of the submitted components is shown in figure 1. Four attachment cap screws for attaching the water pump pulley to the flange on the water pump assembly were fractured. Fractured shank pieces of the four attachment screws remained within the flange shown in figure 2. An attachment screw head piece and 2 washers were received as shown, and a second screw head piece with its washer was embedded within one of the pulley attachment holes. The serpentine belt was partially fractured and deformed, and a portion of the belt was trapped between the pulley flange and the water pump housing. An exemplar water pump pulley, attachment cap screw, and washer were also submitted as shown in figure 1. The engine had reportedly been overhauled 6 hours before the accident.

Figure 1. Overall view of the submitted components.

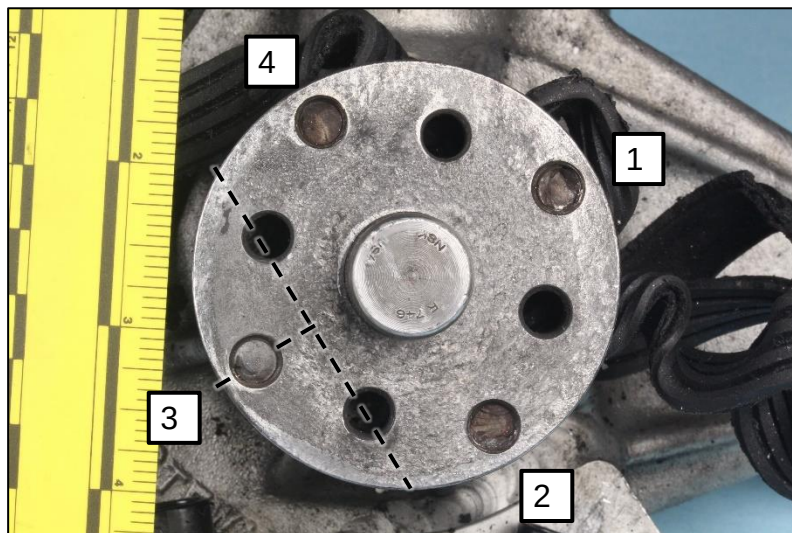
The pulley attachment flange surface shown in figure 2 was rough consistent with heavy fretting contact damage. The mating face of the pulley also similar heavy fretting contact features. The pulley had been attached with four attachment screws, and the screws were arbitrarily numbered clockwise as viewed looking at the attachment flange as shown in figure 2.

Next, attempts were made to extract the pulley attachment flange from the shaft using a puller, but the attachment flange did not move with the available pulling device. Alternatively, the attachment flange was cut along the dotted lines shown in figure 2 to facilitate an examination of the screw 3 threads. After the first cut was made to remove an arc portion of the flange, a Dremel tool was used to cut a slot in the back side of the attachment screw shank. Then a screwdriver was inserted in the slot to turn the screw. The screw turned about  $\frac{1}{2}$  of a turn before the screwdriver slipped out of the slot, and no additional turns were possible without the screwdriver slipping out of the cut slot.

Figure 2. Close view of the pulley attachment flange on the water pump. Attachment cap screw locations were arbitrarily numbered as shown. Dashed lines indicate cut locations.

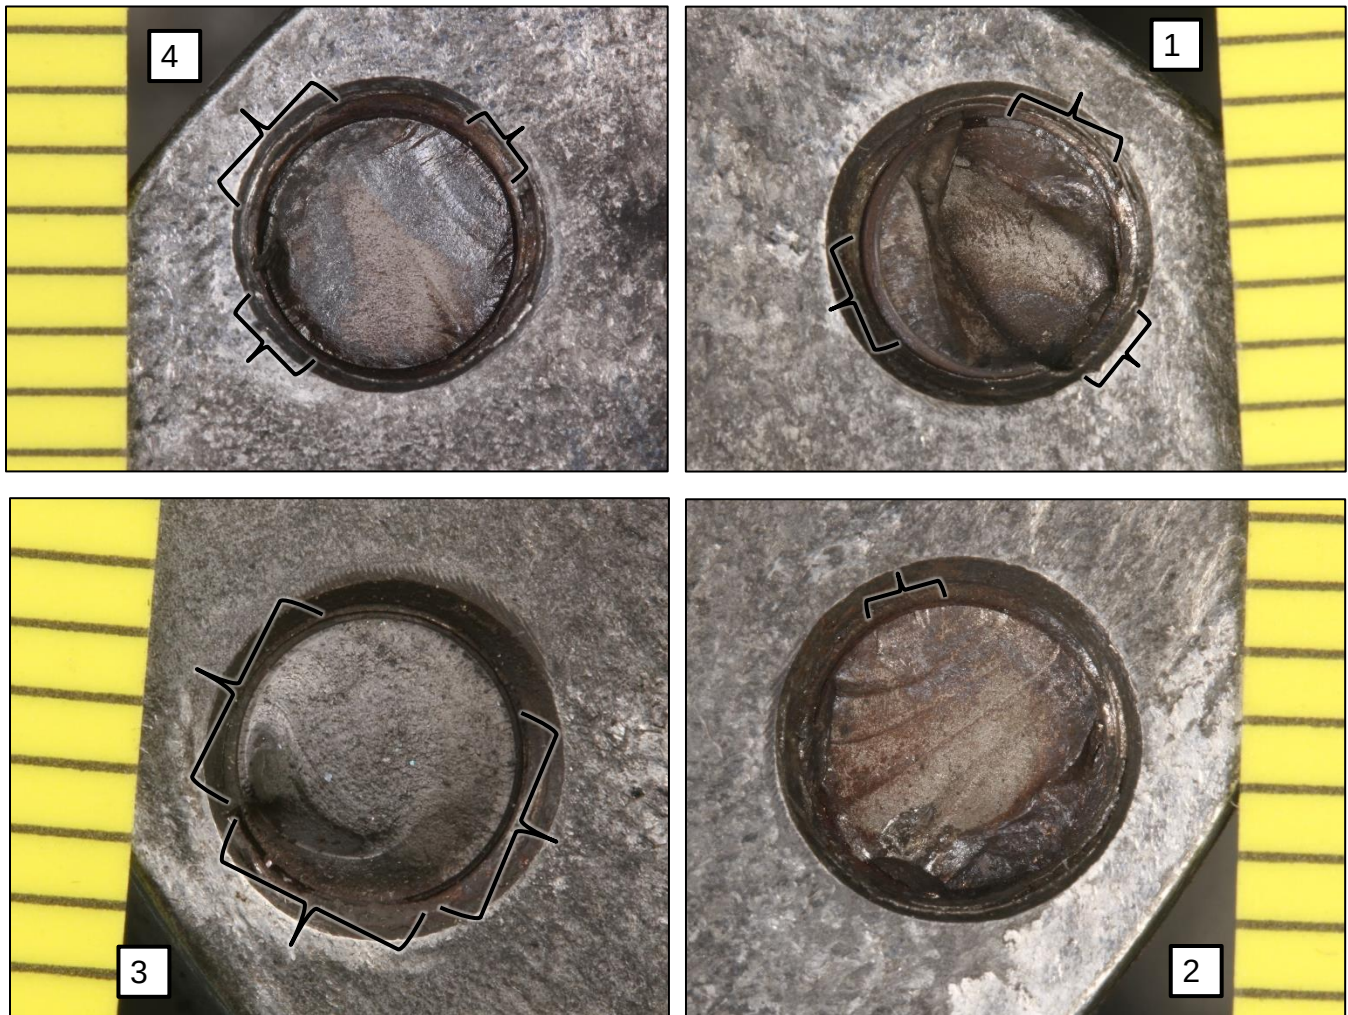
Closer views of the fracture surfaces of the attachment screws are shown in figure 3. Greasy deposits had covered some of the fracture features on screws 1, 2, and 4, so those screws were cleaned with a soft bristle brush using a solution of Alconox detergent and warm water, and the cleaned surfaces are shown in figure 3. The fracture surface of screw 1 mated to the fracture surface of the fractured screw head piece shown in figure 1. The fracture surface of screw 3 appeared to mate with the screw piece

embedded in the pulley. Portions of the screw fracture faces had relatively smooth features oriented perpendicular to the fracture surface with curving crack arrest lines, features consistent with fatigue fracture. Unlabeled brackets in figure 3 indicate fatigue origin areas on each of the screws. Screw 1 had multiple fatigue origins located around its circumference with fracture on multiple planes, a feature consistent with the first screw to fracture in the attachment assembly. Screw 2 had relatively prominent crack arrest lines with a fracture origin area located at one side of the screw, features consistent with fatigue fracture under relatively higher cyclic stresses. Screw 3 had small fatigue regions with multiple origins around the circumference, and the remainder of the fracture surface had matte gray features consistent with ductile overstress fracture. Screw 4 had relatively smooth fracture features with crack arrest marks extending across most of the fracture and origins located around much of the circumference.

Figure 3. Closer view of the pulley attachment cap screw fractures after cleaning.

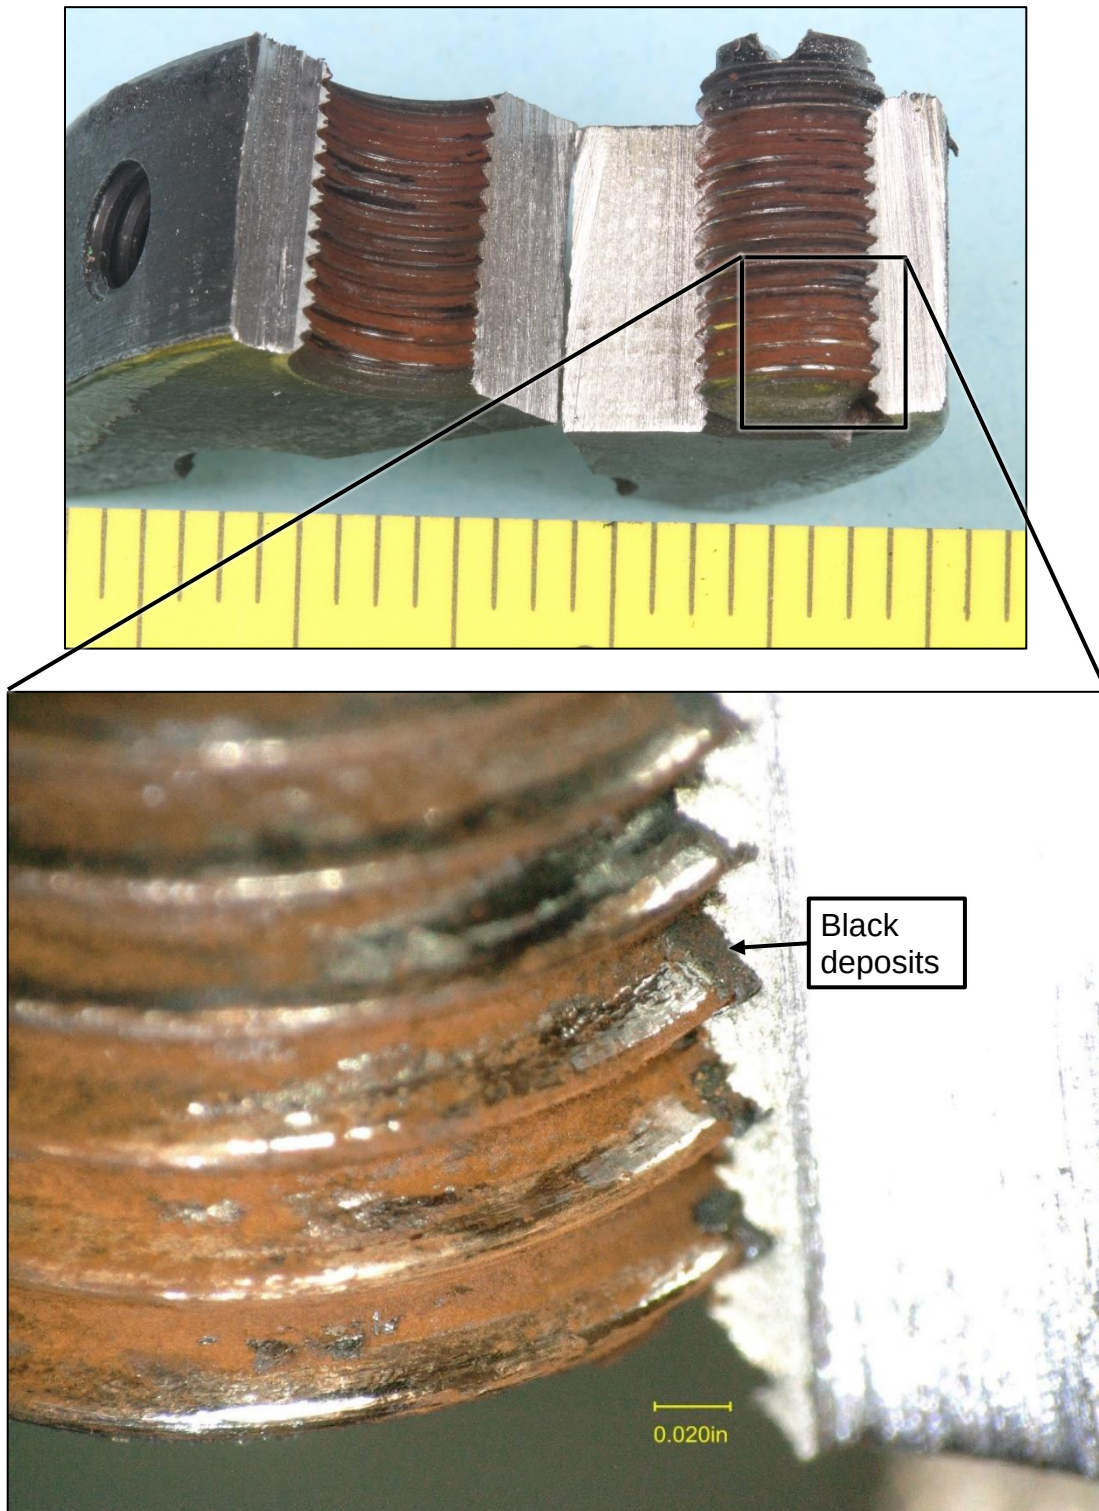
Next, cuts were made along the radial dashed lines in figure 2 toward the screw to separate the flange piece into 2 pieces. A view of the resulting exposed threads for screw 3 are shown in figure 4. A powdery orange deposit consistent with iron oxide was observed on the threads. Upon closer inspection as shown in figure 4, black deposits were observed in the space between the screw threads and the flange threads. The black deposits were probed while viewed under a stereomicroscope using a scalpel, and the material flaked into small pieces with little effort as it was probed.

A sample of the black deposit removed from the screw 3 threads was examined using a Fourier Transform Infrared (FTIR) spectrometer with a diamond attenuated total reflectance (ATR) accessory in accordance to ASTM E1252-98.<sup>1</sup> The spectrometer was used to collect and process infrared wavelength absorbance spectra of the unknown material(s).

stretching bond. The presence of a single peak  $\sim 700\text{ cm}^{-1}$  is indicative of multiple carbon-hydrogen<sub>2</sub> (C-H<sub>2</sub>) bending bonds. Based on peak heights and peak resolution, the sample was present in a very small amount and/or was degraded. The spectrum was consistent with a methacrylate. A spectral library search was performed on the unknown material spectrum. There were no strong matches. However, there were some similarities to the spectra of oleic acid and Loctite® 242.

According to the engine manufacturer, blue Loctite is applied to the threads of the pulley attachment screws at installation. According to the Henkel website,<sup>2</sup> multiple kinds of Loctite® medium strength blue threadlocker are available including Loctite® Threadlocker 242 and Loctite® Threadlocker 243. The website further states that Loctite 243 is an “upgraded version of Loctite 242” and is needed for applications including pulley assemblies.

Figure 4. Views of the cap screw 3 threads after cutting along the dashed lines shown in figure 2.

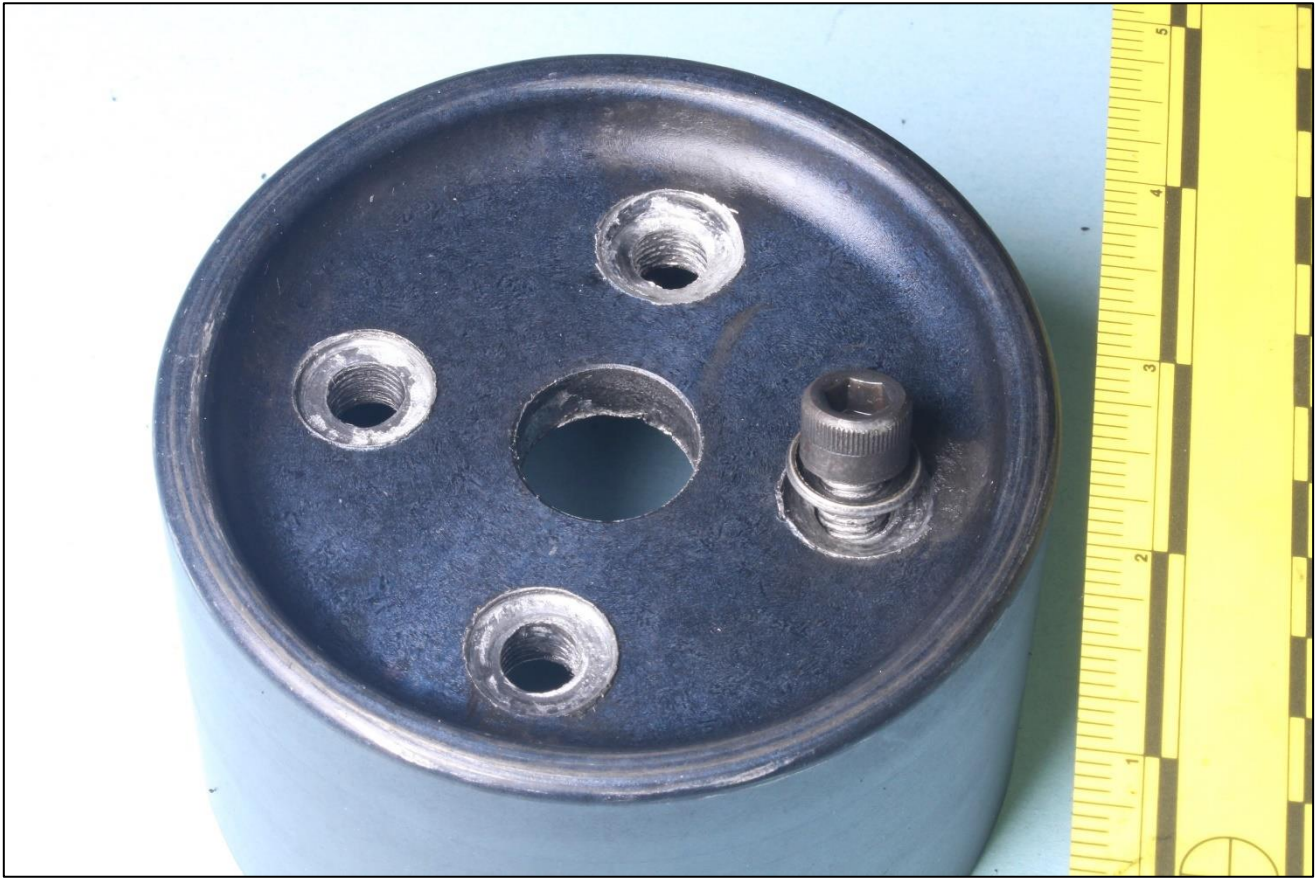
A view of the aft face of the pulley with embedded attachment screw is shown in figure 5. The areas around the attachment holes were worn away consistent with heavy contact wear with the washers. Thread impressions were also observed in the holes consistent with heavy contact with the threads of the attachment screws.

Figure 5. View of the forward face of the pulley with a trapped attachment cap screw and washer.
