To: Don Morgan  
Reno FSDO

SUBJECT: Probable failure of Canopy Bow (P/N 512004-02) and Windscreen Bow (P/N 512004-01)  
Thunder Mustang

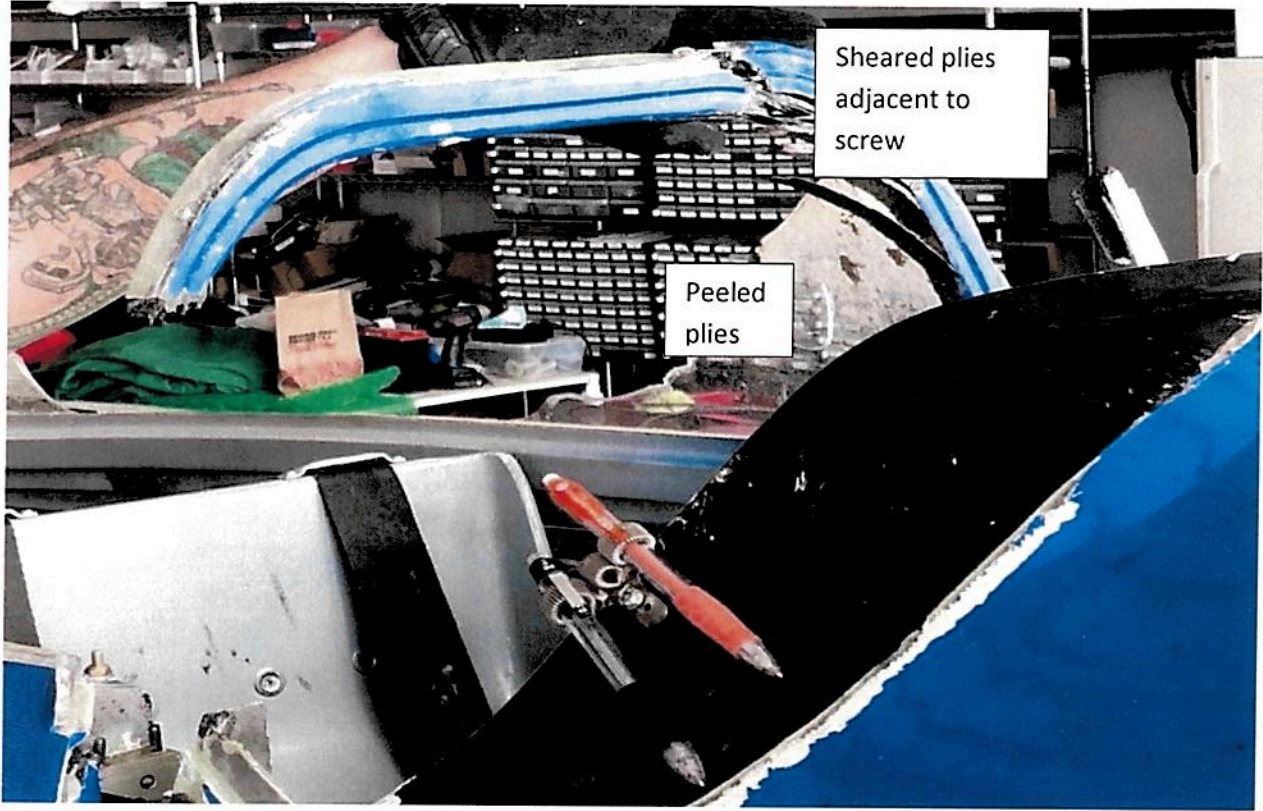
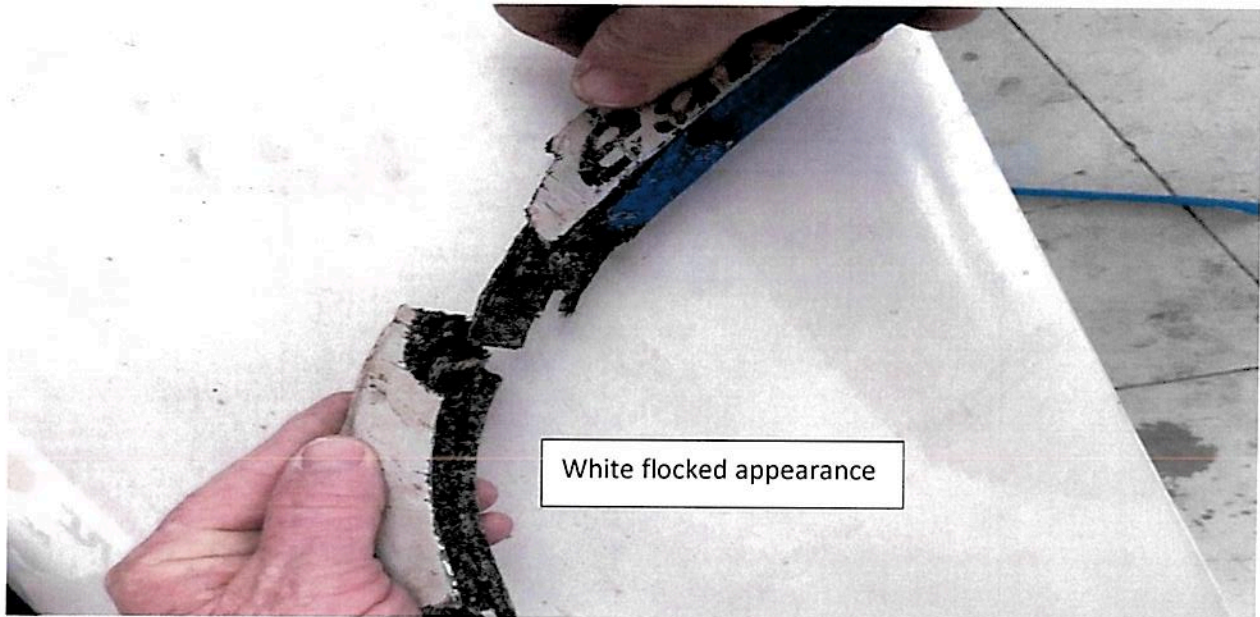
My assessment for both the canopy and windscreen bows: the lack of sufficient consolidation during the manufacturing process resulted in poor quality solid laminates.

One can only surmise that the plies were layed up in a female mold (OML) packing in as many layers as would accommodate the space and either closed off with a vacuum bag or a drop-in male backup tool that provided the overall contour of the IML. Observed were the delaminated plies and sporadic large void spaces internal at the ply interface (glossy empty pockets) were evident in each part. Also there is the appearance of uneven wetting of the plies; some areas exhibit resin richness (white flocking at failed layers). With the layup being resin rich, the lack of consolidation from the tooling and maybe a slight exothermic reaction due to the thickness of the buildup could have resulted in a less than ideal structural element. Reviewing the assembly instructions, photos of both bows showed the same visual external appearance – poor quality laminate. A comparison was made using the failed pieces, the supplied photos along with the assembly manual:

- C. The method of attachment of the windscreen and canopy to the bow with the use of screws may have resulted in point load failure at impact. There was a combination of shearing adjacent to the screws and peeling of layers just under the depth of the drilled holes. The assembly manual indicated the holes drilled to a depth of .5". A better option to preserve the structural effectiveness of the bows and to attach the canopy to the bow would have been bonding.
