**NATIONAL TRANSPORTATION SAFETY BOARD**

**AIRFRAME & ENGINE EXAMINATION**

**WPR18FA141**

Aircraft: Cessna 182G

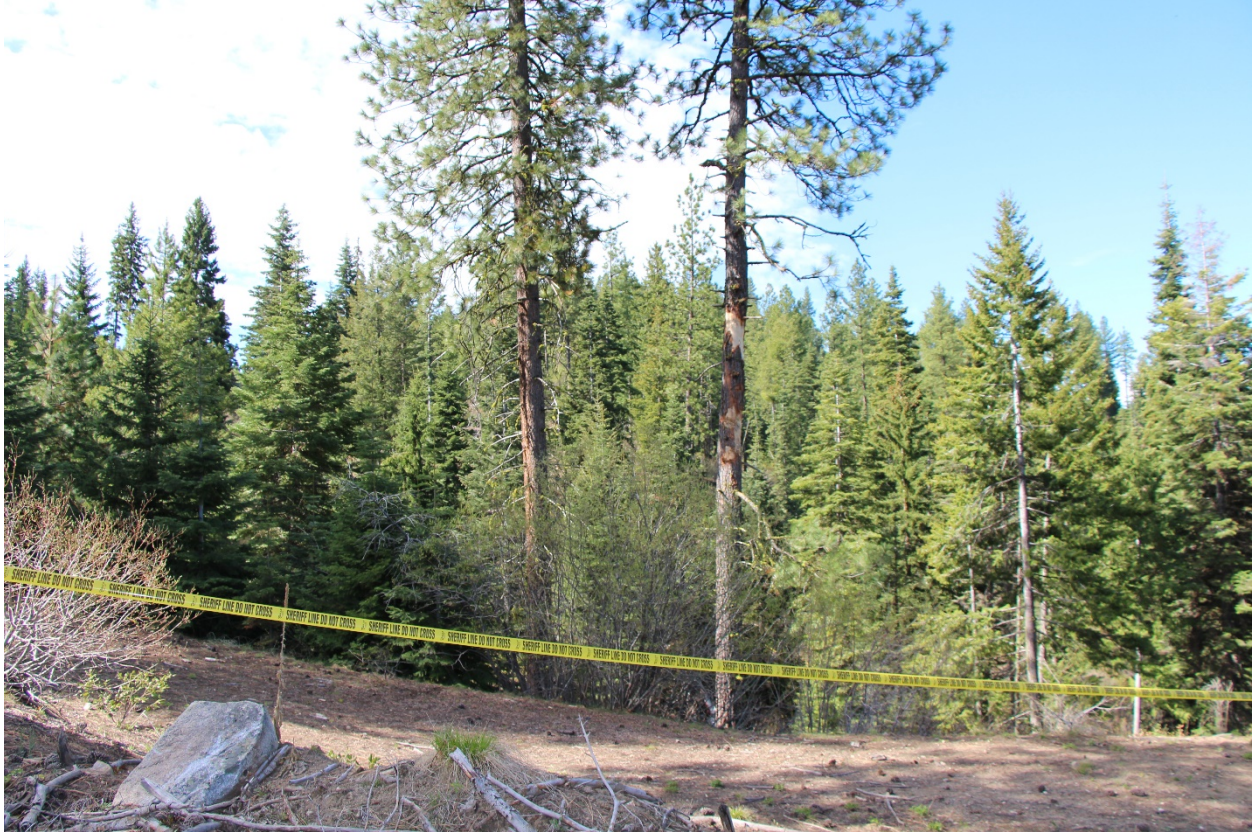
The airplane came to rest in a wooded area approximately 41 nm north of BOI and was oriented on a heading of 195° magnetic. All major structures of the airplane were accounted for at the accident site. The initial impact point (IIP) was identified by two tree scars about halfway up a 70 foot tall tree. The nose landing gear was collocated with the IIP. Wing fragments were distributed along the wreckage path. A ground scar about 12 ft long was located about 20 ft from the main wreckage in the debris path. The left aileron remained attached to the left wing trailing

Photograph 1: Initial Impact Point

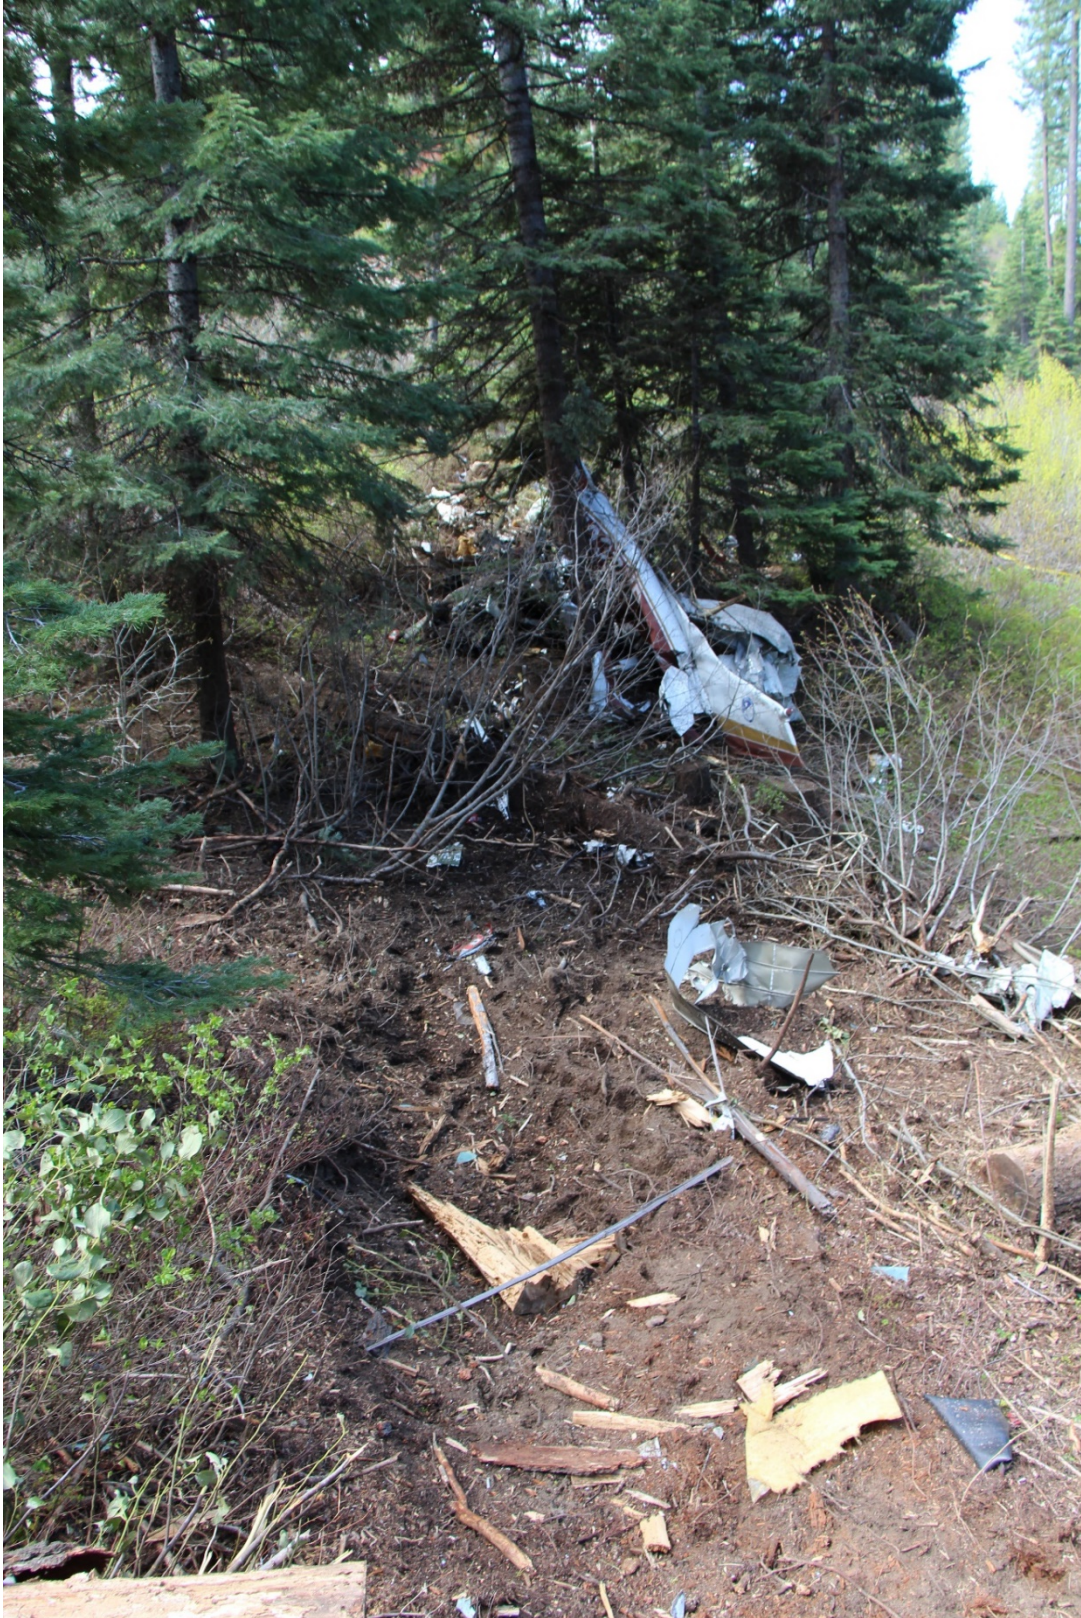
Photograph 2: Ground Scar

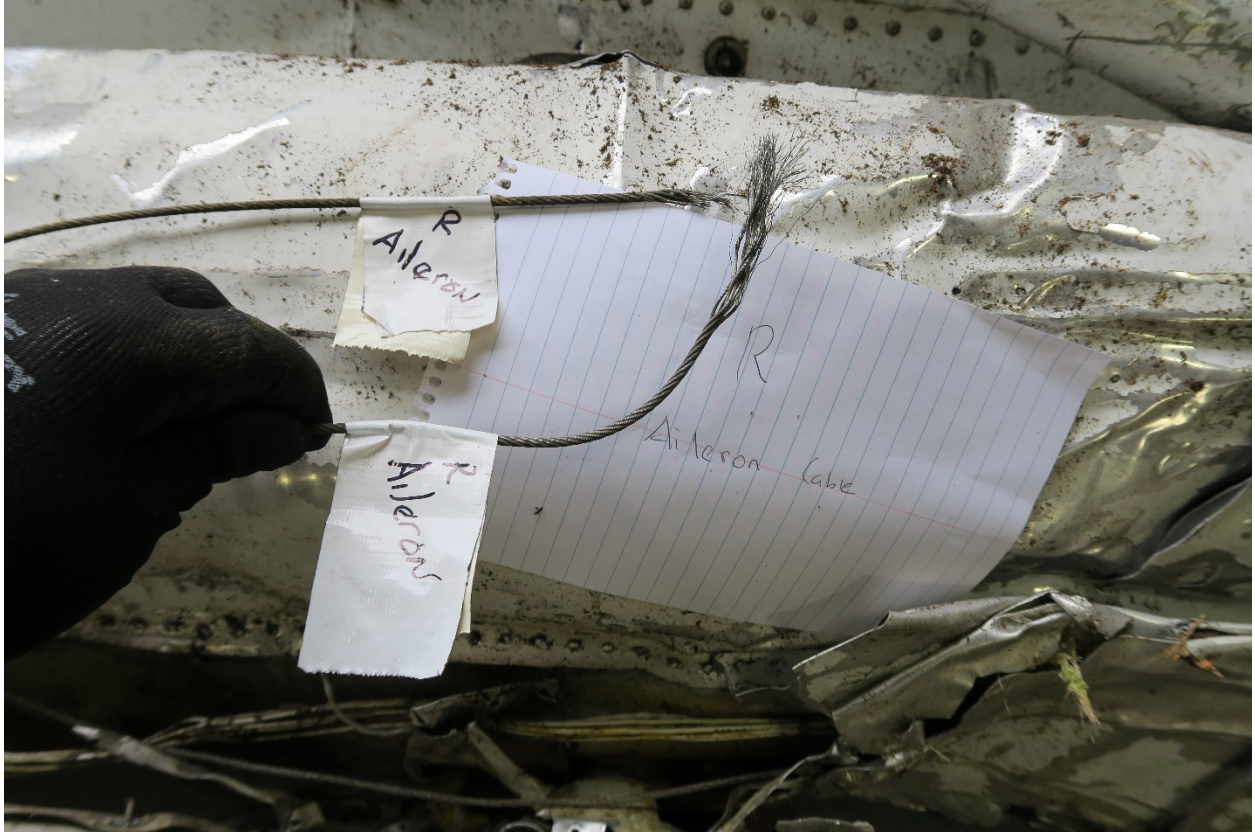
remained attached to the right wing. The right wing skin had split open at the outboard leading edge. Both the main and balance aileron cables were continuous from their attachments at the control surfaces to the wing root. The right flap jackscrew was observed in the neutral position, consistent with a zero flap deployment. The flap indicator cable displayed evidence of overload separation and the flap control cable had separated from the left wing bell crank.

Photograph 3: Right Aileron Cable

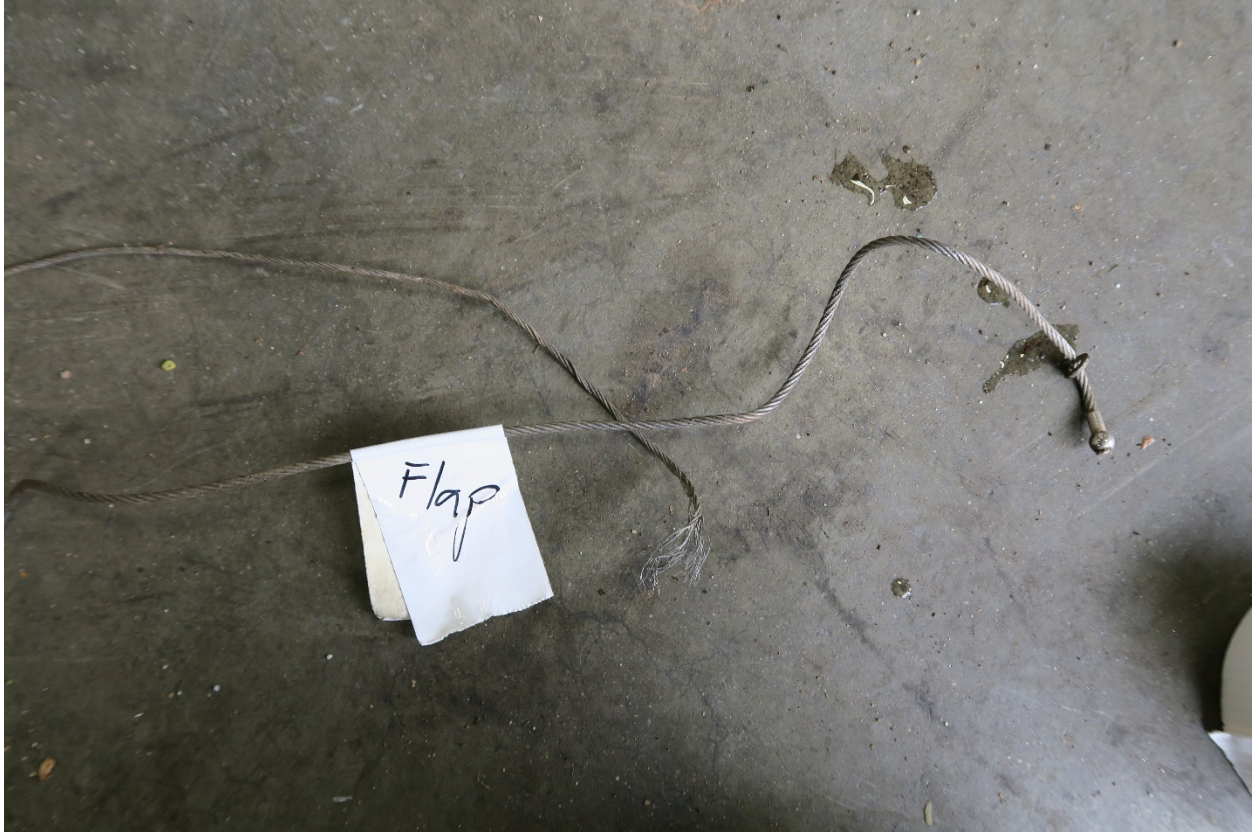
Photograph 4: Right Flap Balance and Main Cables

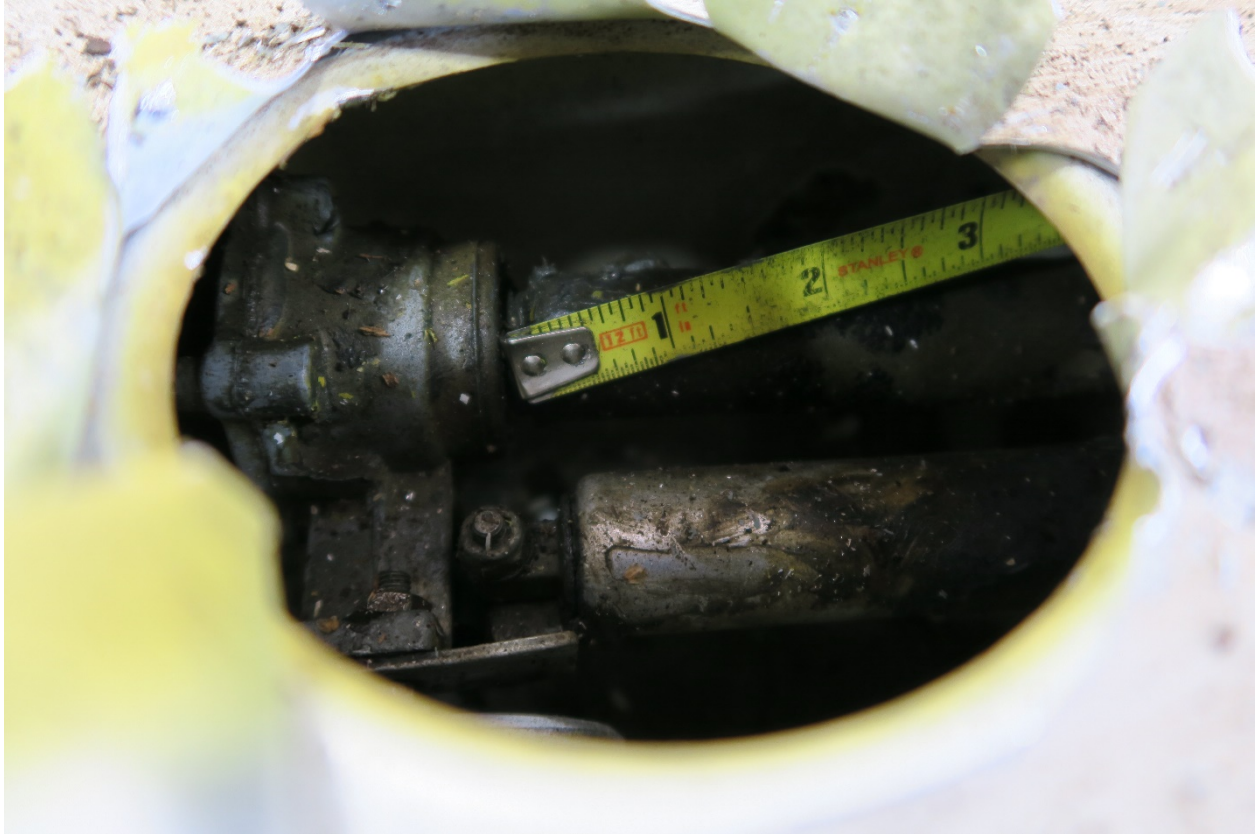
Photograph 5: Flap Jackscrew

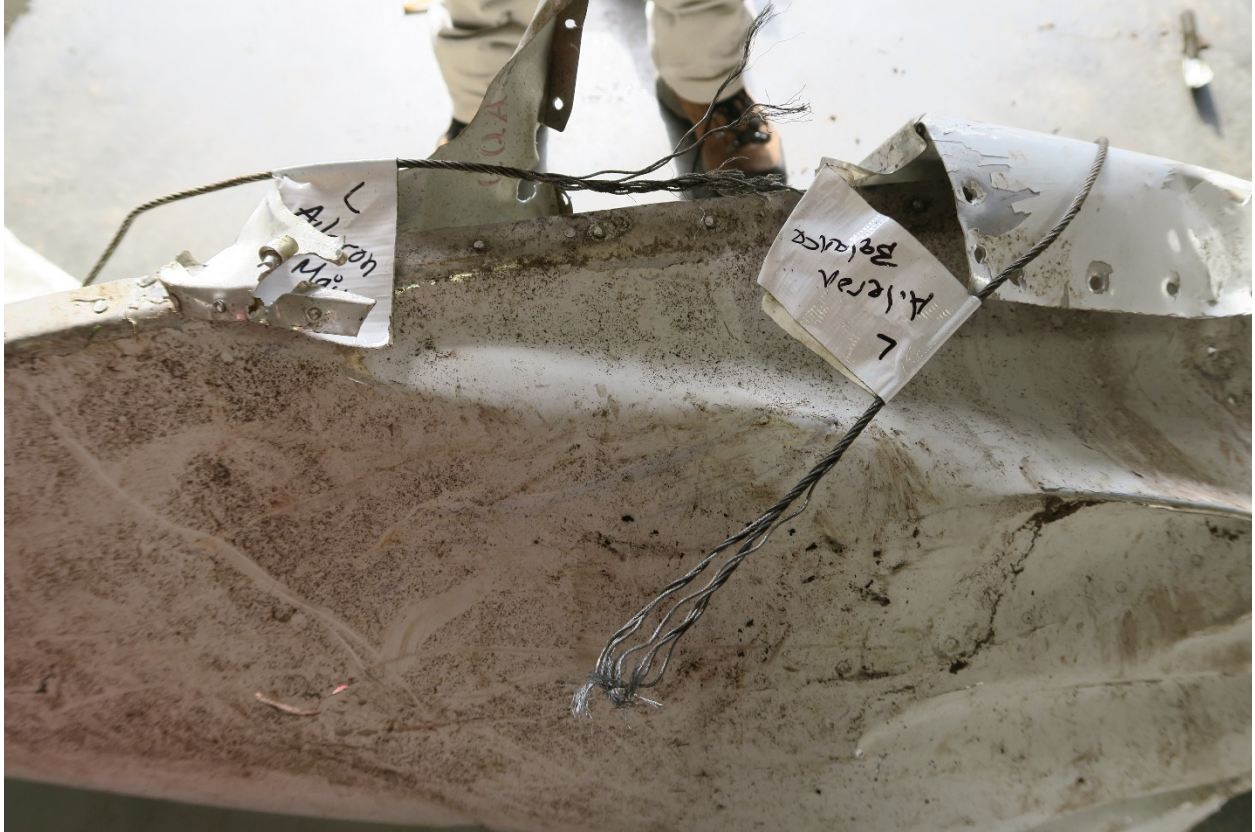
The left wing fuel tank was breached, and contained within the inboard left wing, which was attached to the main cabin roof. A large section of left wing airframe skin that spanned about the length of the wing had torn free from the wing. The left flap separated from the wing along with a portion of the aft spar. The left aileron remained attached to a section of left wing skin, which had separated from the forward spar. The left wingtip was separated. Both the main and balance cables were continuous from the midspan section of the wing to the bell crank. The left aileron push/pull tube separated at the bell crank and the left flap push/pull tube remained attached to the bell crank.

Photograph 6: Left Aileron Main and Balance Cables

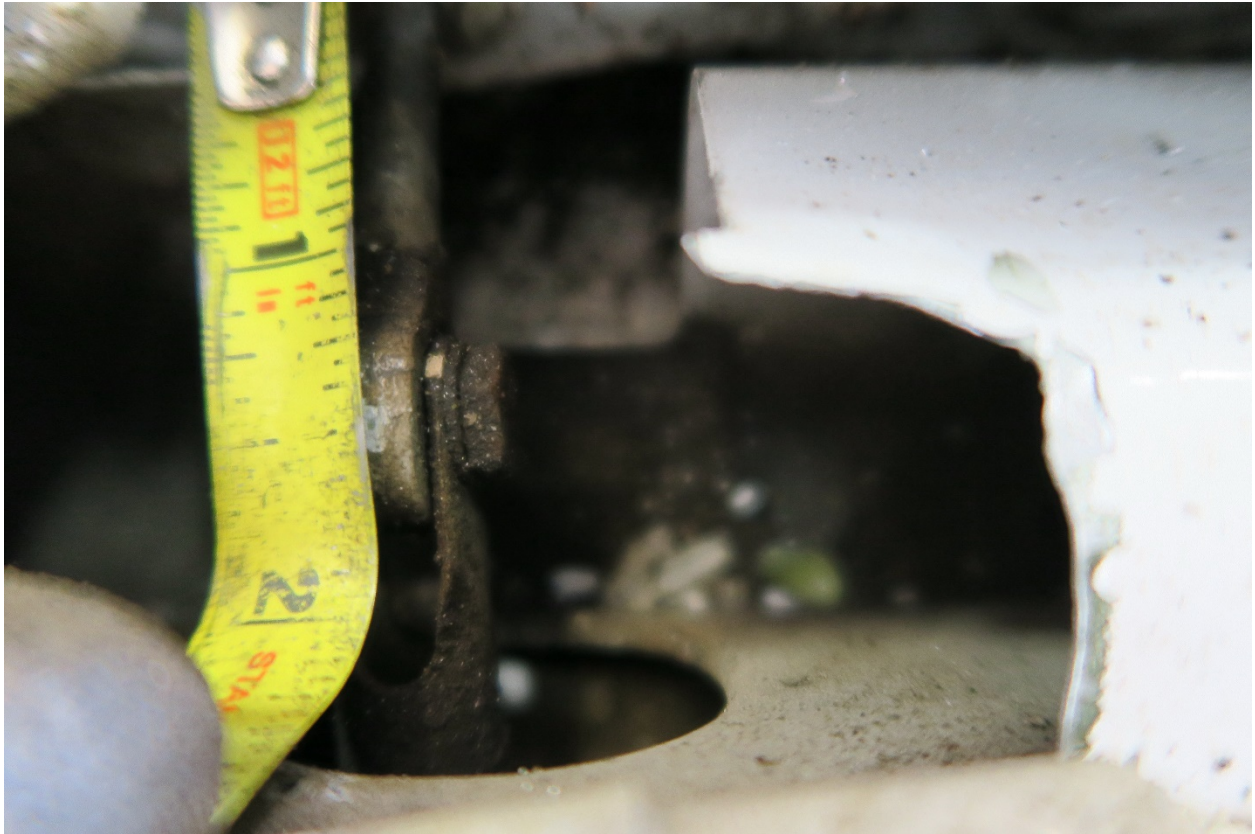
The aft fuselage was attached to the empennage, which was comprised of the right and left horizontal stabilizers and the vertical stabilizer. The right elevator was attached to the right horizontal stabilizer and the left elevator was separated from the left horizontal stabilizer. The rudder cables were continuous from the aft fuselage to the rudder. Both elevator cables were continuous from the aft fuselage to the bell crank. The elevator trim cables were traced from the aft fuselage to the elevator trim tab and the right elevator actuator rod measured about 1.5 inches consistent with a 10° up deflection.

Photograph 7: Elevator Trim Actuator
