# NATIONAL TRANSPORTATION SAFETY BOARD

## MATERIALS LABORATORY FACTUAL REPORT

Report No. 18-087

Place : Melville, New York  
Date : May 30, 2018  
Vehicle : North American SNJ-2, N62382  
NTSB No. : WPR18FA155  
Investigator : Andrew Swick, AS-WPR

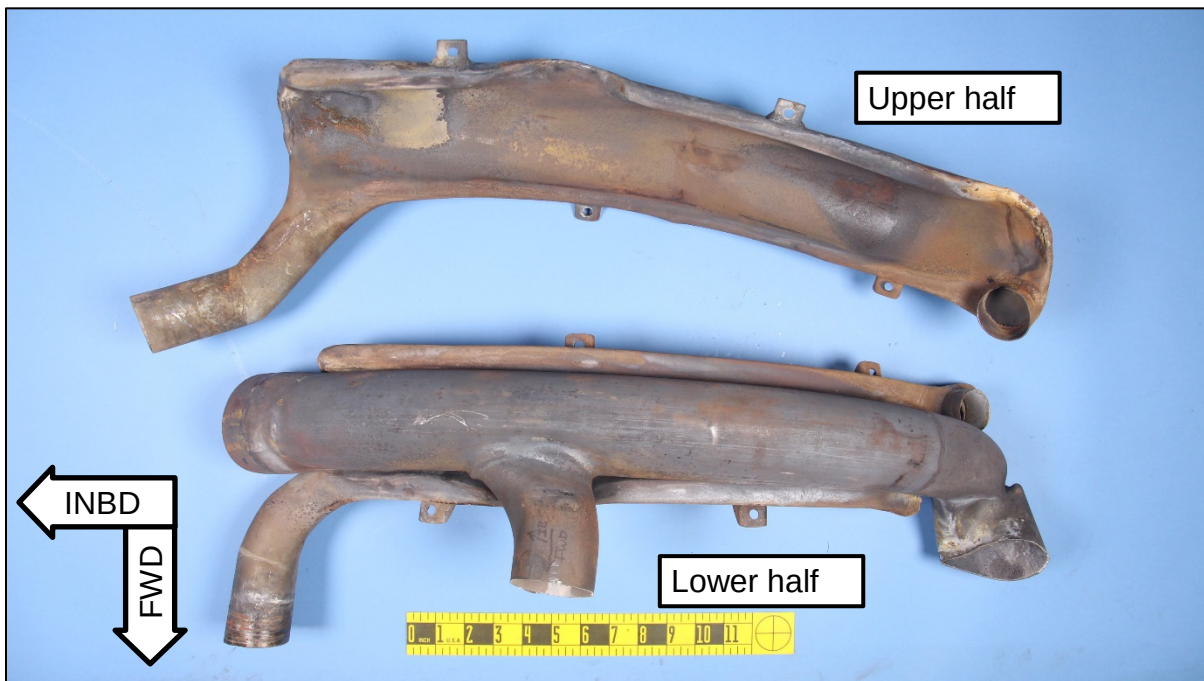
An overall view of the cabin heater assembly is shown in figure 1. The submitted heater assembly components consisted of an upper and a lower airflow chambers that as assembled surround a section of exhaust pipe. The section of exhaust pipe that was enclosed between the heater assembly halves is shown resting in the lower half of the heater assembly in figure 1.

Figure 1. Overall view of the submitted components.

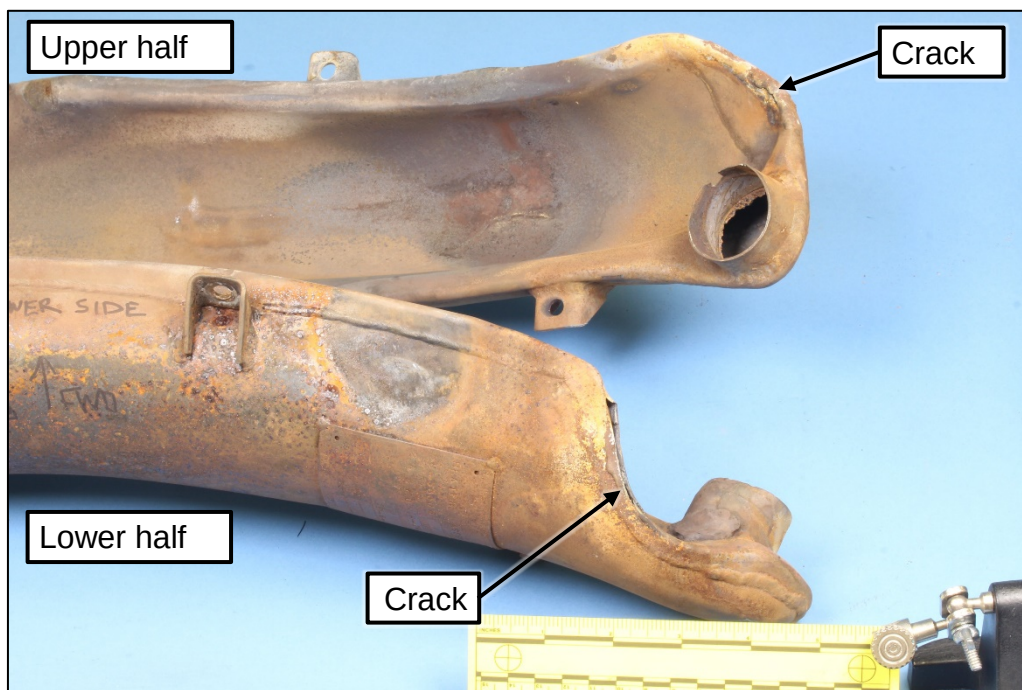
A closer view of the outboard ends of the heater assembly halves is shown in figure 2. Cracks were detected visually along welds at the outboard ends where the interior and exterior walls of the chamber met as indicated in figure 2. The cracks at each location extended through the wall.

Figure 2. Closer view of the cracked ends of the heater assembly halves.

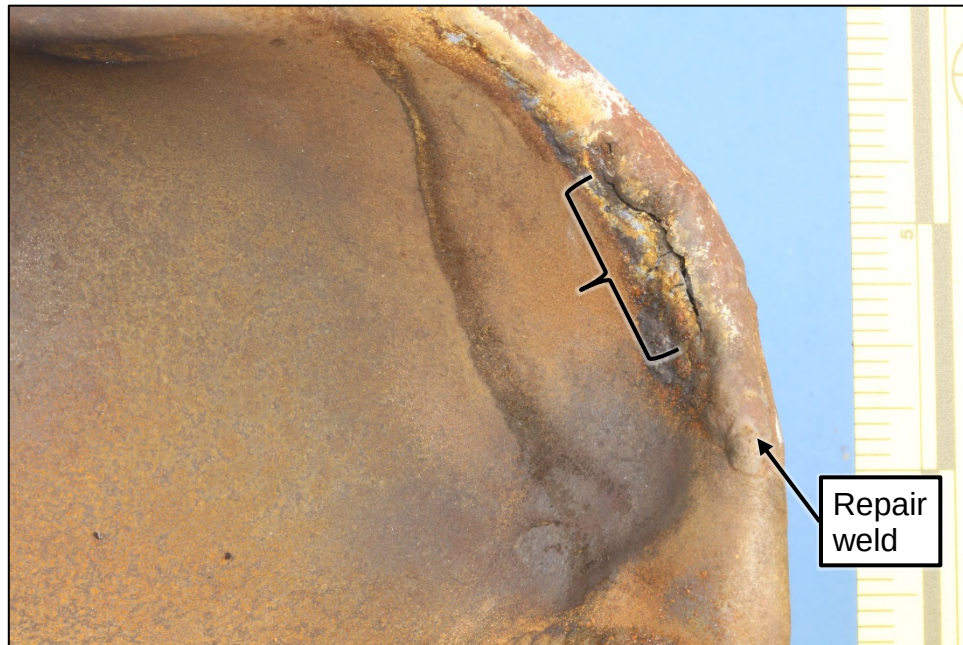
In the upper half of the assembly, the crack was approximately 0.9 inch long and had a crack opening displacement of approximately 0.05 inch as shown in figure 3. Fracture surfaces were viewed through the crack opening using a stereo optical microscope, and fracture features were covered in dark oxide consistent with a preexisting crack.

Weld segments overlapping the as-manufactured welds and welded patches consistent with repair welds were noted in multiple locations on the heater assembly, including in the cracked areas. Several areas of repair welds are noted in figures 3 and 4.

Figure 3. Close view of the crack in the upper half of the heater assembly.

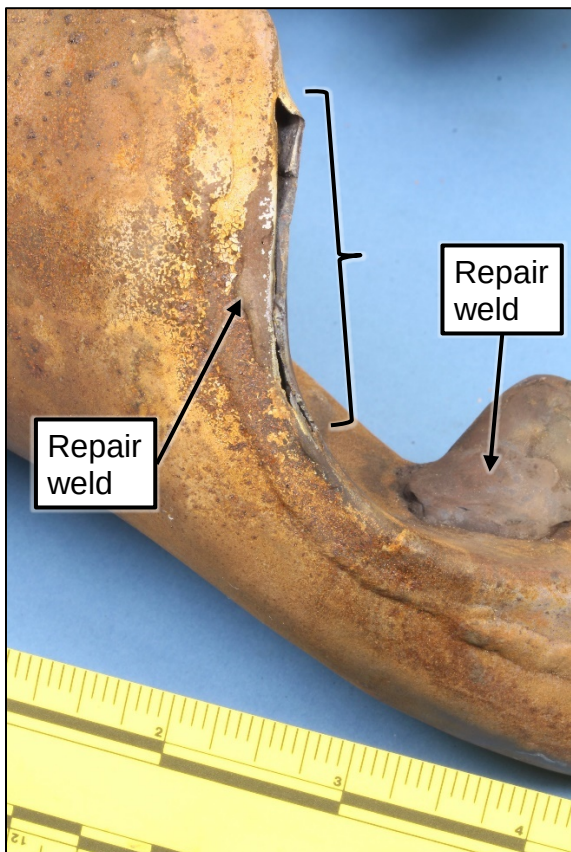
The crack in the lower half of the assembly is shown in figure 4. The fracture surfaces of the crack were displaced laterally, and impact marks corresponding to contact with the exhaust tube were present on the surface of the interior wall of the chamber adjacent to the crack. Portions of the fracture surface of the crack had flat features perpendicular to the interior surface consistent with a preexisting crack. However, light gray fracture features on slant planes were observed on the fracture surfaces adjacent to the interior surface of the chamber wall, consistent with a recent ductile overstress fracture. As noted above, the exhaust pipe was crushed near this area of damage.

Figure 4. Closer view of the crack in the lower half of the heater assembly.
