## **NATIONAL TRANSPORTATION SAFETY BOARD**

# **WRECKAGE EXAMINATION SUMMARY**

**WPR18FA155**

Location: Melville, New York  
Date: May 30, 2018  
Aircraft: N62382; North American SNJ-2  
NTSB Investigator-in-Charge: Andrew Swick

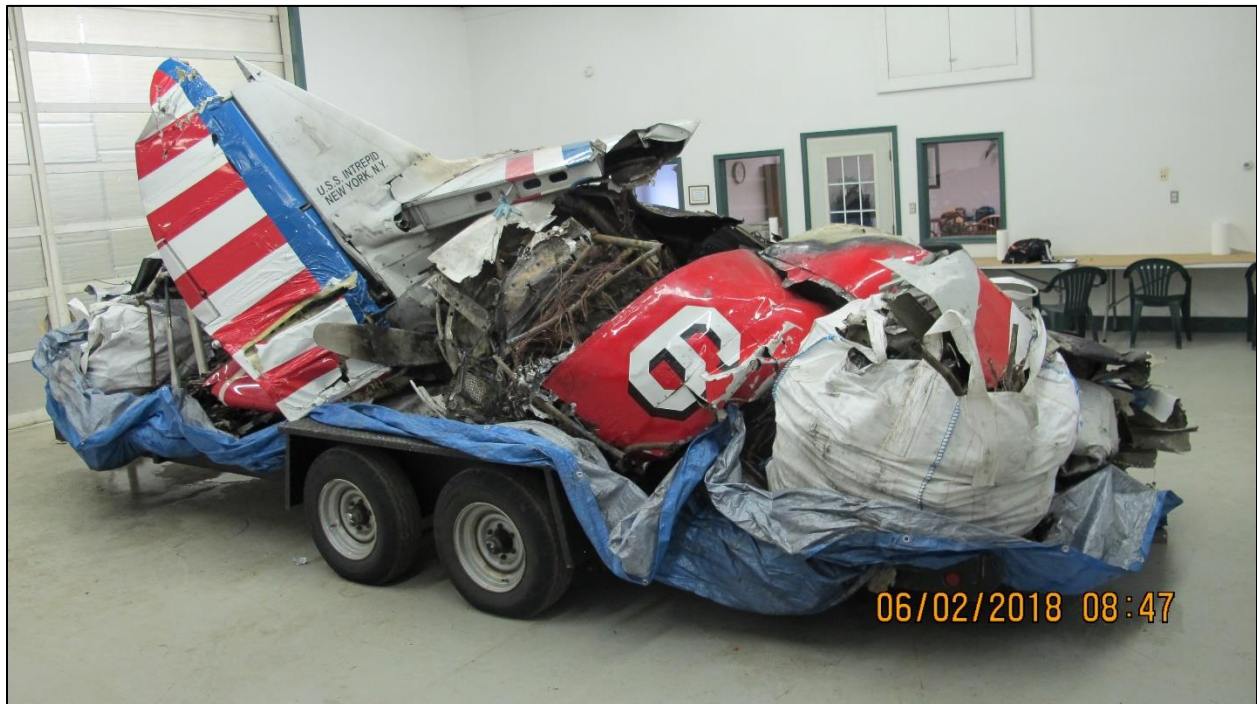
Figure 1-Recovered Wreckage

The post-accident examination of the wreckage was conducted on June 2, 2018, by the NTSB-IIC and the FAA at the facilities of Anglin Aircraft Recovery Services, in Clayton, Delaware. Flight control cable continuity was attained. The engine and propeller assembly separated from the main wreckage and had impact damage to its forward side. Several cylinder pushrod housings were bent aft. The crankcase forward cover was partially separated from the crankcase.

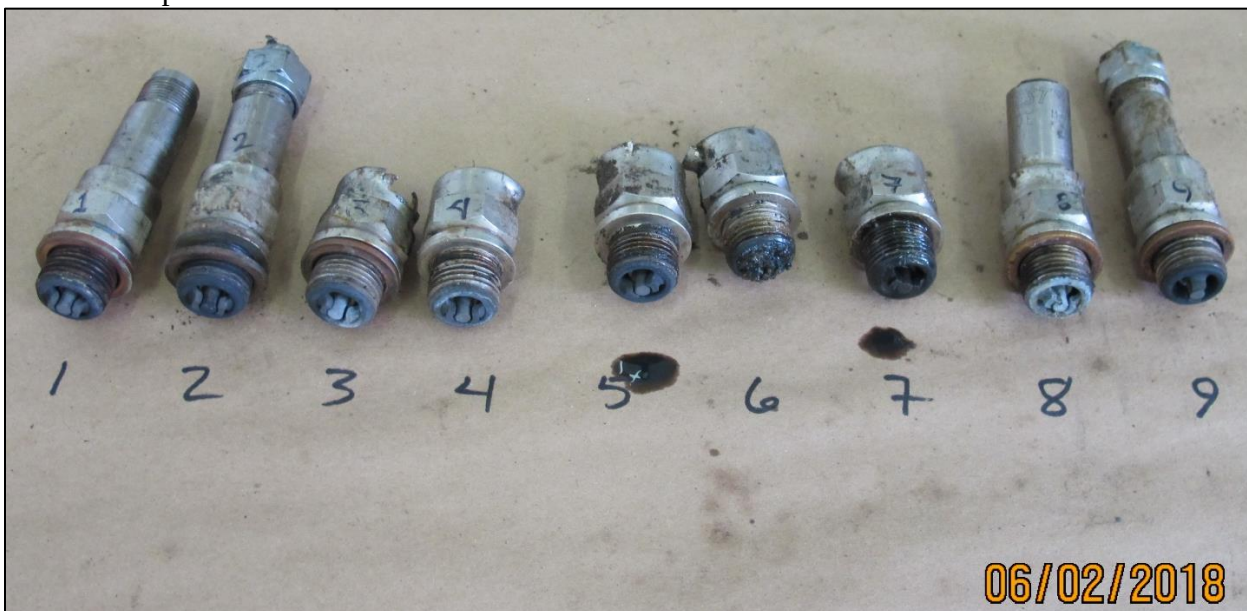
Figure 3-Upper Sparkplugs

The forward positioned sparkplugs were removed, and the electrode areas had normal amounts of carbon deposits and the electrodes revealed normal wear.

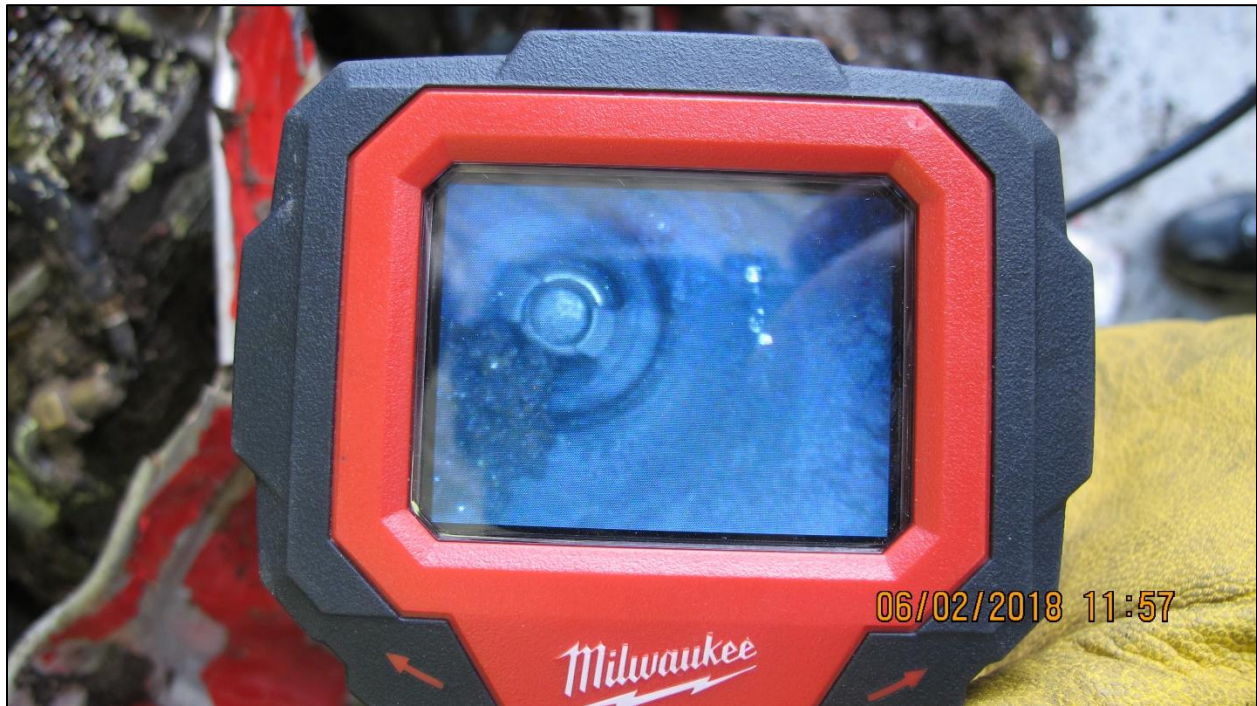
Figure 4-Boroscope View (aft positioned sparkplug)

The cylinders were boroscoped and the cylinder combustion areas showed normal amounts of carbon deposits and were undamaged. The aft positioned sparkplugs were examined, and the electrode areas had normal amounts of carbon deposits and the electrodes revealed normal wear.

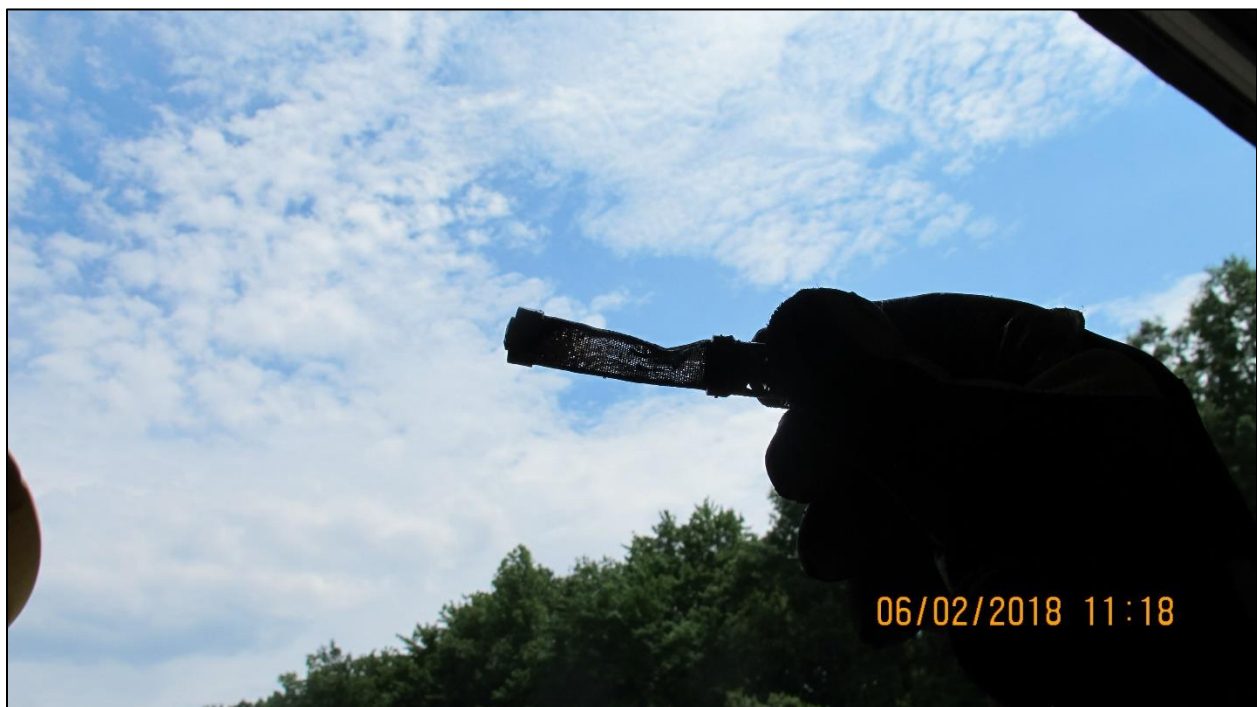
Figure 5-Carburetor Inlet Screen

The carburetor separated from the engine and had impact damage. The inlet screen was removed and was clear of debris. The screen was buckled on one side although intact.

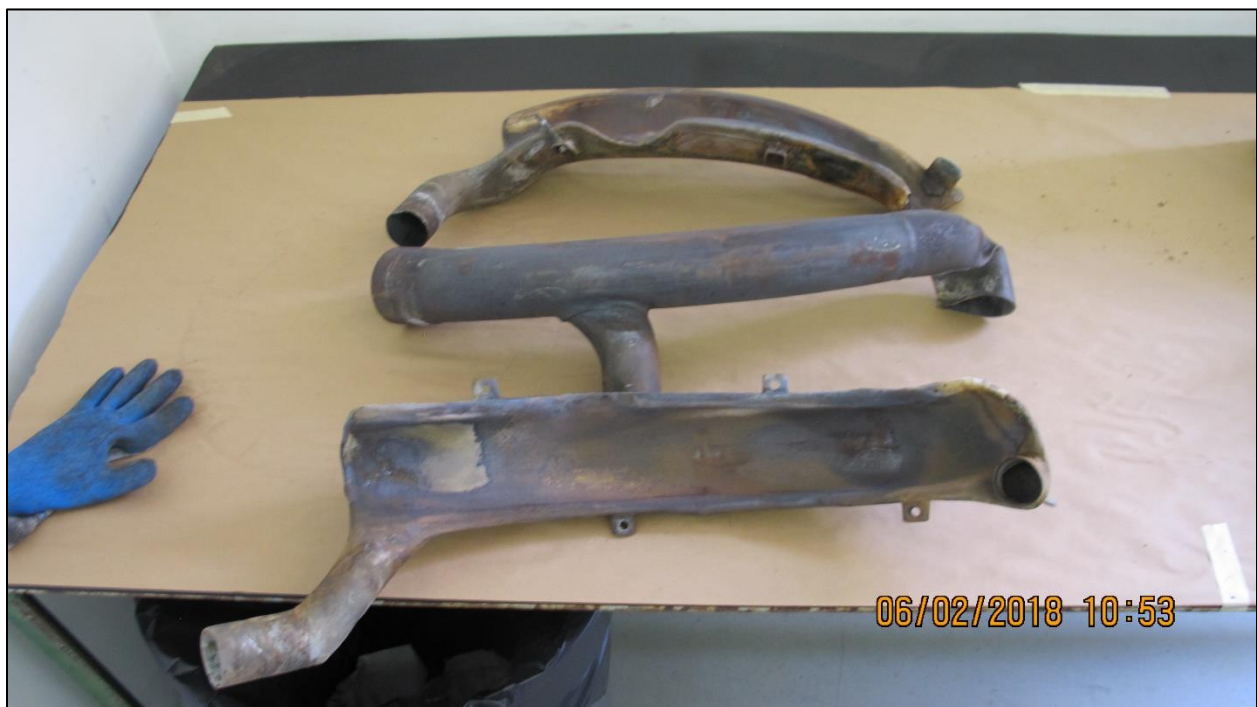
**Figure 7-Exhaust Muff and Exhaust Pipe Section**

The exhaust muff and associated exhaust pipe was removed from the engine. The exhaust pipe was buckled. Wear and rubbing was noted on the exhaust muff. The connected scat tubing had thermal damage. The exhaust muff and associated pipe was sent to the NTSB materials laboratory for further examination.

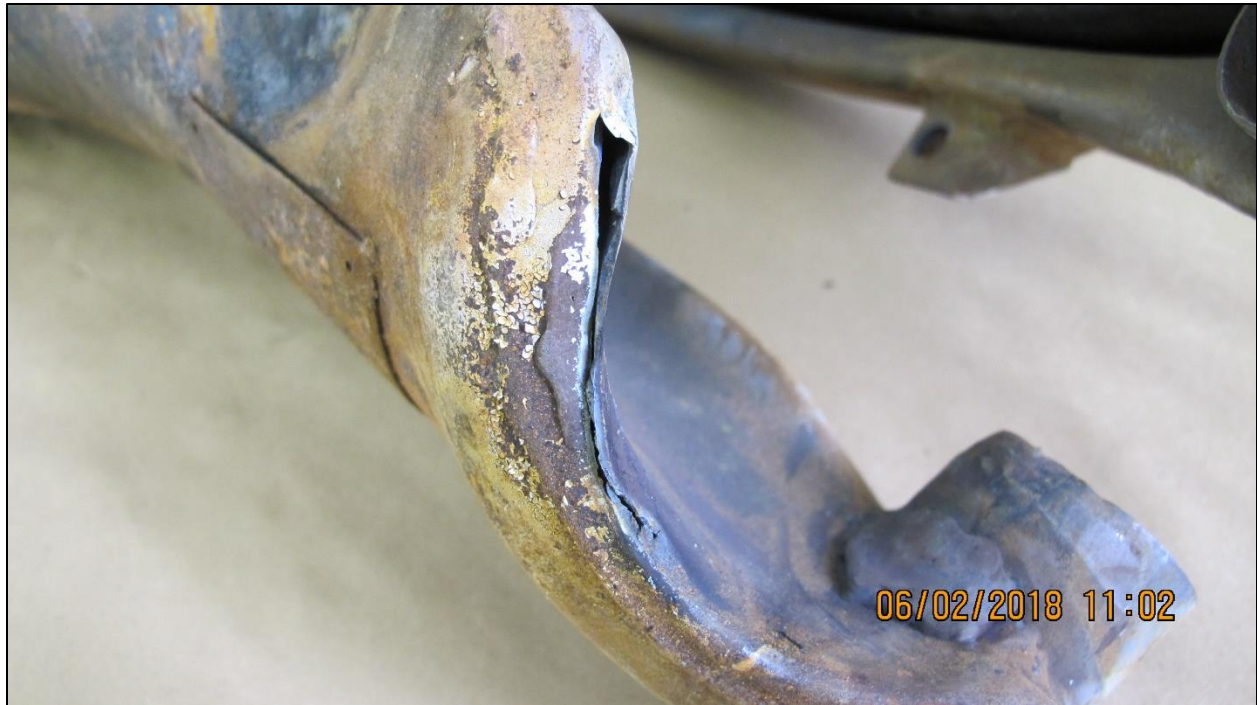
Figure 8-Exhaust Muff Damage

All major structural components of the airplane were identified. Flight control cable continuity was attained. Multiple holes and damage were found on the heater muff and was sent to the NTSB materials lab for further examination. An Appareo Stratus PRX V2 unit was sent to the NTSB Recorders Lab for further examination.

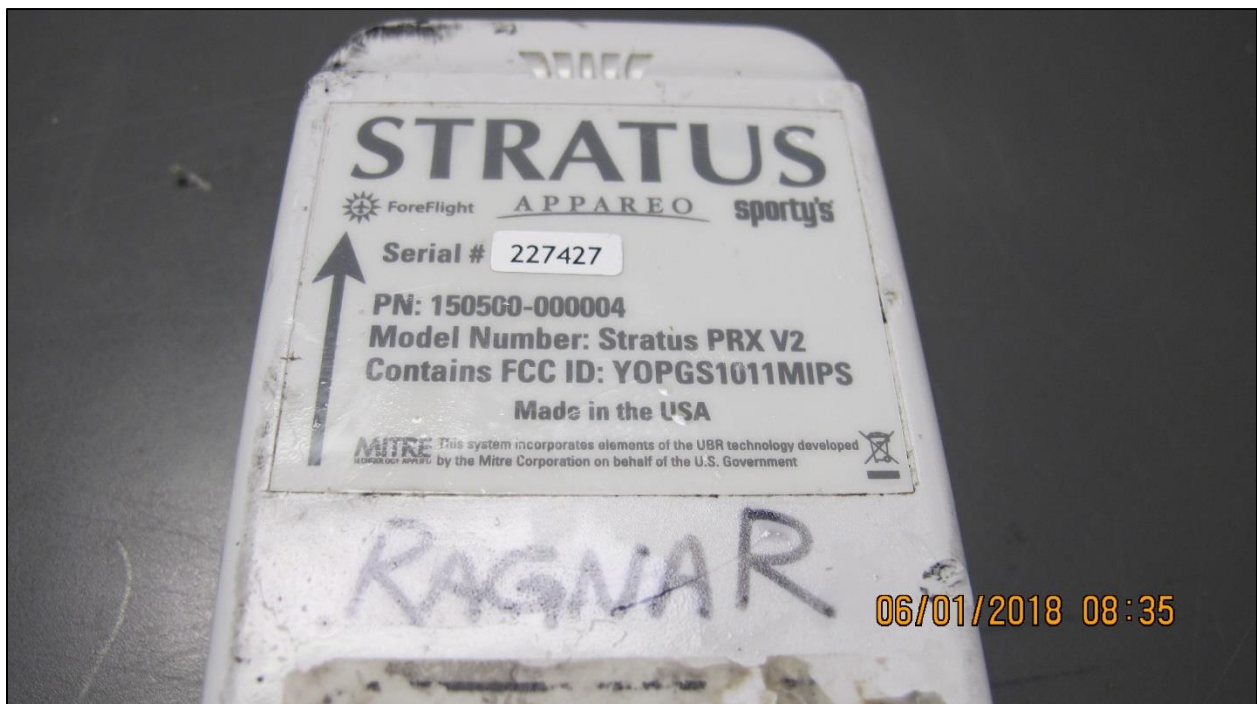
Figure 9-Appareo Stratus PRX V2

An Appareo Stratus PRX V2 unit was found across the street from the main wreckage. The unit was wet and raddled on the inside when shook by hand. The unit was sent to the NTSB Recorders Lab for further examination. An iPad was found near the main wreckage and the screen was broken. The iPad was retained with the wreckage.
