## **NATIONAL TRANSPORTATION SAFETY BOARD**

# **ACCIDENT SITE EXAMINATION SUMMARY**

**WPR18FA155**

Location: Melville, New York  
Date: May 30, 2018  
Aircraft: N62382; North American SNJ-2  
NTSB Investigator-in-Charge: Andrew Swick

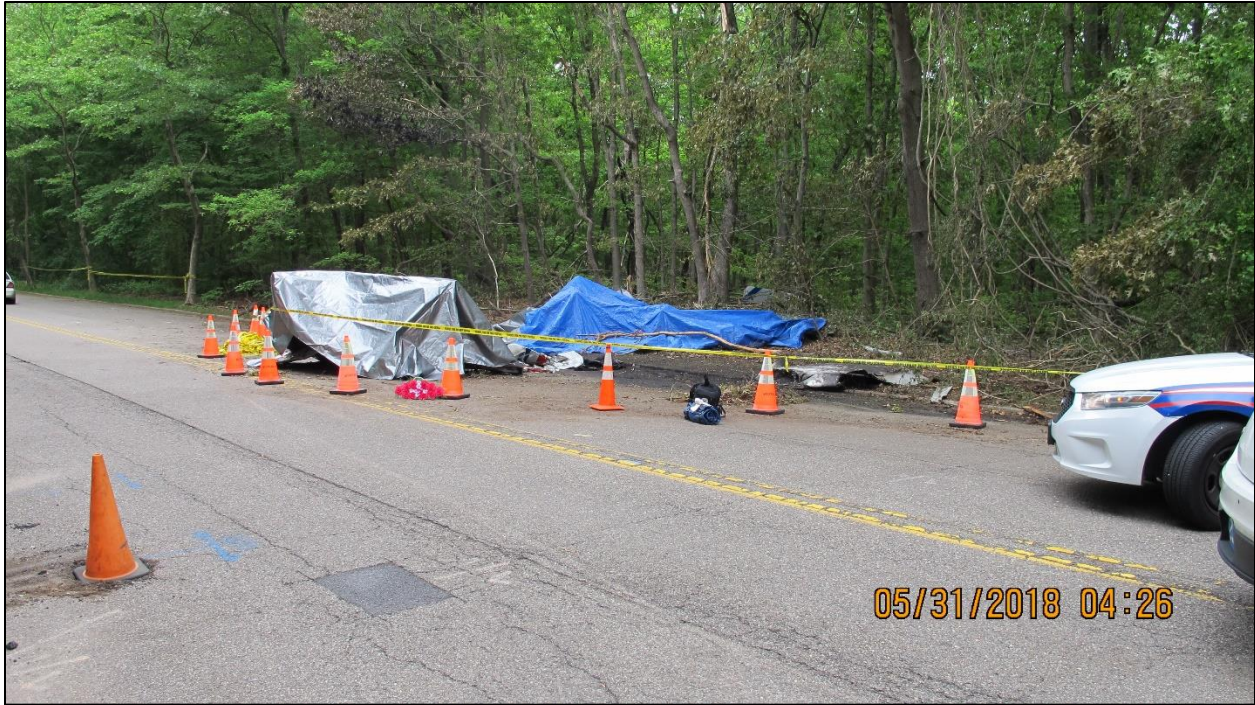
**Figure 2-Accident Site (northeast view)**

Examination of the accident site was conducted on May 31, 2018, by the NTSB-IIC and the FAA. The accident site was located across the street from the address of 29 Northcote Drive, Melville, New York. The wreckage debris was contained within 50ft of the main wreckage. Several trees above and near the accident site were damaged and limbs and large branches were found throughout the accident site. The first identified point of contact (FIPC) with the ground was a crater near the engine and propeller assembly and was about 12ft from the east side of the road. The engine and propeller assembly were partially submerged in the crater. The direction of the airplane wreckage was oriented on a heading of a about 70° magnetic from the empennage to the engine.

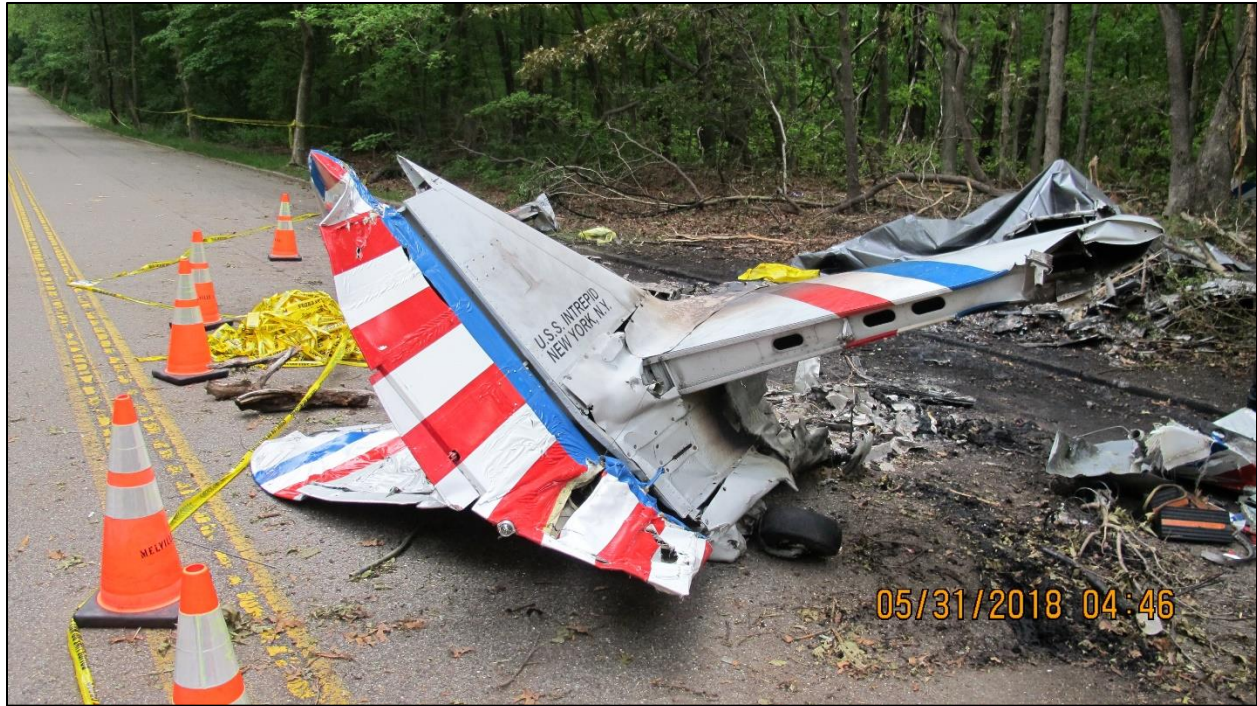
**Figure 4-Main Wreckage, Empennage**

The empennage had impact and thermal damage. The right elevator separated from the stabilizer and was found on the road about 30ft from the main wreckage. Melted metal, control cables and debris were found between the main wreckage and the empennage. The elevator and rudder control cable continuity were attained from the flight control attach points to overload (broomstraw) signatures in the cables. The right rudder control cable was complete from the rudder surface attach point to pedal attach point.

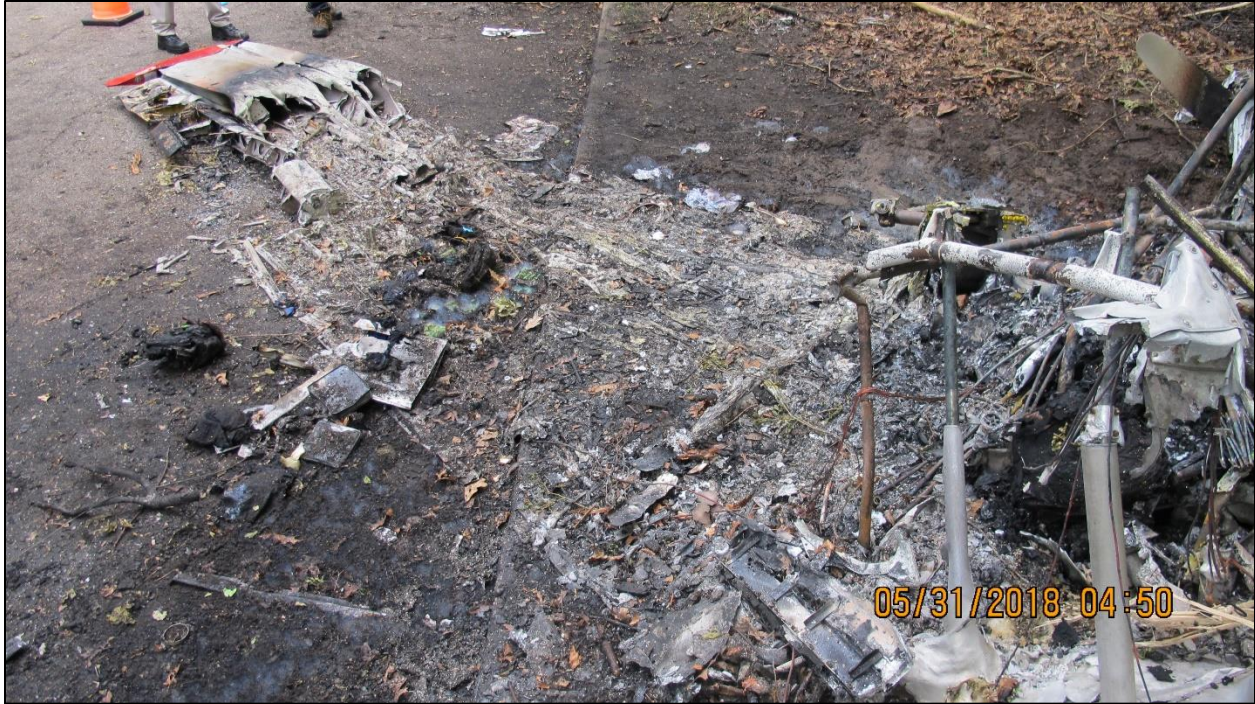
Figure 6-Left Wing (north view)

The left wing was mostly consumed by post-impact fire. The aileron and flap control surfaces were visible in their relative areas. The aileron control cables remained attached to the bellcrank and were continuous to the cabin area. The aileron control rod had thermal damage and was visible in its relative position. The outboard leading edge had accordion type crushing.

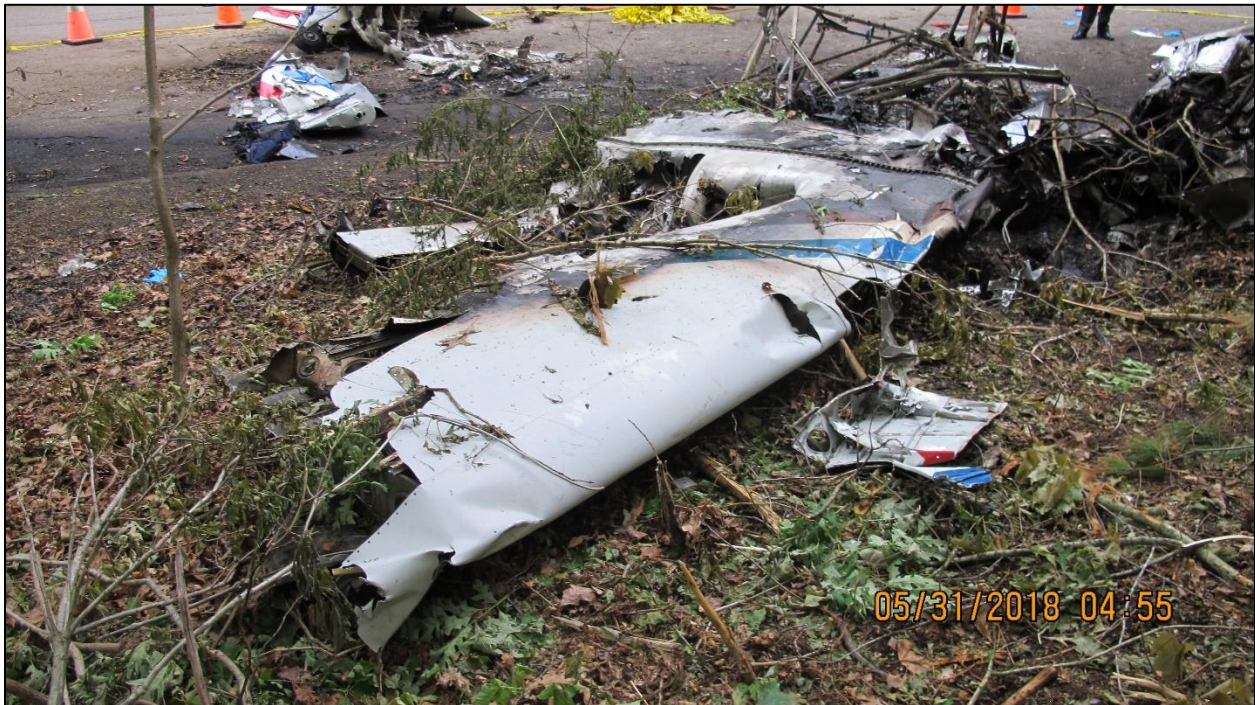
Figure 8-Right Wing (northwest view)

The right wing had impact and thermal damage. The outboard wing section, about 5ft long, separated from the wing. The wing flap was mostly consumed by fire and remnants were visible in the debris. The aileron separated from the wing and was found about 20ft east of the main wreckage. Aileron cables remained attached to the bellcrank in the wing and were continuous to the cabin area.

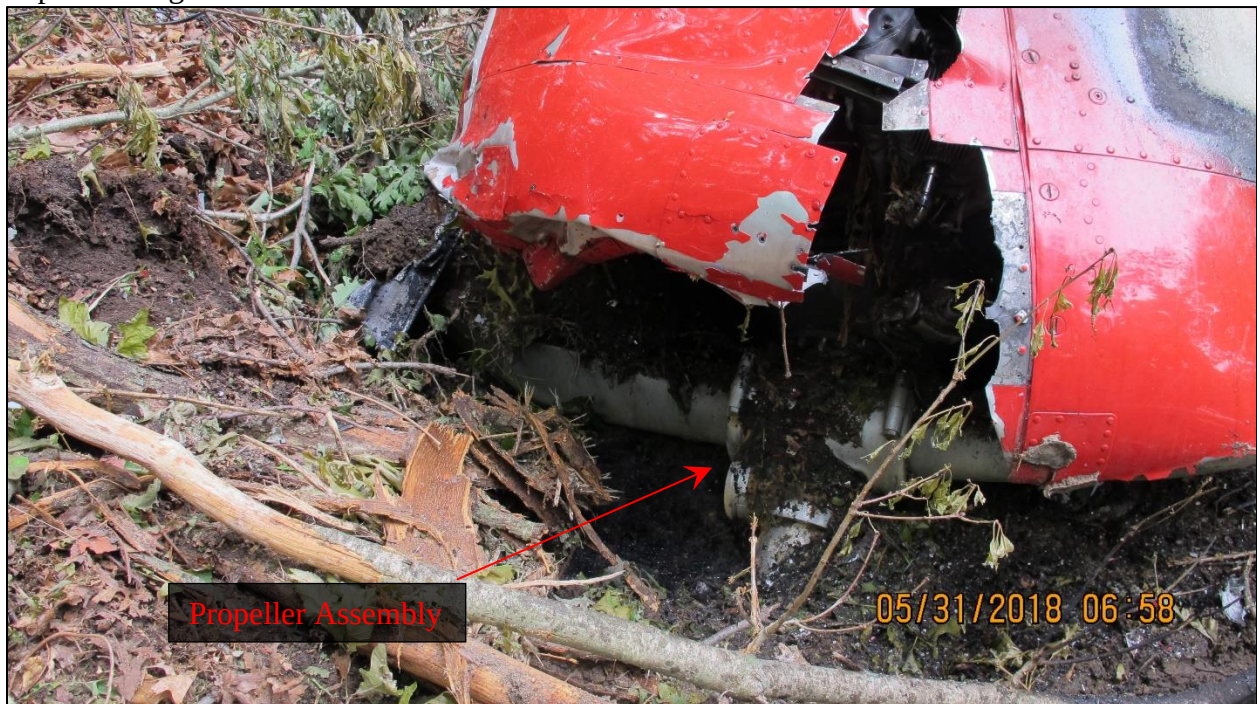
Figure 13-Engine and Propeller Assembly (south view)

The landing gear was found in the retracted position. The engine and propeller assembly remained attached and partially submerged in a small crater. The propeller blades were bent aft and had chordwise scratches and buffing on the cambered face of the blades. The engine cowling remained in its relative position and had impact damage. The engine remained partially attached to the main wreckage through various cables and tubing. The engine mounting assembly had impact damage.

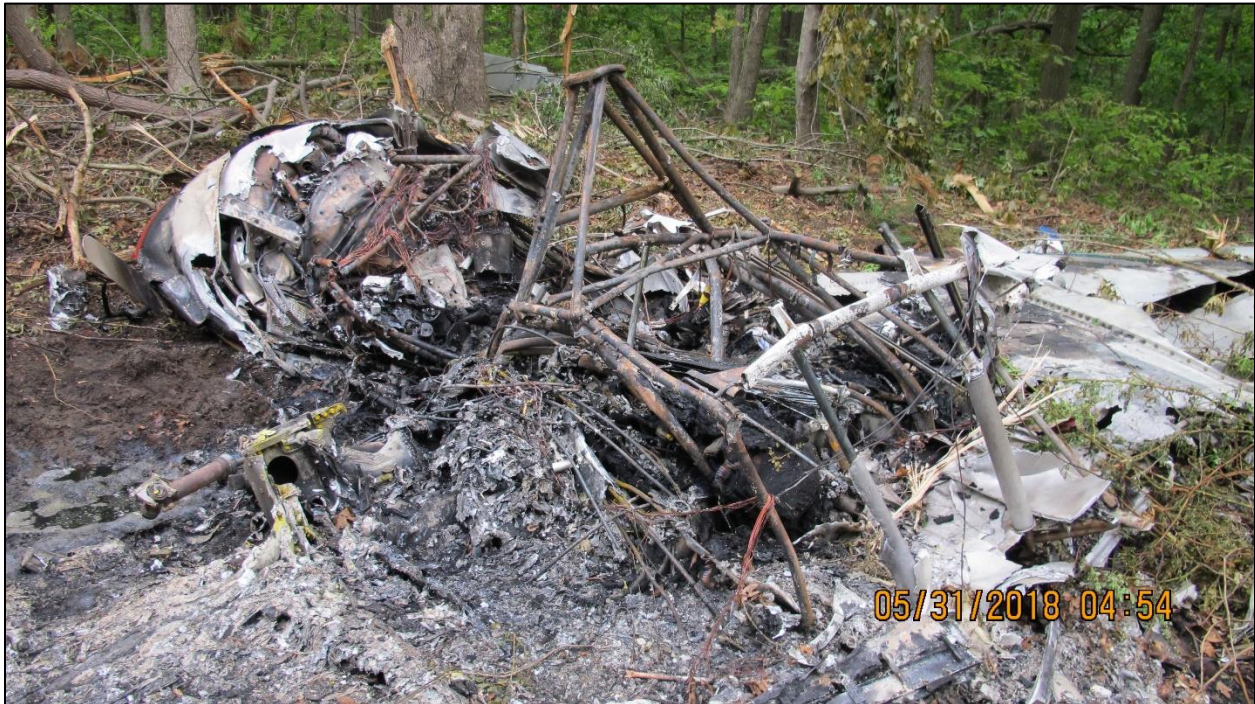
**Figure 134-Cabin Area (east view)**

The cabin area had impact and thermal damage. The rear seat smoke oil tank (full capacity of 50 gallons) was not identified. Several fitting and associated parts with the smoke oil system were found in the cabin area. Cabin flight and engine controls were damaged by post-impact fire and impact damage. Both aileron cables separated from the cabin torque tube arms. Flight control cable continuity was not confirmed while onsite. The wreckage was relocated on May 31, 2018, to Anglin Aircraft Recovery Services, in Clayton, Delaware.
