# WPR18FA188 - Examination Notes

## National Transportation Safety Board Office of Aviation Safety Washington, D.C. 20594

| Aircraft: | N8648F / MDHI 369D |

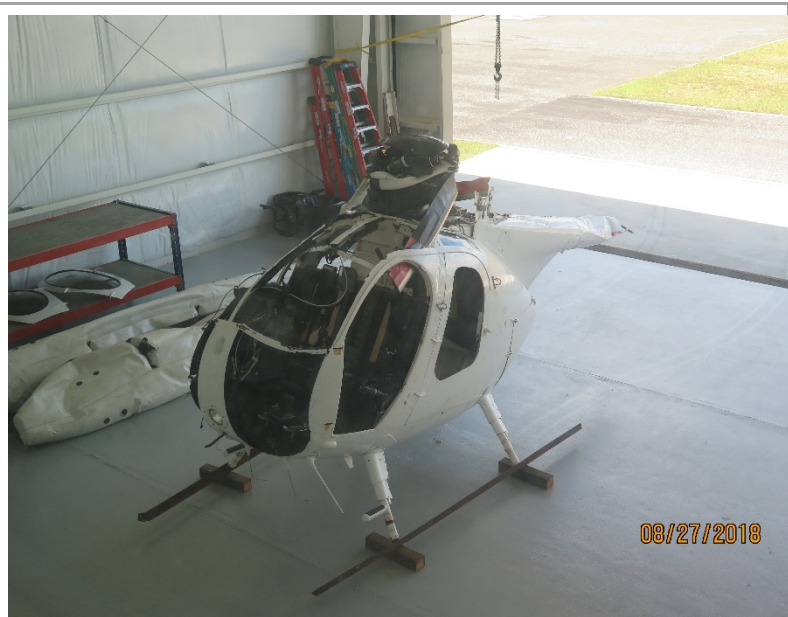
Figure 3 - In Operator's Hangar

- The front left cockpit door was not present. The hinge pins were in place.
- A rotor blade tip (white blade) was wedged into the fuselage above the left door frame.

- Skin buckling was observed on the upper aft left side of the cockpit enclosure near the canted station 78.50 bulkhead.
- The left main cabin door was closed and latched, the window plexiglas was not present.

- A portion of the tail boom remained attached to the fuselage. The aft part of the tail boom, including the tail rotor, tail rotor transmission, and vertical and horizontal stabilizers, had separated from the tail boom and was not present. It was presumed separated and lost during the accident sequence.

- The tail rotor drive shaft and control tube were present in the tail boom up to the location of the tail boom separation.
- Crush and deformation of skin was observed along the upper portion of the aft fuselage and tail boom fairing.

- The engine inlet fairing had separated from the airframe; the right-side had been recovered with the helicopter.
- The entire engine air inlet screen or particle separator was not present.

- Both engine bay doors were attached at their hinges.
- The right-side main cabin door was closed and latched. The window plexiglas was not present.
- The right-side copilot door was not present. The hinge pins were in place.

- The right- side copilot door frame was buckled inward. A witness indentation was located on outer edge of the cockpit deck. The door frame had a creased deformation at the forward center. Black paint transfer marks were identified on the upper portion of the door frame area.

- The center windscreen bow was fractured about pilot head level. Windscreen plexiglass was not present for either pilot or copilot sides.
- The left, right, forward, and aft landing gear struts and braces were attached to the fuselage with no apparent damage to the attachment structure.

- The right front landing gear strut was bowed and displaced slightly inward.
- A fuel sample was taken from the fuel tank sump. The sample was clear, straw colored, and no contamination or water was visible. 23 gallons of fuel was drained from the aircraft.

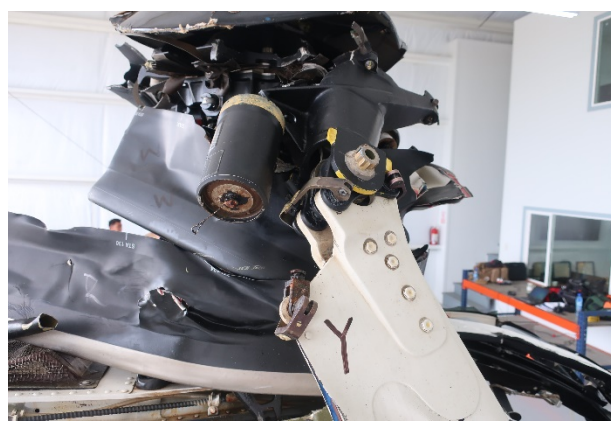
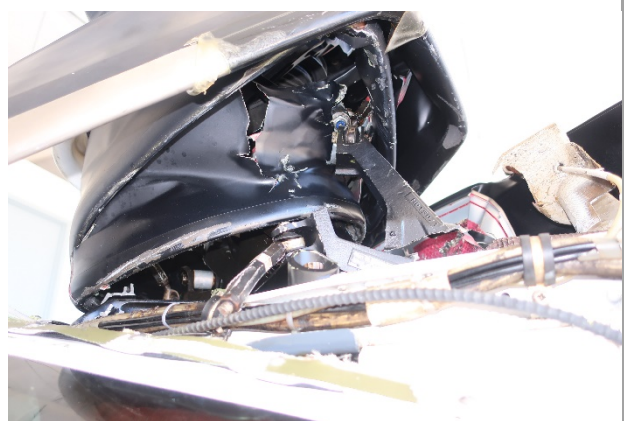
Figure 4 - Rotor Head

- The main rotor hub was attached to the main rotor drive shaft, which remained within the static mast and splined into the main transmission.
- Red pitch housing

- Pitch arm was fractured from the pitch housing
  - Pitch link was attached to swashplate
  - Pitch housing was attached to the strap pack assembly
  - Pitch control bearing housing was fractured

- Lead-lag links were attached & undamaged
  - Rotor blade retention pins were in place
  - Blade was in an extreme lag position
  - Elastomeric damper not present

- The entire red blade wrapped around rotor head 1 3/4 times
- White pitch housing
  - Pitch link rod end was fractured at swashplate and bent
  - Rod end at pitch housing was attached.

- Pitch control housing was fractured
  - Strap pack assembly was intact
  - Lead-lag links were undamaged
  - Blade retention pins were in place.
  - Elastomeric damper was attached to blade

- Entire white blade was wrapped around rotor head 2 times
- Blue pitch housing
  - Strap pack assembly was fractured at the upper hub
  - Pitch housing and blade was not recovered

- Lead-lag links were not recovered
  - Pitch change link was attached to the rotating swash plate
  - Blue blade was not recovered
- Yellow pitch housing
  - Pitch change link was fractured at pitch link bearing
  - Pitch control housing was fractured
  - Strap pack assembly was intact
  - Lead-lag links were intact
  - Elastomeric damper was fractured at clevis
  - Damper clevis was attached to yellow blade
  - Yellow blade section was 32 inches long and bent 90° aft of root fitting doublers. Remaining section of blade not recovered.
  - Blade pins were attached.
- Green pitch housing
  - Pitch housing, lead-lag links and blade was not recovered.
  - Blade pins were not recovered
  - Strap pack assembly was fractured at upper hub
  - Pitch link fractured at lower swash plate pitch link bearing

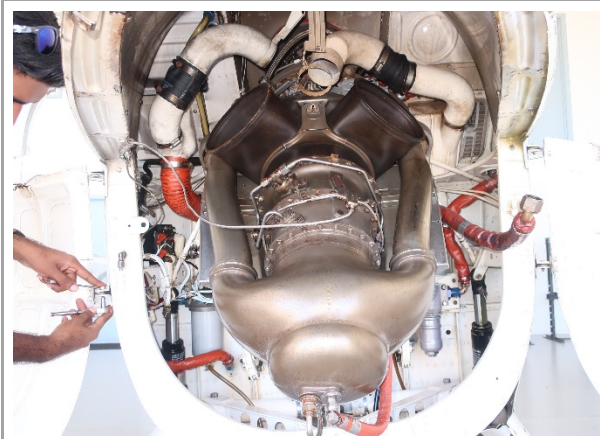
Figure 6 - Engine

- Engine was securely mounted with evidence of external damage.
- FCU was in the fly setting of the throttle input lever.
- Power turbine governor linkage was continuous to the collective and moved freely

- N1 rotor was frozen
- N2 freewheeled in opposite direction of drive, would not turn in the drive direction
- Compressor inlet and first stage wheel showed no foreign object damage

- 4th stage turbine wheel was undamaged
- All fuel lines contained fuel
- Pressure and scavenge oil filters were clean
- Airframe and engine mounted fuel filters were clear of contaminants

- Fuel samples were retained from both fuel filters
- Oil sample was retained from the oil scavenge filter
- Upper or lower chip detectors had no ferrous material

- Engine was field disassembled with no pre-event abnormal conditions noted
- Vacuum check was performed on fuel system, no leaks detected.
- All external line connections were secure
