# Engine Investigation Report

**Rolls-Royce Model:** 250-C20B  
**Engine Serial Number:** CAE 833577\*  
**Aircraft Model:** H369D  
**Registration Number:** N8648F  
**Operator:** Vertol  
**Accident Date:** 4 July 2018  
**Wreckage Exam Date:** 29 Aug 2018  
**Report Date:** 8 Jan 2019

## Appendix A, Wreckage Exam Photographs

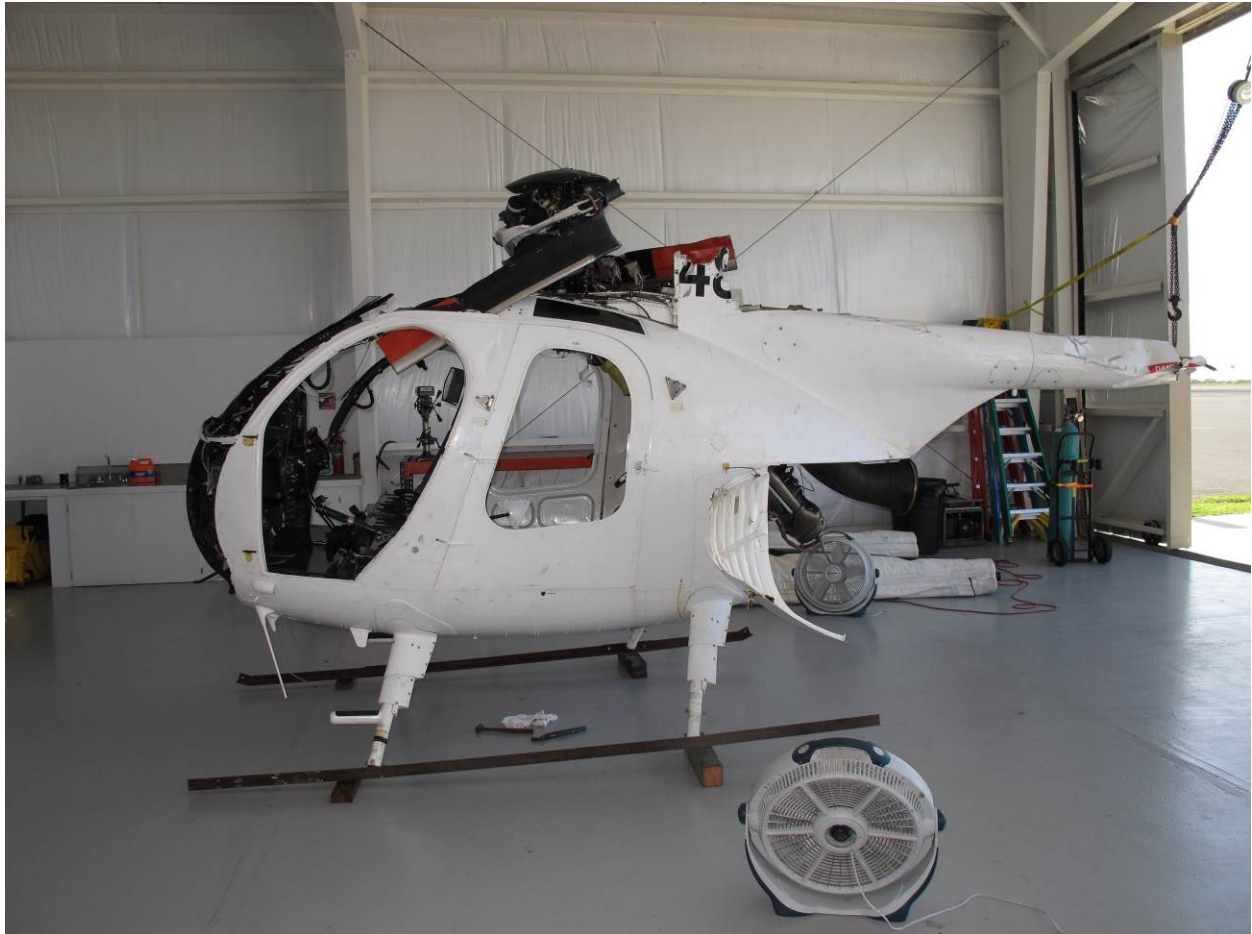
Figure 1 Aircraft General

The aircraft was recovered to the local Vertol maintenance facility at MAJ airport and secured in a large metal container (CONEX) until the parties arrived. The aft section of the tailboom to include the tail rotor assembly was not recovered.

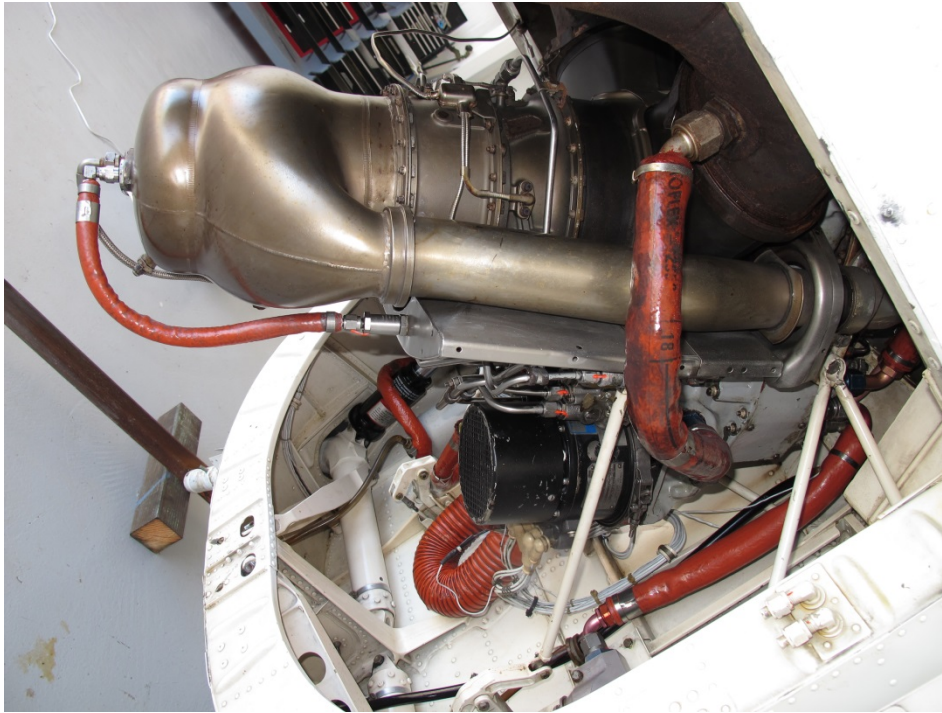
Figure 2 Engine Right Side

The engine was securely mounted to the airframe. The throttle was in the "fly" position and the linkage to the fuel control unit was intact and moved smoothly. The power turbine governor input linkage was connected to the collective and moved smoothly. The N2 rotor could not be turned in the drive direction but freewheeled appropriately. A vacuum check was performed on the fuel system prior to engine removal with no leaks detected.

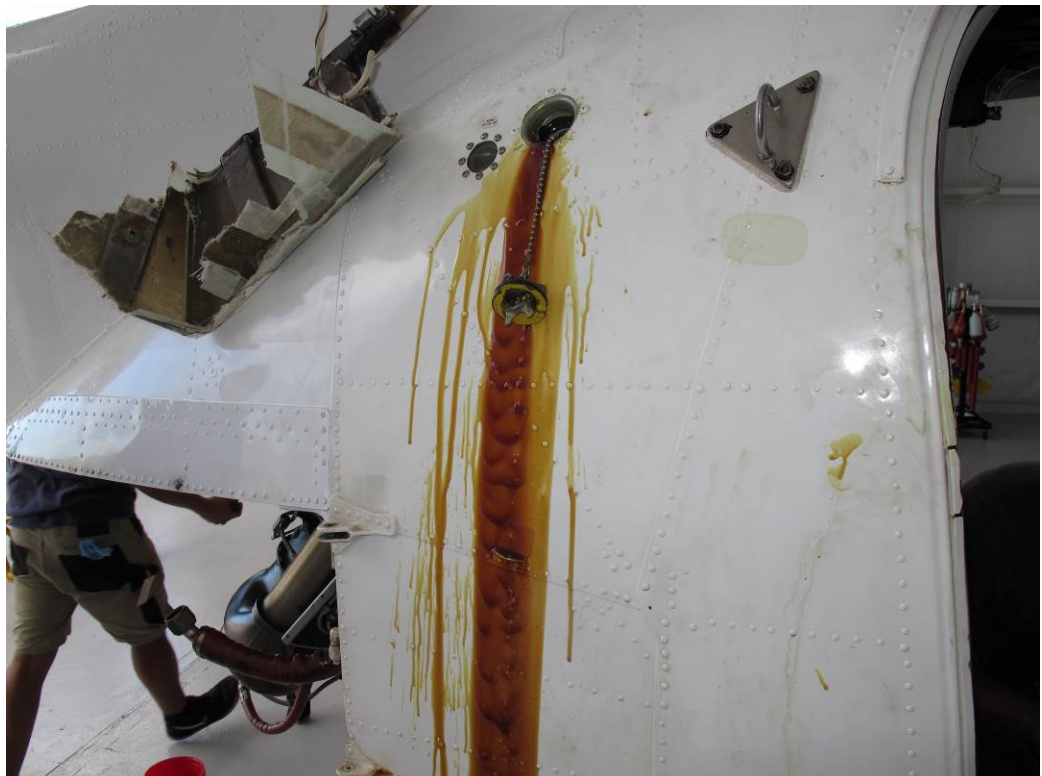
All of the external air, oil, and fuel line connectors were secure when checked by hand. The aircraft mounted oil system was undamaged and the scavenge oil filter pending bypass button was not extended. The oil tank was over filled with oil, likely due to the aircraft lying on its side after recovery, allowing engine oil to backfill into the reservoir. The oil was normal in appearance. The aircraft mounted scavenge filter was inspected and no debris was noted within the filter element. The aircraft mounted fuel filter element was free of debris and the filter bowl was full of fuel. A fuel sample was retained from the filter bowl.

Figure 3 Oil Spilling from Reservoir

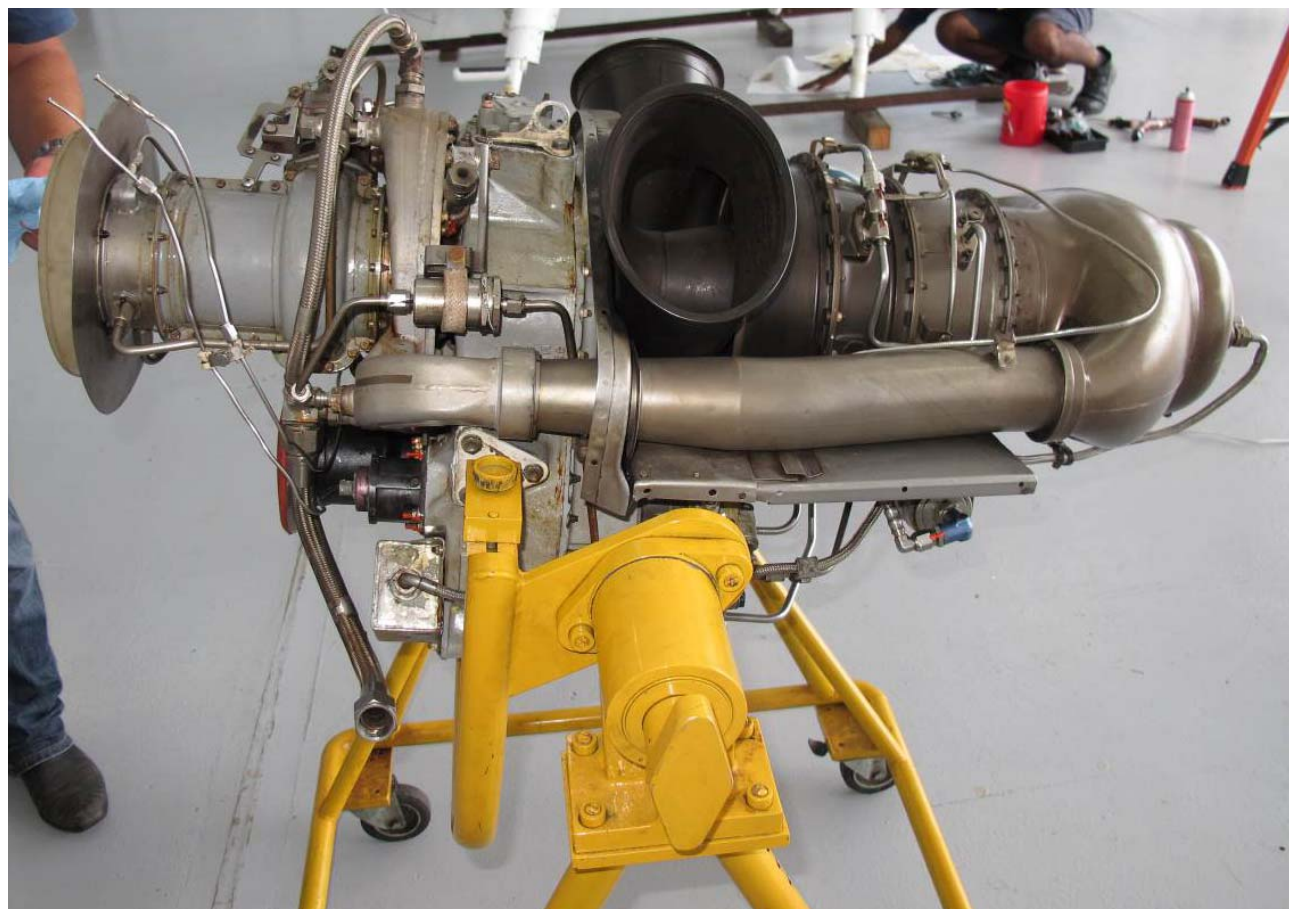
Figure 6 Engine after Removal from Aircraft

The engine was removed from the aircraft and installed in a turnover stand to facilitate the field examination. Fuel was present in the fuel line into the engine and the oil in and out lines were unobstructed. A pneumatic system leak check was attempted; however an obstruction in the power turbine governor Pc air input tee prevented the pressurized air from entering the entire system. The engine fuel system components were removed and the lines inspected. No cracks or abnormalities were observed on the lines.

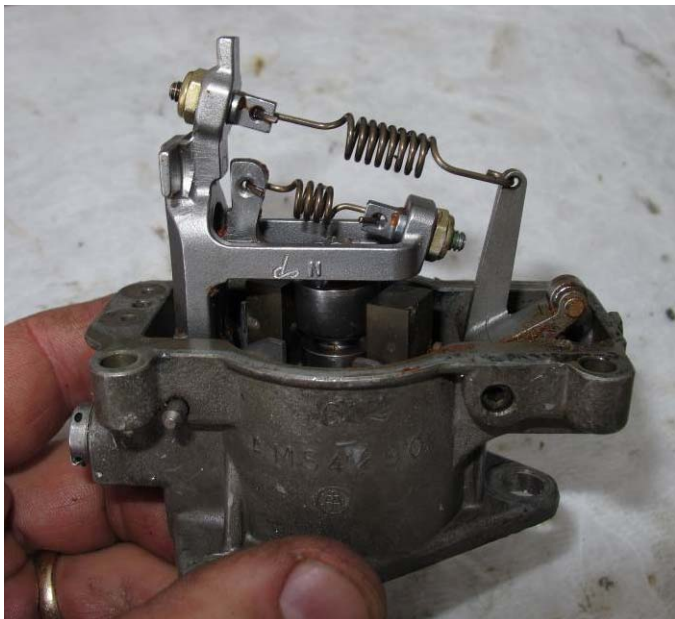
Figure 7 Fuel Control Unit Drive Body

The fuel control unit was partially disassembled and the drive shaft turned freely with no abnormalities noted to the drive or spool bearings. The governor and speed enrichment

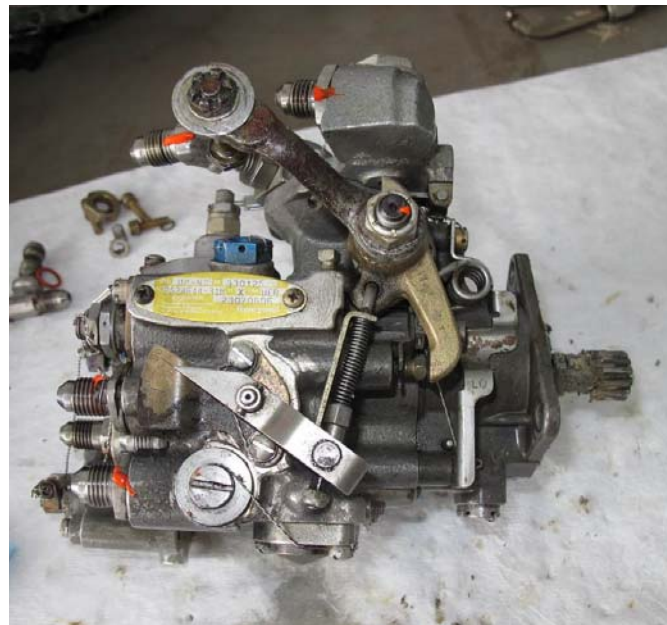
Figure 8 Fuel Control Unit

springs were intact and no abnormalities were noted within the fuel control unit. The fuel inlet strainer did not contain debris or contamination.

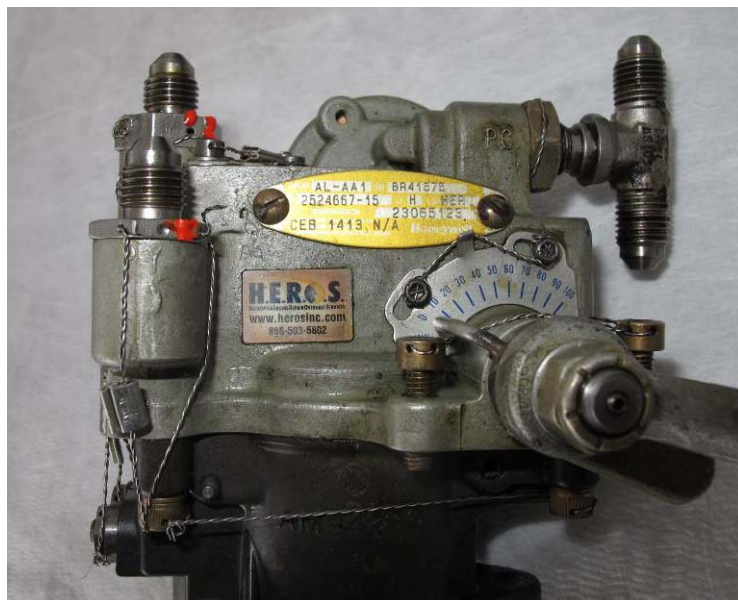
Figure 9 Power Turbine Governor

The power turbine governor was also partially disassembled. The drive shaft spun smoothly and the spool bearing was normal in appearance and feel. The governor spring was intact and appeared normal. The fuel pump was partially disassembled and the filter bowl was full of fuel. A sample was retained from the filter bowl. The filter element was inspected and appeared normal. The fuel pump gears and bearings were inspected with no anomalies noted. The fuel nozzle was disassembled and no contamination was noted on the fuel screen surface. The air shroud and both primary and secondary orifices displayed heavy corrosion.

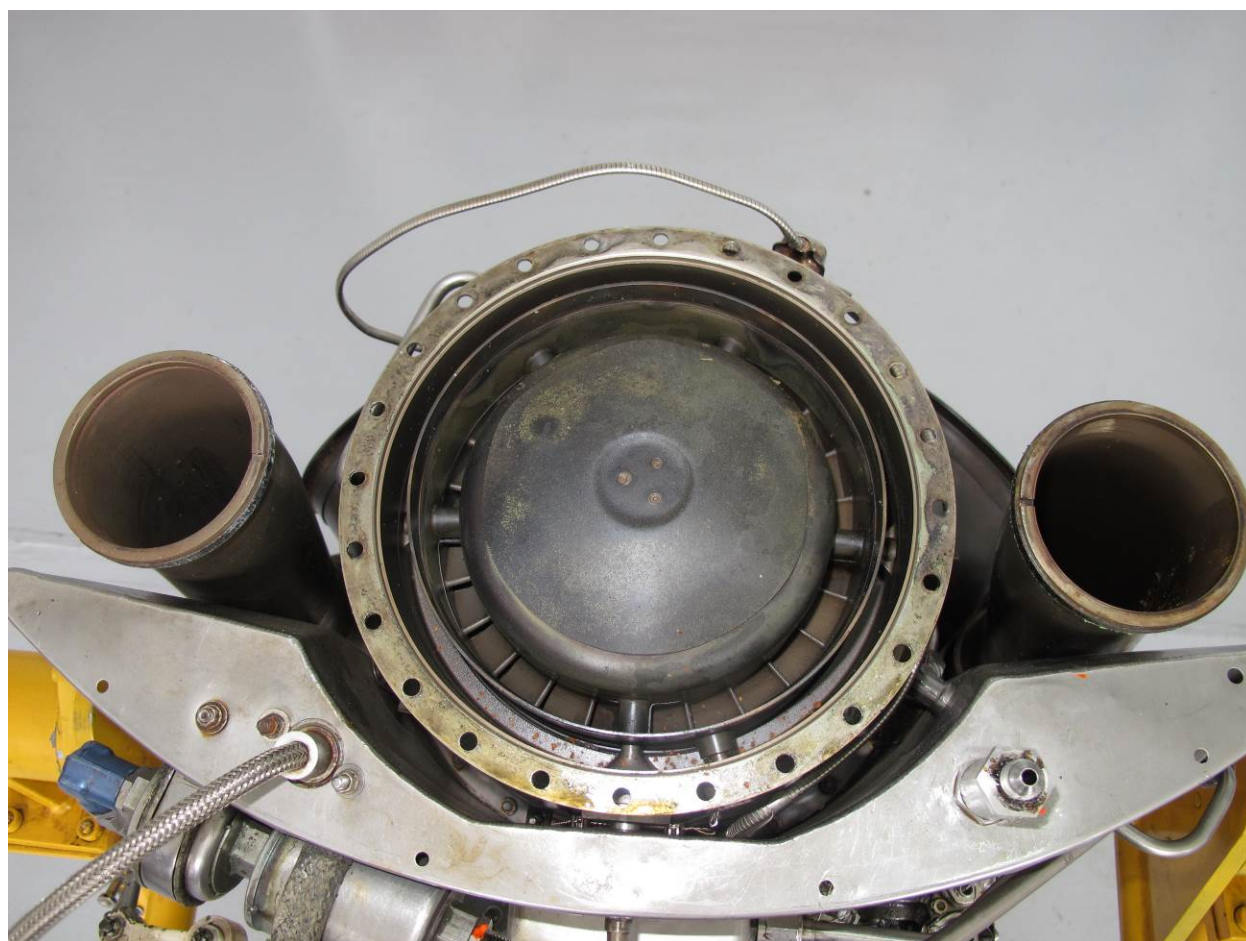
Figure 13 First Stage Turbine Nozzle

Once the turbine module was removed from the gearbox both the N1 and N2 rotors spun freely. The turbine module was partially disassembled and all of the turbine wheel blades were observed to be intact with no damage noted. The first stage turbine nozzle and nozzle shield appeared normal with no obvious hot streaks. The third stage turbine nozzle was covered in a purple substance likely due to salt water immersion. The turbine bearings were oil wetted and turned freely while the shafting was intact with no evidence of disconnects.

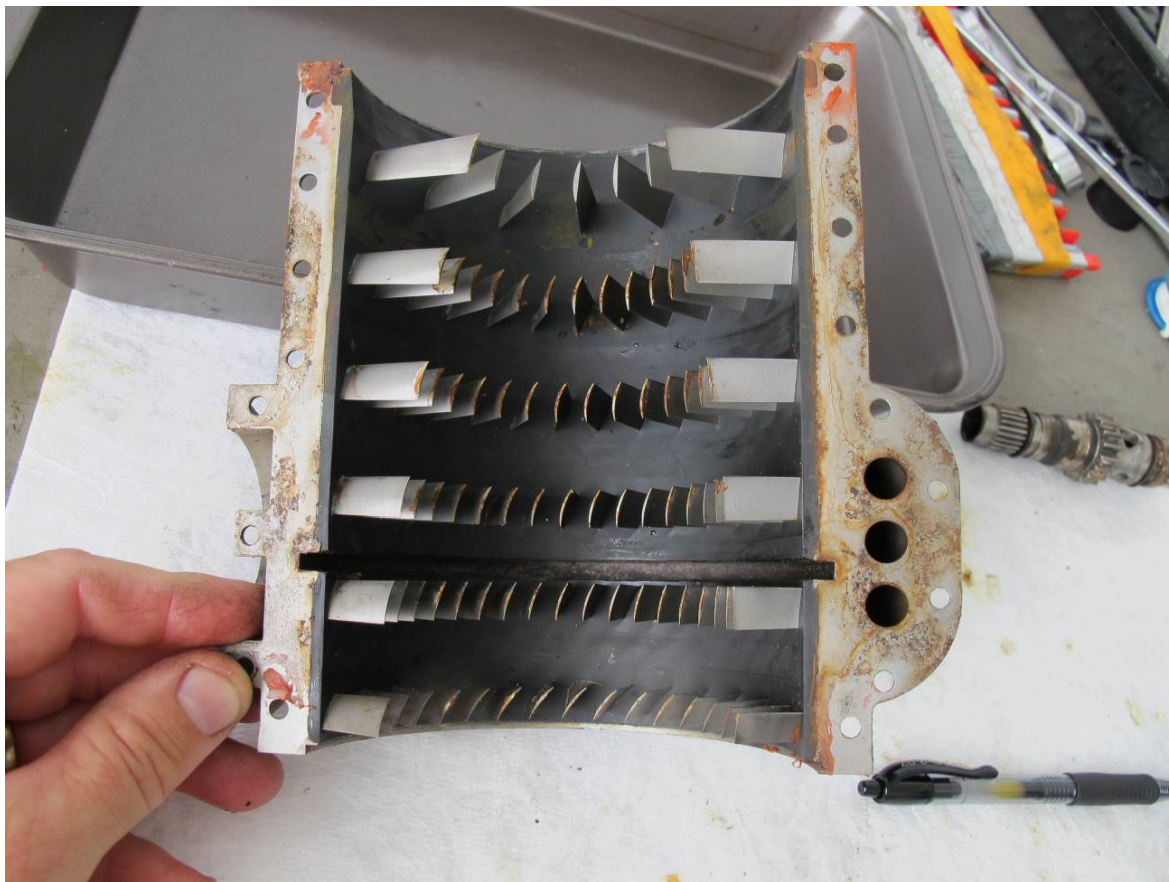
Figure 17 Compressor Case Half

Once the compressor was removed from the gearbox the rotor spun freely. The compressor inlet was undamaged and a piece of debris was lying in the rotor. The compressor was disassembled and the rotor was undamaged. The compressor case halves were inspected and some corrosion was noted on the vane airfoils. The corrosion was consistent with exposure to salt water and likely occurred after the event during storage. The spur adapter gearshaft was intact with some corrosion noted.

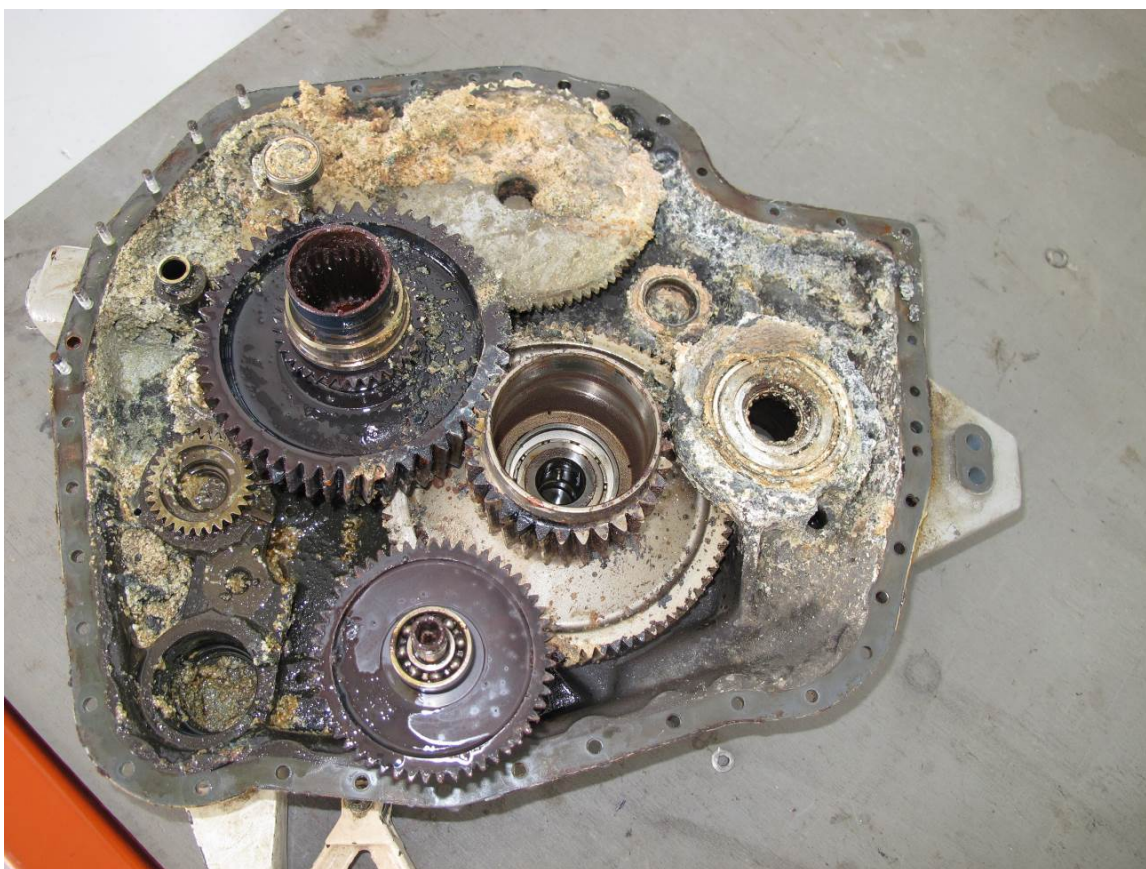
Figure 19 Gearbox

The gearbox was opened and the magnesium case had begun to disintegrate into a sludge like material. The N1 and N2 gears were undamaged with no missing teeth or broken shafts. After some manipulation, both the N1 and N2 gear trains turned. Neither the upper nor lower magnetic chip detectors retained ferromagnetic debris (although some sludge was present on the detectors from the deteriorating gearbox). The oil pressure filter was inspected and some sludge and a black plastic-like material was observed. The contamination was not significant enough to obscure the filter element.
