# NATIONAL TRANSPORTATION SAFETY BOARD

## MATERIALS LABORATORY FACTUAL REPORT

Report No. 20-029

Place : Deer Park, WA  
Date : July 13, 2018  
Vehicle : Cessna 172, N24442  
NTSB No. : WPR18FA195  
Investigator : Zoe Keliher (AS-WPR)

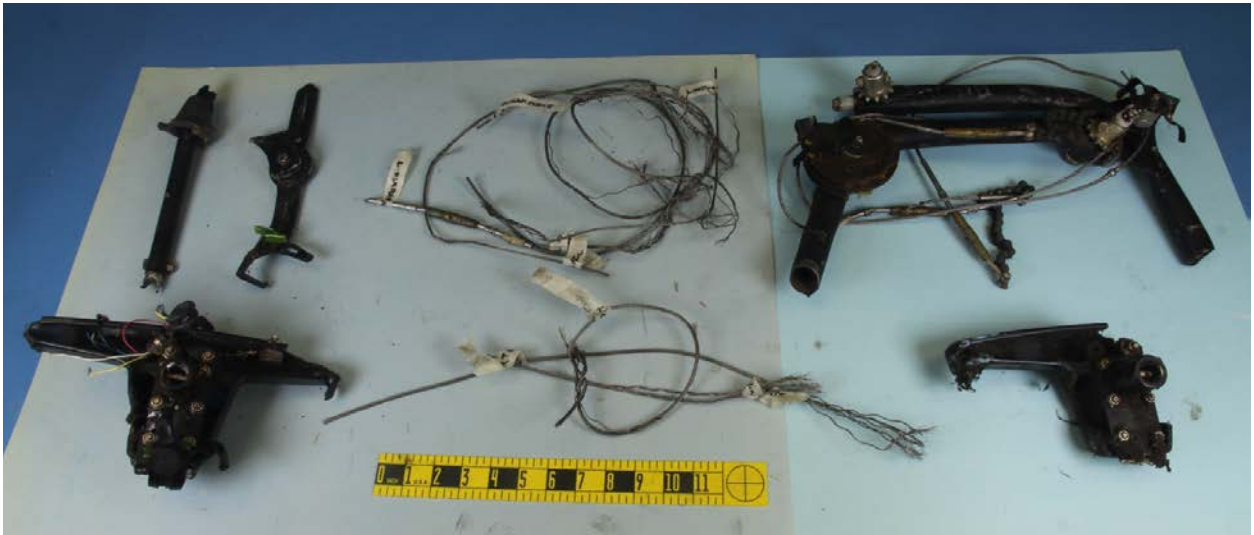
The control yoke and associated mounting hardware was submitted for evaluation (Figure 1). The parts were examined macroscopically and using a 5x to 50x stereomicroscope. The fracture surfaces on the separated portions of the yoke and hardware were consistent with overstress. The secondary damage to the hardware surfaces was consistent with impact damage. No obvious signs of long-term wear or contact marks were observed.

Figure 1: Overall photo of the submitted control yoke and associated mounting hardware, and various control cables.

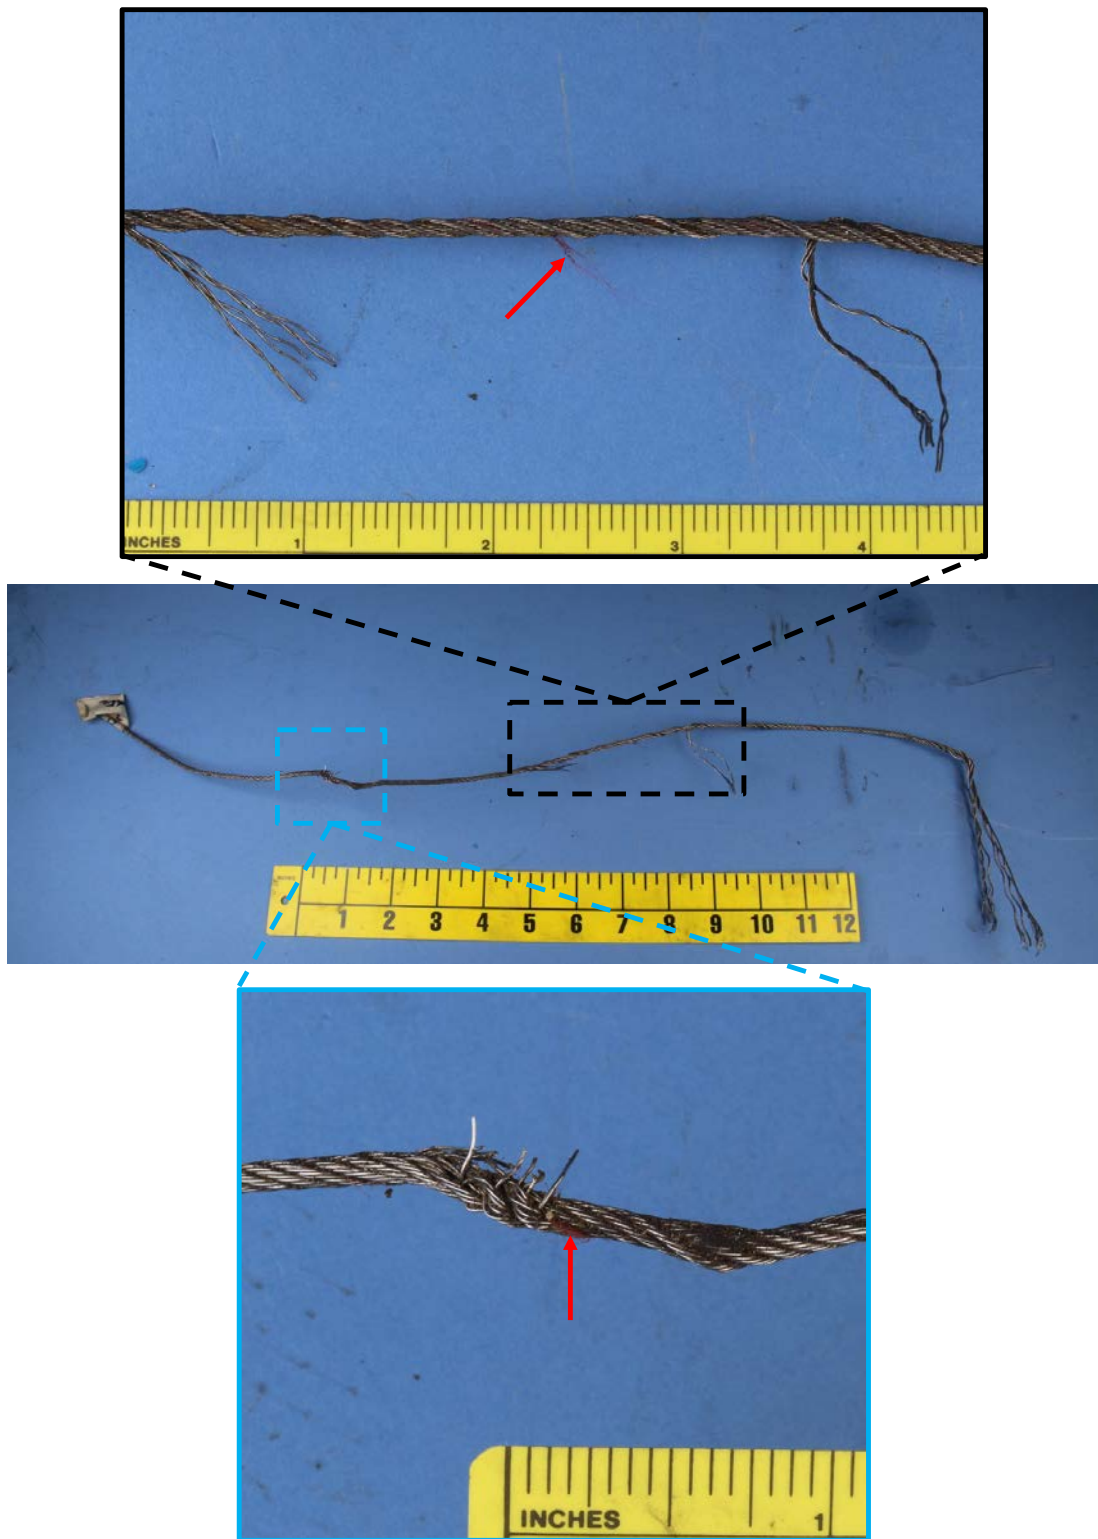
Red colored debris was visible on several of the cables in areas where strands had unraveled (red arrows, Figures 2-4). The debris appeared to be entangled with the strands. Several cables were selected for further examination using a digital microscope, including those with the following labels: left wing aileron, left wing aileron 2, left wing aileron outboard, and left overhead aileron to wing. The debris was determined to be fibers entwined with the cables. Both red colored and gold colored fibers (red and orange arrows, respectively) were observed, as shown in Figure 9. The exact source of the fibers was not determined.

Figure 2: Photos of the left wing aileron cable. The red arrows points to red colored debris observed between loosened strands of the cable.

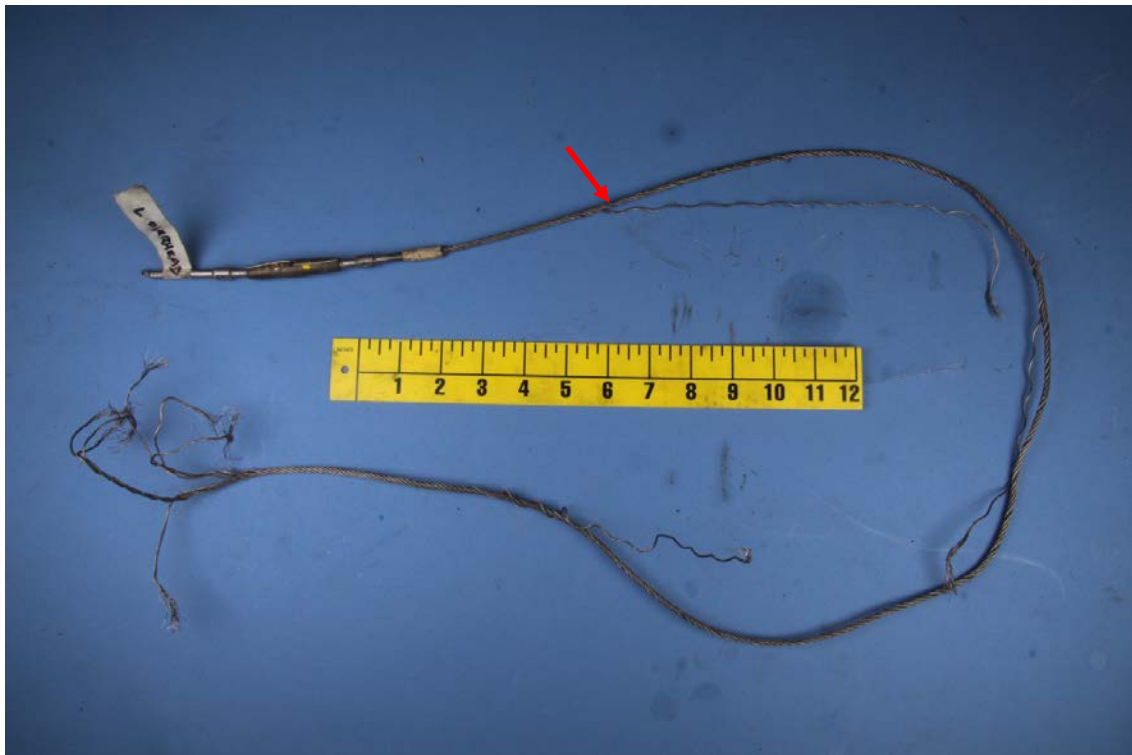
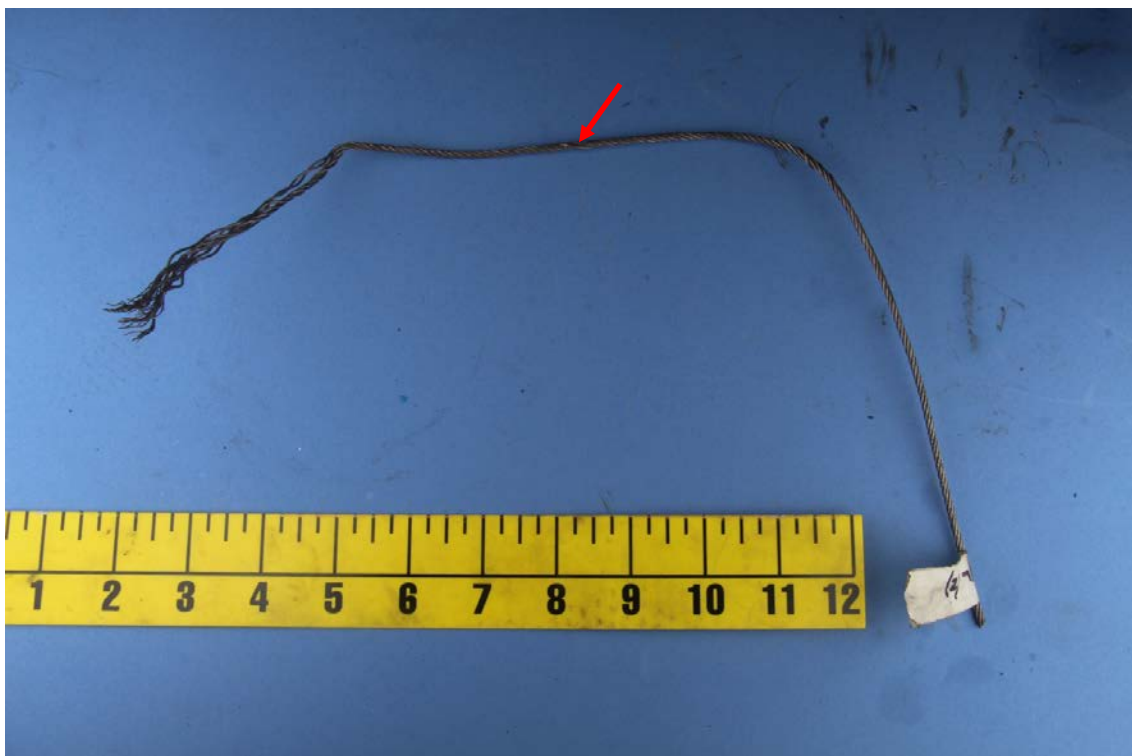
Figure 3: Photos of the left overhead aileron to wing cable (top) and left wing aileron 2 cable (bottom). The red arrows point to red colored debris observed between loosened strands of the cables.

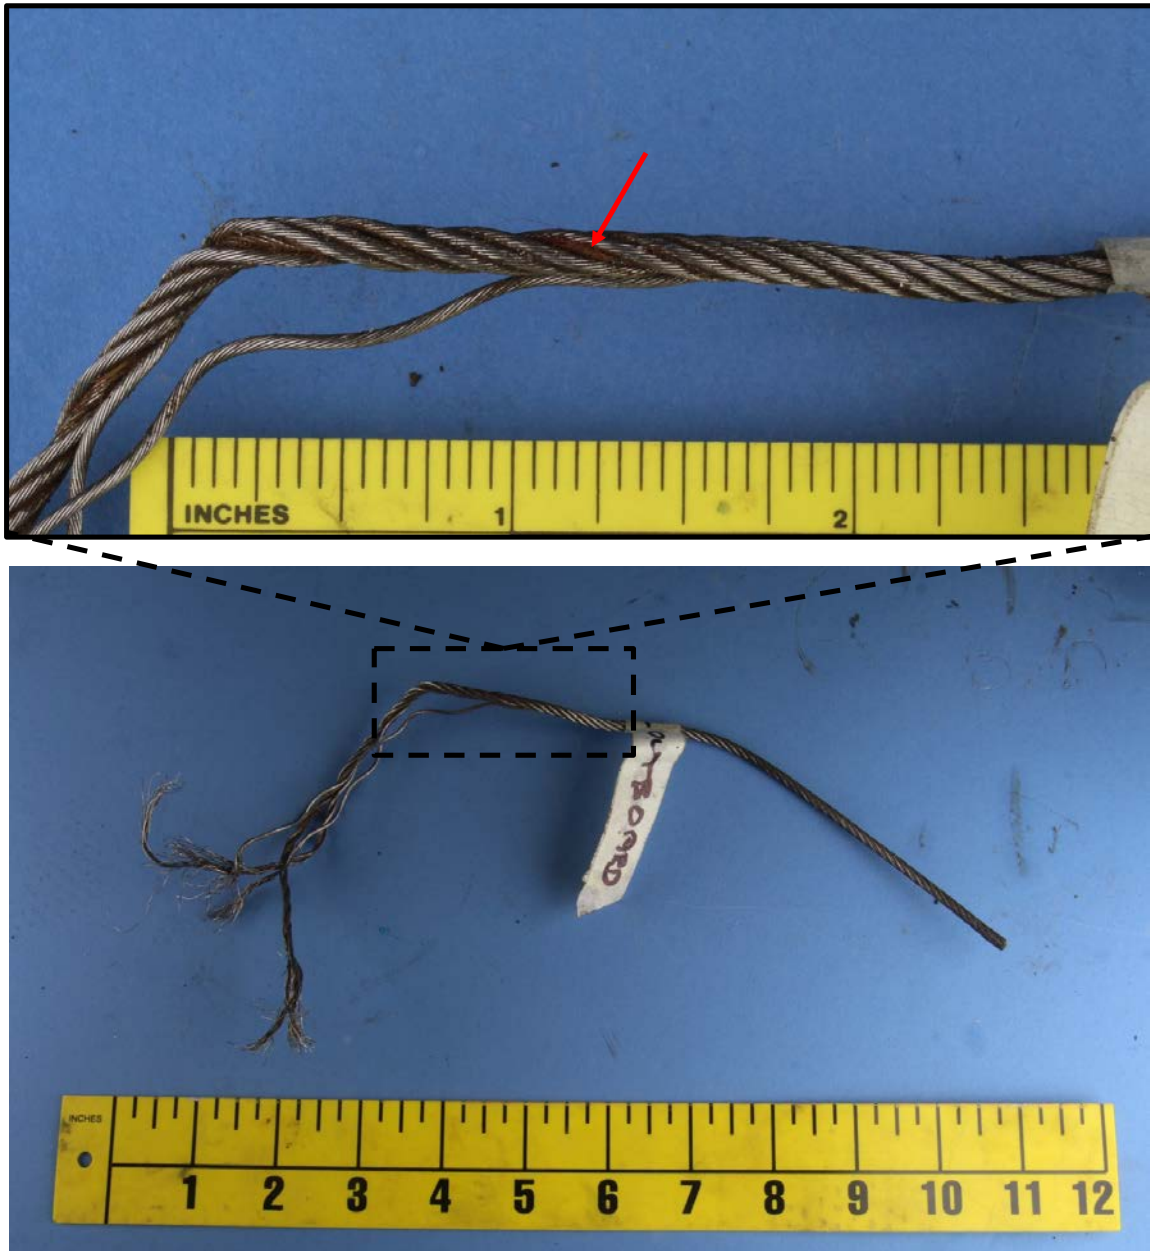
Figure 4: Photos of the left wing outboard cable. The red arrow points to red colored debris observed between loosened strands of the cable.

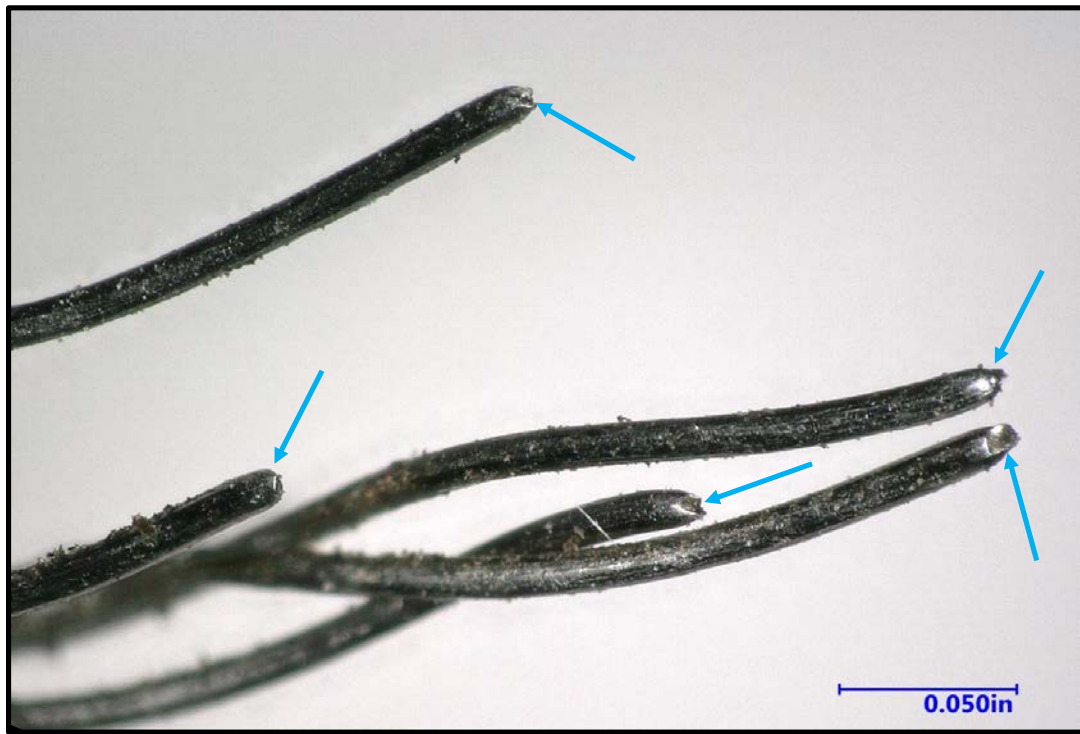
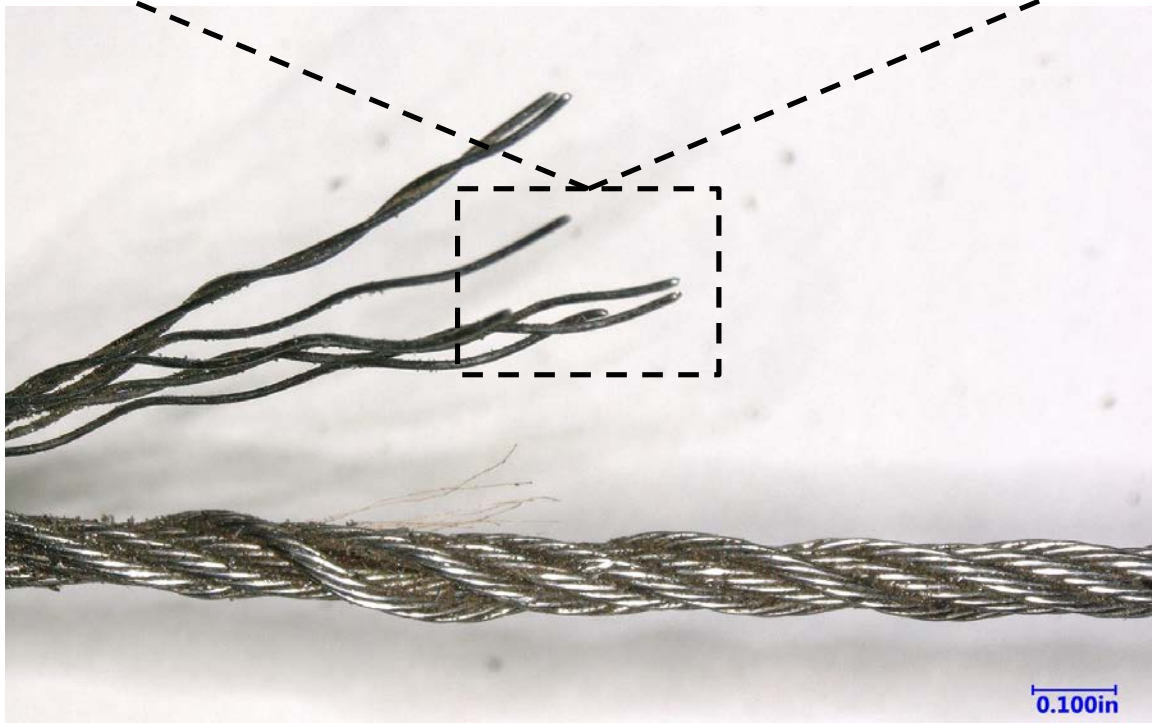
Several control cables were also submitted for evaluation (Figures 2-8). The control cables had areas where some of the strands had loosened, with strand wires that had separated and unraveled. The separated wires had necking at the ends and cup-cone fracture surface geometries, as indicated by the blue arrows in Figure 5. These features were consistent with overstress fracture.

Figure 5: Digital microscope images of separated wires (blue arrows) from one the strands in the left wing aileron cable.

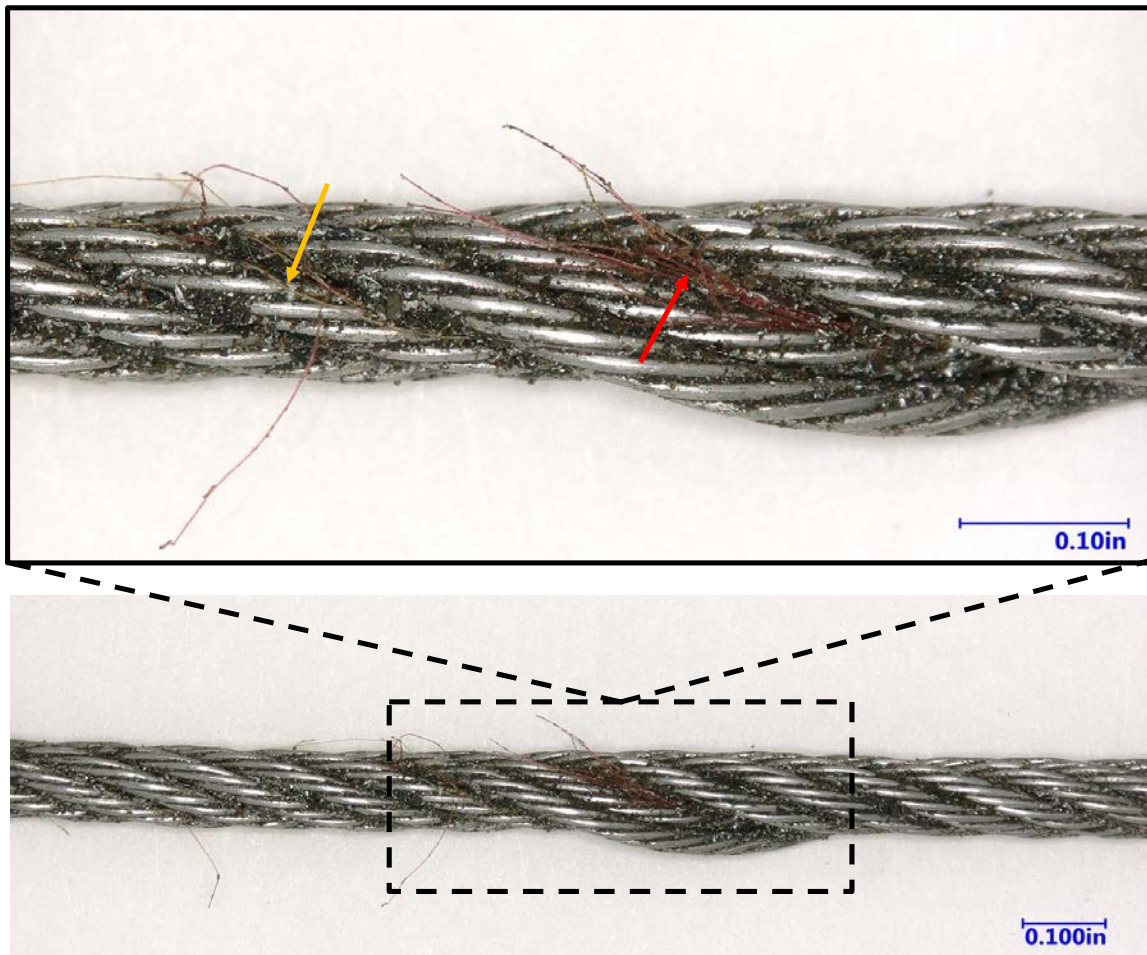
Figure 6: Digital microscope images of red colored and gold colored fibers (red and orange arrows, respectively) entwined it the left wing aileron 2 cable.

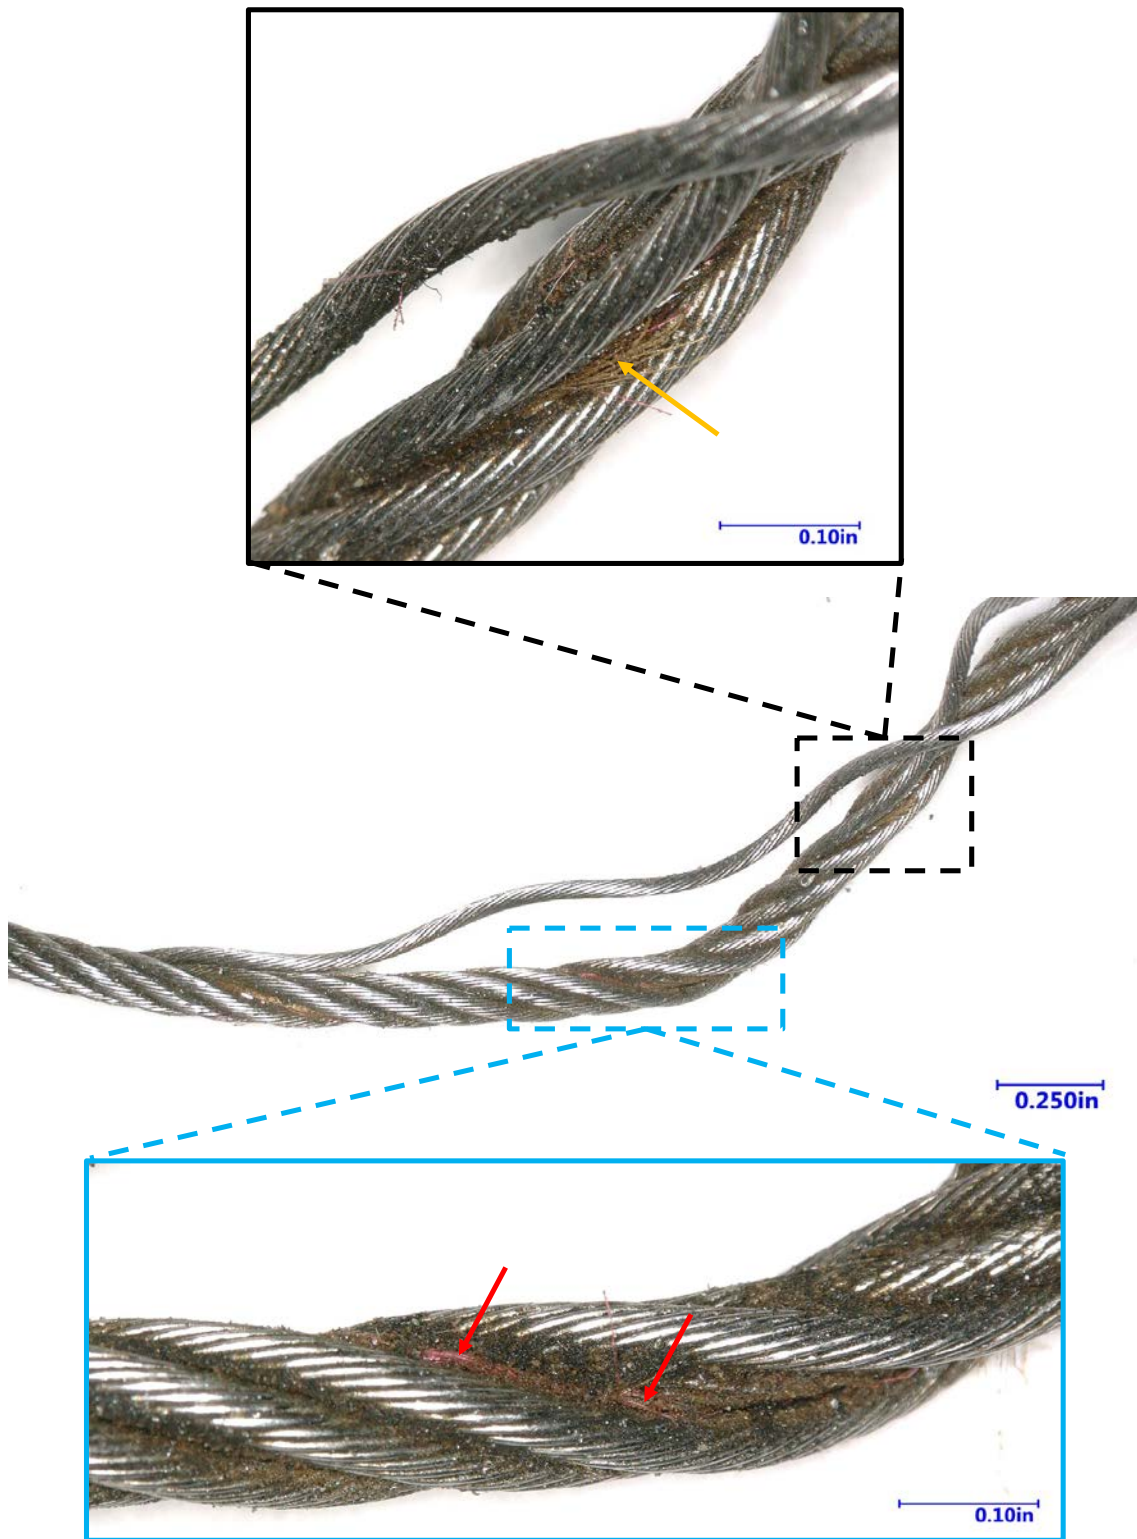
Figure 7: Digital microscope images of red colored and gold colored fibers (red and orange arrows, respectively) entwined in the left wing aileron outboard cable.

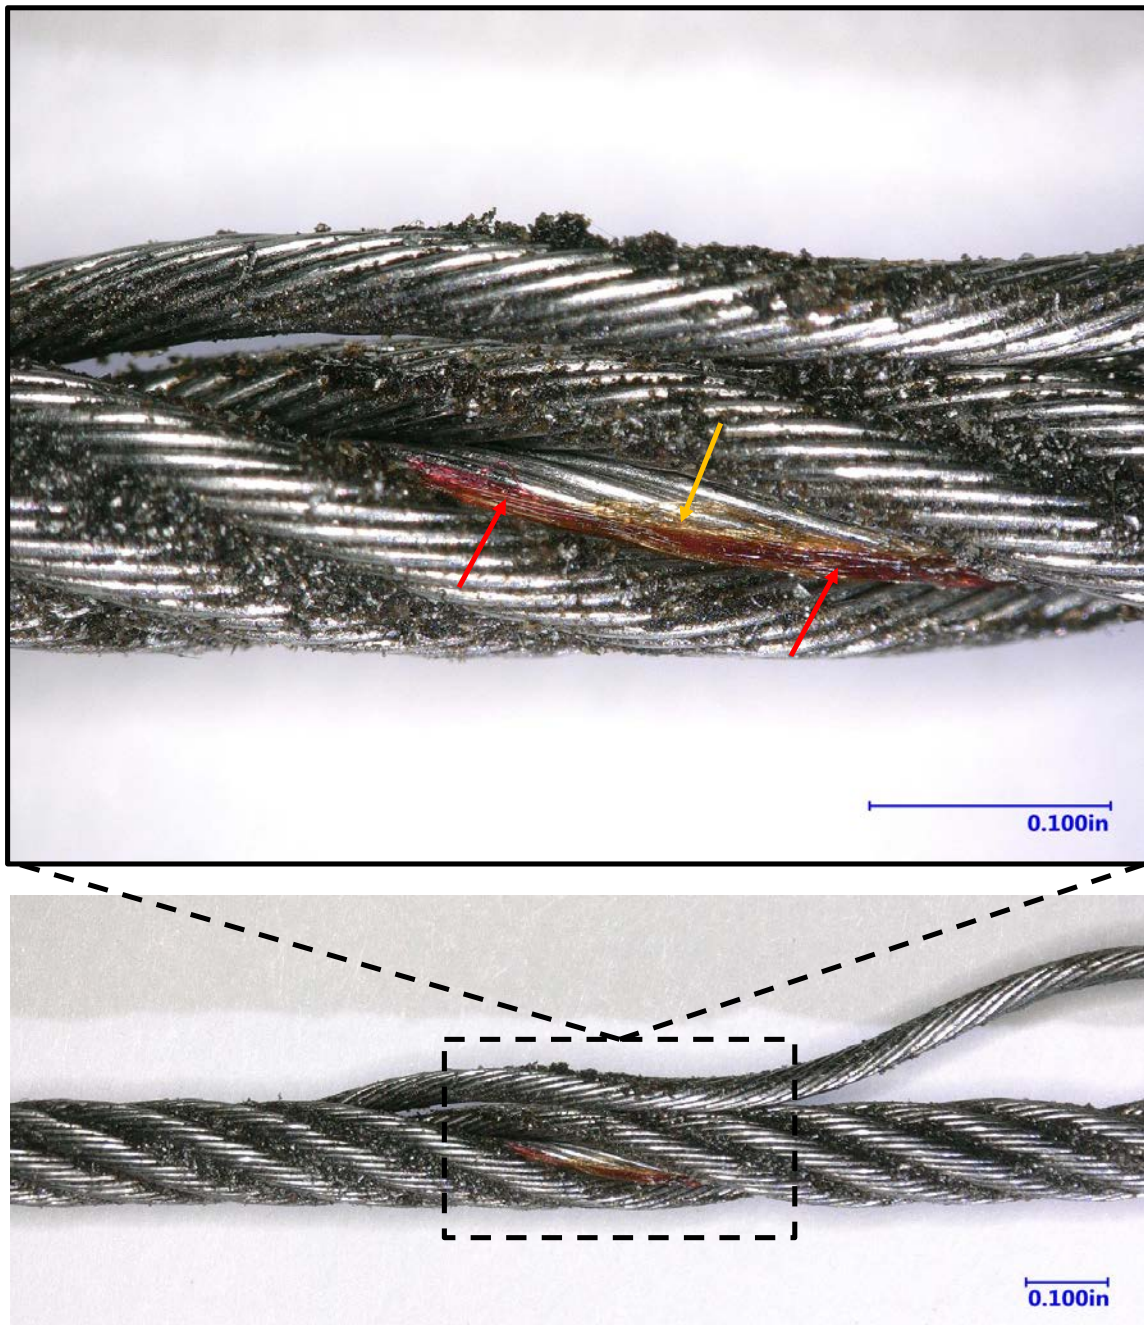
Figure 8: Digital microscope images of red colored and gold colored fibers (red and orange arrows, respectively) entwined in the left overhead aileron to wing cable.

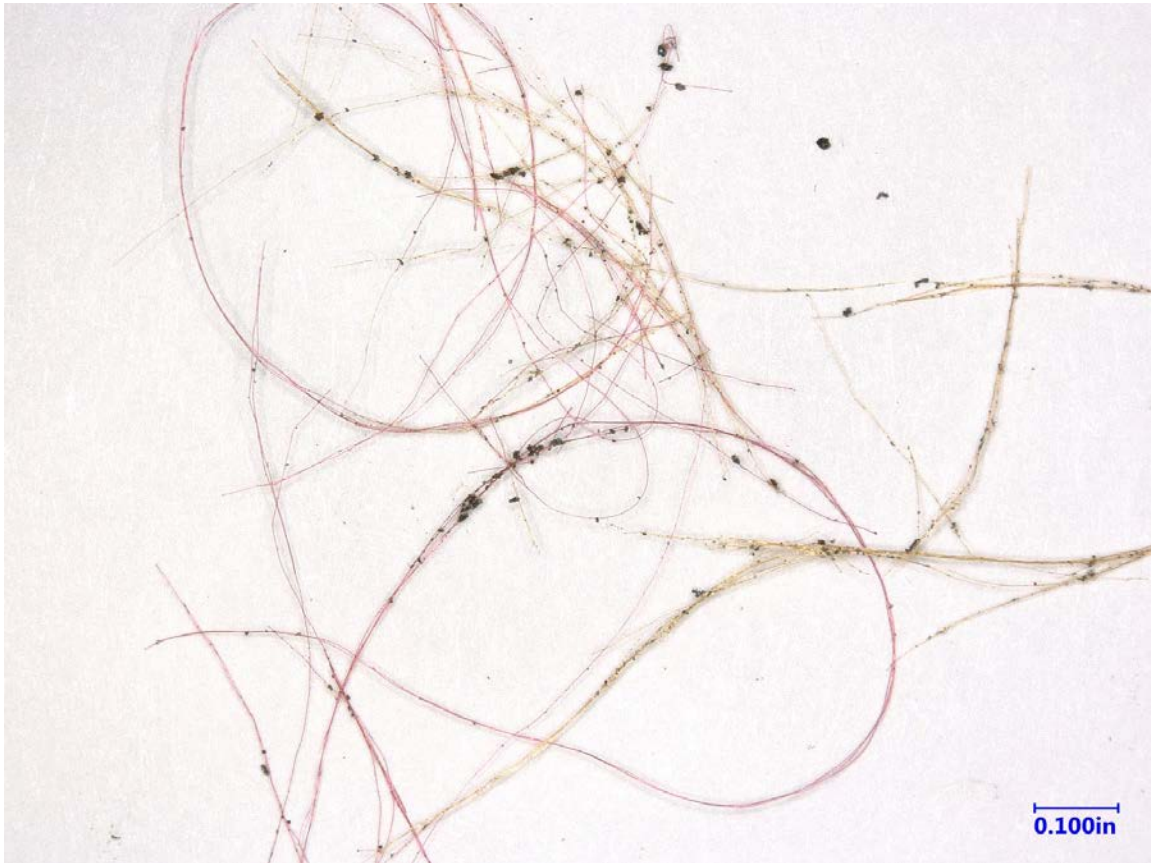
Figure 9: Digital microscope image of red colored and gold colored fibers removed from the left overhead aileron to wing cable.
