## FIELD NOTES

### HISTORY OF FLIGHT

On July 13, 2018, at 1021 Pacific daylight time, a Cessna 172R Skyhawk, N24442, experienced an inflight breakup and collided into a field in Deer Park, Washington. The certified flight instructor (CFI) and two student pilots were fatally injured. The airplane was substantially damaged. The airplane was registered to and operated by Moody Bible Institute of Chicago as a 14 *Code of Federal Regulations* Part 141 training flight. Visual meteorological conditions prevailed at the time of the accident and no flight plan had been filed; the pilot was receiving flight following advisories. The local flight originated from Felts Field about 0955.

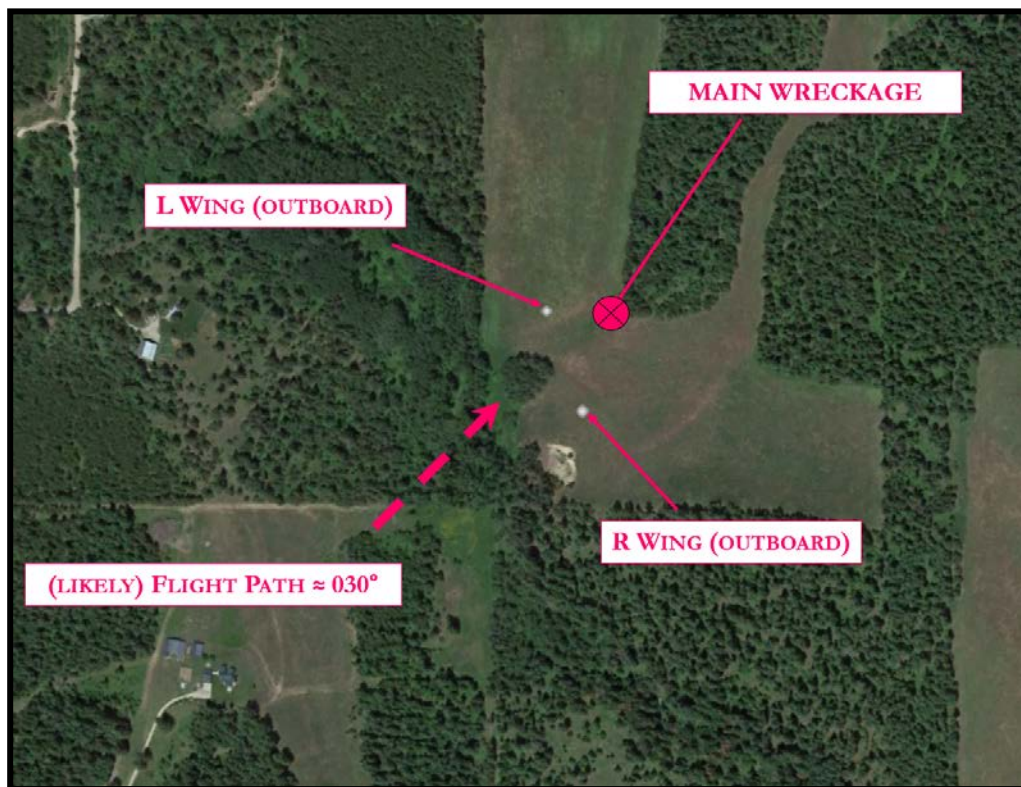
Picture 05: Accident Site in Reference to the Surrounding Terrain

The wreckage was found distributed over a 400 ft distance on a median magnetic bearing of about 030°. The outboard sections of both the right and left wing were located at the beginning of the debris field. The debris field between the wings and the main fuselage wreckage consisted of left wing pieces. All control surfaces and their associated mass balance weights were accounted for in the debris field.

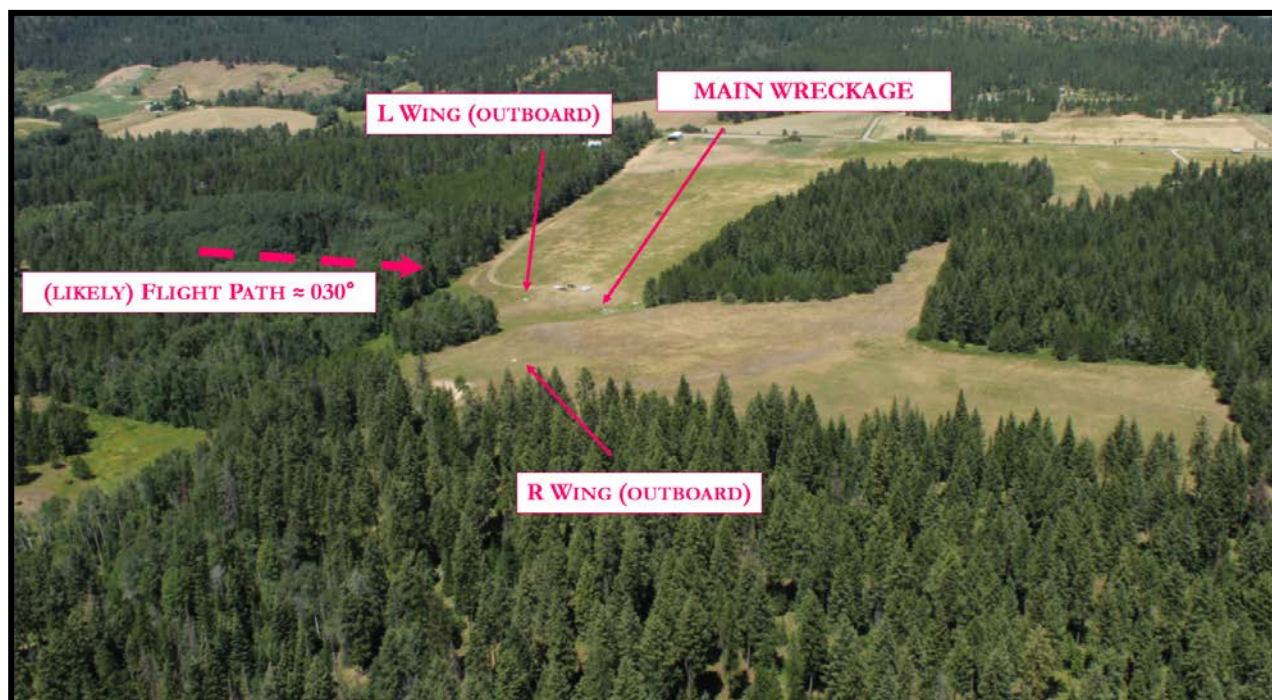
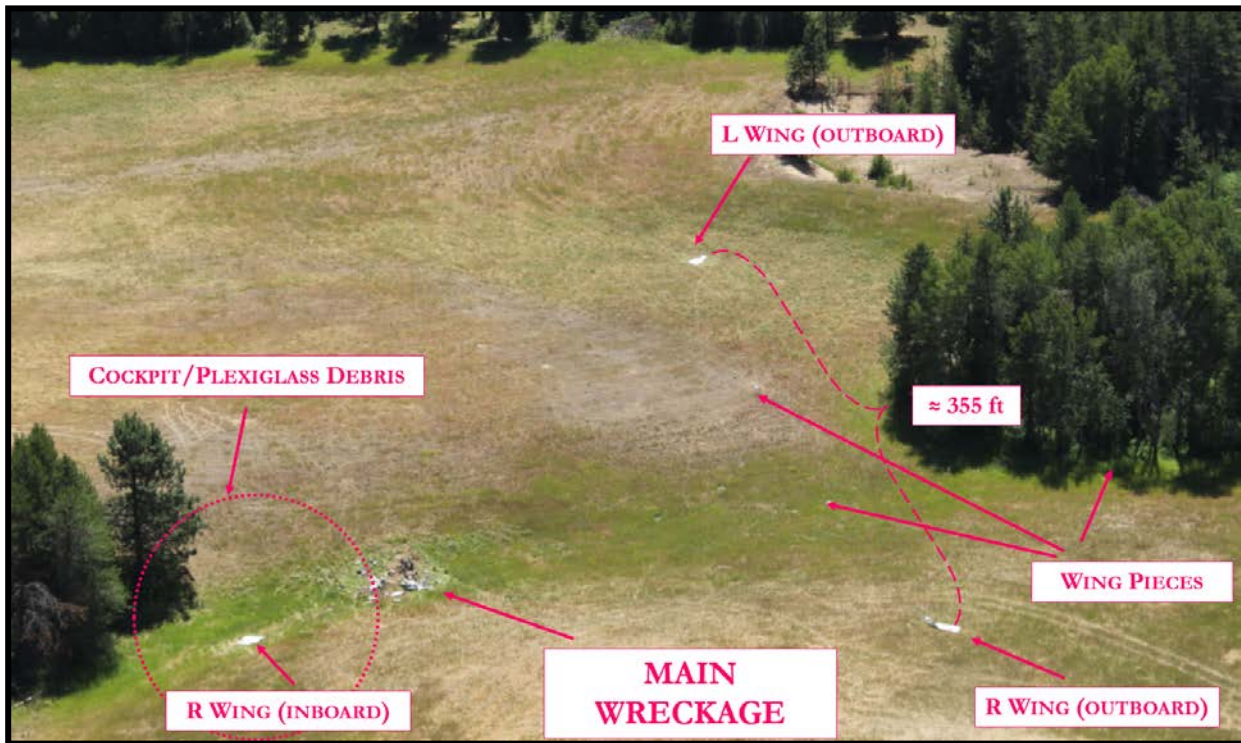
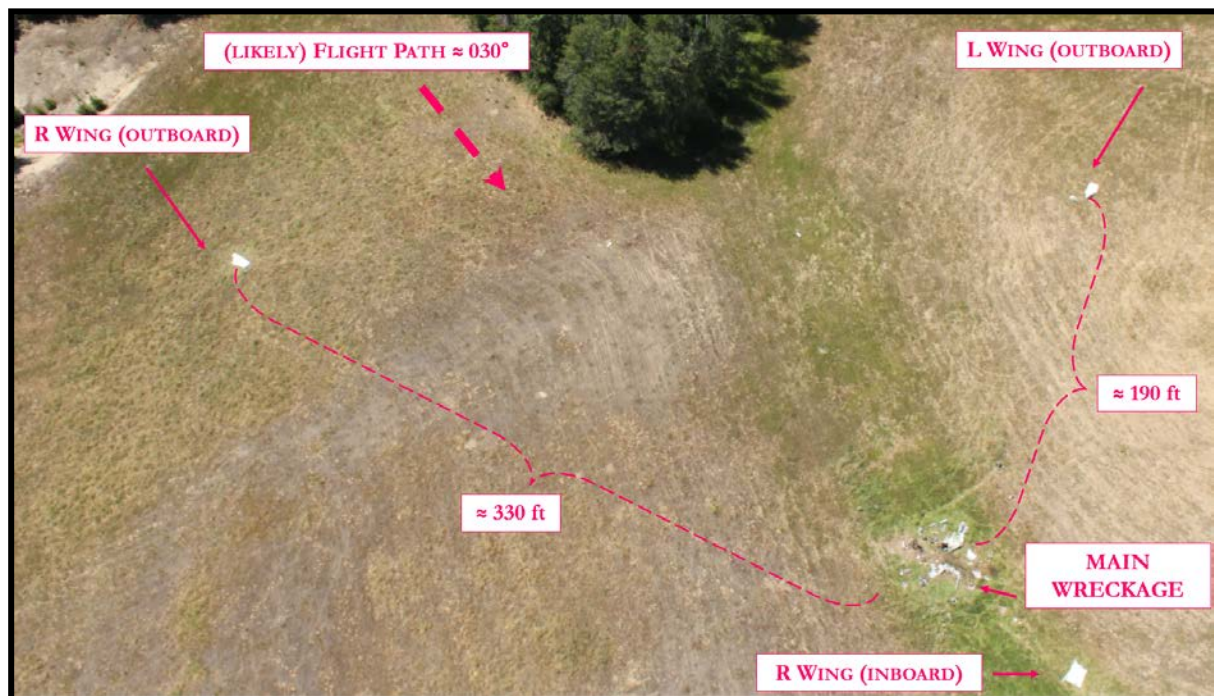
The main wreckage consisted of the: fuselage, engine, propeller, inboard left wing, vertical and horizontal stabilizers, rudder, and elevators. The main wreckage came to rest at the base of a small hill. The remaining wreckage components were found in the debris field adjacent to the main wreckage and principally consisted of plexiglass, cockpit debris, the left lower nose cowling, and the inboard right wing.

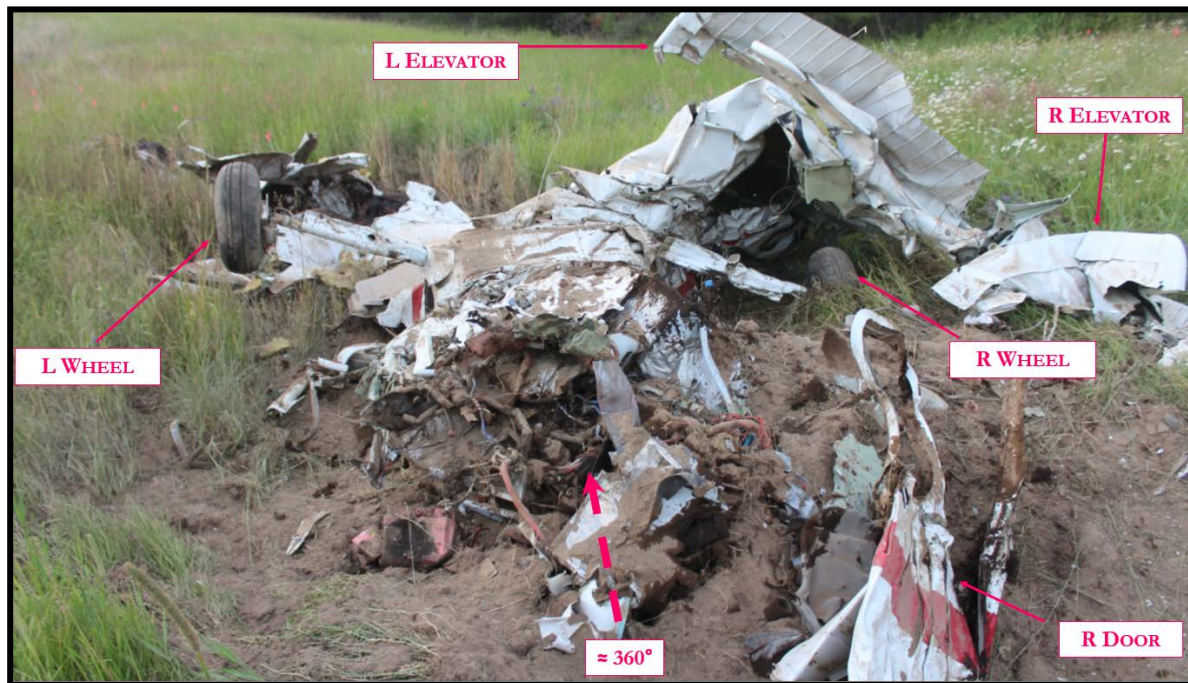
*Picture 09: Bottom of Fuselage*

The fuselage came to rest nearly vertical and slightly inverted at the base of two shallow hills. The nose of the airplane was buried in the soft dirt; the propeller and engine were on a magnetic bearing of  $360^\circ$ . An

impact scar, consistent with the inverted fuselage and engine, was located just prior to the fuselage resting point. The cockpit and cabin area was crushed. The nose landing gear and cockpit components were all located in the immediate vicinity of the fuselage.

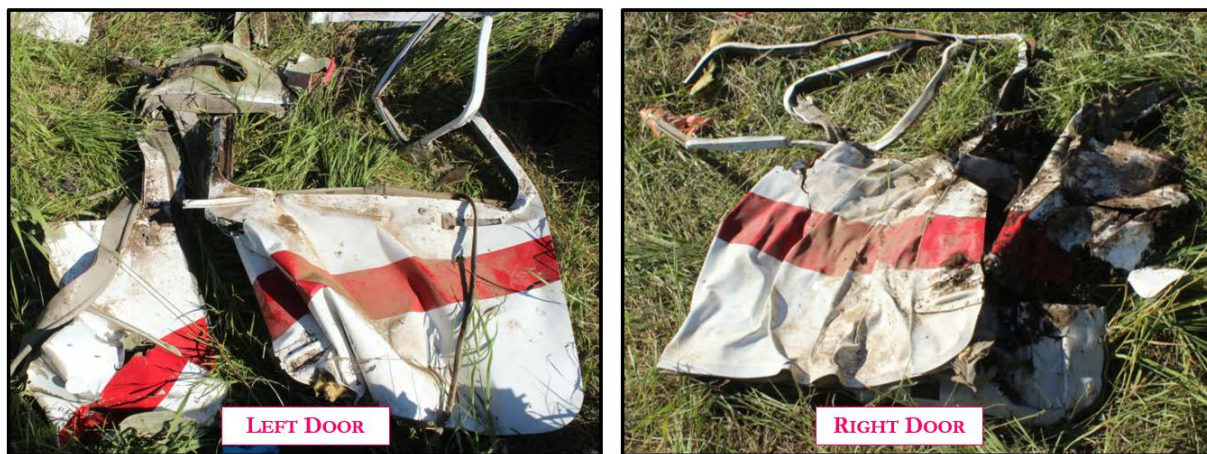
*Picture 10: Doors*

The left door was found on the left side of the main wreckage; the latch was locked. The right door was farther right in the debris field; the latch was locked. Both doors had sustained aft crush deformation with the metal folding back on itself indicative of a near-vertical impact.

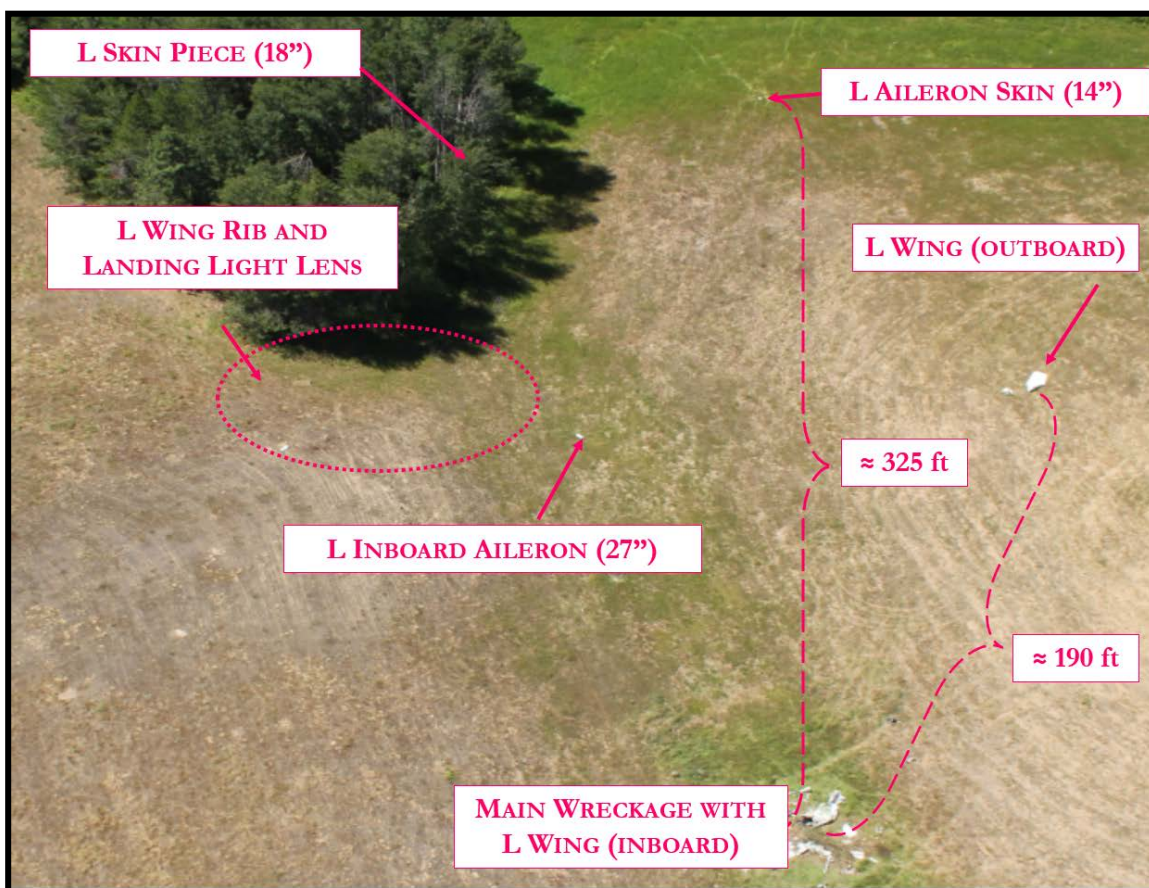
Picture 11: Left Wing Distribution in the Debris Field

The left wing was separated into two major sections. The left outboard wing section was located about 190 ft from the main wreckage on a heading of 275°. The inboard portion of the wing was found imbedded with the main wreckage. An outboard section of the left flap and attached wing skin was adjacent to the outboard wing. A small piece of the aileron skin, upper wing skin, landing light lens, and the remainder of the inboard aileron were located in the debris field.

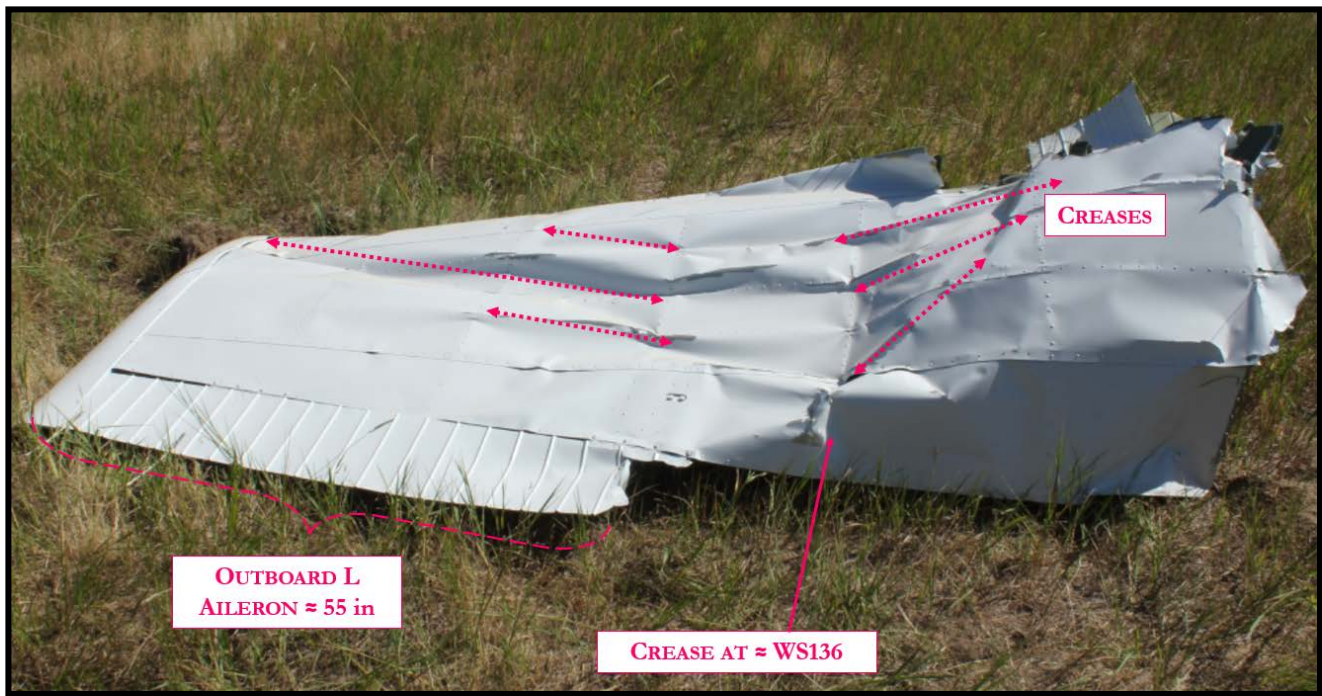
Picture 12: Outboard Left Wing (upper surface)

The section included the wingtip inboard 118 in. and the outboard portion of the aileron which was 55 in. (around WS 154). The outboard wing was a v-shape with the lower valley near WS136 and creases in the upper skin stretching from that area to the outboard leading edge.

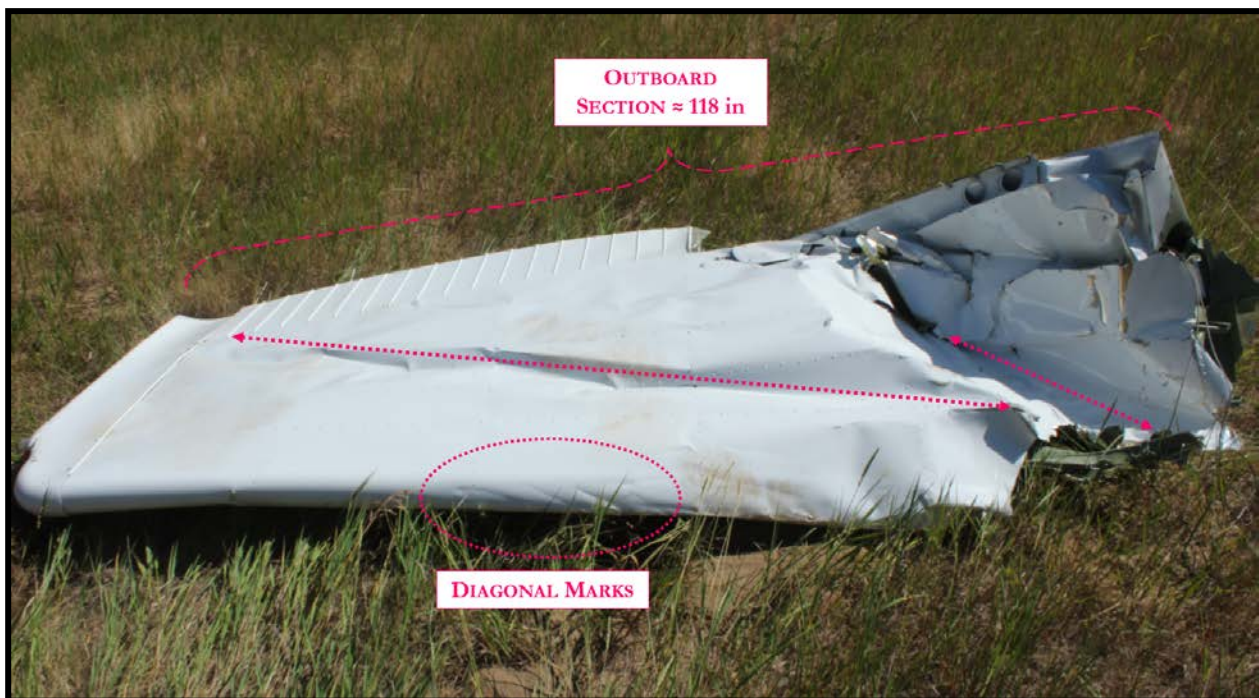
Picture 13: Outboard Left Wing (lower surface)

The lower wing skin had crease oriented diagonally from the outboard trailing edge to the inboard leading edge stretching from WS208 to WS118. The forward and aft upper spar caps were bent in a downward direction.

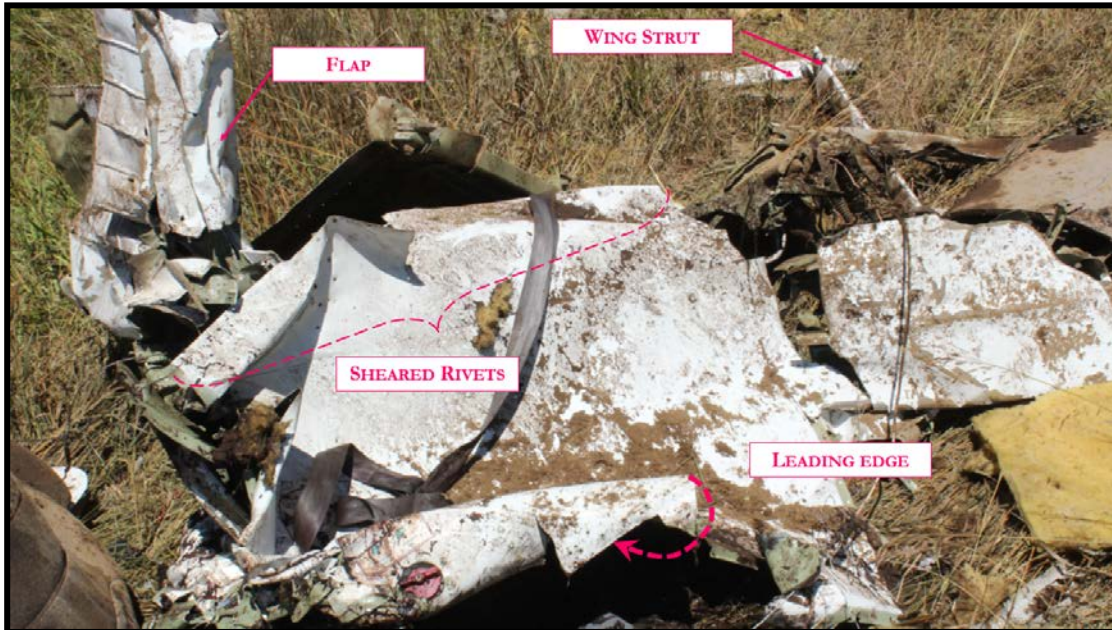
Picture 14: Inboard Left Wing (lower surface)

The left inboard wing, part of the main wreckage, had sustained the most damage of all the wing sections and measured 78 in. The leading edge and bottom skin had folded back from the ribs. The trailing edge rivets had sheared consistent with a downward torsional force. The upper portion of the strut was still attached; the lower position was immediately nearby.

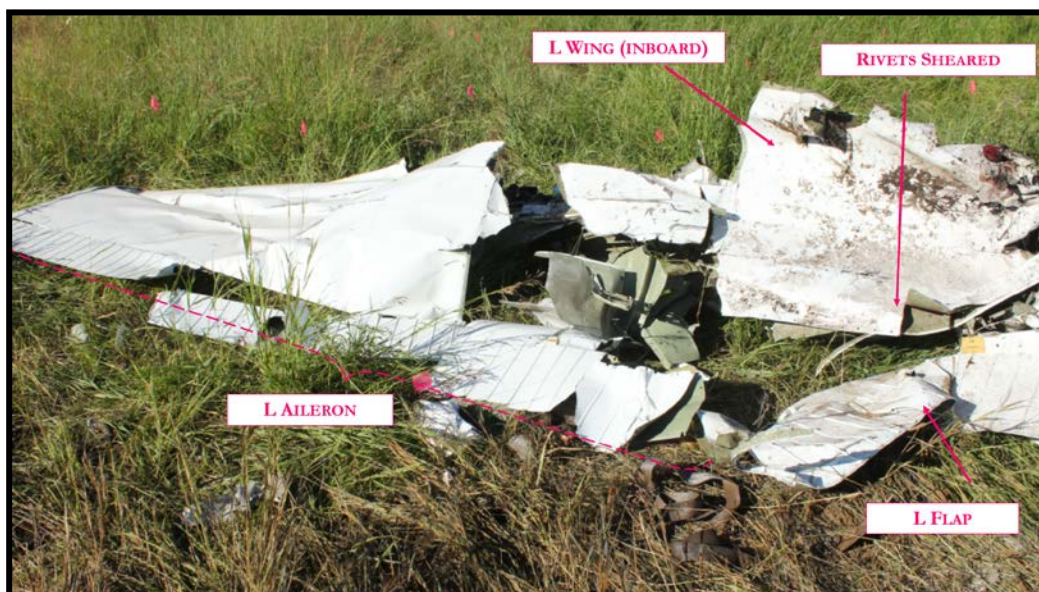
Picture 15: Left Aileron and Flap

The left aileron was separated into numerous pieces with only the outboard portion remaining attached. The area of the most fragmentation was near where the aileron and flap meet. The flap remained attached to the inboard attach fitting and was bent back on itself.

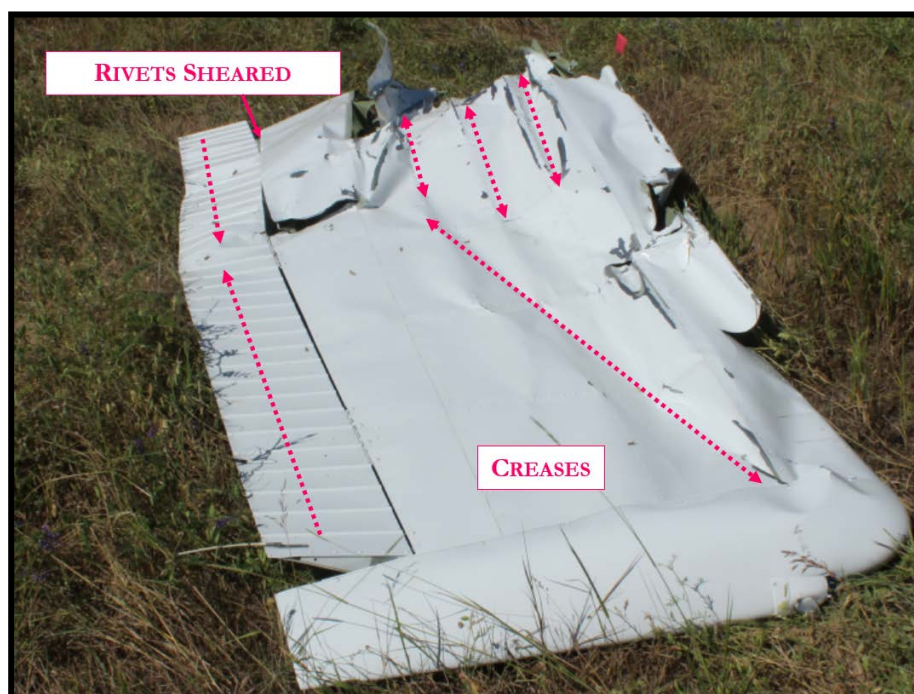
*Picture 16: Outboard Right Wing (upper surface)*

The outboard right wing separated from the structure, and the leading edge was in different directions having been cut in several areas. The upper skin had a diagonal crease from WS 208 near the leading edge aft and outboard to WS 118 where aft rivet line had sheared consistent with a torsional load from the wing tip being twisted down.

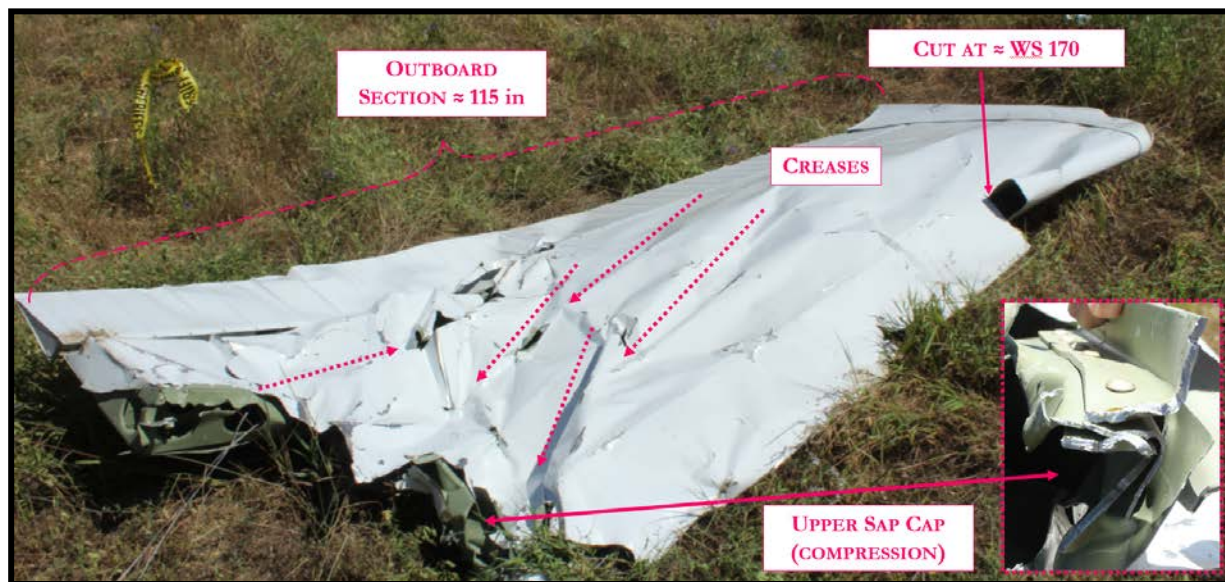
Picture 17: Outboard Right Wing (lower surface)

There were numerous creases on the lower skin oriented from the outboard aft trailing edge to the inboard leading edge area. There were many red/brown spots on the leading edge and lower surface that were swabbed. There were additionally scrapes and metal transfer marks consistent with contact and sawing from the aileron cables. Examination of the forward and aft spars disclosed evidence of compressive and tensile overstress on the upper and lower spar caps, respectively, which was consistent with a primary failure of this portion of the wing in a positive direction.

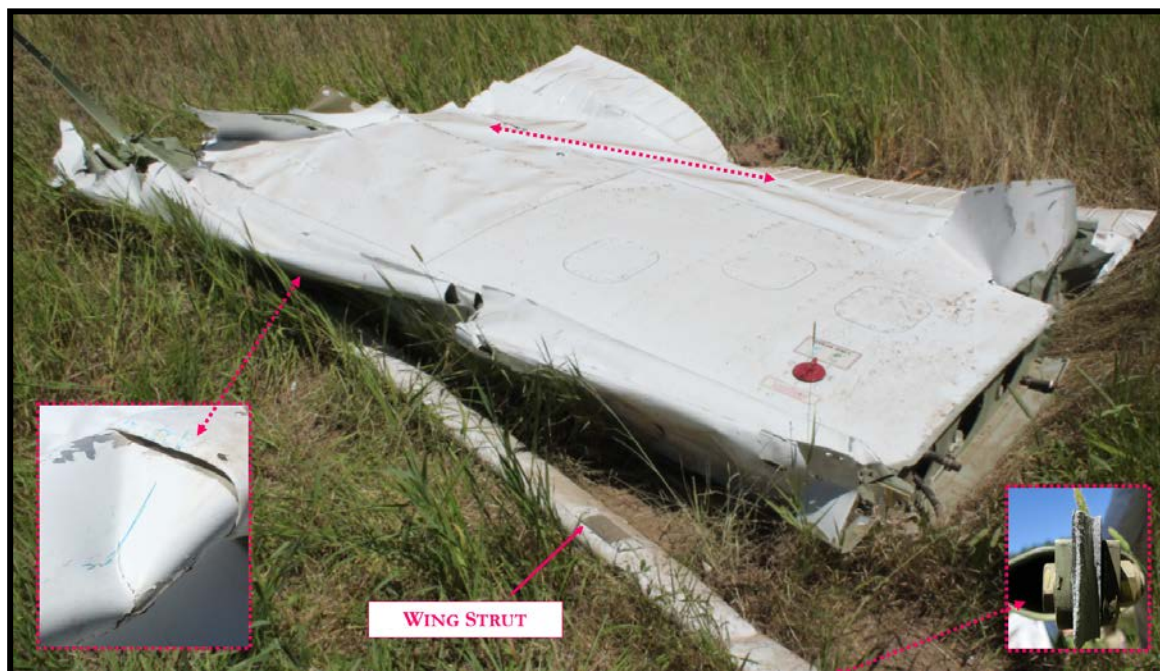
Picture 18: Inboard Right Wing

The inboard right wing was 94 in. in length and the flap and wing strut remained attached. The fuel caps was secured. The wing strut and areas on the leading edge had blue paint transfer marks. A tear in the fuselage skin created a saw mark from the outboard aft area inboard about 10 in consistent with an aileron control cable. Examination of the forward upper and lower wing spar caps disclosed evidence of compressive and tensile overstress on the lower and upper spar caps respectively. The aft wing spar disclosed evidence of compressive and tensile overstress on the upper and lower spar caps, which was consistent with a failure of this portion of the wing in a positive direction. The wing strut attachment had a granular fracture surface.

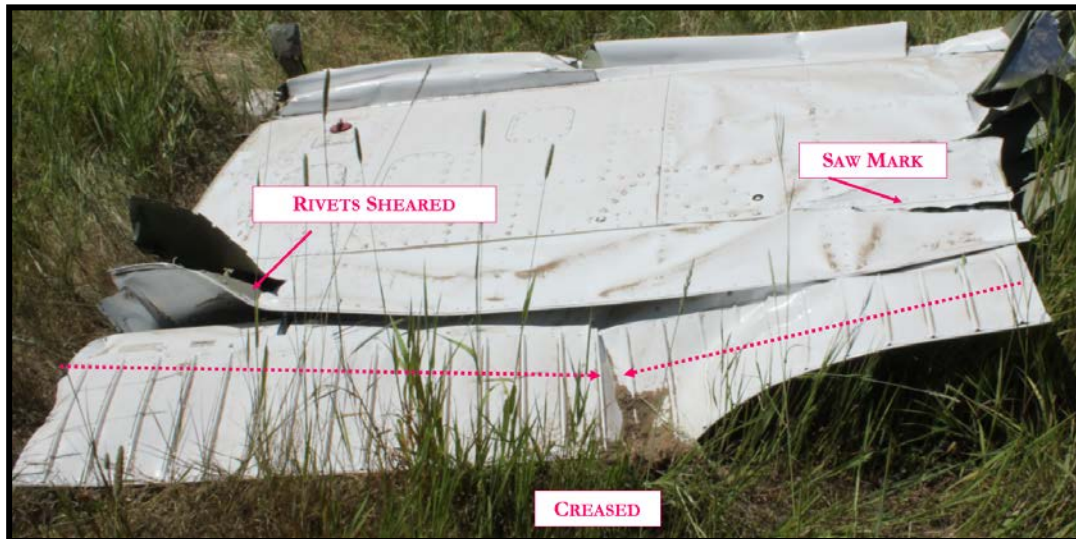
Picture 19: Right Flap

The right aileron remained attached via control cables and attach fittings on their respective bellcrank arms. There was a slight downward v-shaped bend near WS140. The control cable ends had a broomstrawed appearance consistent with an overload separation. The right-wing flap cables were separated inside the wing but the control surface remained attached to its respective fittings. The flap control had deformed into a v-shape with the downward crease near the center.

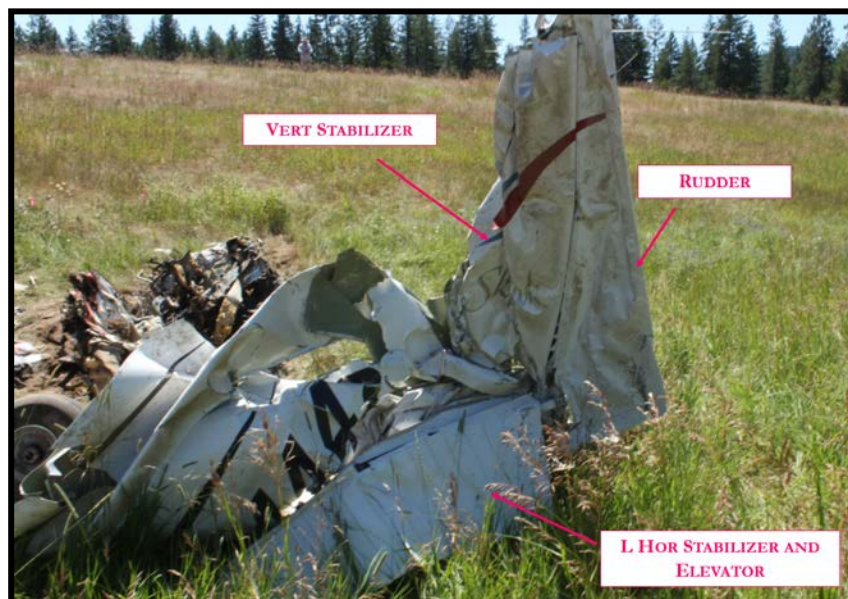
Picture 20: Tail Section

The tail section encompassed an all-metal structure consisting of a horizontal stabilizer with elevators, and a vertical stabilizer with rudder. The entire tail section was part the main wreckage and had folded over the engine and cockpit.

The vertical stabilizer was intact and the rudder remained attached at its receptive fittings. The vertical stabilizer attach point was pulled with the bolt secured in place. The left rudder horn piece was absent and appeared to have fractured in the accident sequence. The stops were intact and did not show any evidence of abnormal contact.

The rudder was attached to all its hinges and had folded to a stationary position against the vertical stabilizer. The vertical stabilizer had sustained crush damage along its leading edge and contained a large vertical crease indicative of how it came to rest folded over the right side of the wreckage.

The right elevator remained attached on the mid connection hinge. The horizontal stabilizer was crushed forward. Both surfaces sustained the most deformation at the center hinge. The horizontal stabilizer was bent in a downward “V-shape” with the peak at 38 inches from the inboard and then the other portion of the “V-shape” being 18 inches from the edge of the outboard. The inboard leading edge had paint chips about 28 inches outboard. The entire bottom inboard skin was crushed up toward the forward spar.

The upper spar caps contained a torsional load and the lower spar caps appeared to have been bent as a result of impact damage; the fracture surfaces were indicative of that of compression. The forward spar was too deformed to determine any fracture directions. At the elevator control tubes most of the rivets were sheered out of the coupling. The right elevator was bowed upward with the peak being 32 inches up. The actuator on the trim tab was ripped past a meaningful point to be able to measure. The spar on the fuselage connecting the horizontal stabilizer was bent upward on the lower spar cap and downward on the upper spar cap.

The left horizontal stabilizer was crushed and it torsional twisting with the outboard section folded almost fully over on itself to the bottom of the elevator. The left horizontal stabilizer was still connected to the fuselage continued to bend forward to reaching the most damage about 28 inches where the main hinge point for the elevator was located. There are numerous blue transfer marks on upper skin. The left elevator control tube had sheared almost completely out of the coupling on the fuselage and had sheared from the ribs in the elevator body. The elevator was peaked upward with the apex about 28 inches where it was still connected.

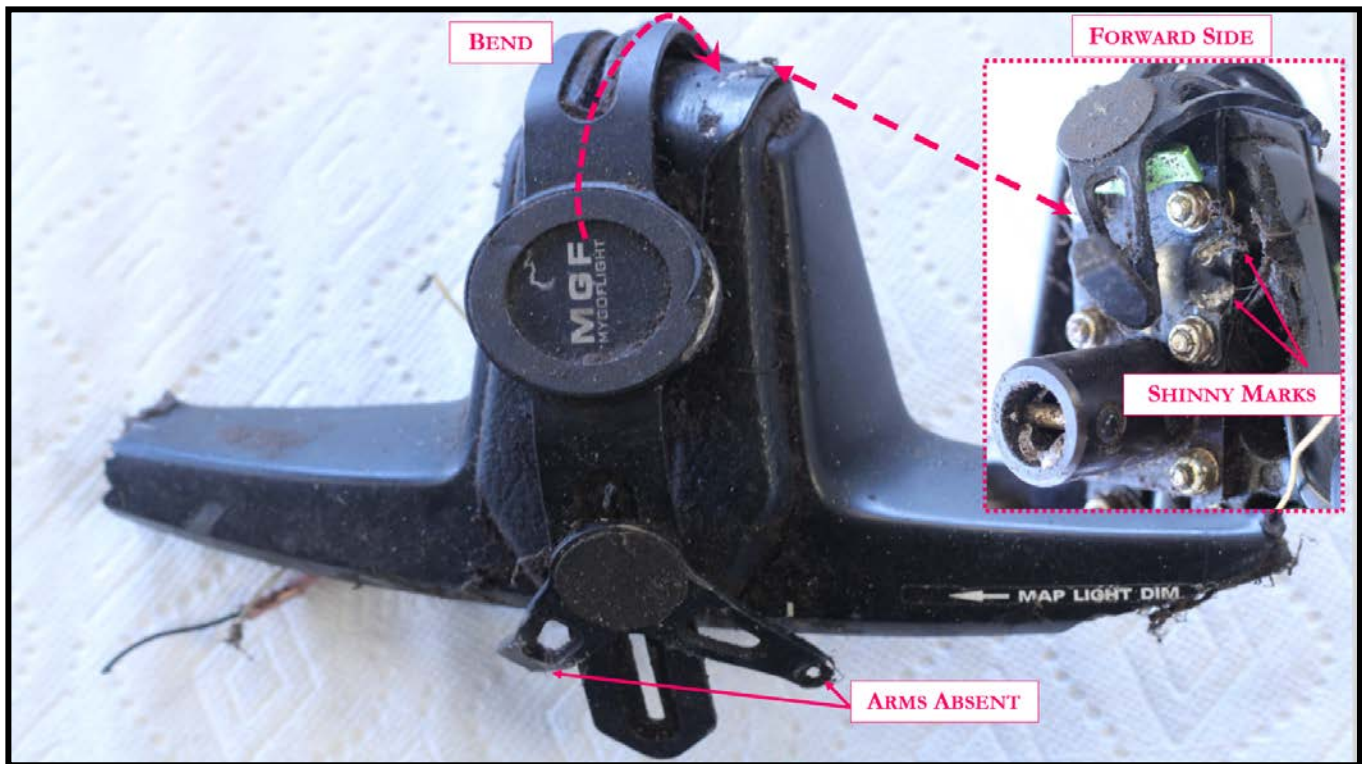
Picture 25: Left Control Yoke

The left side MyGoFLight iPad bracket remained fixed to the main body and was bent over the top with the green knob attached. The bracket arms were all broken off except the upper right arm which had folded over to the outboard side. There were to shinny indentations in the forward side of the main body, consistent with the bracket making contact. The control tube from the main body to the cog on the left aileron control was found in the panel.

The left control yoke attaching from the main body was still located in the panel and the control horns had separated on both sides. The right control yoke body was more fractured than the left. The control horns were both located in the wreckage and the iPad bracket had come separated.
