## **NATIONAL TRANSPORTATION SAFETY BOARD**

# **ON SCENE OBSERVATIONS**

**WPR18FA219**

Location: Sylmar, California  
Date: August 12, 2018  
Aircraft: Beech A36TC, Registration N136RM, Serial #EA97  
NTSB IIC: Samantha Link

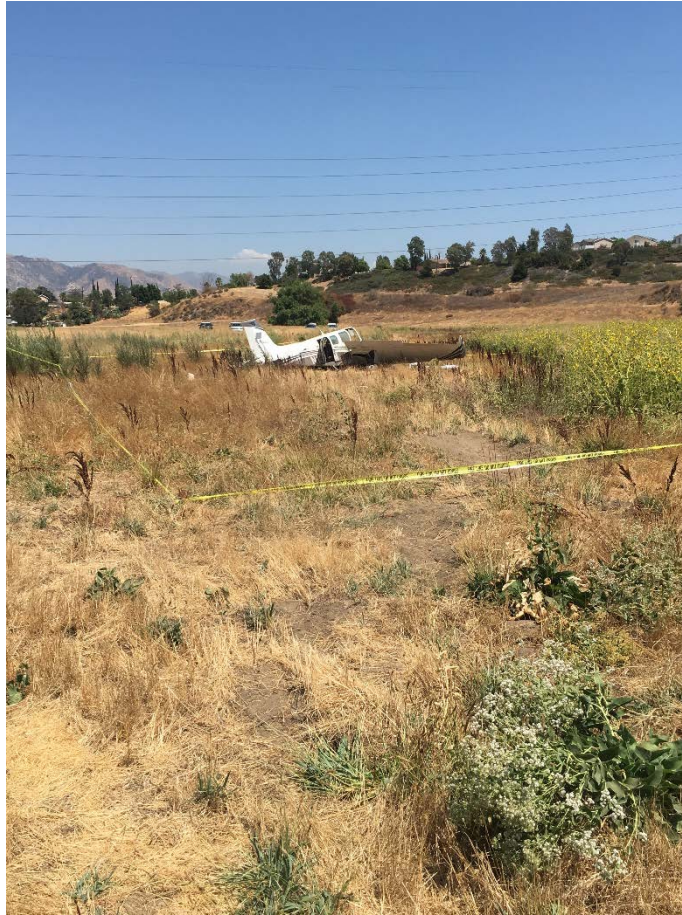
- The airplane came to rest in a field adjacent to interstate I-5. The debris path was about 107 feet long. The first identified point of impact was a strip of disturbed dirt with a fragment of grey paint in the area. About halfway through, and to the right of the strip of dirt was a paralleling strip of disturbed dirt. Followed by a large disturbed area and the nose landing gear strut. There is about an 80-foot section of mostly undisturbed

Figure 1: Start of Debris Path

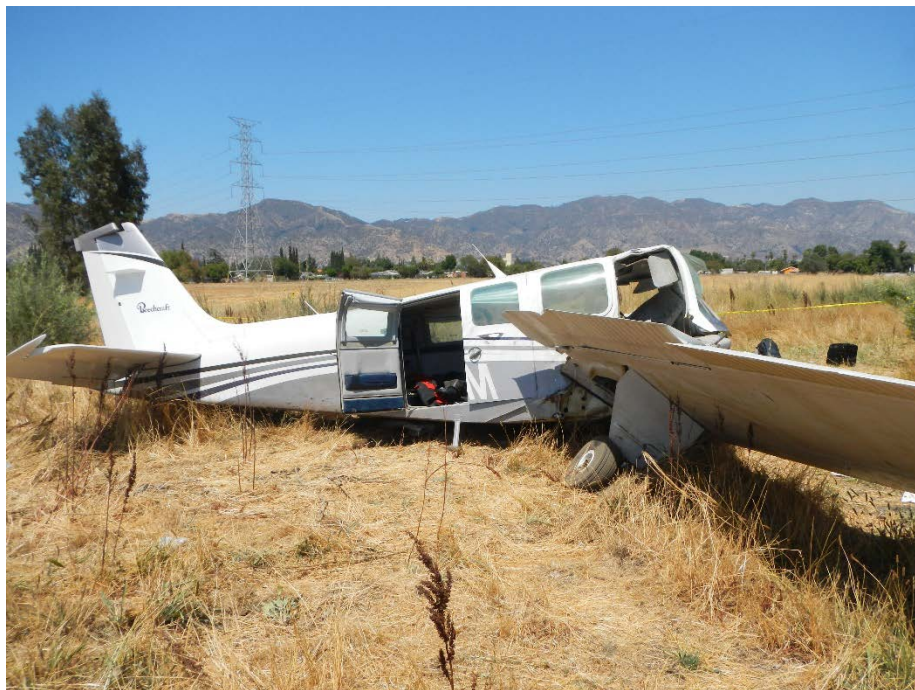
- The main wreckage came to rest mostly whole and upright. The engine and forward fuselage were fracture separated with the exception of the some of the left side fuselage. The engine came to rest upside down and to the left of the cabin area. The three bladed propeller was still attached to the hub, all three blades were bent aft. One blade exhibited chordwise paint burnishing. The left wing was heavily damaged and was covered in dirt consistent with that found at the accident site. The wing was bent aft at the root and fractured midspan. The outboard section was bent aft underneath the inboard section and came to rest with the leading edge facing aft. The left main fuel tank was breached, and the left main landing gear was fracture separated. The left aileron was fracture separated with the exception of the inboard about one foot which was still secured at its attachment point. The left tip tank remained attached to the wing and the outer fiberglass was damaged and separated, however, the tank itself was mostly undamaged. The left side fuselage was intact although exhibited inboard crushing at the trailing edge of the wing. The empennage was intact and mostly undamaged. The right side aft fuselage was intact and mostly undamaged. The right wing was mostly whole; however, the rear spar was fractured at the root and the forward portion of the wing was bent downward. The right main landing gear remained attached and was found in the down and locked position. The forward portion of the right wing tip tank was crushed inboard. The right wing main fuel tank appeared to be undamaged and the fuel cap was secured. The cabin area exhibited heavy crush damage at the forward seats and floor board. The instrument panel was fracture separated from the right side for the fuselage and exhibited crush damage in the center.

Figure 2: Right Side of Airplane

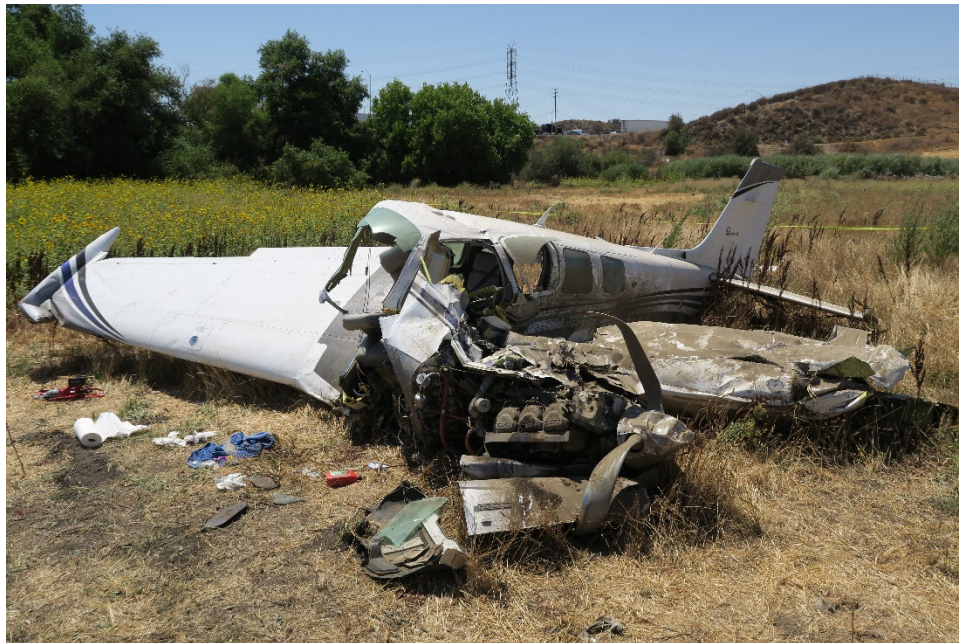
**Figure 3: Forward and Left Side of Airplane**

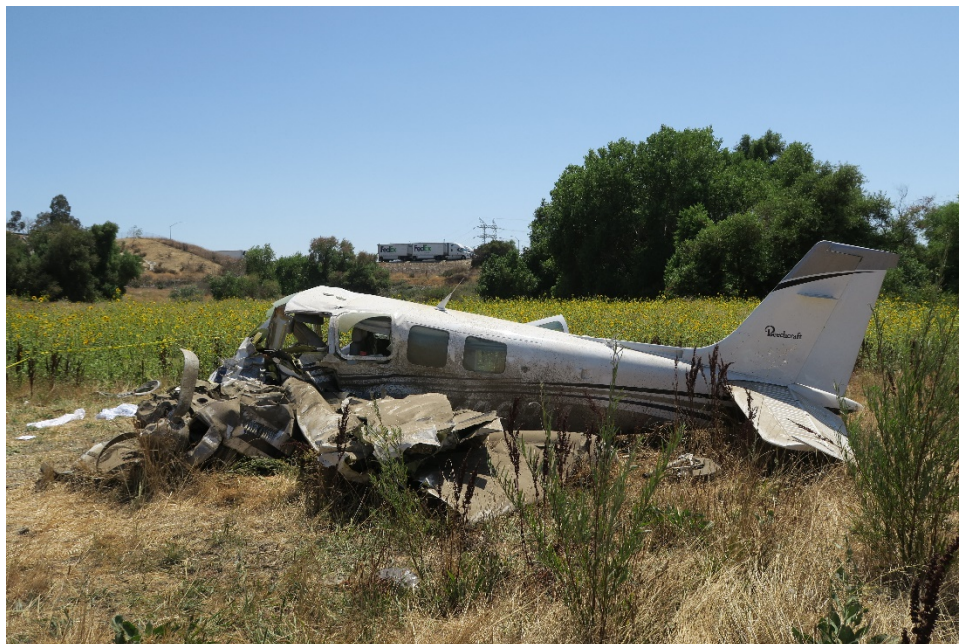
**Figure 4: Left side of Airplane**

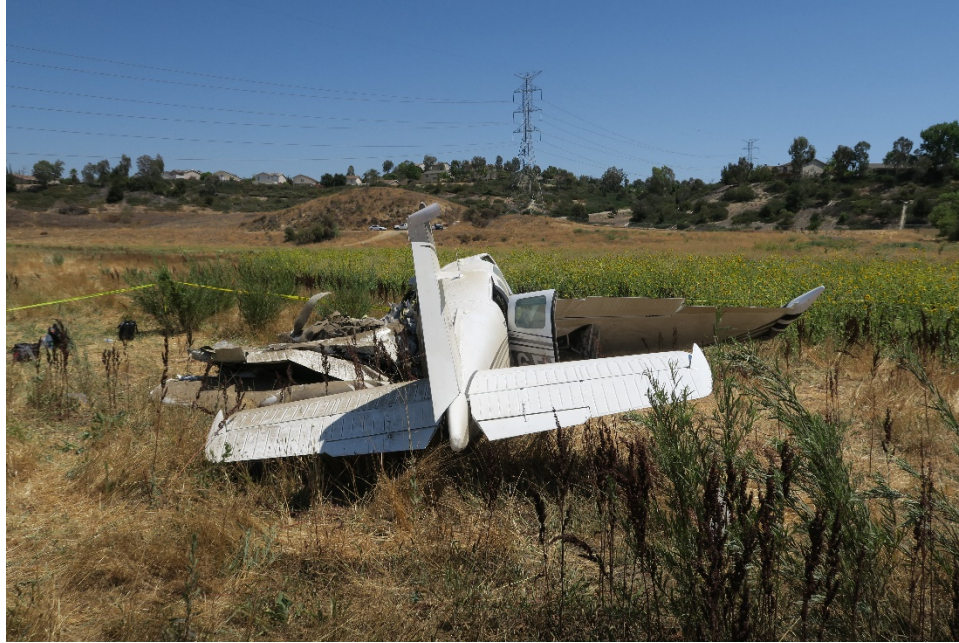
Figure 5: Empennage

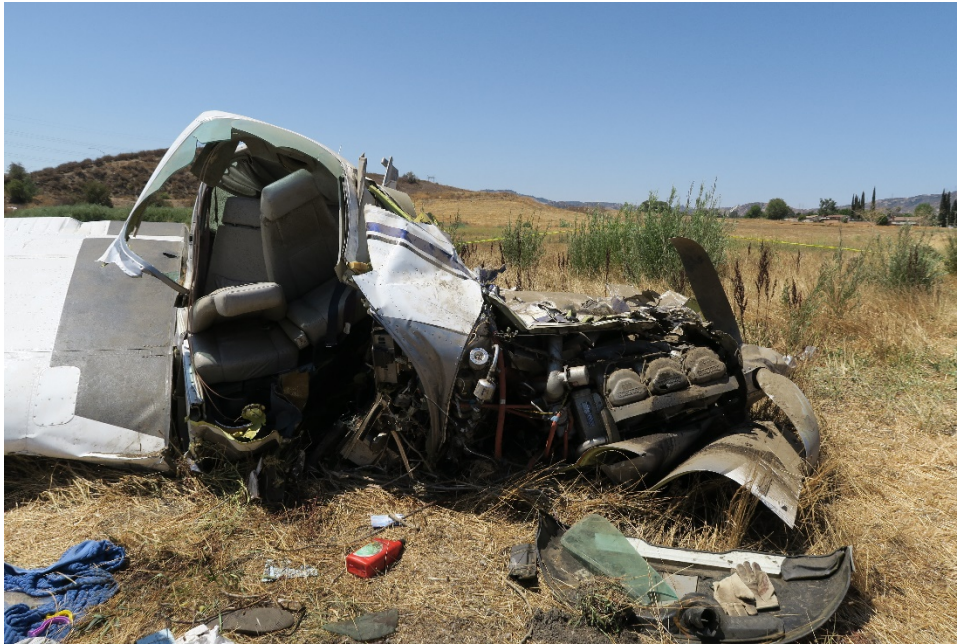
- The right auxiliary fuel gauge indicated empty
- Four of the six cabin seats were observed within the airplane and they remained secured in place.

- The left seat seatbelt was found draped across the seat and was unlatched. The shoulder harness was found secured to the lap belt.

Figure 6: Cabin Area

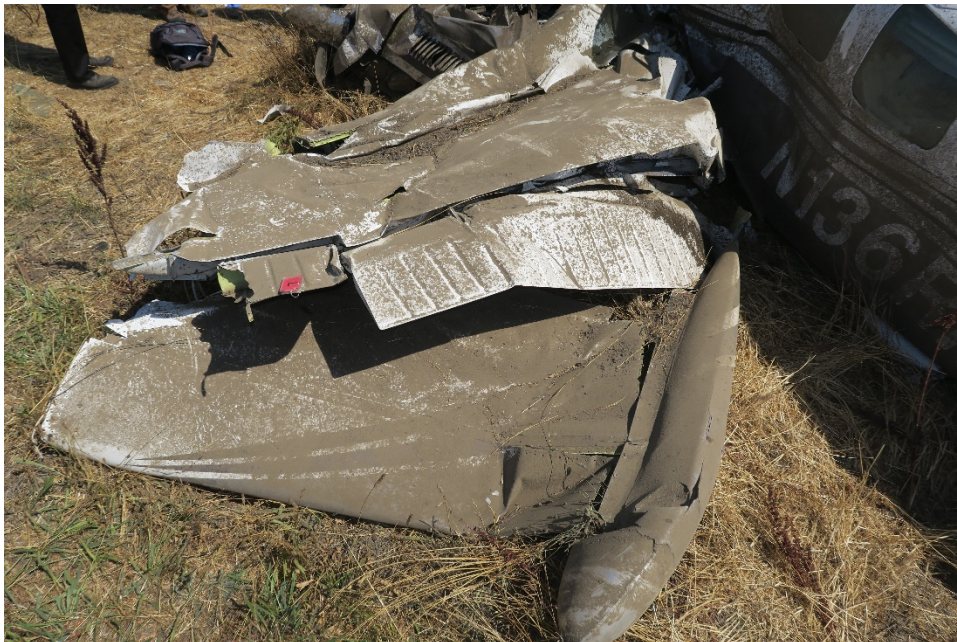
- Control continuity was established throughout the airframe with the exception of the cabin area due to impact damage.
- The left wing main fuel tank was heavily damaged

- The fuel cap was still secured in place
  - When the left wing was moved for recovery purposes, an unknown quantity of fuel was observed exiting the tank.

Figure 7: Left Wing

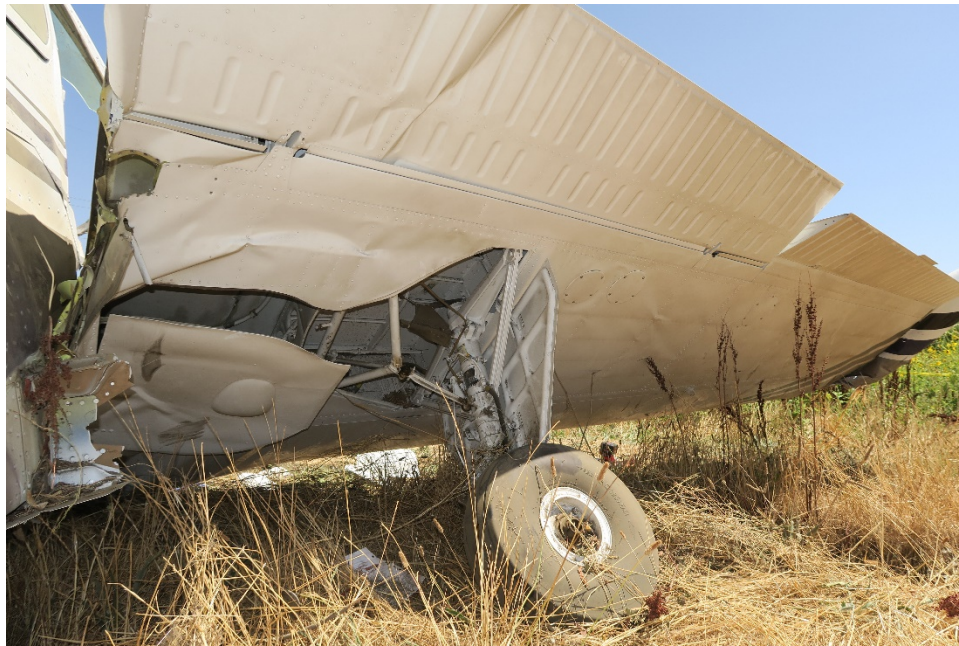
**Figure 8: Right Main Landing Gear**

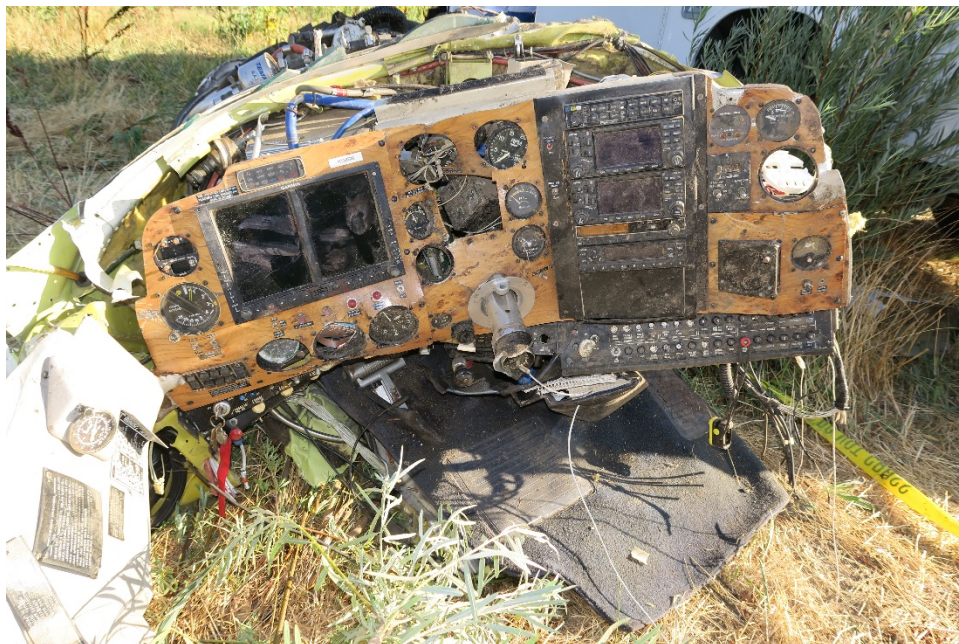
**Figure 9: Instrument Panel**

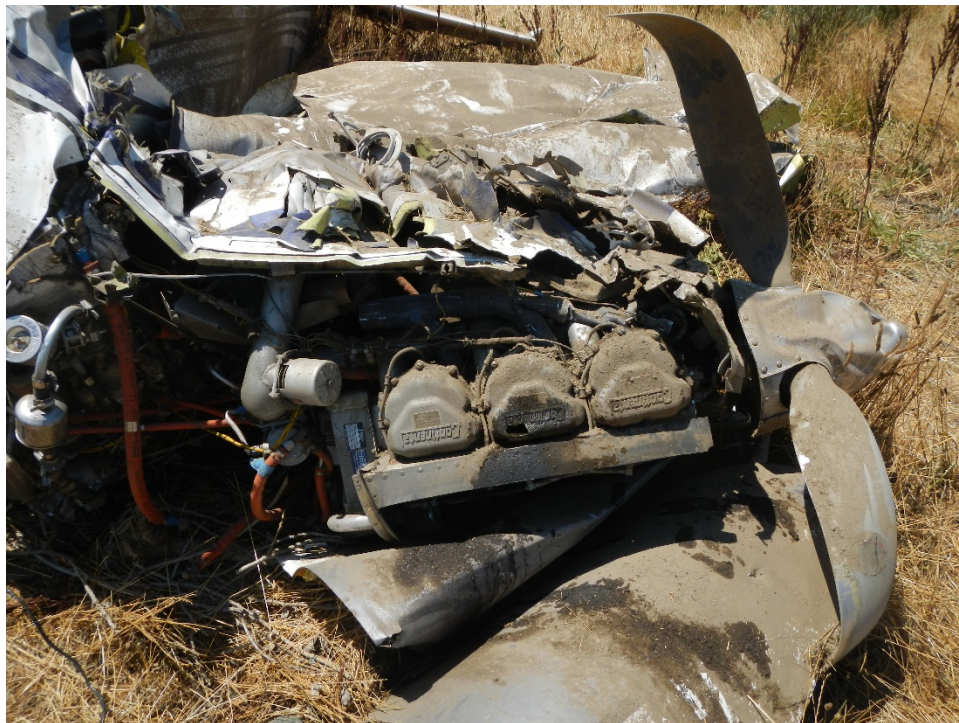
- Engine came to rest inverted with the odd-side cylinders lying low
- The engine was covered in dirt and grass consistent with that found at the accident site
- The intake filter remained in the bracket and the intake air box was deformed and flattened
- The inlet to the turbocharger impeller was clear and the impeller rotated freely
- The mixture control cable remained attached to the mixture control lever and the lever remained with the shaft; however, the mixture lever was bent.
- The throttle cable remained attached to the throttle lever, however, the throttle lever was fractured and exhibited deformation.
  - o The throttle control was manipulated by hand and corresponding motion was observed at the throttle shaft
- The fuel metering unit to the manifold valve fitting was observed fracture separated at the metering unit consistent with impact damage

Figure 10: Left Side of Engine

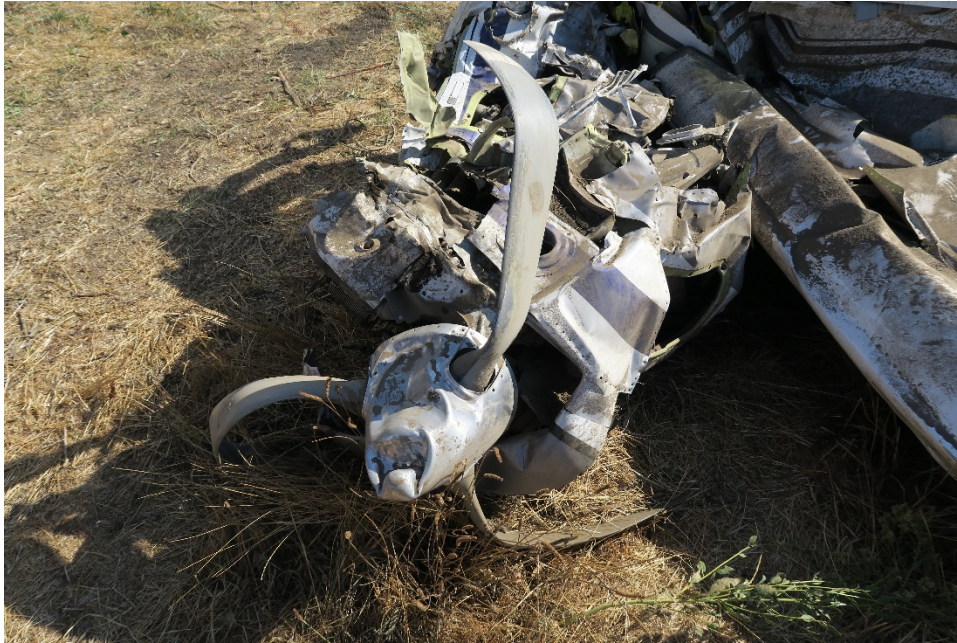
Figure 11: Propeller Blades

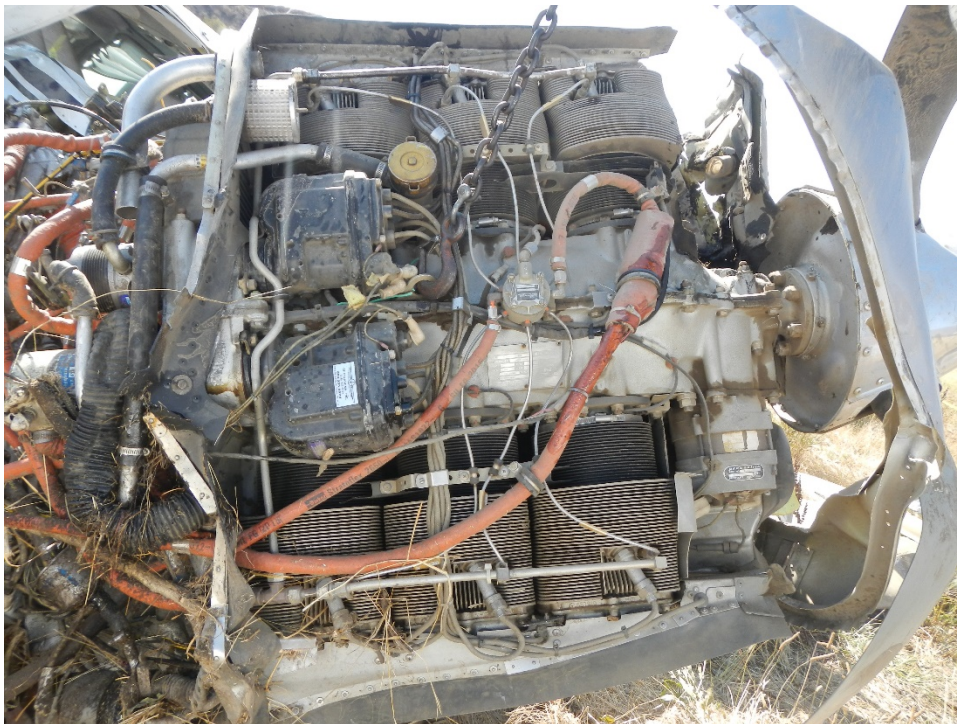
Figure 12: Top of Engine

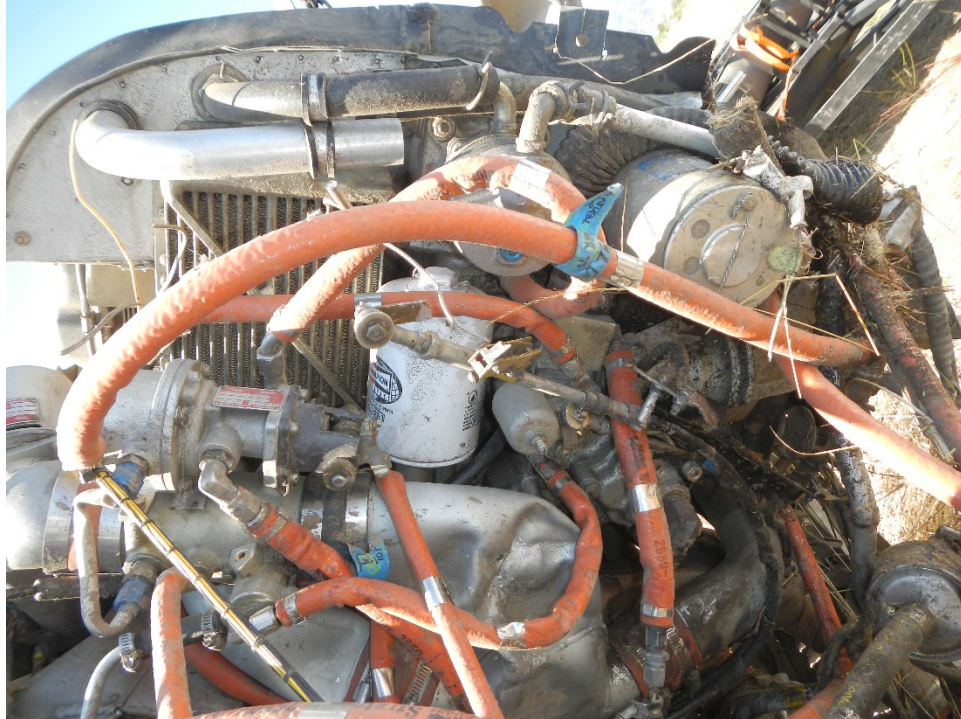
Figure 13: Accessory Section of Engine
