## **NATIONAL TRANSPORTATION SAFETY BOARD**

# **AIRFRAME AND ENGINE EXAMINATION**

**WPR18FA219**

Location: Sylmar, CA  
Date: August 12, 2018  
Aircraft: Beech A36TC, Registration N136RM, Serial #EA97  
NTSB IIC: Samantha Link

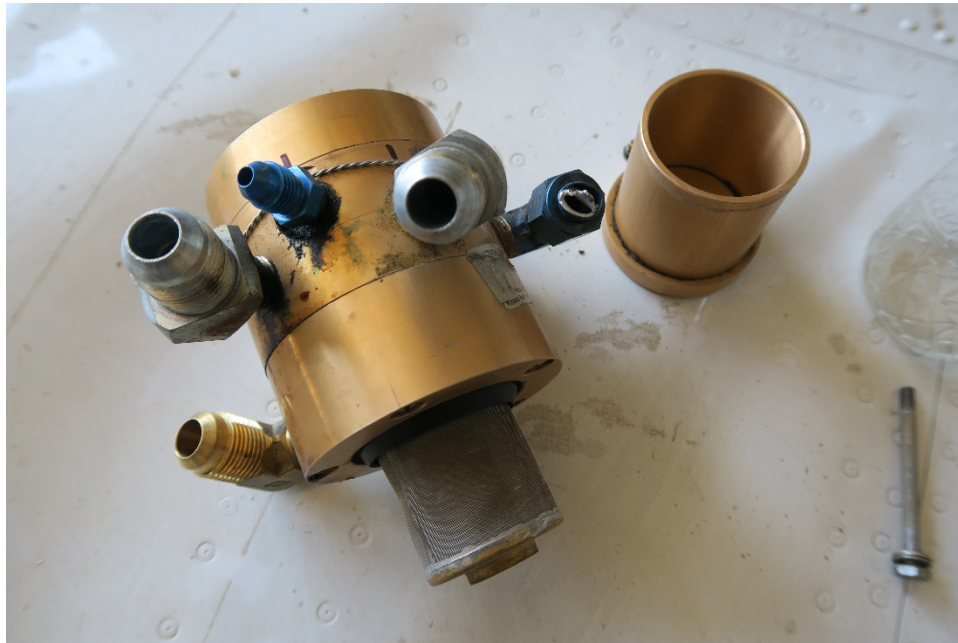
Figure 1: Fuel Selector

- o The left rudder bellcrank located in the forward floor assembly was found fractured
- The fuel system was fracture separated in several places throughout the airframe, however, fuel was noted in all of the fractured lines
- The gear actuator was observed and was in the gear down position.
- The flap actuators were measured at 1.7 inches, which is consistent with the flaps in the up position.
- The elevator trim actuators were measured at 1.1 inches which is consistent with 5 degrees tab up.
- The fuel selector faceplate was fracture separated. The fuel selector unit was removed from the airframe and examined
  - o The screen was clear of debris
  - o Air was blown through the selector and it was positioned at the left main fuel tank.
- The auxiliary pump was not on
- 12V battery power was added to the fuel boost pump and residual fuel was pumped from the system.

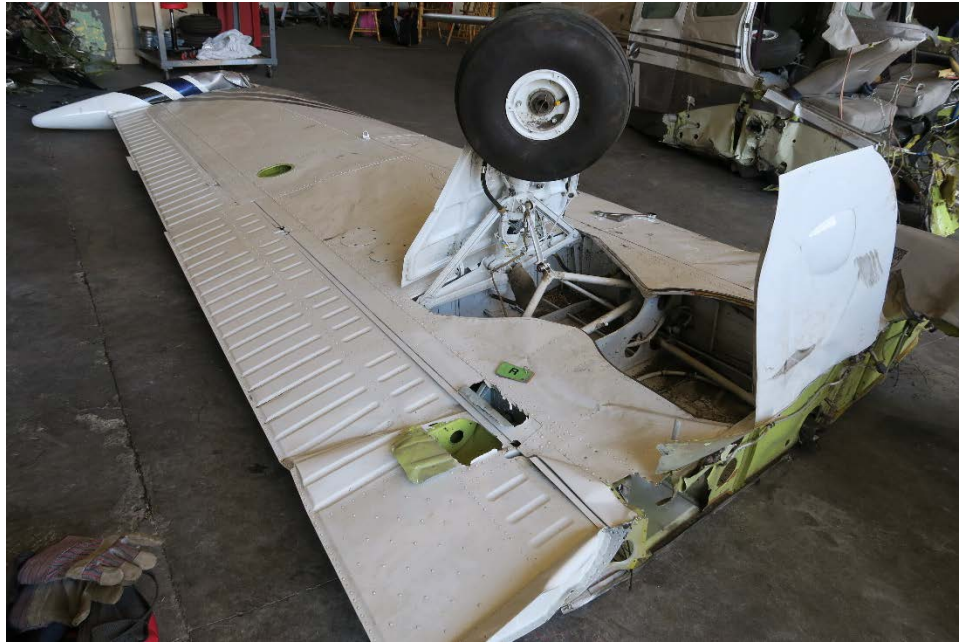
Figure 2: The Right Wing

- Flight control continuity was established throughout the airframe from the flight control surfaces to the controls within the cockpit.
  - The right aileron bellcrank was fractured and pulled through the aileron stop into the wing rib

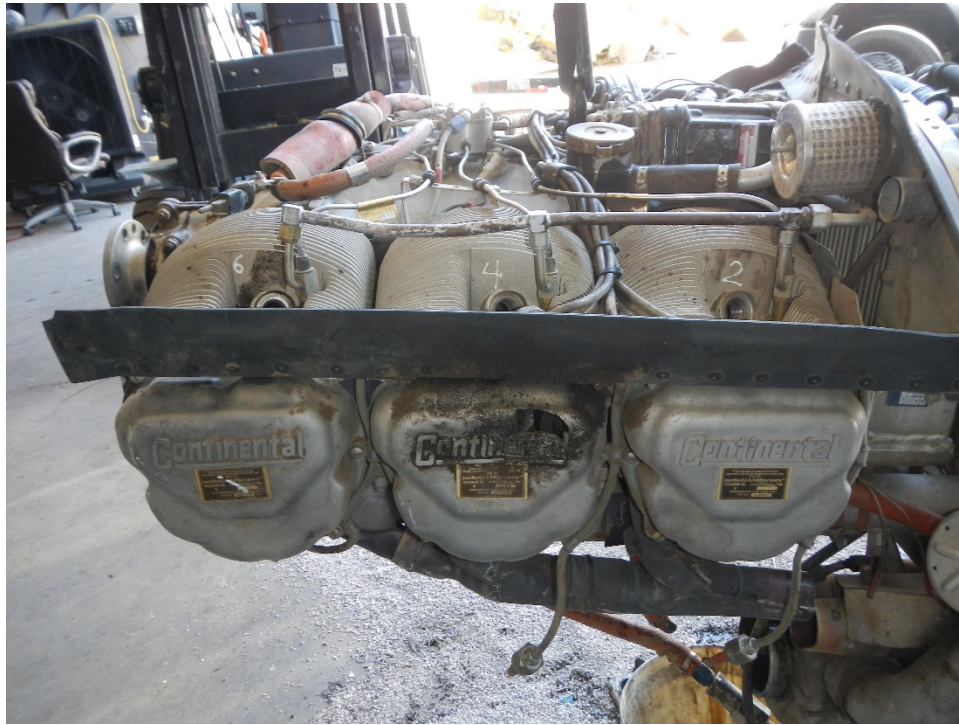
Figure 5: Left Side of Engine

- The engine was removed from the attached fuselage components
- The left side of the engine sustained the most significant impact damage
  - Deformation damage noted on the cylinder #6 intake and exhaust tubes

- The cylinder #4 rocker cover was punctured from the outside-in.
  - The exhaust manifold was displaced aft from the risers on the left side.
- All b-nut fittings (fuel, air reference, and oil) were in place and secured on their respective fittings.

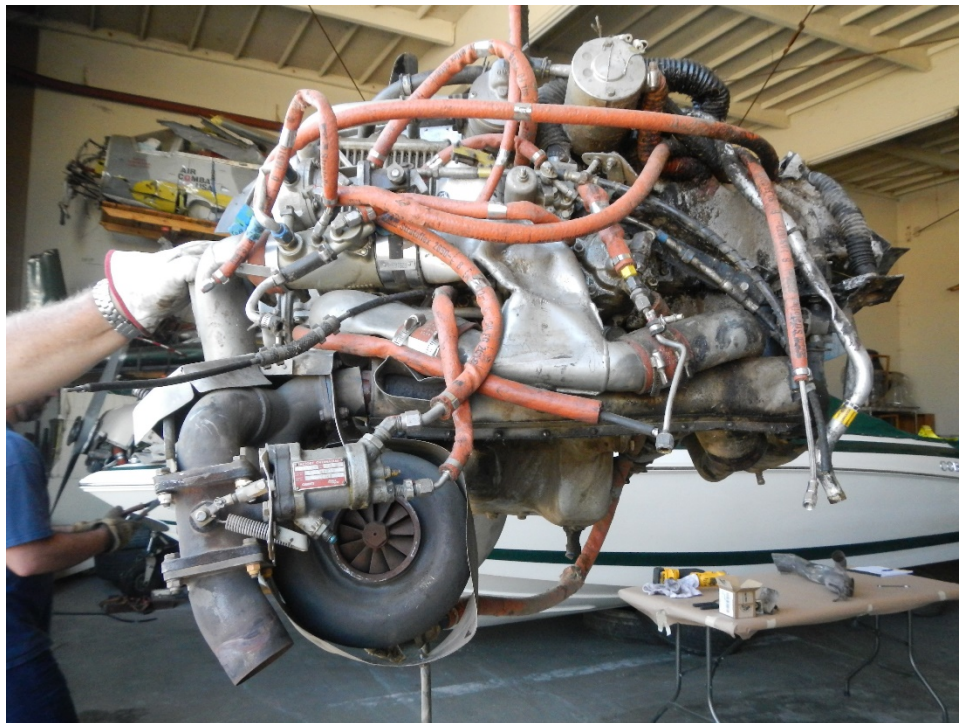
Figure 6: Turbocharger System

- All oil lines to and from the turbocharger bearing, wastegate actuator, and VAPC were in place and intact.
- Rotation of the turbocharger turbine resulted in coinciding rotation of the impeller with no binding noted.

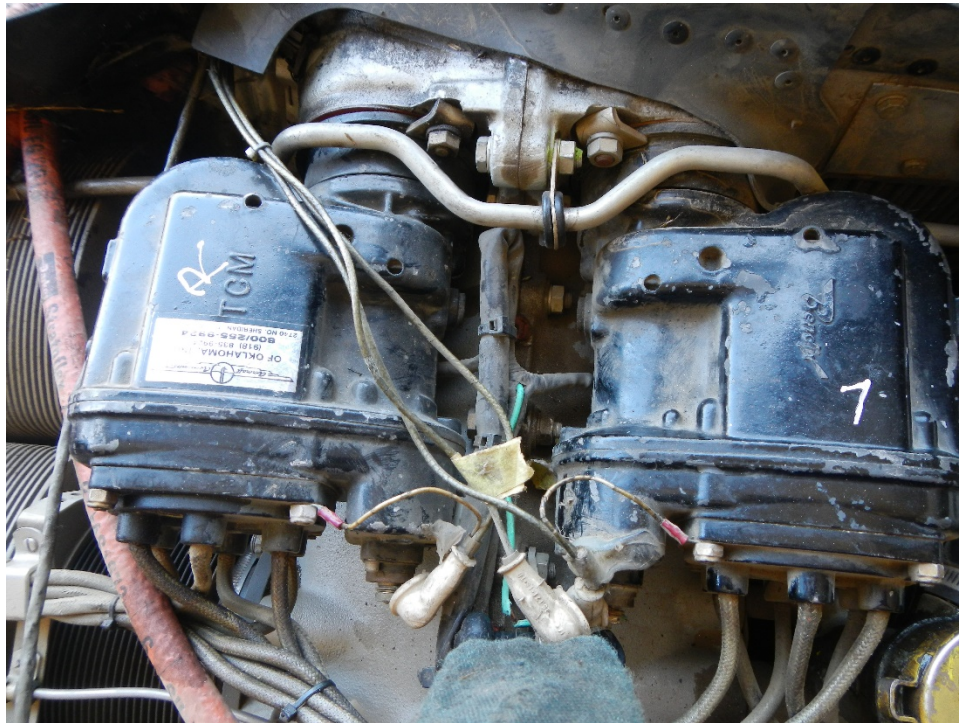
Figure 7: Magnetos

- The right magneto was slightly displaced from the mounting pad and the flange was fractured.

- The left magneto remained in place.
- The ignition harness remained in place and all terminal ends remained attached to the spark plugs.
- The upper spark plugs were removed

- The vent plugs for both magnetos were removed and the distributor gears rotated during the manual rotation of the crankshaft. All distributor gear teeth appeared to be intact.

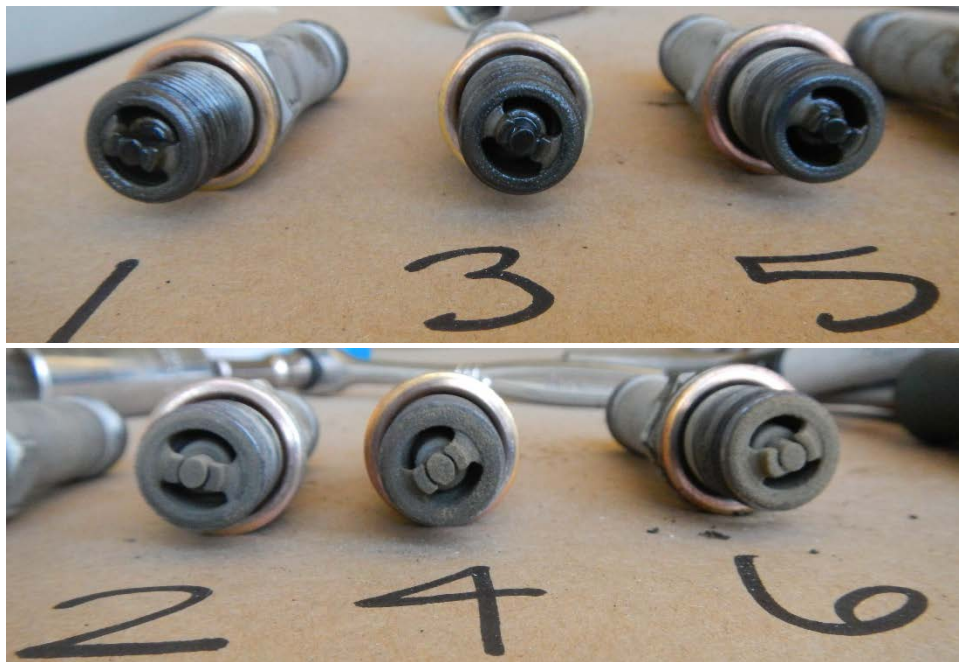
Figure 8: Upper Spark Plugs

- The spark plugs from cylinders 1, 3, and 5 were oil coated.
    - There were no signs of lead or carbon fouling.
  - The spark plugs from cylinders 2, 4, and 6 were coated in dirt and dust consistent with that found at the accident site.

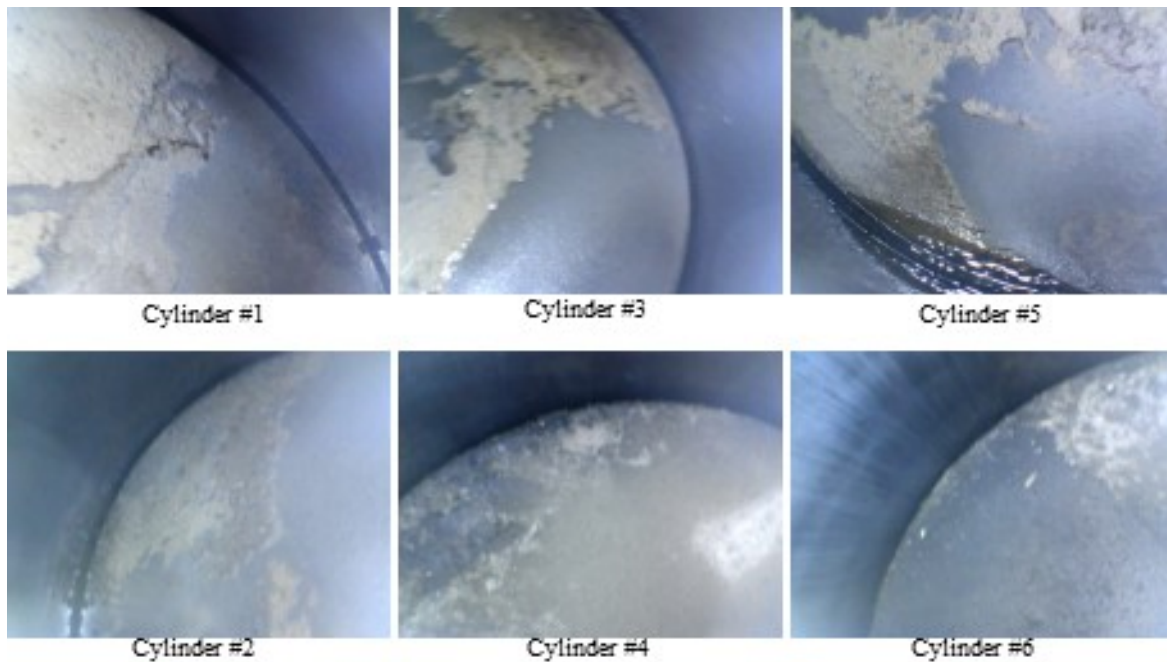
Figure 9: Borescope Images of Piston Faces and Cylinder Walls

- Borescope inspection of the cylinders revealed no pre-accident anomalies with the pistons, barrels, valves, and valve seats.
  - Dirt and debris from the accident site was noted in the #4 and #6 cylinders.

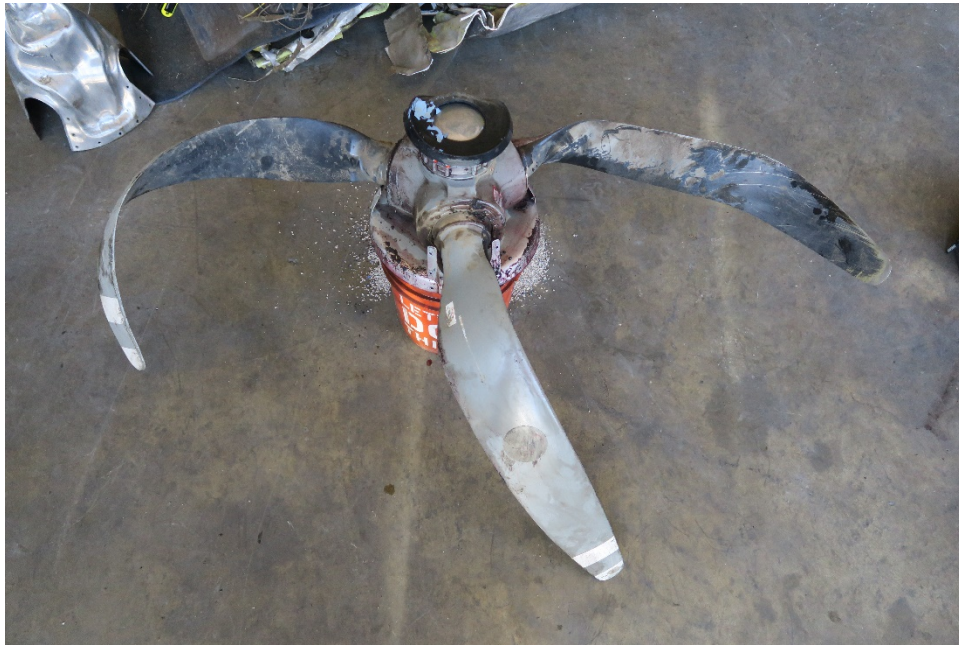
Figure 10: Propeller Assembly

- Propeller assembly remained attached to crankshaft and was removed
- All 3 pitch change links were found fractured
- Blade #2 was found curled toward low pitch and exhibited chordwise paint burnishing
- Blade #1 was bent aft near the root of the blade
- Blade #3 was bent both near the root and the outboard portion of the blade
- The propeller governor was observed fractured and the pump gear were visible
  - The propeller control cable remained attached, but the housing was
  - fractured
