## **NATIONAL TRANSPORTATION SAFETY BOARD**

# **ENGINE EXAMINATION – CONTINENTAL MOTORS**

**WPR18FA219**

Location: Sylmar, CA  
Date: August 12, 2018  
Aircraft: Beech A36TC, Registration N136RM, Serial #EA-97  
NTSB IIC: Samantha Link

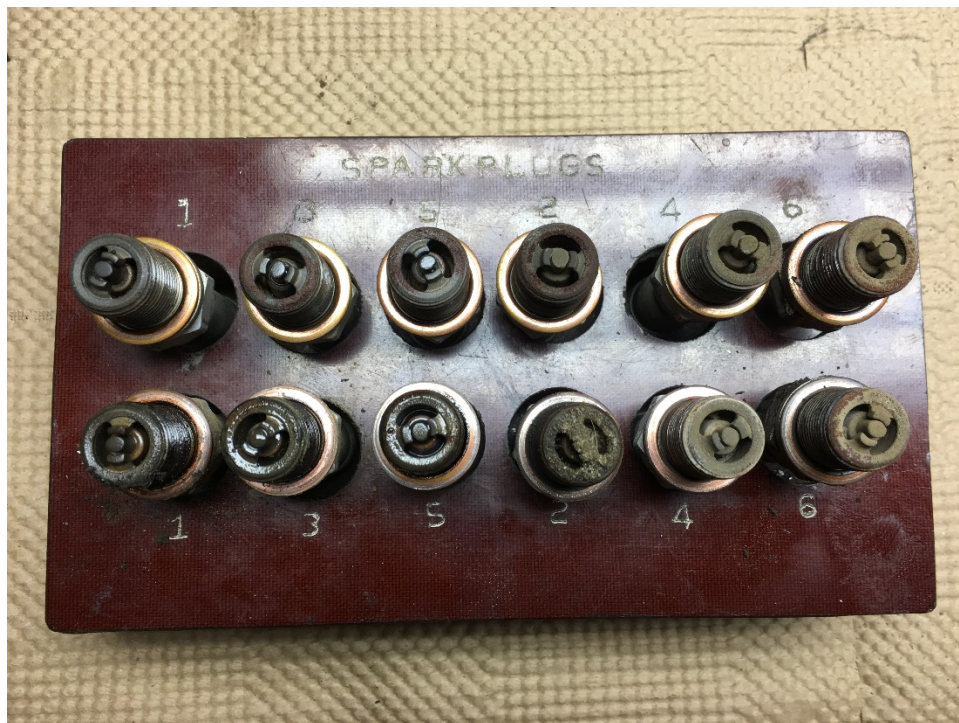
Figure 1: Spark Plugs

- The crankshaft was fractured aft of the propeller flange and it was out of alignment
- The spark plugs were removed and exhibited normal operating signatures

- Upper spark plugs #4 and #6 exhibited dirt consistent with the accident site.
  - Lower Spark plugs #1, #2, #4, and #6 exhibited dirt consistent with the accident site.

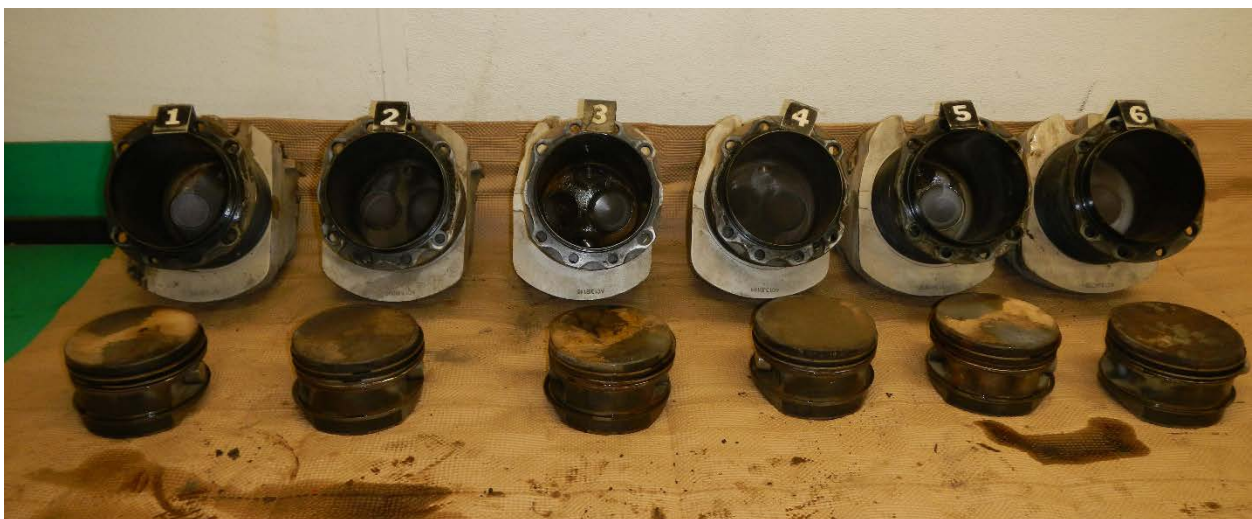
**Figure 3: The Removed Cylinders**

- The cylinders were removed and exhibited normal operating signatures
  - The piston heads exhibited normal operating signatures
- The turbocharger was removed, and the impeller housing exhibited no scoring

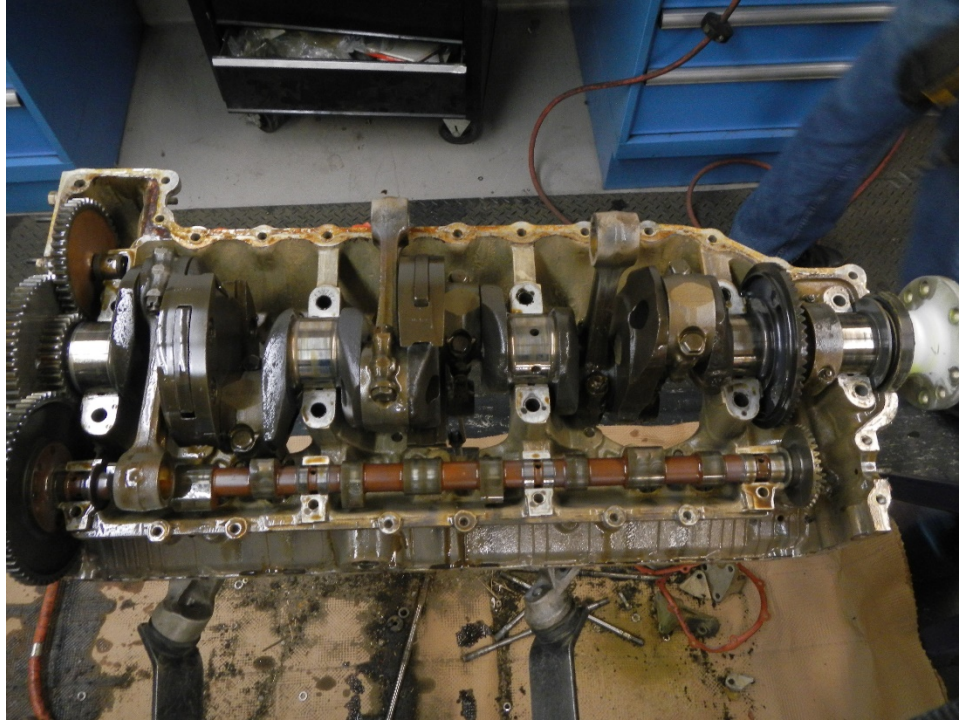
Figure 4: The Split Case

- The pump was disassembled, and all components exhibited normal operating signatures.
- The crankcase was split and the crankshaft, camshaft, piston arms, journals, were all oily and exhibited no abnormal or thermal signatures

- Some small environmental debris was noted inside the case.
  - The camshaft lobes exhibited normal operating wear signatures
- Oil filter was removed and opened

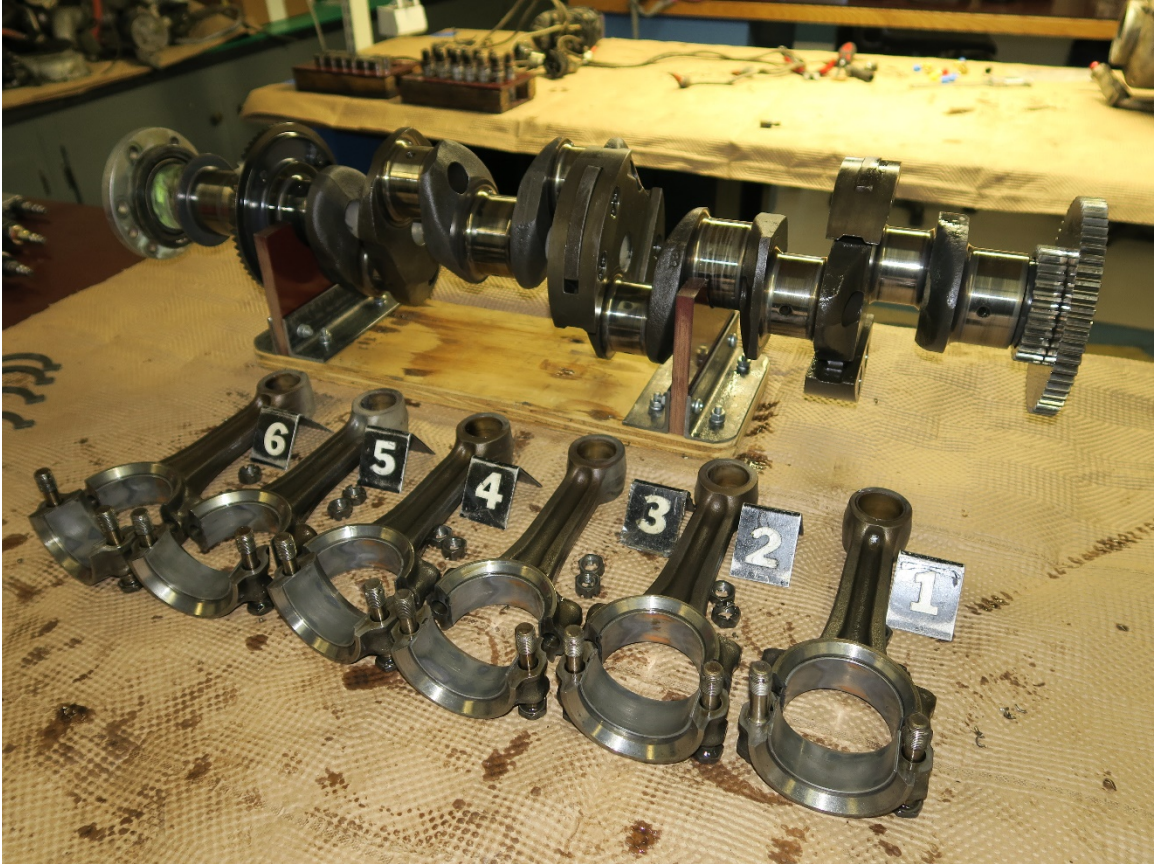
**Figure 6: Crankshaft and Bearing Wear**

- The main bearing in journal #2 on the 2, 4, 6 side exhibited some wear on the bearing, consistent with fatigue disintegration. There was no corresponding wear on the crankshaft.

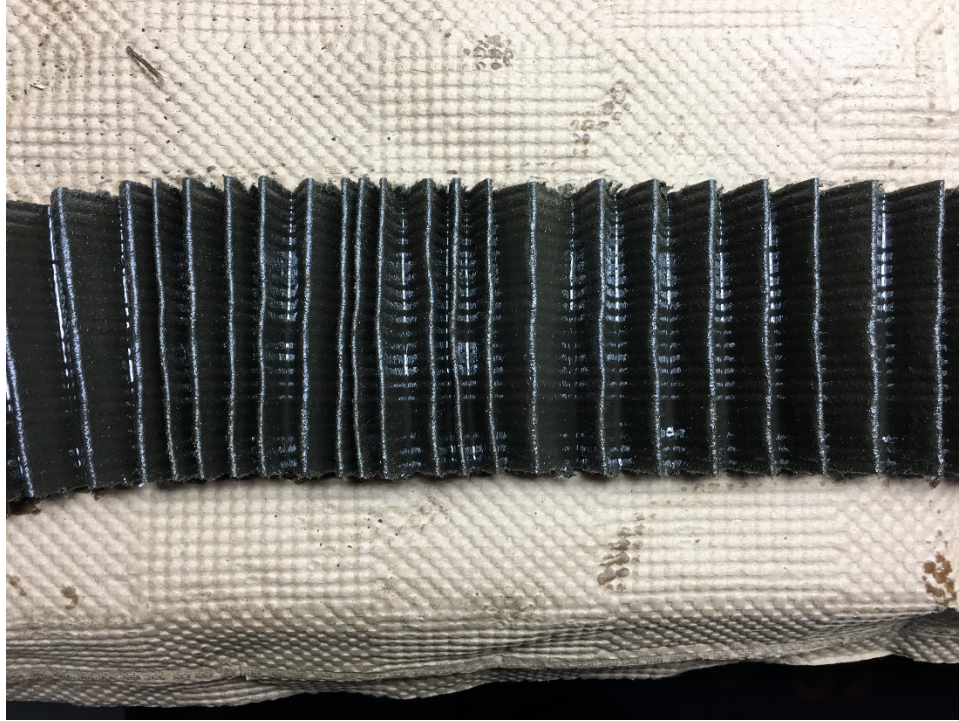
Figure 7: Oil Filter

- There was no debris.
- The magnetos were installed onto a test bench and produced a strong spark at various RPMs over a 7 mm gap.
- The arm between the waste gate actuator and the valve was bound due to impact damage.
