# NATIONAL TRANSPORTATION SAFETY BOARD

## Onboard Image Recorder

### Specialist's Factual Report

Location: Phoenix, Arizona  
Date: 08/20/2018  
Aircraft: Acroduster II, N787WM  
Operator: Private  
NTSB Number: WPR18FA229

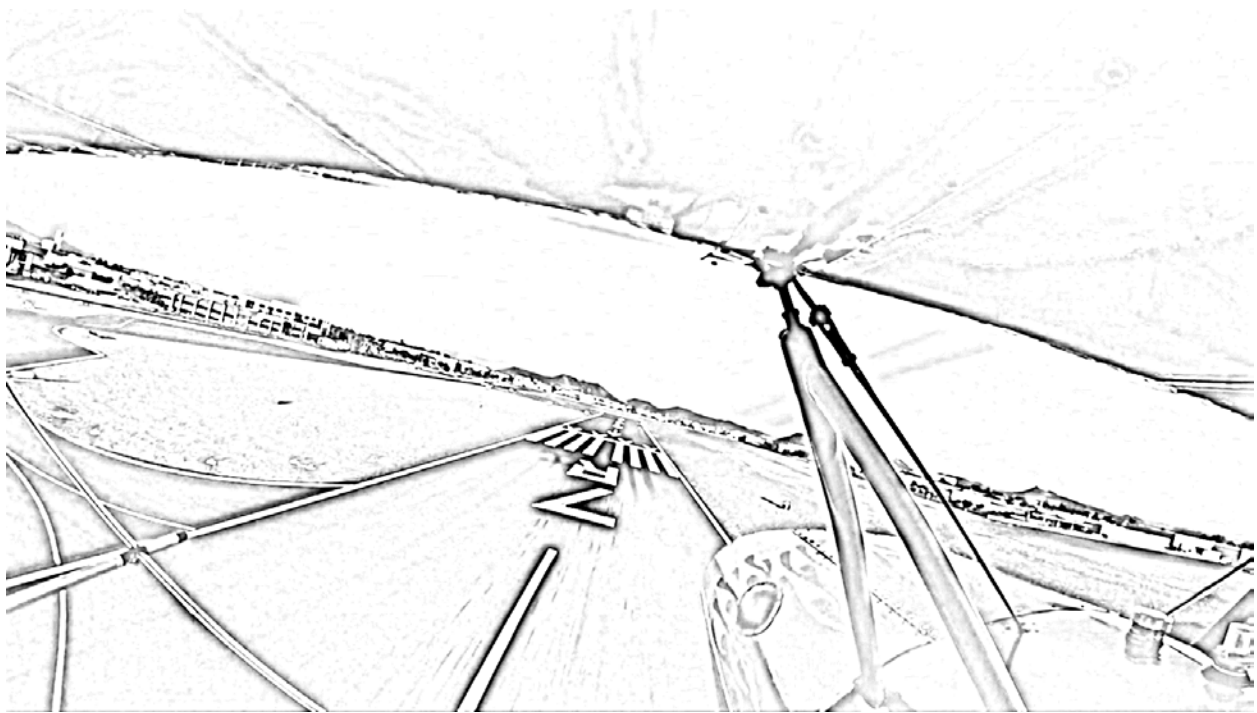
Figure 1 is a digital illustration of the camera's field of view. The camera was mounted on the left wing of the aircraft and was looking forward over the nose of the aircraft on the left side. It captured an indication of whether the engine was running but did not capture control positions. An audio track was included with the video files.

Figure 1. A digital illustration of the field of view of the camera.
