## **NATIONAL TRANSPORTATION SAFETY BOARD**

**(WPR18FA229)**

### **A. ACCIDENT**

| Aircraft: | Acroduster II, N787WM |

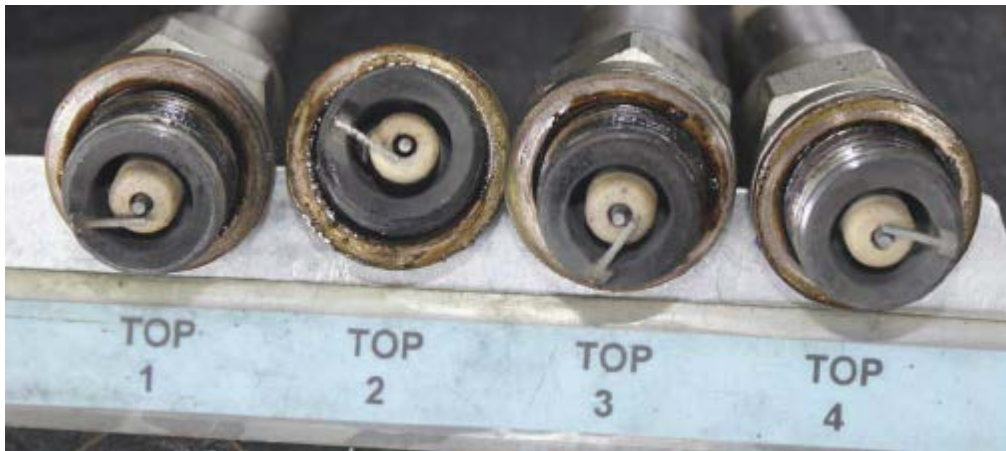
**Spark plugs:** The spark plugs were secure at each position with their respective spark plug lead attached. The spark plugs were removed, examined and photographed. The spark plug electrodes remained mechanically undamaged, and according to the Champion Spark Plugs Check-A-Plug chart AV-27, the spark plug electrodes displayed coloration consistent with normal operation.

Figure 1 - photo of spark plugs

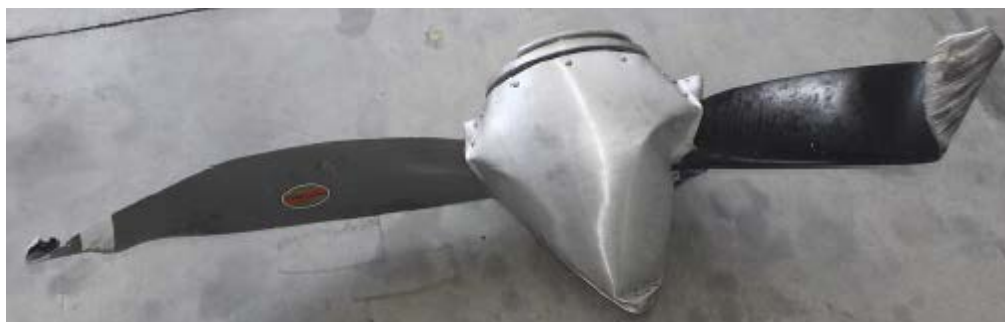
The metal two bladed constant speed propeller, along with the attached crankshaft flange were displaced from the engine. The crankshaft fracture surface exhibited signatures consistent with torsional overload due to the absorption of rotational energy. The propeller blades remained attached at the hub. Both blades displayed leading edge gouging, torsional twisting, chordwise striations across the cambered surface and trailing edge "S" bending. The tip section of each blade had been torn from the blade and recovered at the accident site.

Figure 2 - photo of damaged propeller blades
