## **NATIONAL TRANSPORTATION SAFETY BOARD**

### **ENGINE EXAMINATION**

**WPR18FA232**

Location: Granger, Texas  
Date: August 21, 2018.  
Aircraft: Hughes 369FF, Registration: N530FU  
NTSB IIC: Elliott Simpson

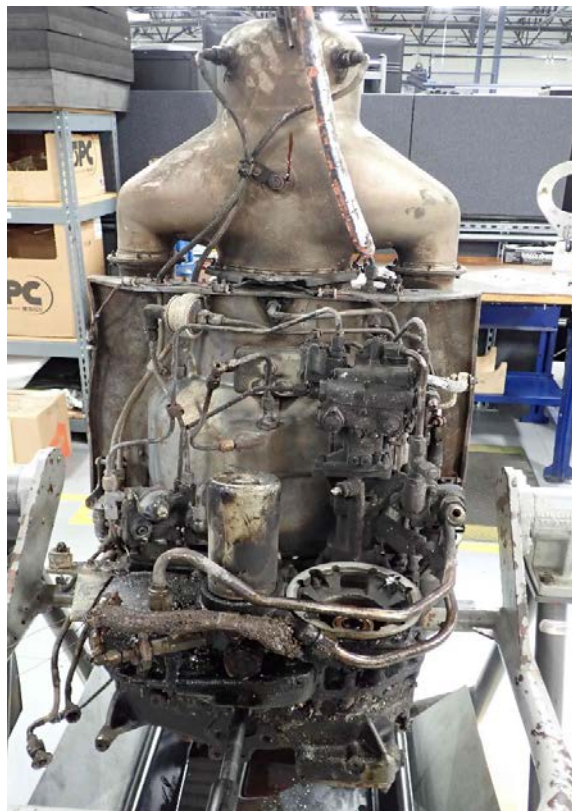
**Photo 1 – Engine in Stand**

The engine exhibited indications of external thermal damage and was coated in light brown soot. The gearbox was coated in darker colored soot and oil residue (Photo 1). All ancillary lines were intact at their respective fittings. The N2 stage could be rotated by hand; N1 had a range of motion of about 20 to 30° in either direction movement was inhibited.

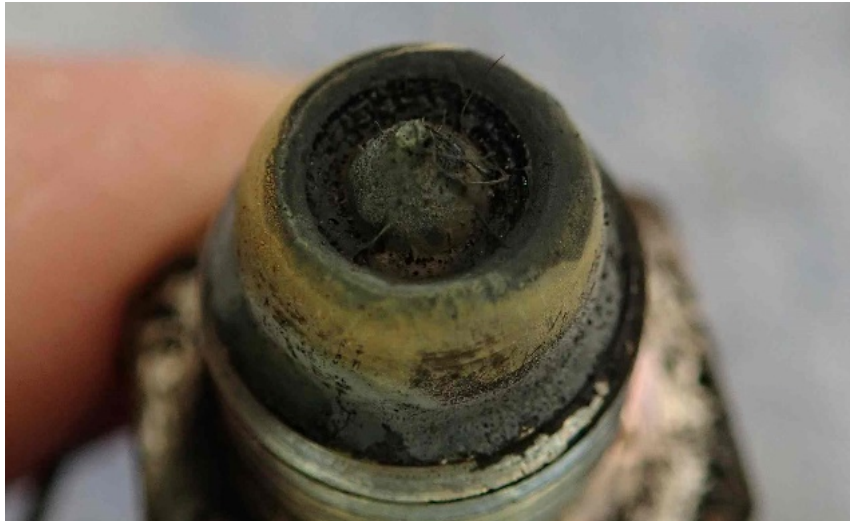
**Photo 2 - Gearbox Upper Chip Detector**

The engine gearbox oil had been drained prior to engine shipment. The upper chip detector was dry, brown, thermally damaged, and covered with about three hair-like strands (Photo 2). The lower chip detector was coated in dark oil and black debris (Photo 3).

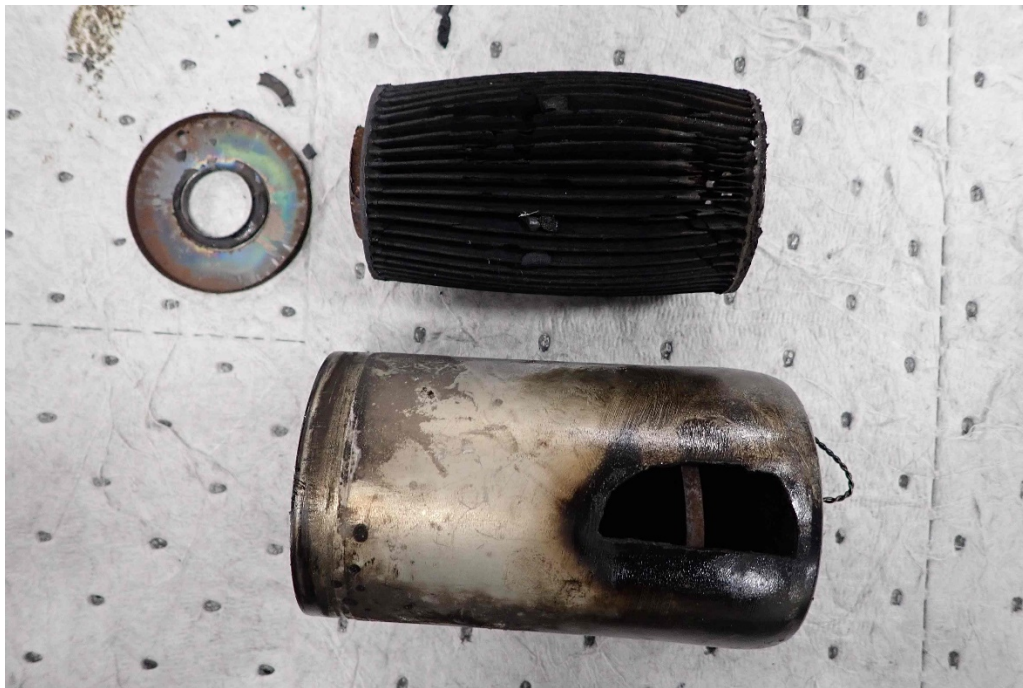
**Photo 4 – Fuel Filter**

The fuel filter remained partially attached to its housing assembly. The top of the filter can exhibited a 1 inch wide by two inches long opening, exposing the filter element. The element was removed and had a charred appearance charred, and no particles were observed between the pleats. (Photo 4).

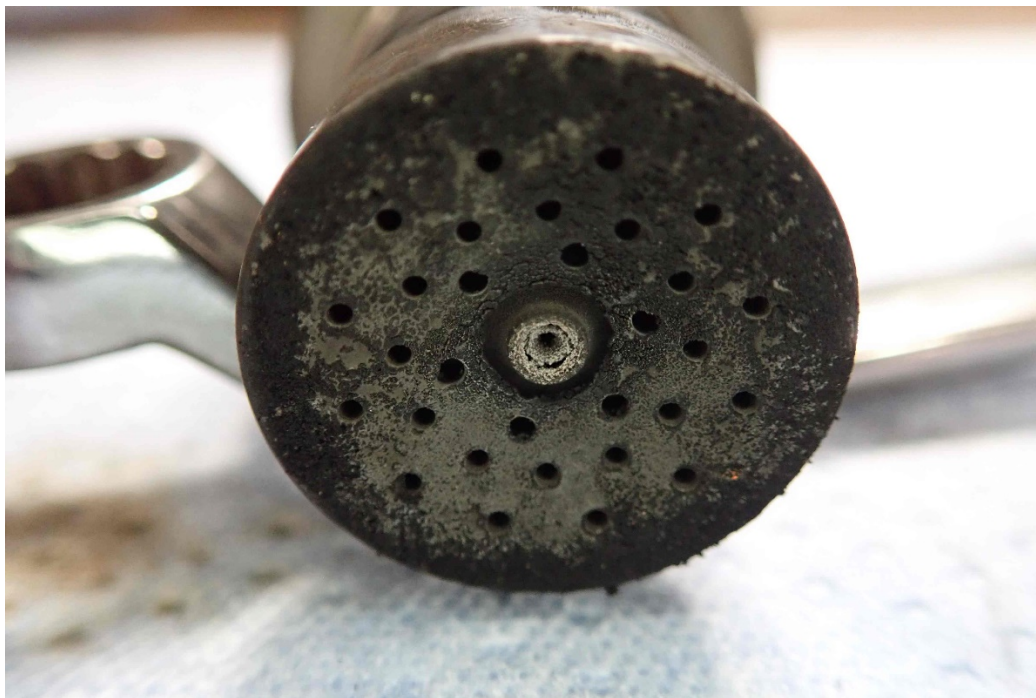
**Photo 5 – Fuel Nozzle**

The fuel nozzle displayed even black and gray deposits around the circumference of its spray face (Photo 5). Both ignitors appeared to be coated in dark brown and black soot, and both exhibited chafing signatures about 3/8 inch short of their tips.

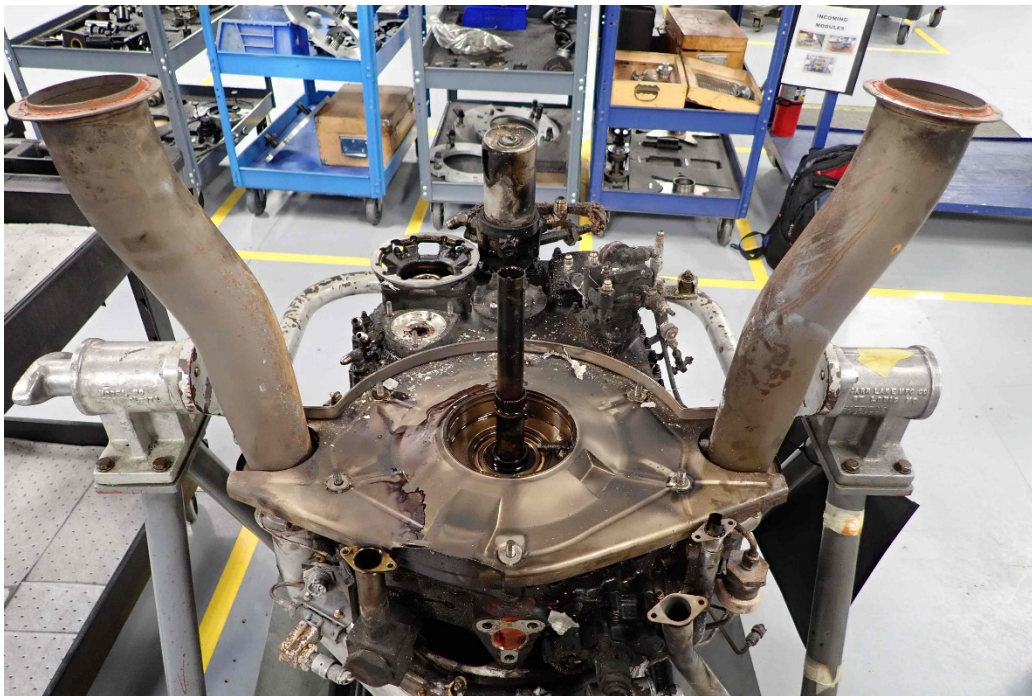
**Photo 6 – Engine Spilt at Exhaust Collector Support**

The ancillary lines and horizontal fire shield components were removed, and the engine was split at the exhaust collector support to facilitate internal inspection (Photo 6). The shims used for alignment of the turbine section and exhaust collector support were checked, and matched those found in the shim record card.

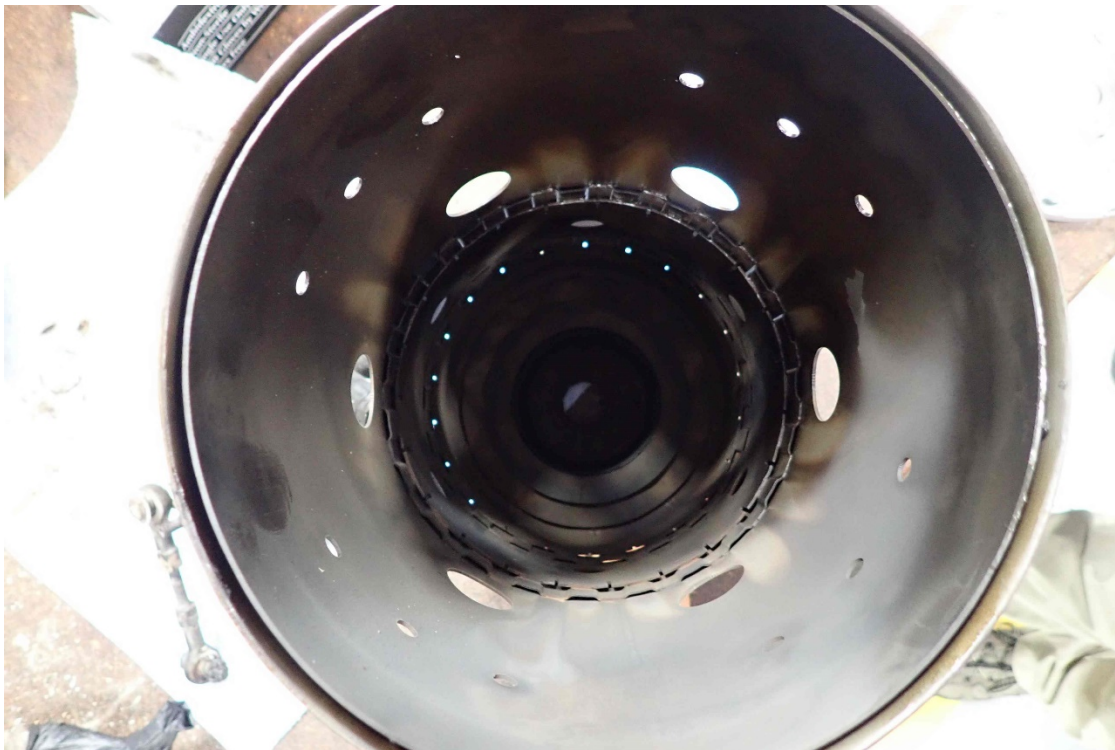
**Photo 7 – Combustion Liner**

The outer combustion case was then removed, and the internal combustion liner examined. The inner surface of the liner was coated in an even pattern of dark brown and black soot, and the liner did not exhibit any indications of damage (Photo 7). The number one nozzle shield and nozzle were intact and exhibited even burn patterns and dark brown sooting deposits. (Photo 8). The power turbine assembly could be rotated smoothly by hand. The fourth stage turbine wheel was viewed through the exhaust collector shroud, all blades appeared intact and undamaged (Photo 9).

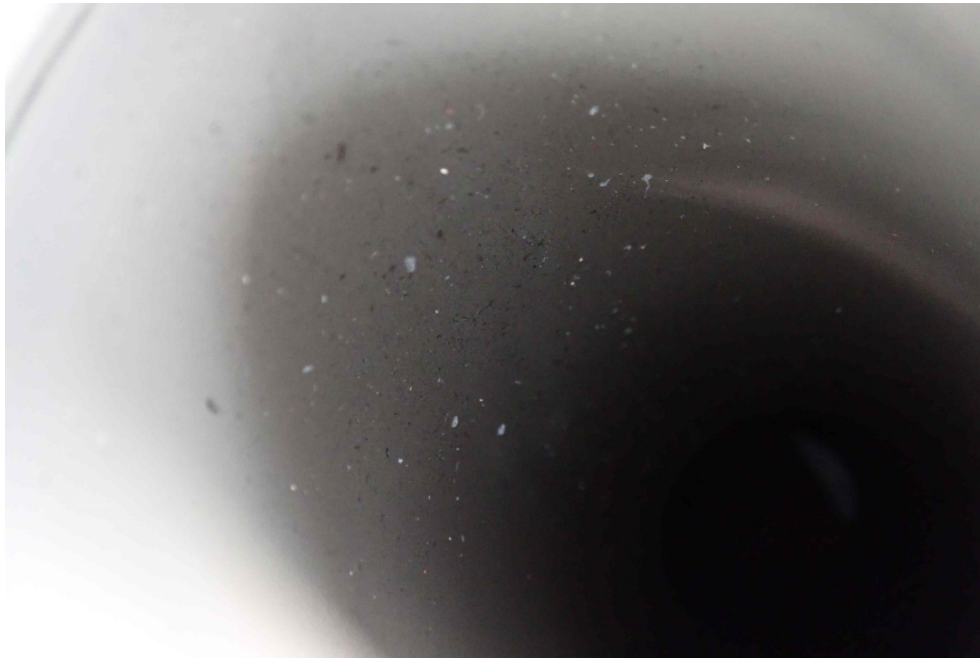
**Photo 10 – Inner Surface of a Compressor Discharge Tube**

The inner surface of the compressor discharge tubes were coated in even dark brown deposits, and speckled with white dust-like particles (Photo 10).

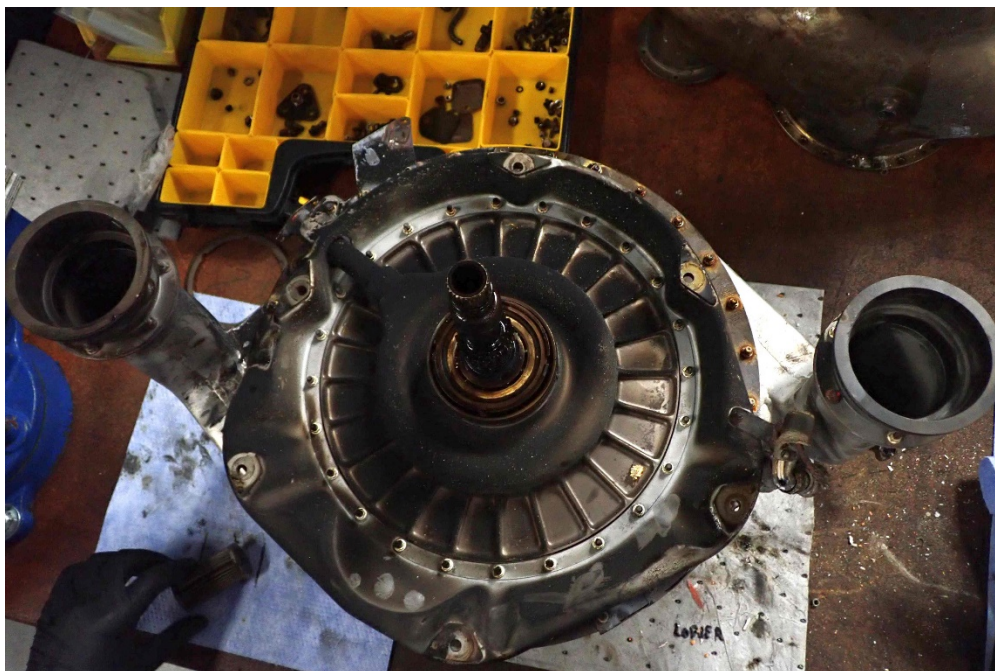
**Photo 11 – Impeller Shroud and Spur Adapter**

The compressor section was removed from the gearbox. The alignment shims were checked and found to match those found in the shim record card. The impellor could be rotated by hand and no indications of binding within the scroll could be felt (Photo 11). The number 2 bearing was coated in oil and appeared intact. The spur adapter was intact, coated in oil and appeared

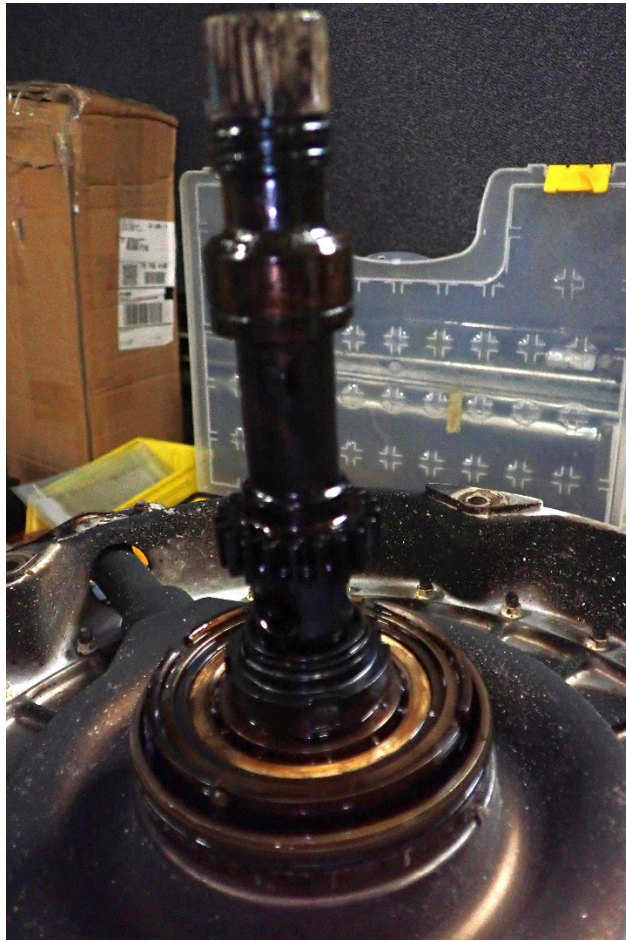
**Photo 12 – Number 2 Bearing and Spur Adapter**

undamaged (Photo 12). The pressure oil filter was coated in oil and there were no visible particles within the pleats (Photo 13).

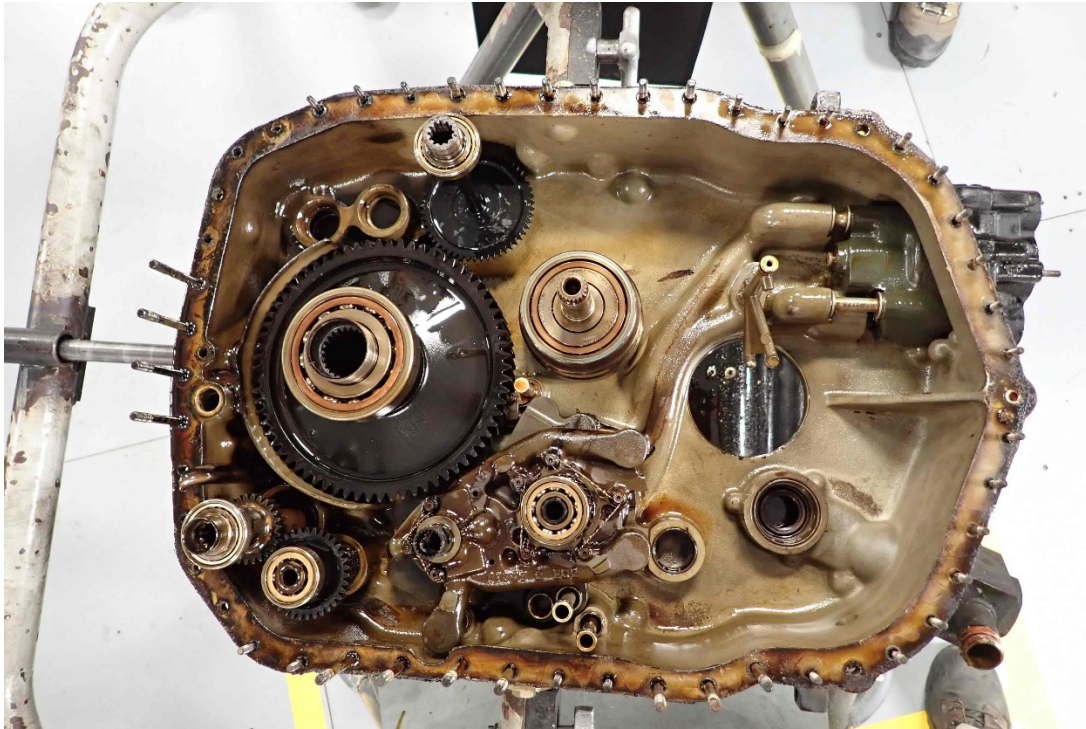
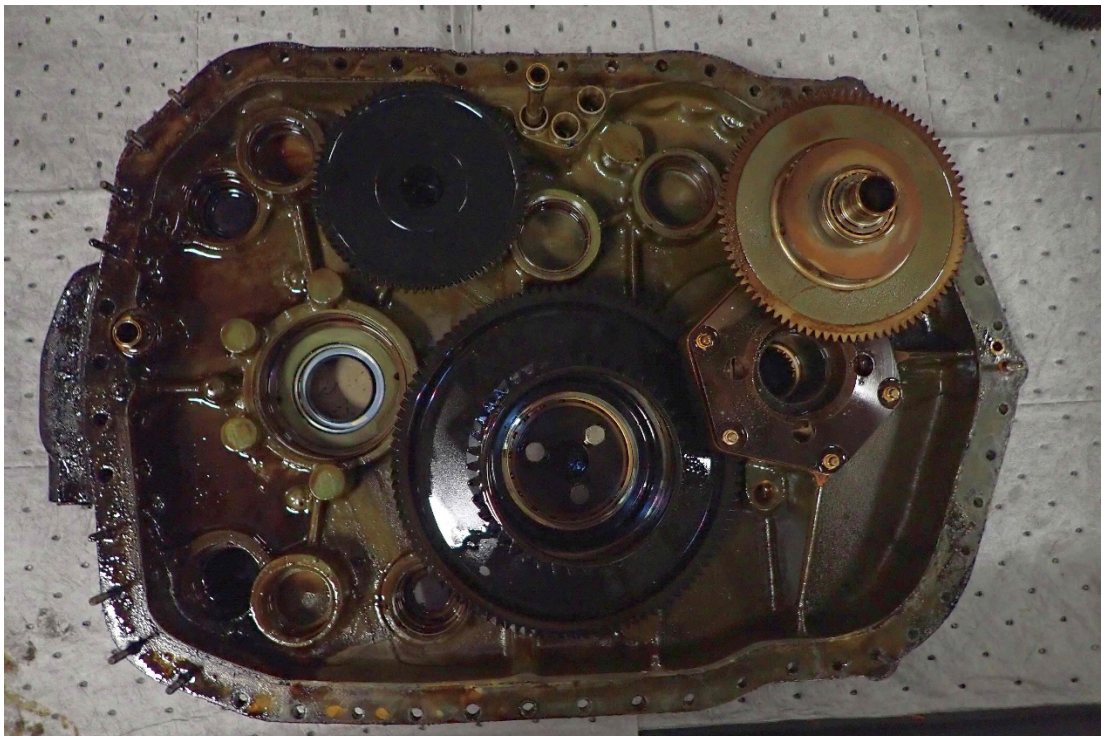
Drive train continuity throughout the gearbox was confirmed between the N2 tach generator output and power output drive. The N1 tach generator output could not be rotated by hand. The gearbox case was opened, and gears examined (Photo 14,15). All gears were intact and coated in oil. The case was free of debris or visible metal shavings. The oil pump input shaft could not be rotated. The oil pump was removed and disassembled; the pressure side gears were wet with oil, intact, and the pump cavity was free of gouges (Photo 16). The scavenge gears were all intact and undamaged, and coated in a black “baked” glaze that appeared to prevent rotation (Photo 17).
