## **NATIONAL TRANSPORTATION SAFETY BOARD**

### **AIRFRAME EXAMINATION**

**WPR18FA232**

Location: Granger, Texas  
Date: August 21, 2018  
Aircraft: Hughes 369FF, Registration: N530FU  
NTSB IIC: Elliott Simpson

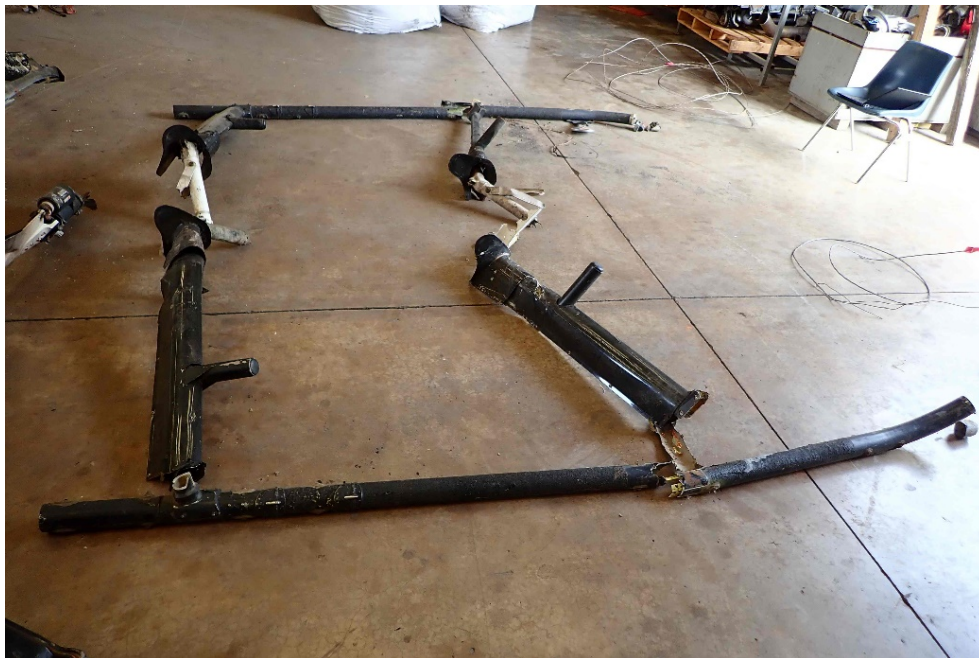
**Photo 1 – Strut and Skid Assembly**

All four landing gear struts remained attached to their respective braces, all of which had detached from the center beam (Photo 1). The forward ends of both skid tubes were impacted with dirt. The red position light remained loosely attached to the forward end of the left skid by the lights wiring; the green position light was separated and displayed indications of thermal damage and was located detached in the burn area of the debris field.

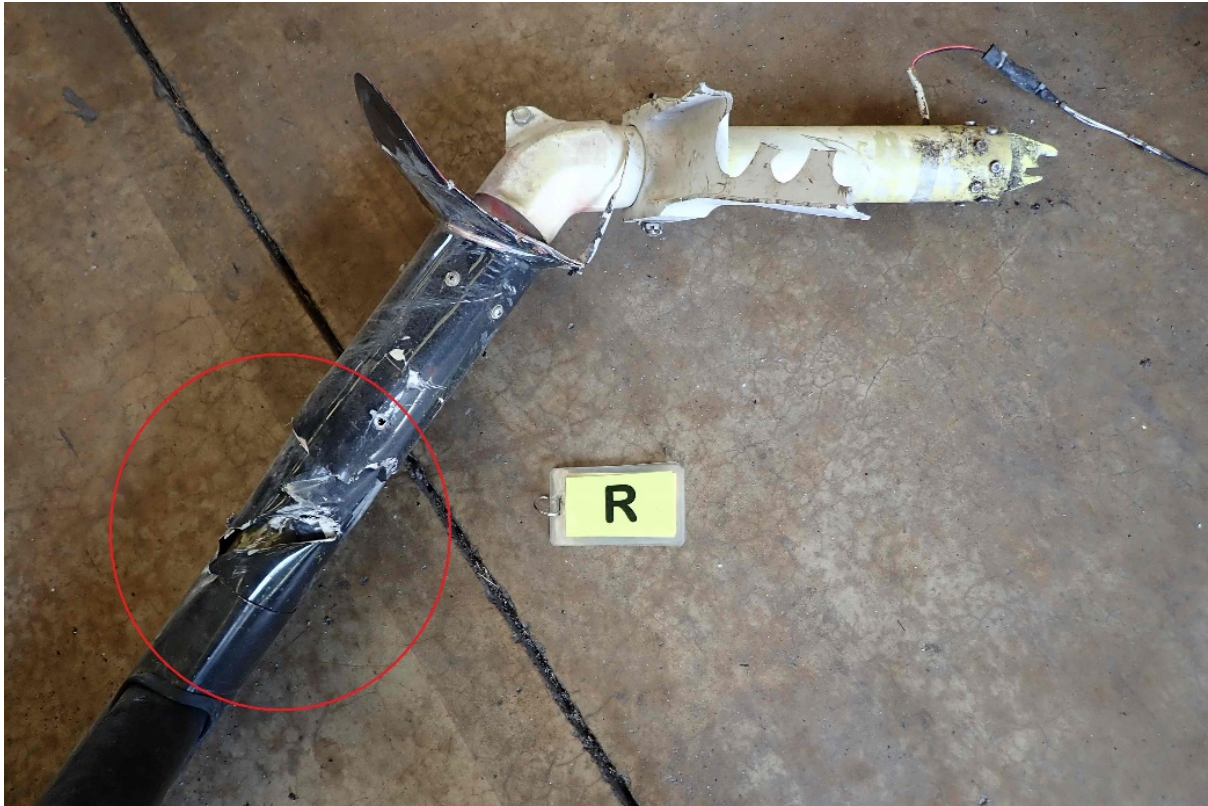
**Photo 2 – Forward Right Strut and Fairing**

On the right landing gear assembly, the front and rear struts had broken away from the skid tube at their respective feet. The skid tube had separated into two pieces at the intersection with the foot of the forward skid. A serrated gouge, parallel to the helicopters horizontal plane, was observed in the leading edge of the forward upper strut fairing (Photo 2). Horizontal scratches in the paint and outer surface of the strut fairing continued up the fairing, exposing red paint and the resin surface of the strut fairing. Wire-like striations were present along the outboard side of the rear strut fairing (Photo 3).

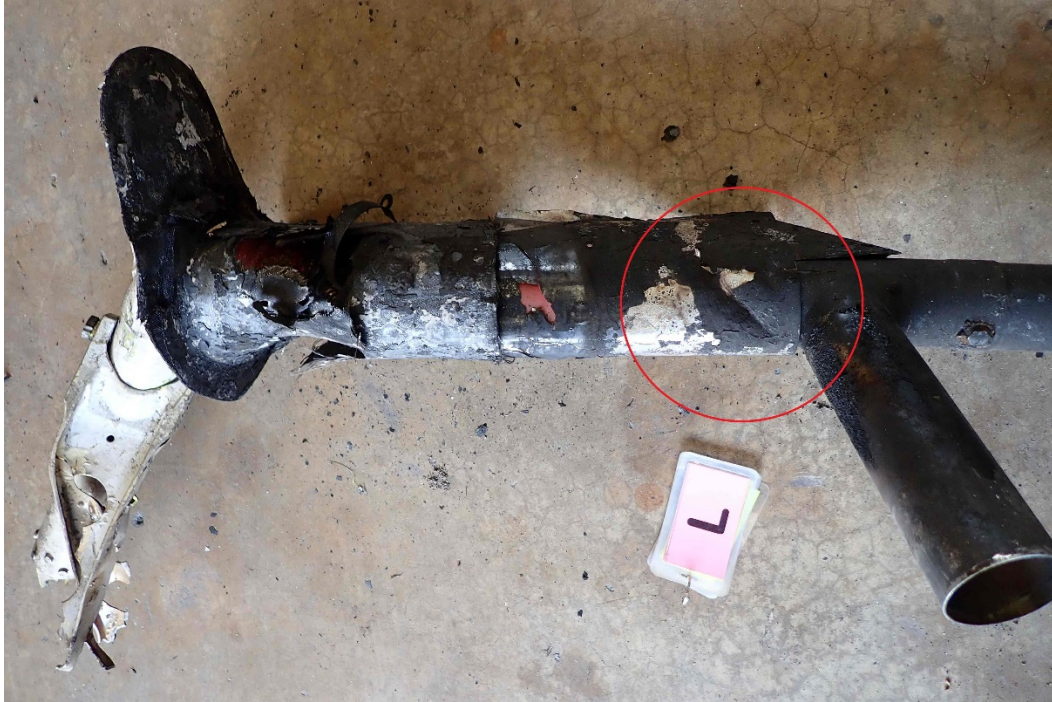
**Photo 4 – Left Forward Strut, Upper Fairing**

On the left side landing gear assembly, the front strut had broken away from the skid tube at its feet. The skid tube had separated into two pieces at the intersection with the foot of the forward skid. The rear section of the skid remained attached to the rear strut. The front strut below the step did not have a fairing installed. According to the representative from Brunner Aerospace, the strut fairing had been removed to aid with ground observations during helicopter use. The forward strut's fairing exhibited a vertical dent on the outboard side, just above the step (Photo 4). The rear strut fairing exhibited an 8-inch-long series of striation marks, leading to a tear on its trailing edge near the upper section of the fairing. The width of the tear and its damage features were similar to that of the power line. (Photo 5, 6)

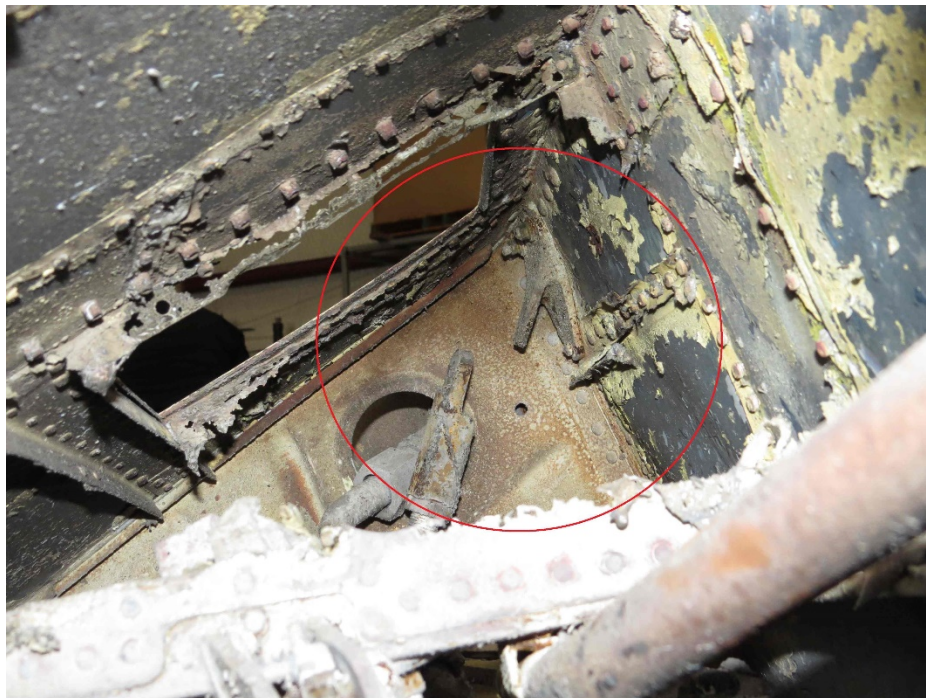
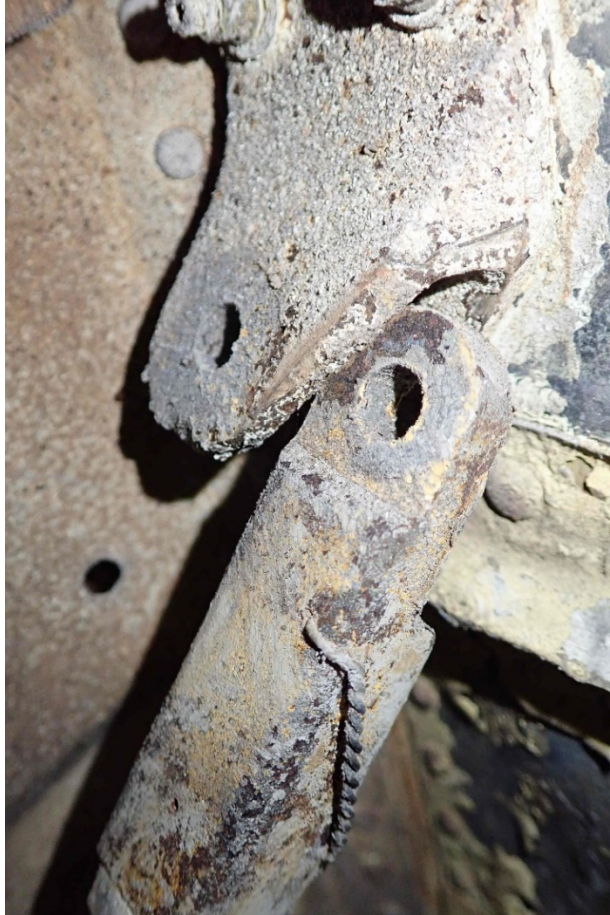
The engine was coated in soot deposits but remained largely intact. The left upper engine mount assembly remained attached to the engine and airframe. The lower engine mount assembly was attached to the engine but had fractured at the threaded section near the station 137.5 airframe attach point. The right upper engine mount remained attached to the engine and the lower tube was attached to the airframe at the landing gear damper fitting. The upper tube of the right upper engine mount was observed detached from its mount fitting at the station 124 canted frame. There was no evidence of its attachment nut, bolt, or washers, and there was no indication of damage to the bores of either the tie rod or corresponding bulkhead attachment bracket, or fretting damage to the mating surfaces indicative of long term movement (Photo 7, 8, Figure 4).

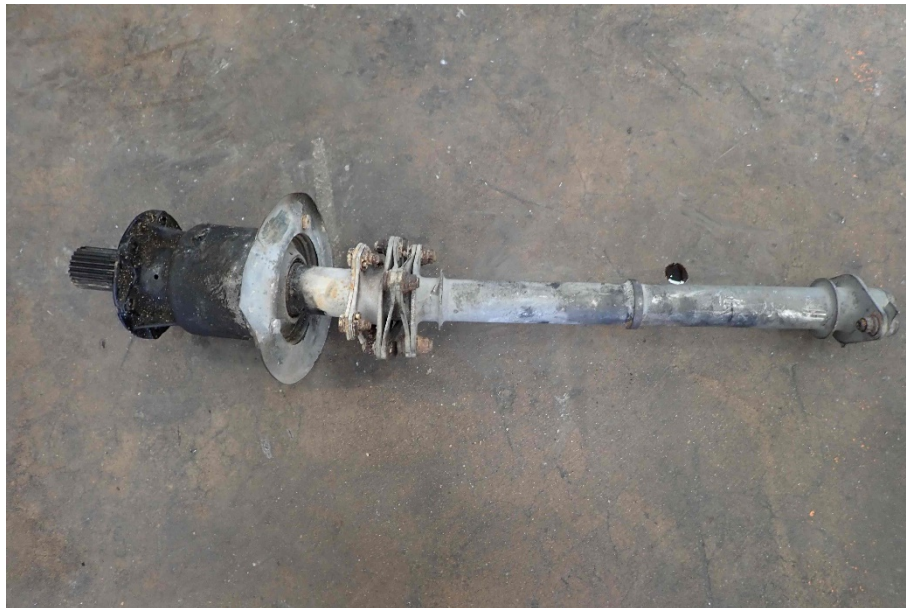
**Photo 9 - Overrunning Clutch and Engine Driveshaft**

The overrunning clutch and engine Kamatics' KA flex® driveshaft remained attached to the engine gearbox output drive (Photo 9). The overrunning clutch could be rotated by hand in one direction and would lock when rotated in the other direction. The flexible coupling at the engine side of the driveshaft was intact. The flexible coupling on the main transmission side had detached, with segments of the flexible coupling frames still remaining on the shaft (Photo 10, 12), and segments of coupling frames detaching from the complete assembly (Photo 11). Neither the overlapping sleeve nor the driveshaft insert exhibited any indications of rotational scoring. (Photo 10, 12).

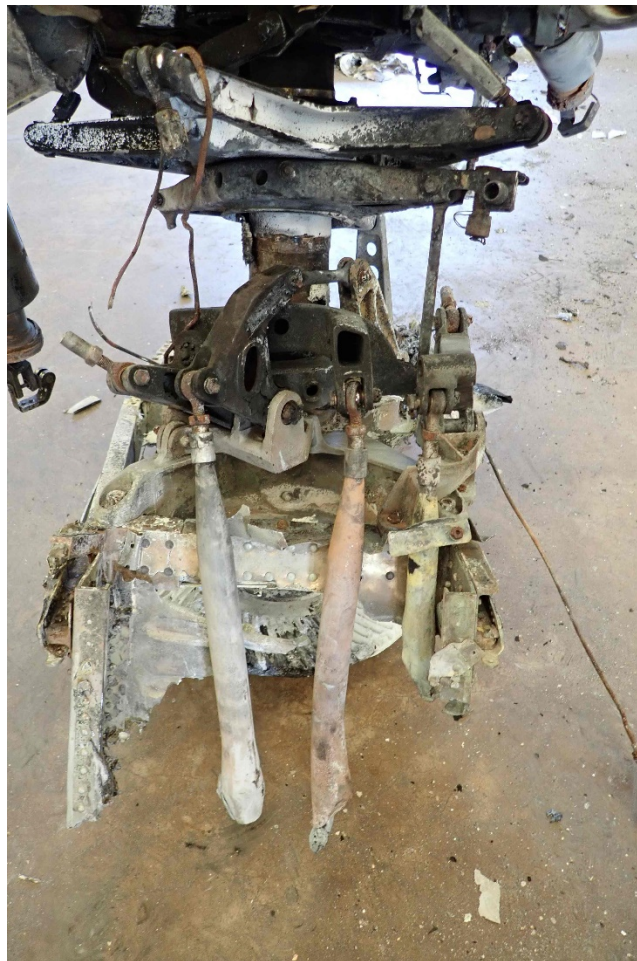
**Photo 13 – Static Mast and Upper Main Rotor Flight Controls**

The collective mixer control rod, longitudinal mixer control rod, lateral mixer control rod, and anti-torque control rod remained attached to their respective idlers and bellcranks. All rods except for the collective appeared to have burnt away about 10 inches below their respective rod end at the approximate entry location to the control tunnel entrance (Photo 13). The collective rod had separated directly below the threaded portion of its rod end.

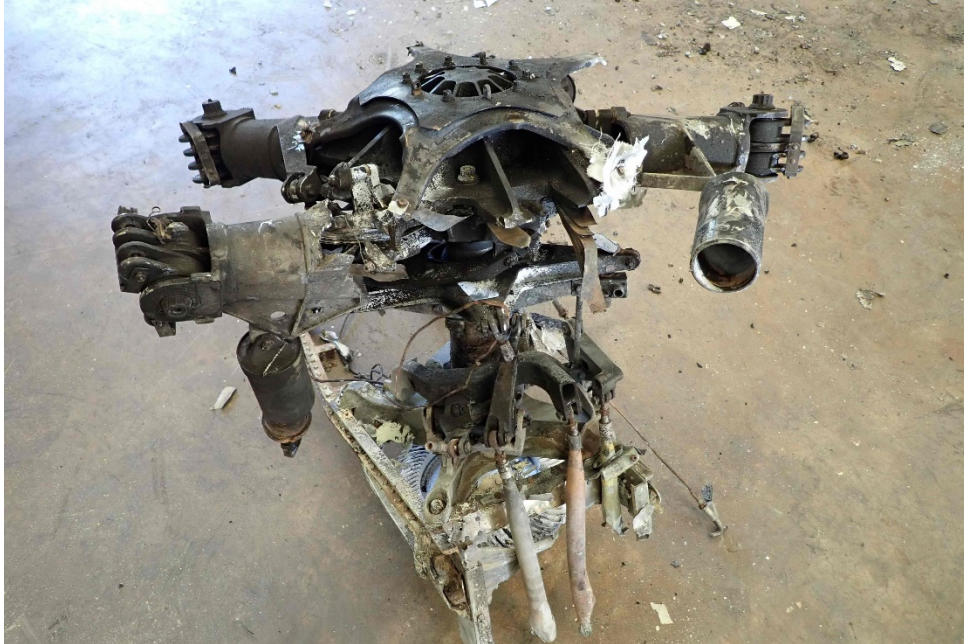
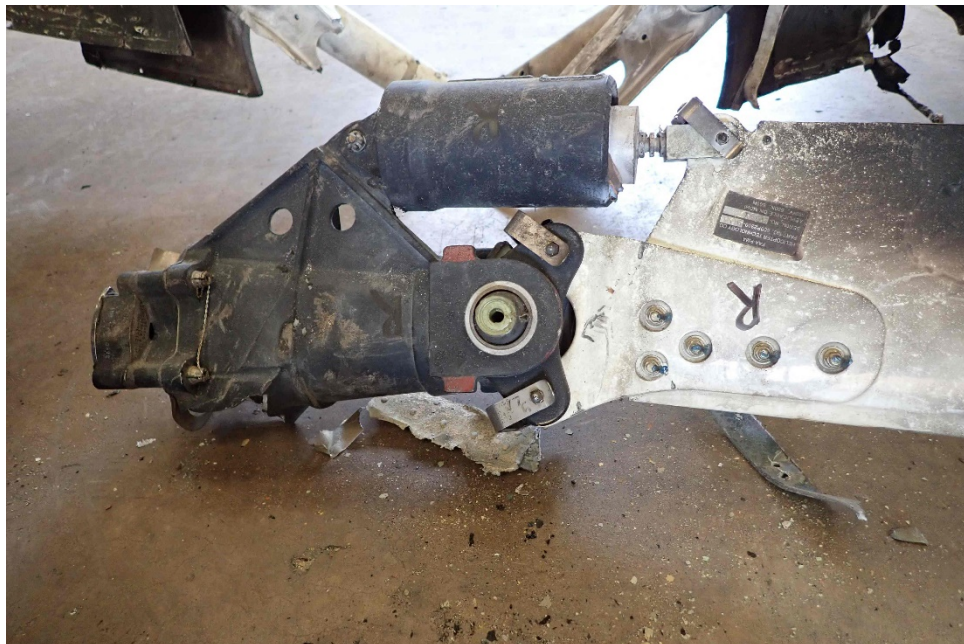
The entire red blade pitch housing had pulled away from the upper hub, revealing remnants of the strap pack assembly (Photo 14). The blade remained attached to the pitch housing, and the lead lag bolt was intact along with the damper (Photo 15). The entire blade was bent 90 ° opposite the direction of travel in a progressive curve (Photo 16). The tip was still attached, and the trailing edges had opened exposing the core. The inboard 30-inch trailing edge section of the blade was coated in soot.

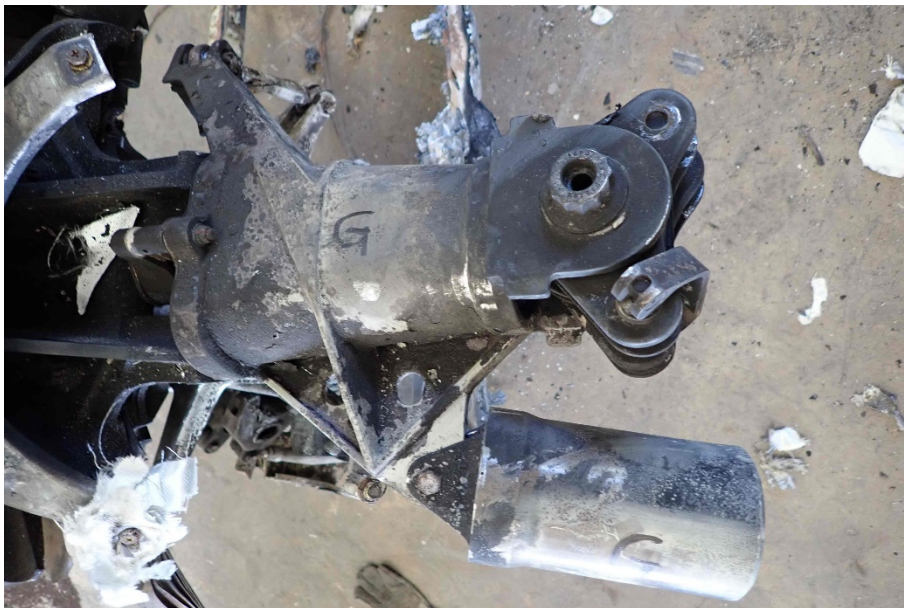
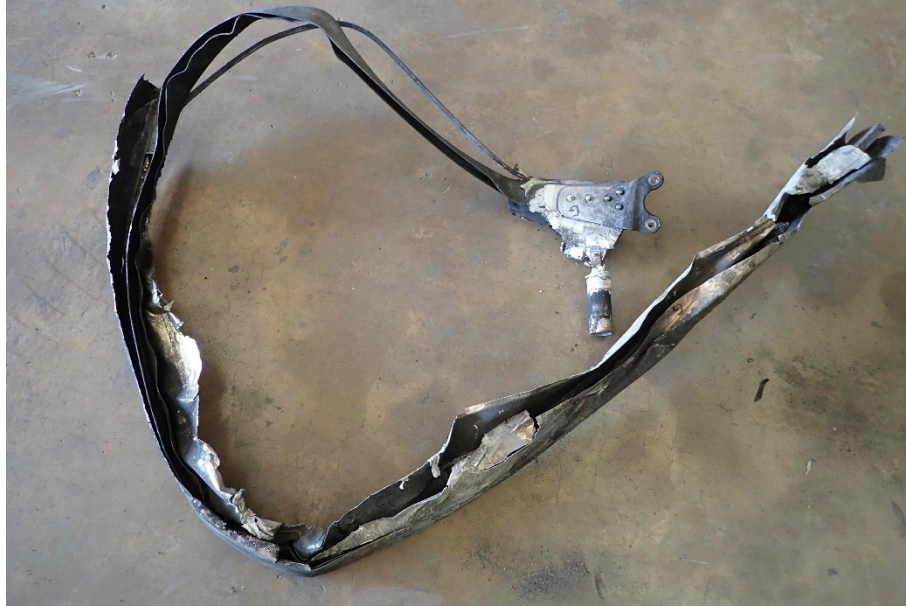
The green blade pitch housing remained attached to the upper hub. The damper was still attached to the pitch housing, and the elastomer had pulled free (Photo 17). The blade remained attached to the pitch housing and had bent back on itself such that the tip was resting next to the root (Photo 18). The tip was still attached, and most of the skins and honeycomb material were consumed by fire, exposing the main spar and leading-edge balance weight.

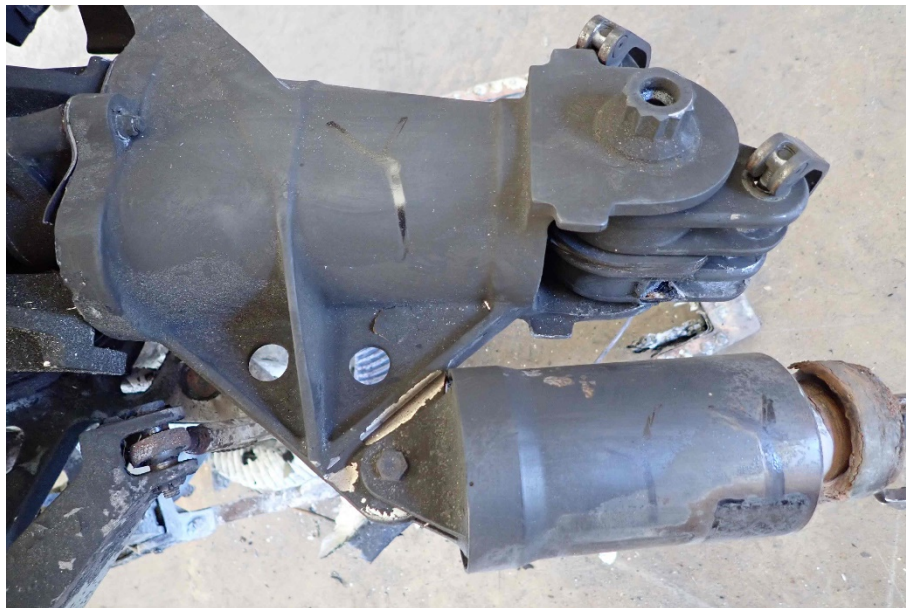
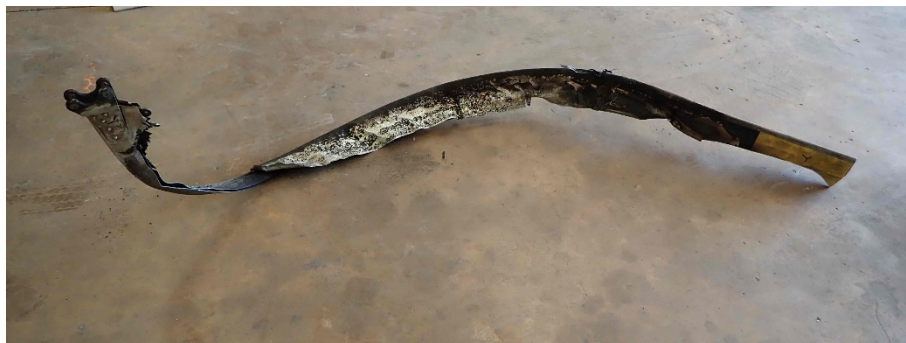
The yellow blade pitch housing remained attached to the upper hub (Photo 19). The damper was still attached to the housing, and the elastomer remained loosely within. The blade was still attached to the pitch housing and was twisted into a progressive “S” shape along its entire length (Photo 20). The tip was still attached, and fire had consumed about 4ft of the skins from the root outboard.

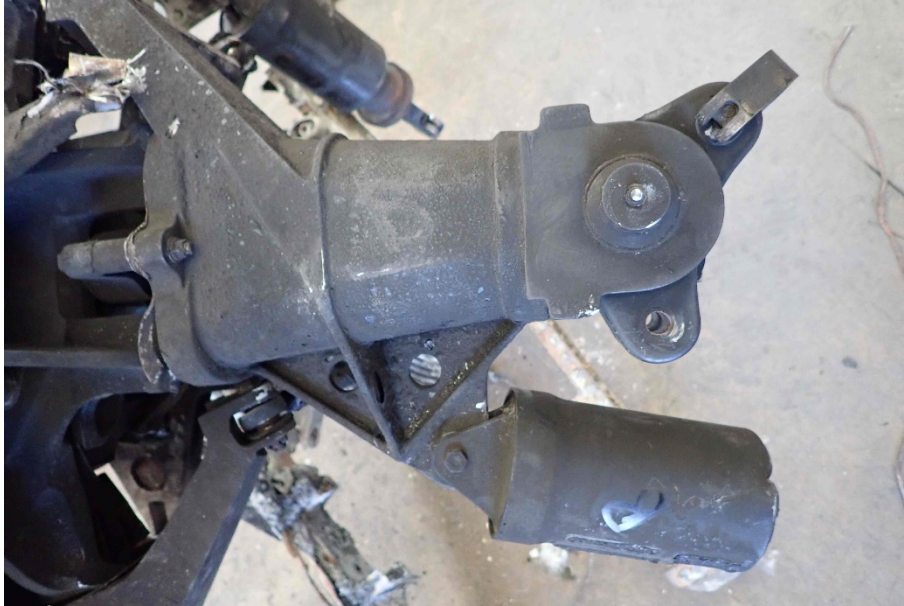
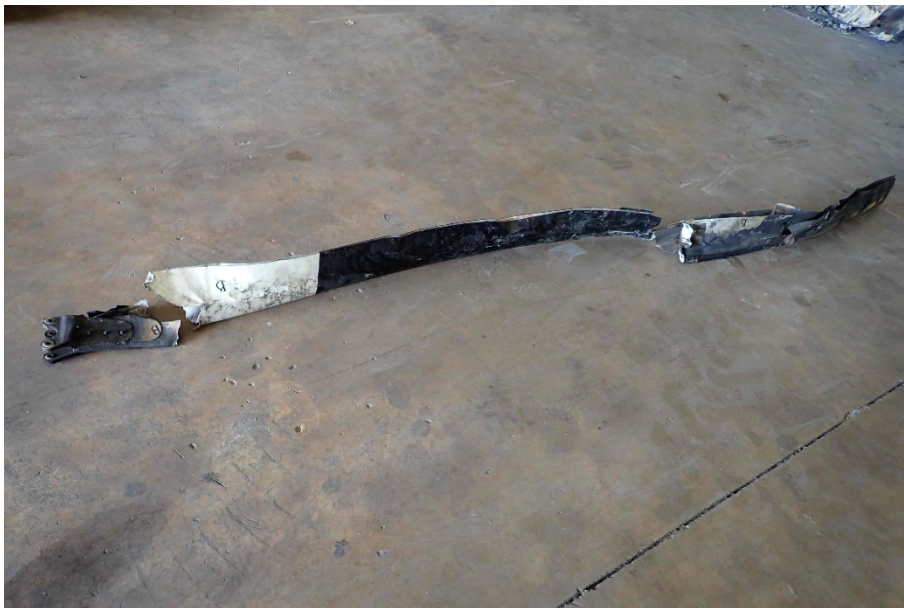
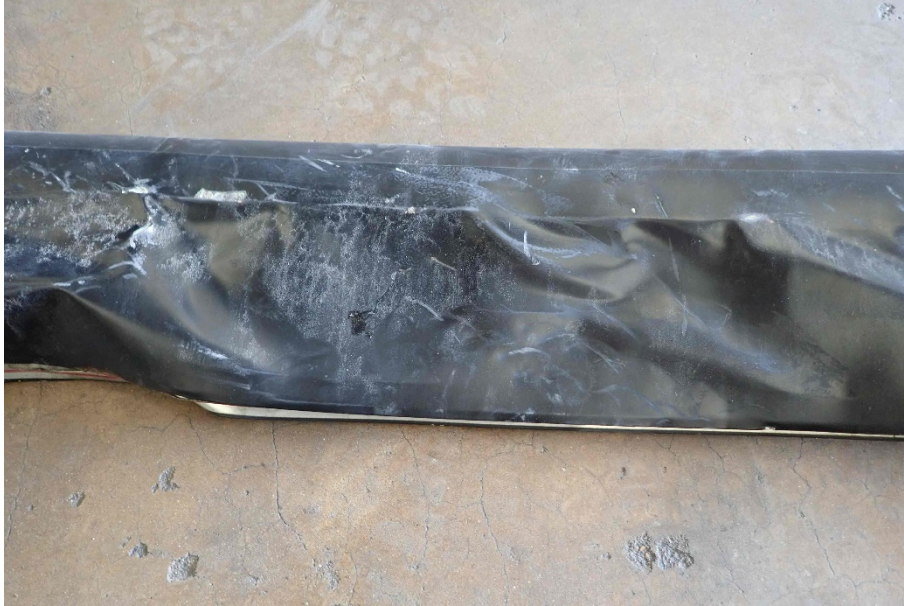
The blue blade pitch housing remained attached to the upper hub. The damper was still attached to the housing, and the elastomer had pulled free (Photo 21). The blade had detached from the pitch housing and separated into two equally sized sections (Photo 22). The outboard section had sustained thermal damage, and the inboard section, which was found separate from the main wreckage in the debris field, exhibited striations on its underside (Photo 23). The tip was still attached.

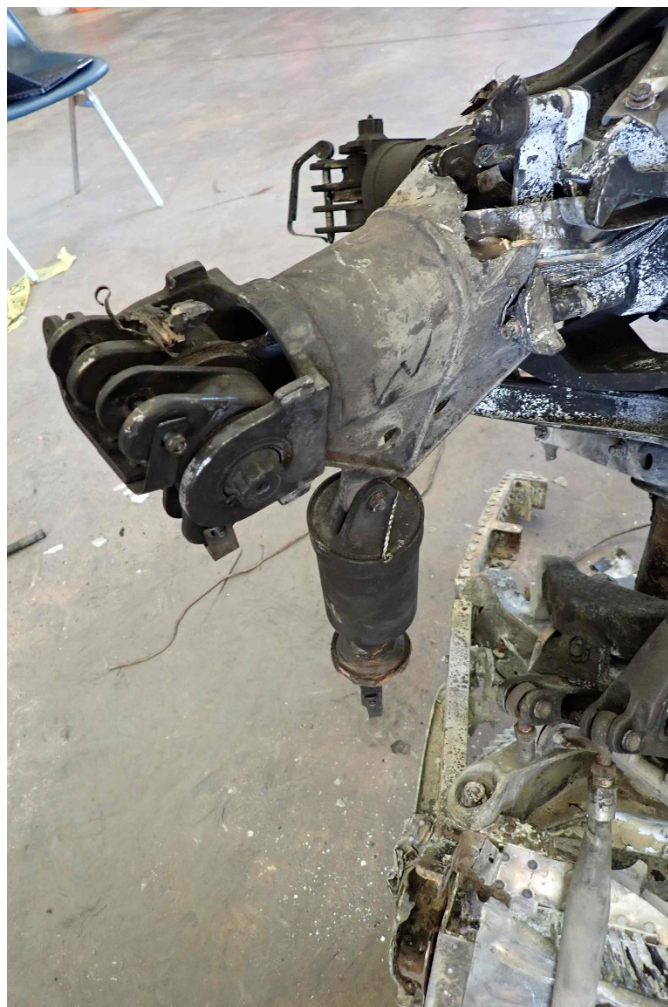
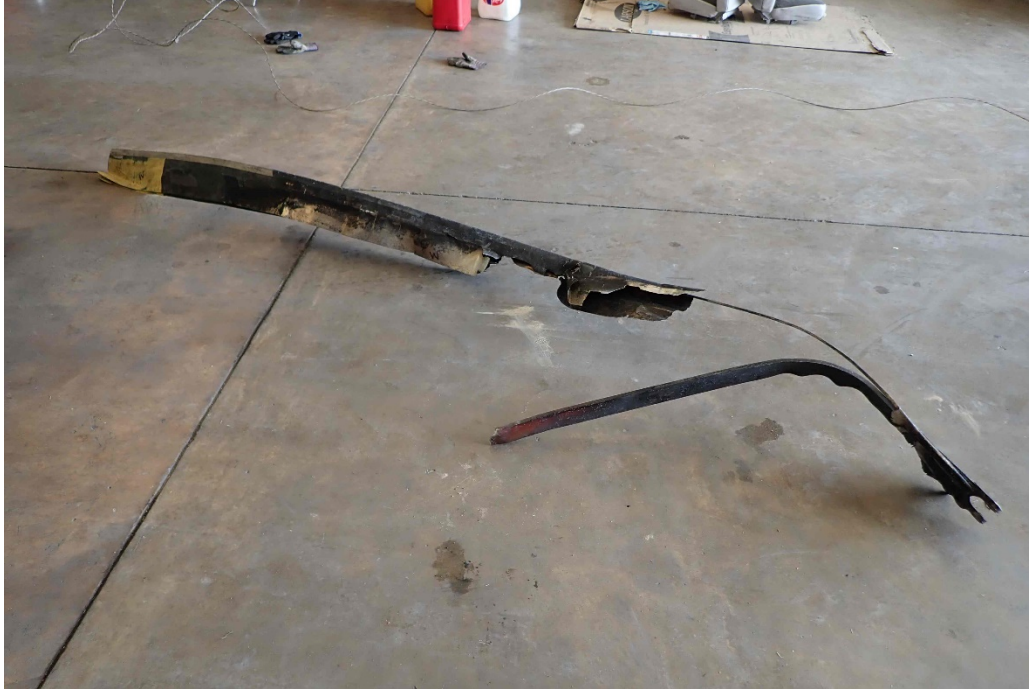
The white blade pitch housing had fractured at its base but remained partially attached by the straps (Photo 24). The damper was still attached to the housing, and the elastomer remained loosely within. The blade was still attached to the pitch housing, and the inboard 6 ft section of skins had burnt revealing the main spar and leading-edge balance weight. (Photo 25).

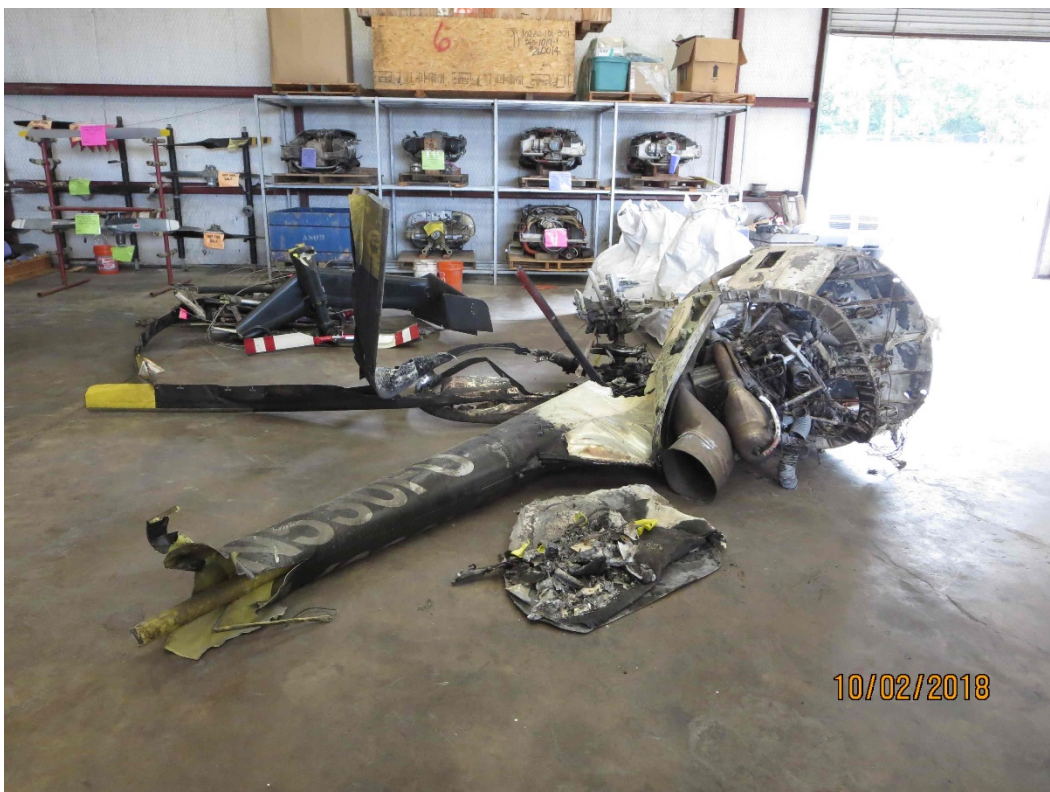
**Photo 26 – Tailboom and Main Wreckage**

The aft boom fairing sustained thermal damage just above the engine and remained partially attached to the aft fuselage section (Photo 26). The remaining section of the tailboom sustained less thermal damage, limited to bubbling paint and soot deposits. The aft end of the tailboom had detached about 10 inches forward of the horizontal stabilizer attachment fittings (Photo 27). Both the tail rotor driveshaft and tailboom control rod were continuous within the tailboom, and the aft section of the driveshaft was impacted with mud. The tail rotor gearbox, along with the upper

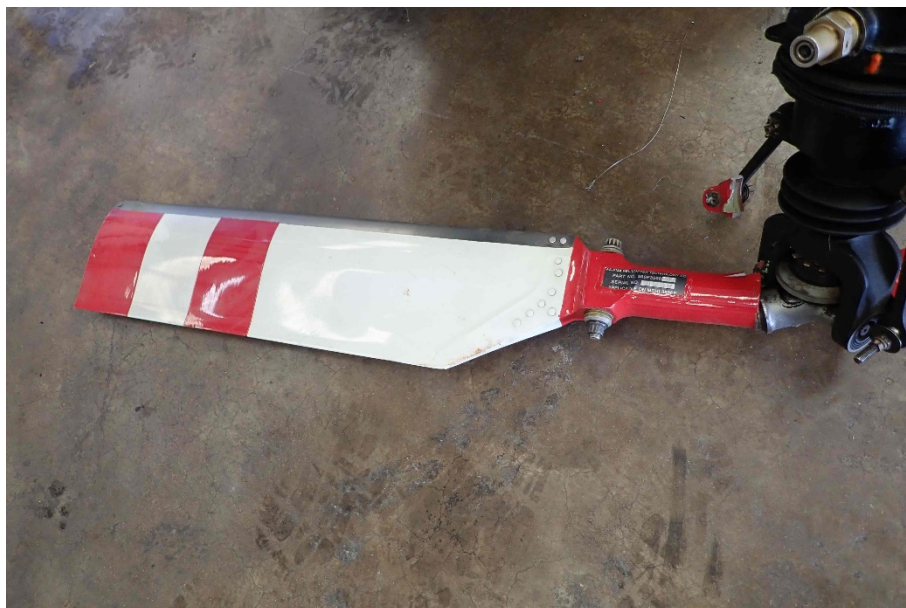
**Photo 30 – Tail Rotor Blade**

The tail rotor gearbox remained attached to the aft tailboom through its extension tube. The tail rotor control bellcrank at station 284 had fractured from the tail rotor transmission housing. The swashplate bearing could be moved and rotated smoothly. One blade was attached to the tail rotor hub assembly, and its pitch link, which was intact, was connected to the swashplate. The tail rotor blade exhibited a square-shaped 4-inch-wide indentation to its outer surface about midspan (Photo 28). The indentation contained yellow transfer marks, similar in shade to the yellow paint on the main rotor blade tips (Photo 29). The main rotor blade tip weight section was about 4 inches wide (Photo 29). The other tail rotor blade remained partially attached to the hub and had broken away from its pitch link (Photo 30).

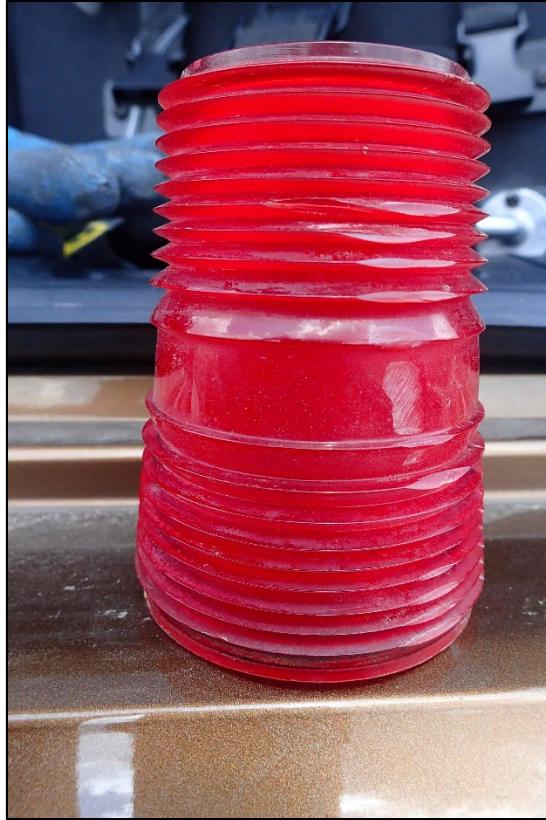
**Photo 31 - Red Belly-mounted Beacon Lens**

Most of the fuselage forward of the station 124 bulkhead was destroyed by fire and impact damage. Unburnt cabin components included those ejected during the impact sequence, and located in the unburnt area debris field, close to the initial point of impact. These included a fire extinguisher, fragments of cabin Plexiglas, and the left foot pedals. The red belly-mounted beacon lens was located about 100 ft east of the severed power line, and 800 ft west of the main wreckage (Photo 31).

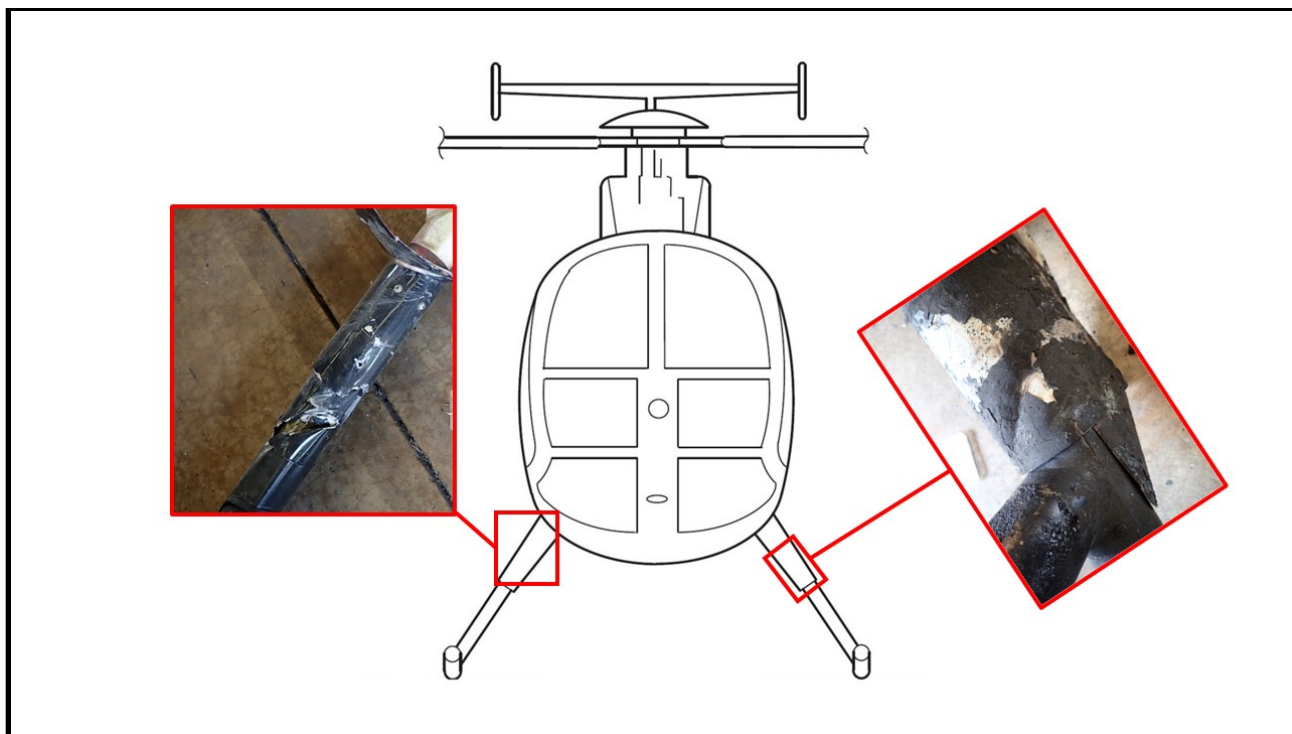
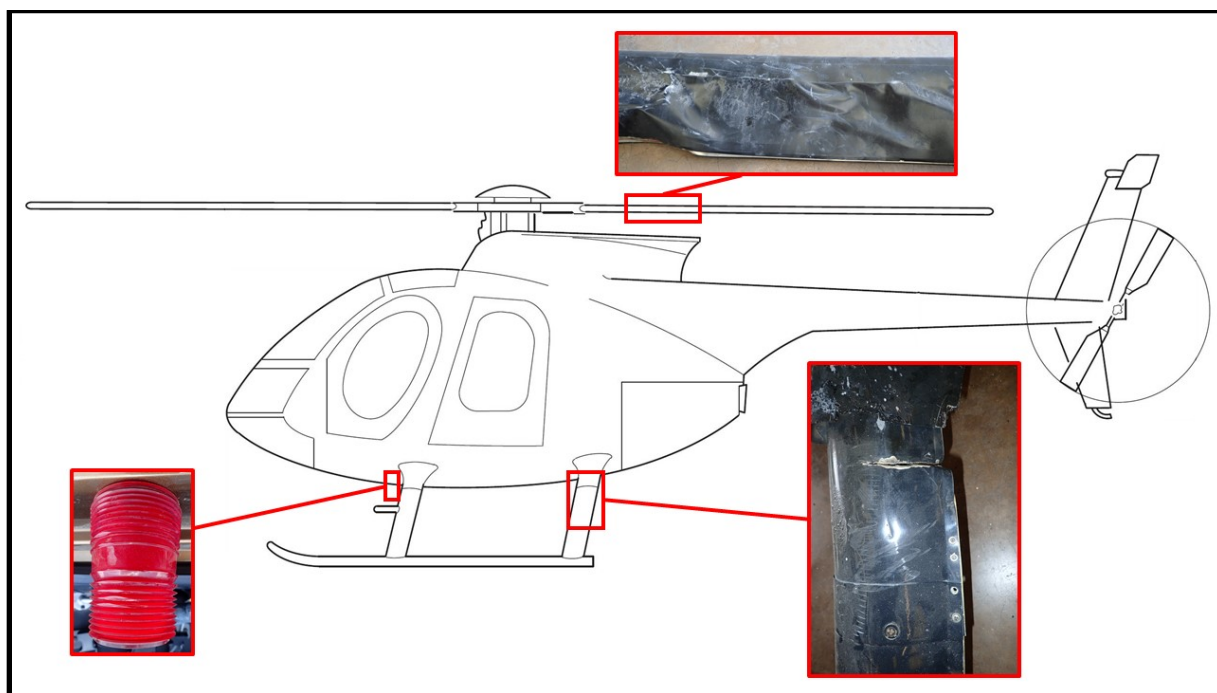
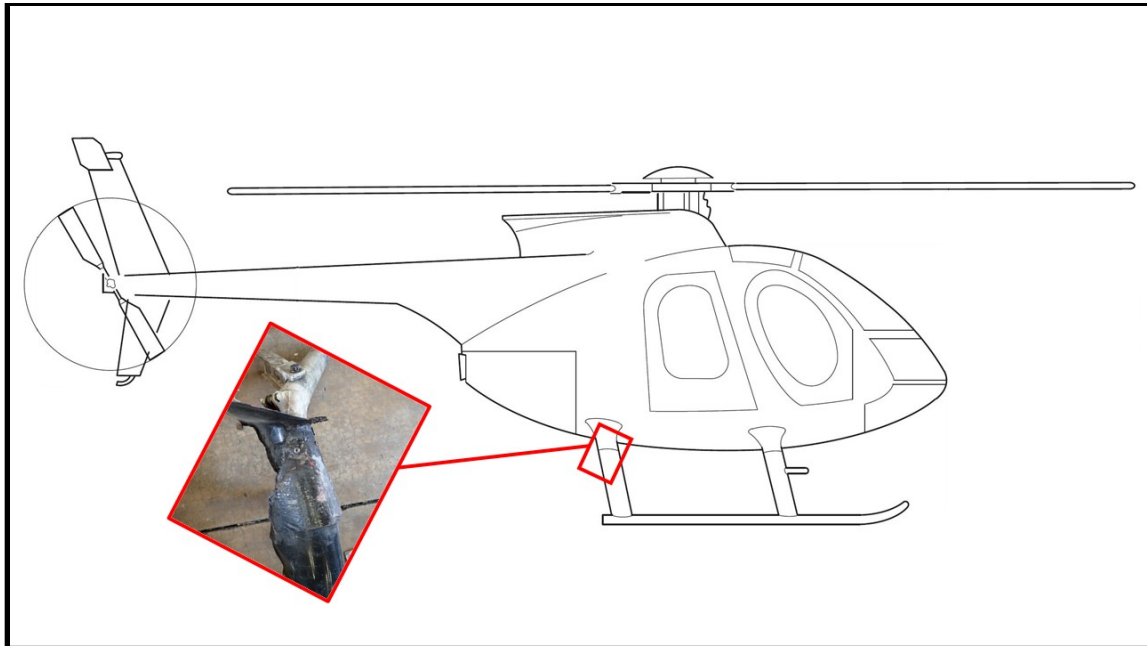
Figures 1, 2, and 3 indicate areas that displayed gouges, cuts, dents, and striation marks.
