## **NATIONAL TRANSPORTATION SAFETY BOARD**

# **ACCIDENT SITE EXAMINATION SUMMARY**

**WPR18FA237**

Location: Descanso, California  
Date: August 22, 2018  
Aircraft: N1682G, American Champion-7KCAB  
NTSB Investigator-in-Charge: Andrew Swick

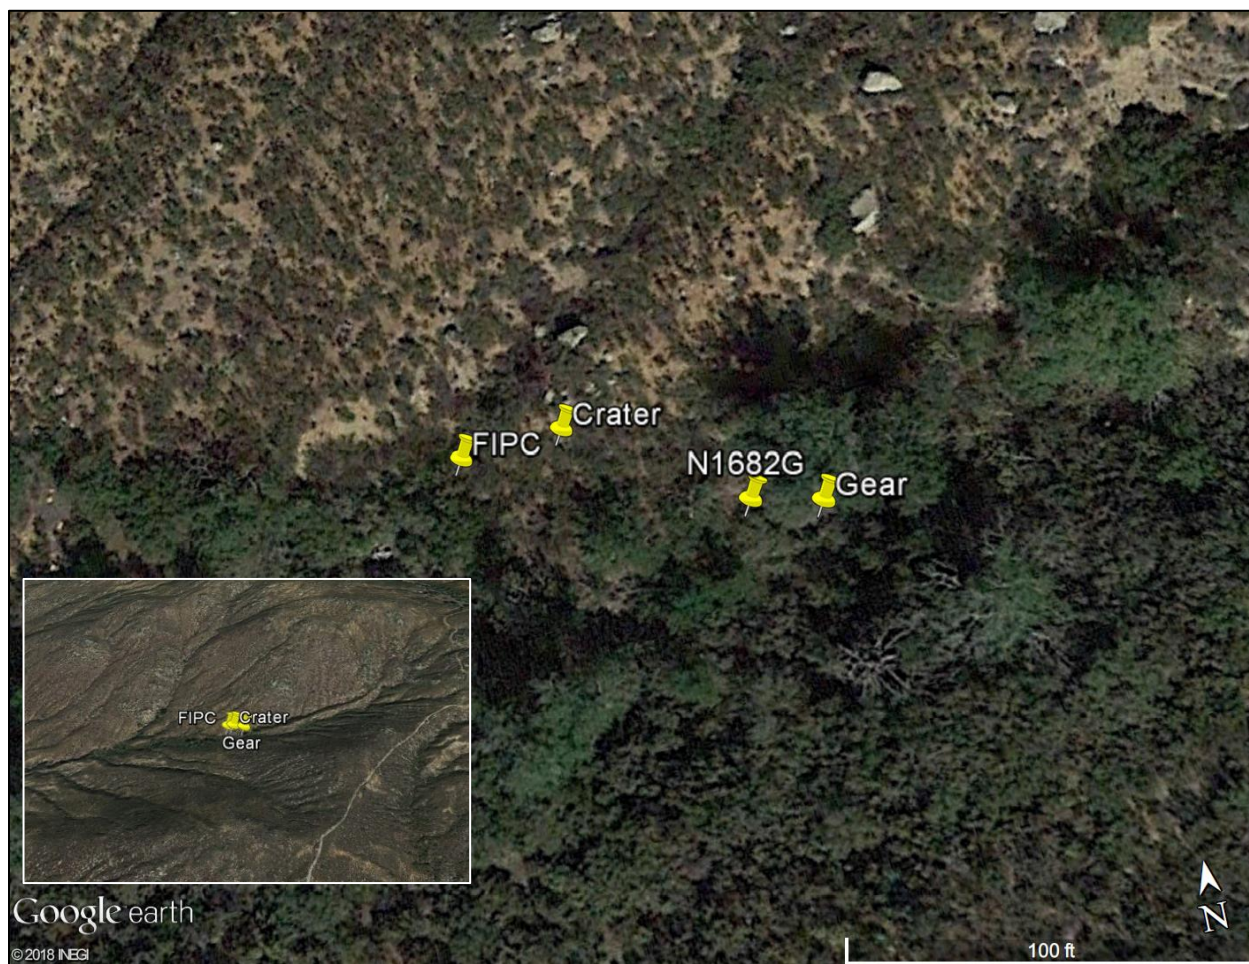
**Figure 1-Google Earth View-Wreckage Diagram**

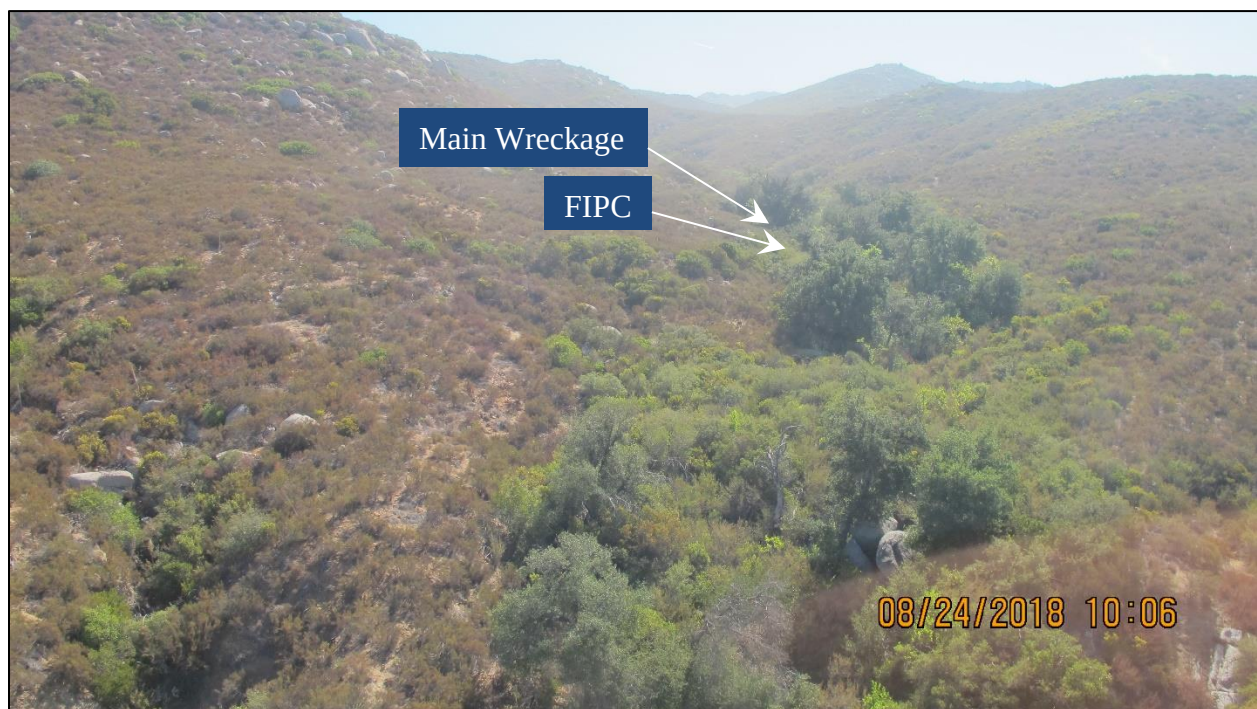
**Figure 2-Accident Site, East View**

The airplane was substantially damaged by impact forces and was found adjacent to a heavily wooded ravine. The main wreckage was repositioned, and the cabin area structure was cut and opened by the medical examiners in an effort to recover the occupants on August 23, 2018. The main wreckage was contained within a debris field about 120ft in length and about 20ft wide on a directional heading of 112-degrees magnetic. The debris field was relatively level compared to the surrounding terrain that was increasing in elevation to the north. The first identified point of contact (FIPC) was an area of disturbed ground containing a small crater. A flat rubber seal was found near the FIPC and contained small fragments of green glass, consistent with the right wing tip navigational light. Small red wing access panels were also found near the FIPC.

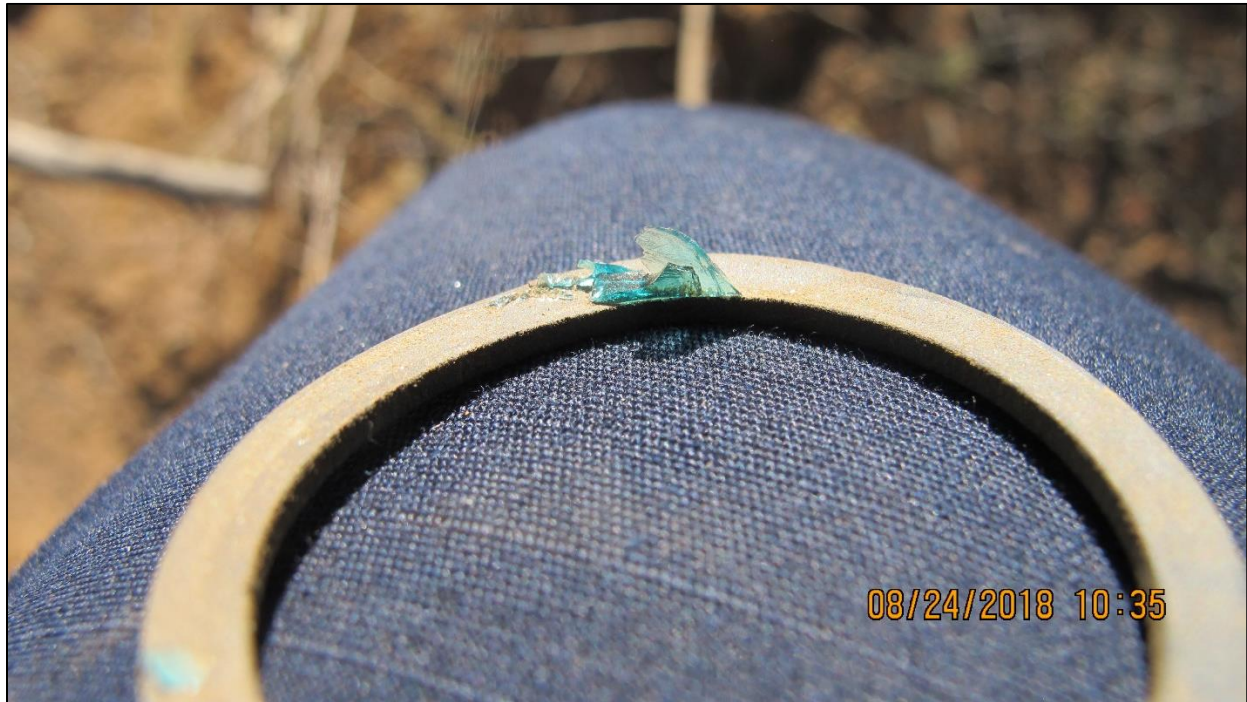
**Figure 3-Right Wing Tip Lens Fragment Found Near the FIPC**

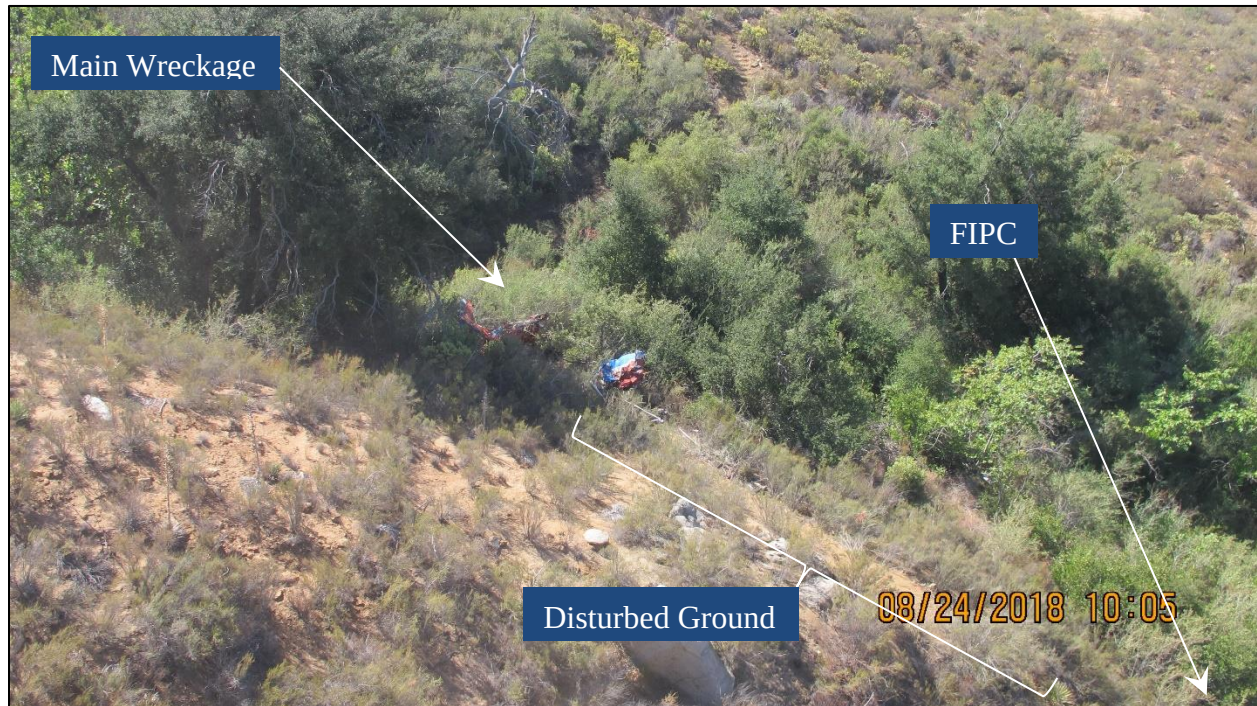
Further up from the FIPC was an area of disturbed ground and brush about 70ft in length and about 6ft wide. The area contained a larger crater, about 4ft in diameter and 6in deep about 30ft from the FIPC. More red and blue wing panels were found were found in this area. The aircraft cabin door had impact damage and was found near the ravine in the bushes adjacent to the large crater. Broken Plexiglas was found surrounding this area. A broken red lens fragment was found near bushes on the left of the debris field about 70ft from the FIPC. The main wreckage was found about 90ft from the FIPC. The left wing had impact damage and was intact. The left wing was removed from the main wreckage by the medical examiner to help gain access to the cabin area.

**Figure 4-Accident Site, Overhead View**

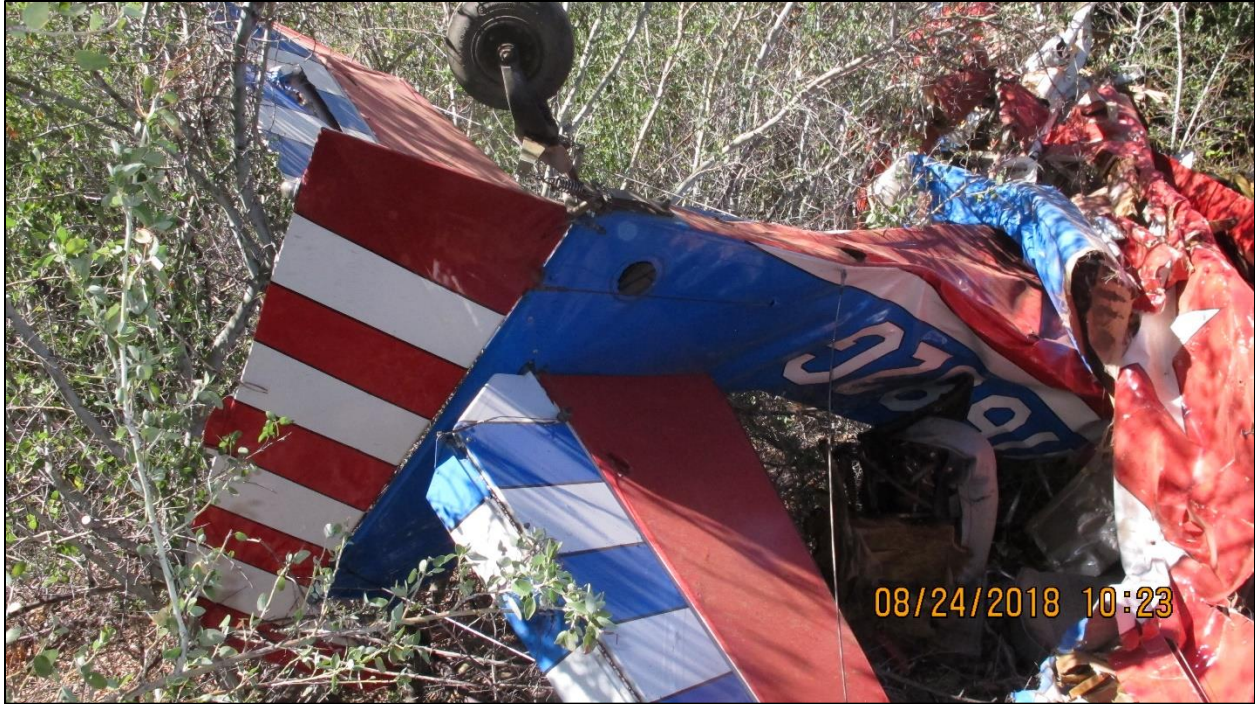
The right-wing had excessive impact damaged and remained attached to the main wreckage. A landing gear strut and wheel assembly separated from the main wreckage and found near the main wreckage. The other main gear strut was the furthest piece of wreckage and the wheel assembly separated and was not found. The main wreckage was on a directional heading of about 180 degrees magnetic.

**Figure 5-Main Wreckage**

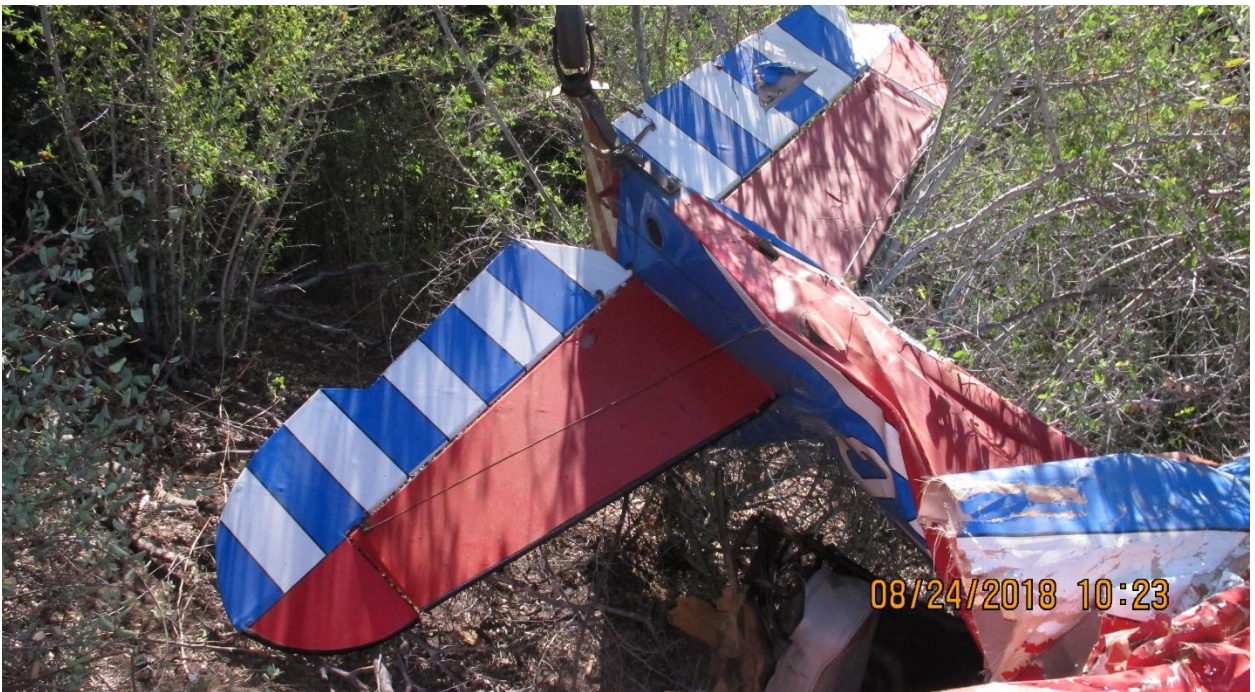
The empennage remained intact and flight control continuity was established to the cockpit controls. The left rudder control cable exhibited overload signatures near the connection of the rudder pedal. The aileron and flap continuity could not be attained onsite. Both ailerons and flaps remained attached to the wings.

**Figure 6-Main Wreckage-Empennage**

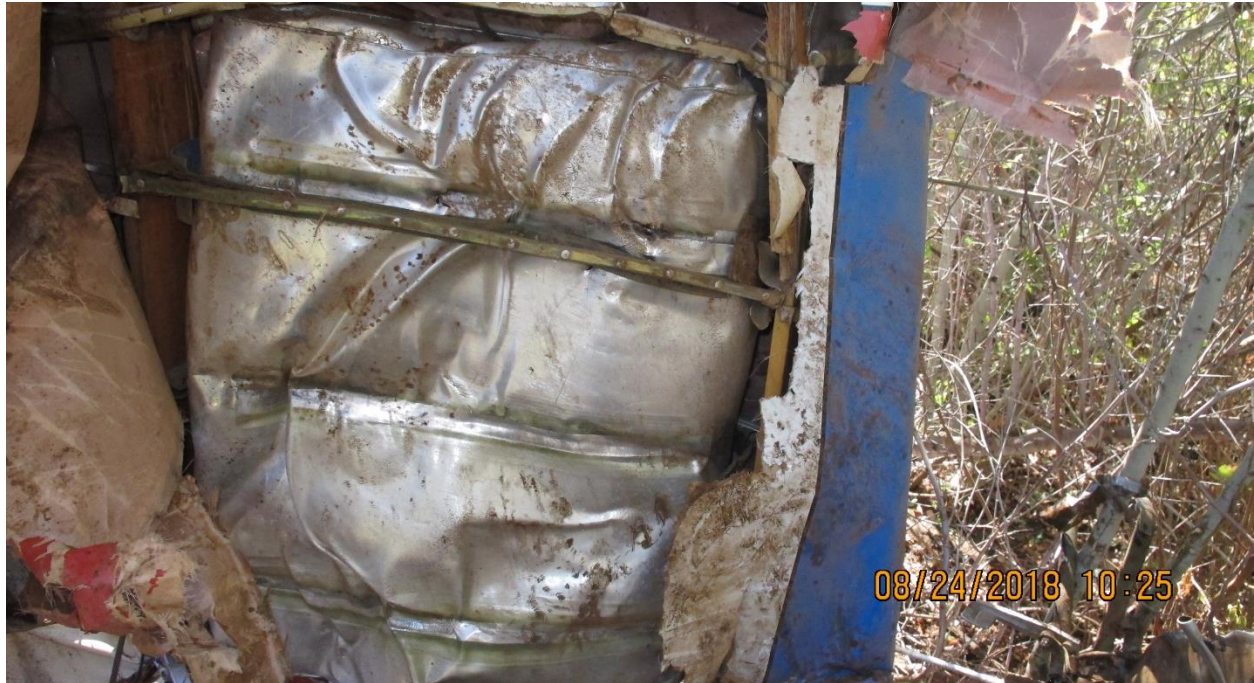
The wing tanks were breached, and both exhibited hydraulic deformation.

**Figure 7-Right Wing Fuel Tank**

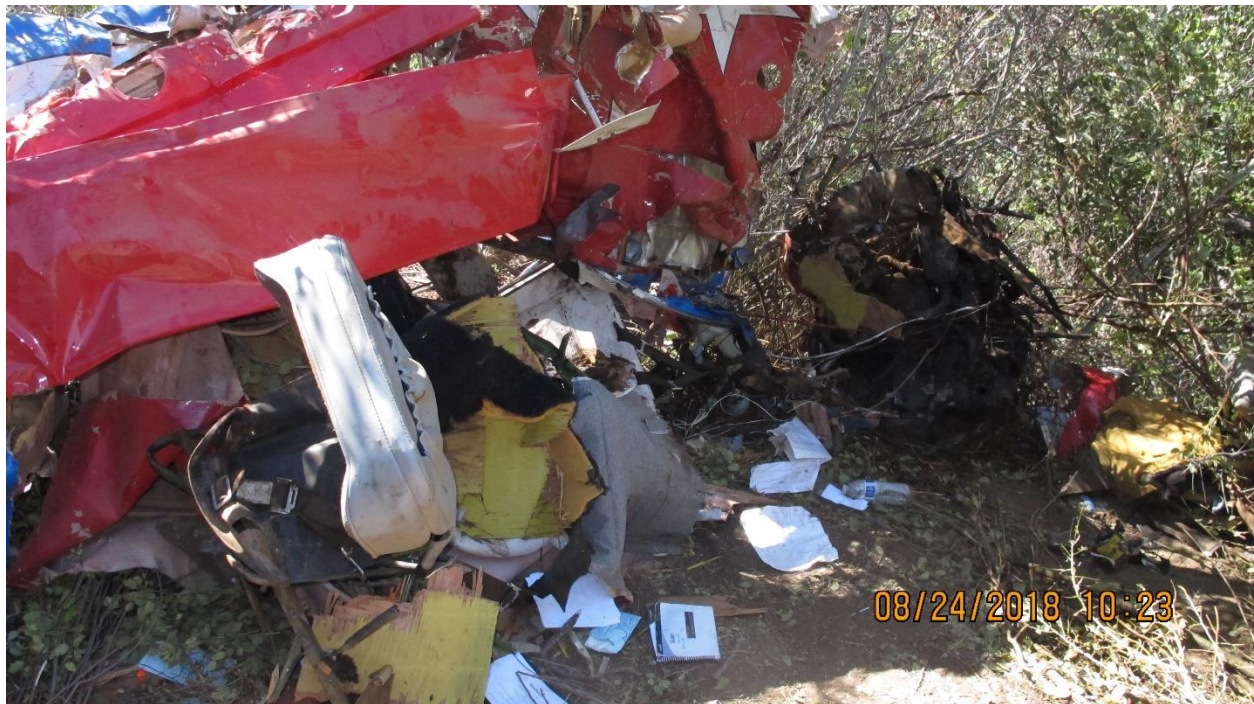
The cabin area showed crush damage and the engine and its mounting assembly was broken from the airframe structure. The engine had impact damage to the accessory section and was found inverted. The induction and exhaust assemblies had impact damage. Engine control levers and cables had impact damage.

**Figure 8-Accident Site, Main Wreckage and Engine**

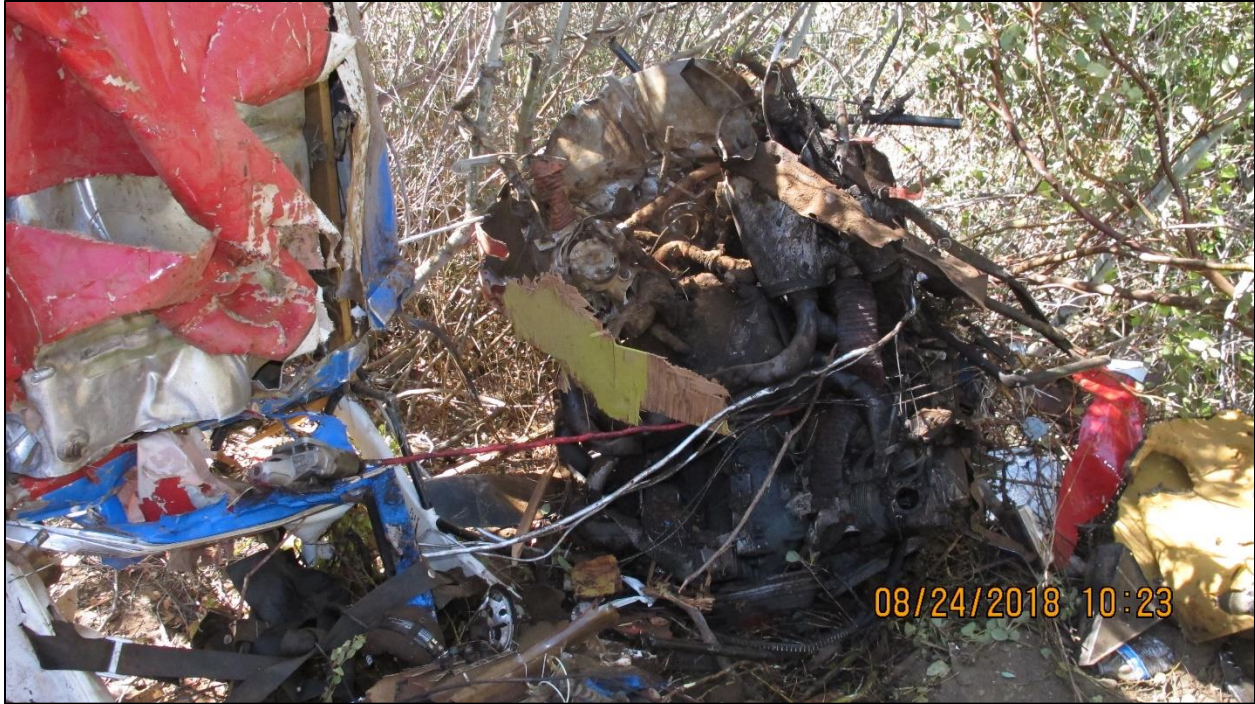
**Figure 9-Engine**

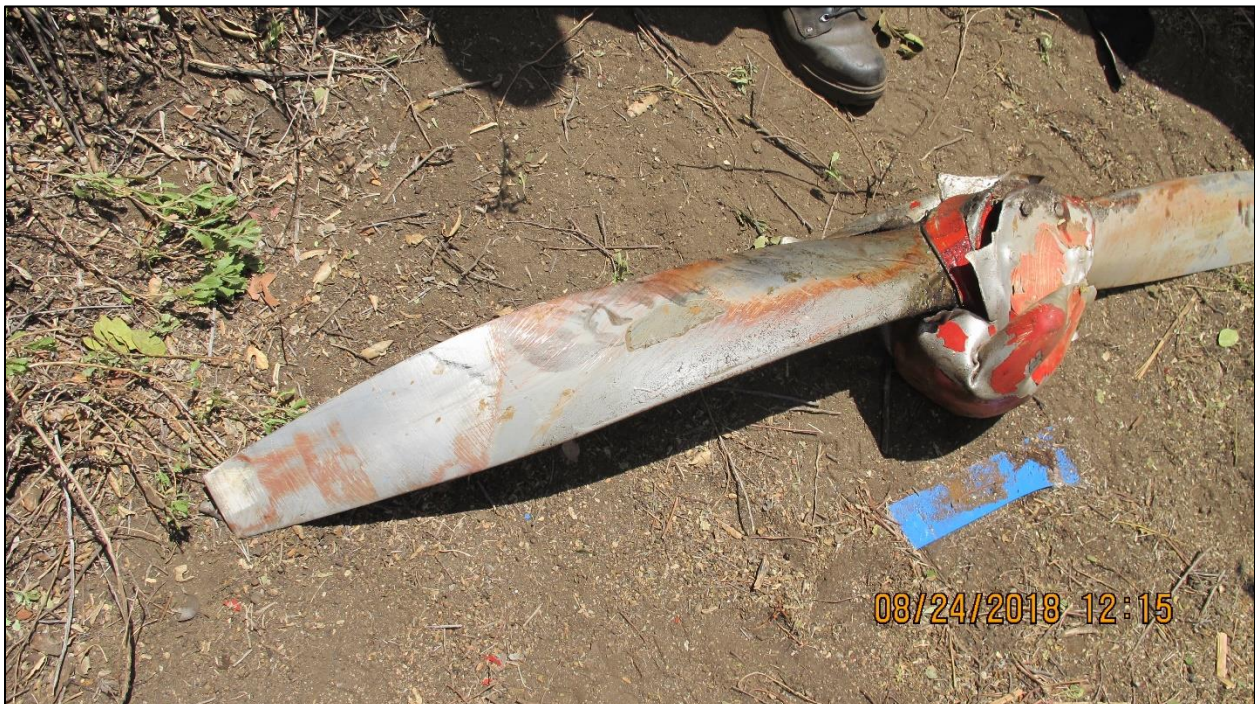
The propeller and the crankshaft propeller flange separated from the engine. The propeller blades showed light chordwise scuffing on the chambered sides and both were bent slightly aft.

**Figure 10-Propeller Assembly**

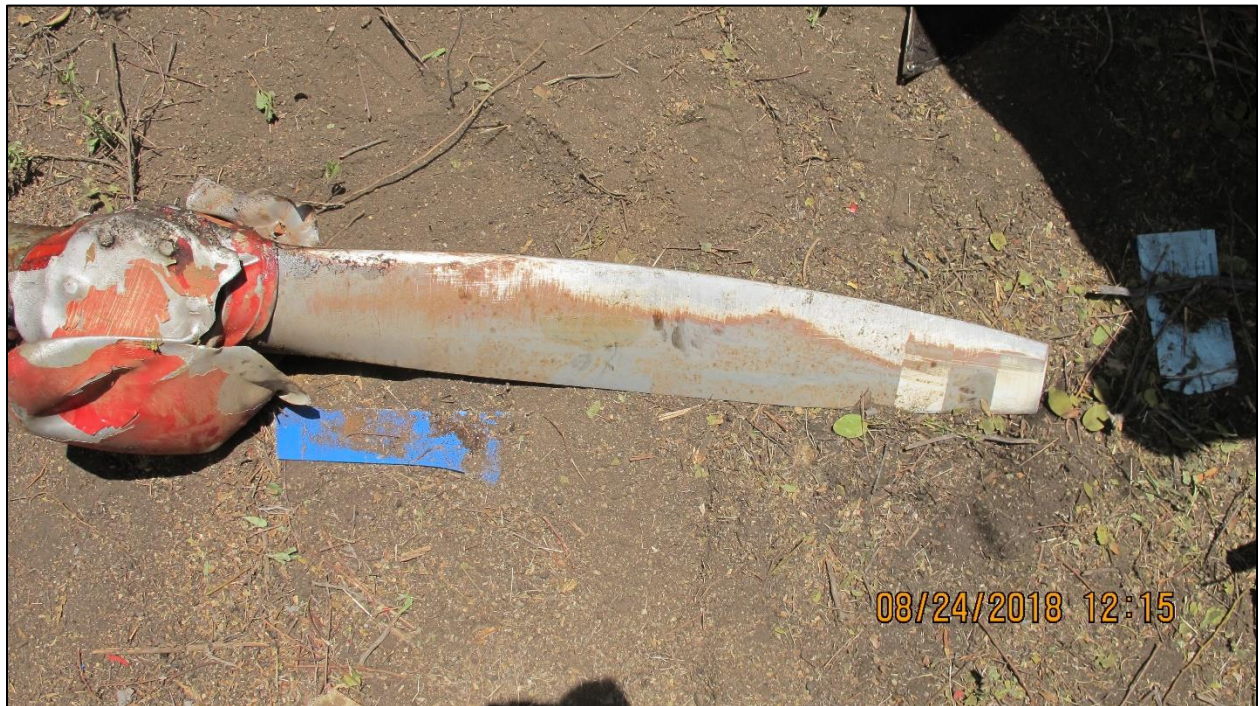
The spinner was crushed, and the majority of the crush damage was on one side.

**Figure 11-Propeller Assembly**

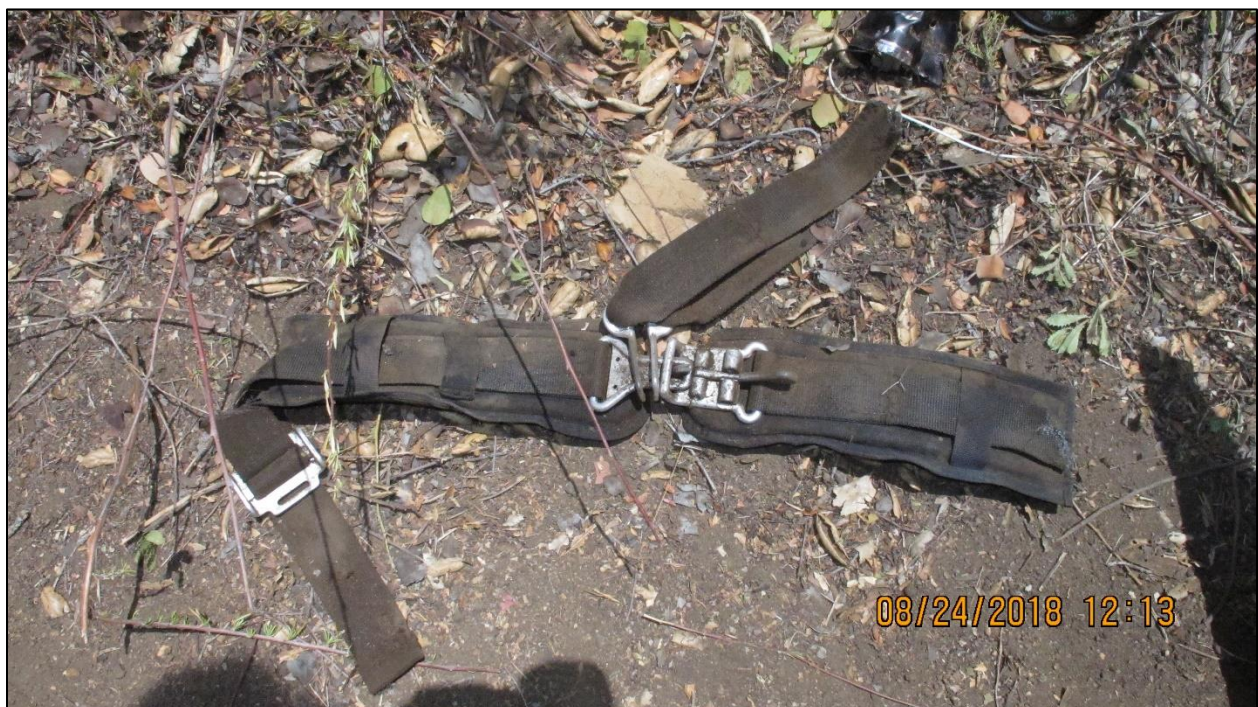
Seatbelts were secured and latched on both occupants.

**Figure 12-Seatbelts, Forward Position**
