## **NATIONAL TRANSPORTATION SAFETY BOARD**

# **WRECKAGE EXAMINATION SUMMARY**

**WPR18FA237**

Location: Descanso, California  
Date: August 22, 2018  
Aircraft: N1682G, American Champion-7KCAB  
NTSB Investigator-in-Charge: Andrew Swick

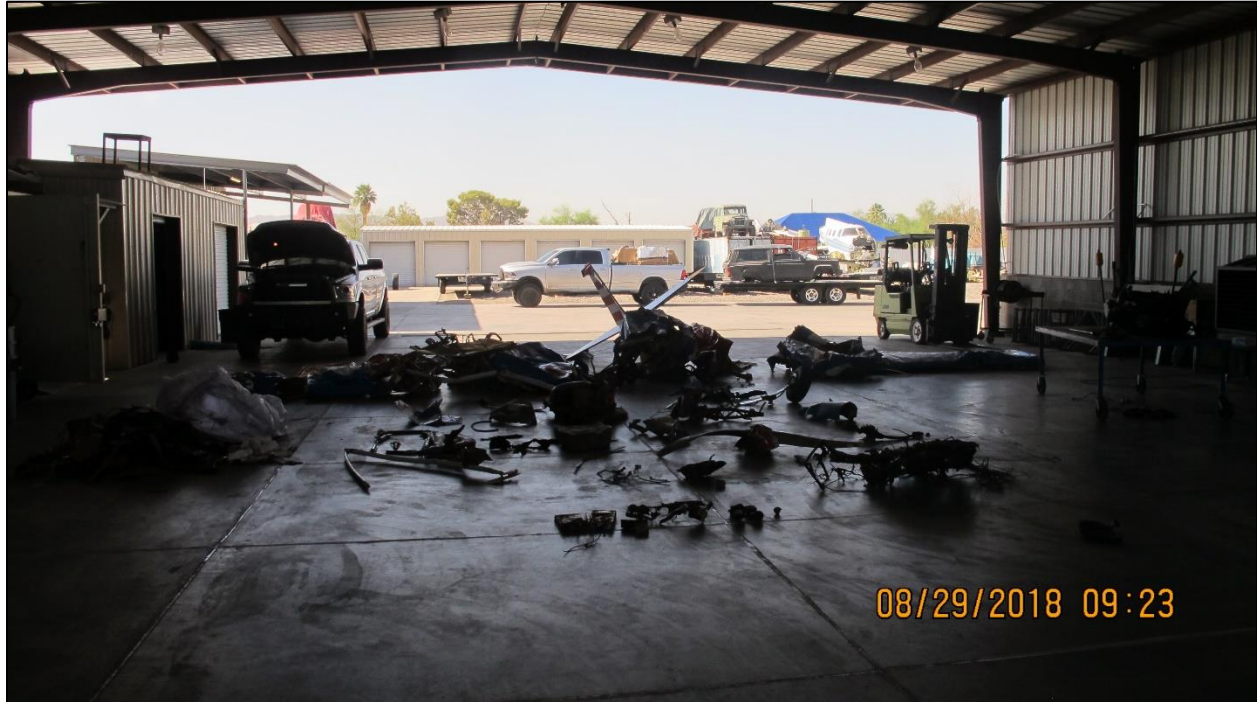
Figure 1-Wreckage Examination

The wreckage was laid out on the floor and impact damaged items were identified and placed in their relative position.

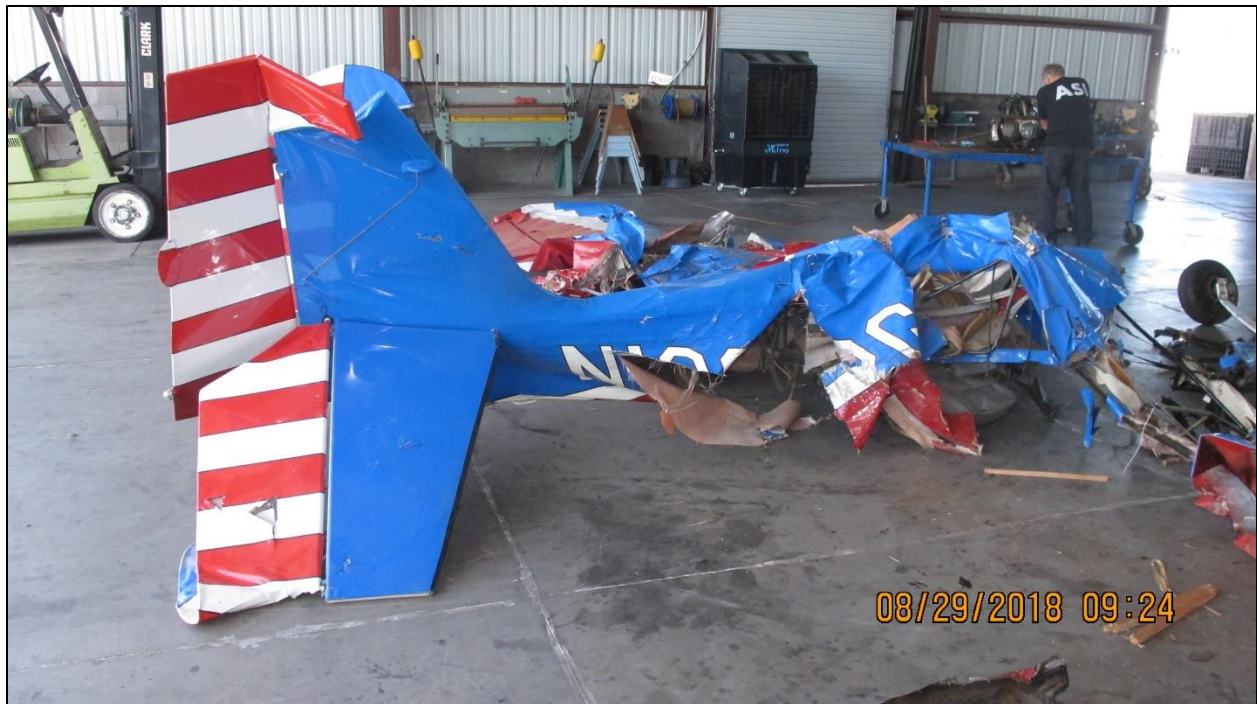
Figure 2-Empennage and aft fuselage.

The empennage remained attached to the aft fuselage and had impact damage. Flight control cables were identified, and cable connections were examined. The flight controls surfaces had impact damage and moved freely on their attachments.

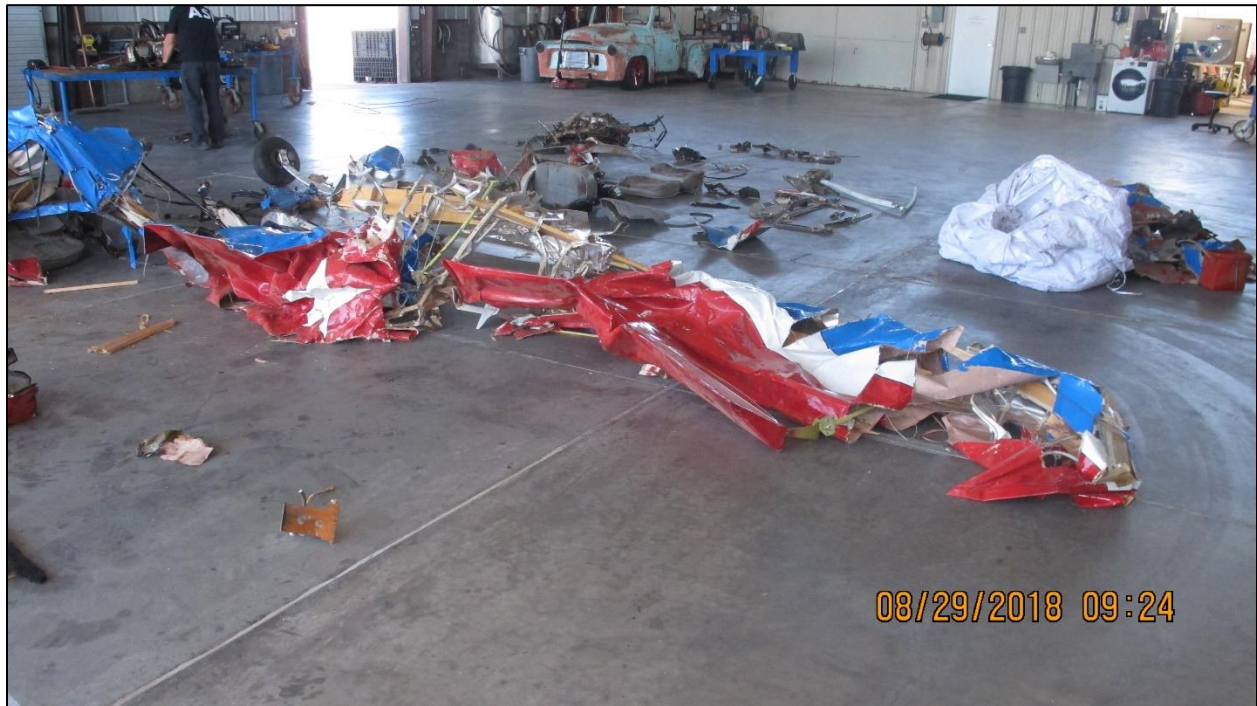
**Figure 3-Right wing**

The right wing had extensive impact damage revealing the internal structure. Aileron cables and the aileron bellcrank showed overload signatures. The left wing tank remained in the wing and had deformation, consistent with fuel in the tank at the time of impact. The fuel tank cap was secured and the seal undamaged.

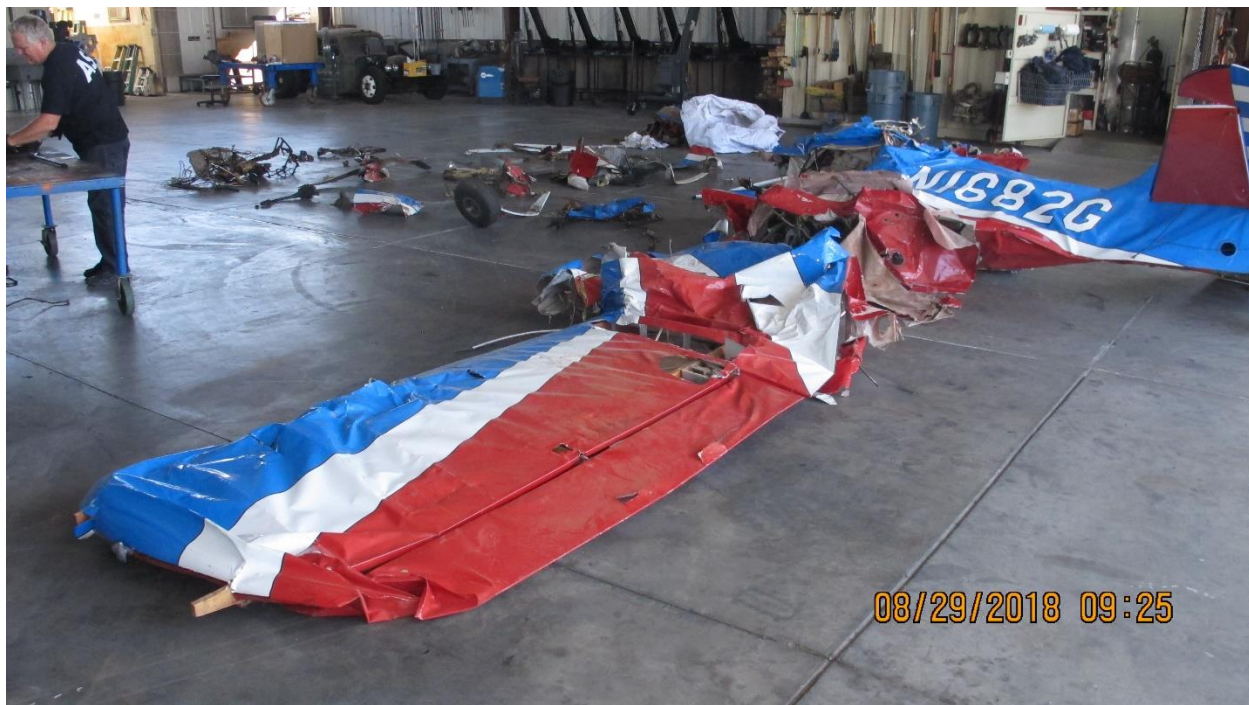
**Figure 4-Left wing**

The left wing was separated from the fuselage during the relocation of the wreckage. The left wing tank remained in the wing and had deformation, consistent with fuel in the tank at the time of impact. The fuel tank cap was secured and the seal undamaged.

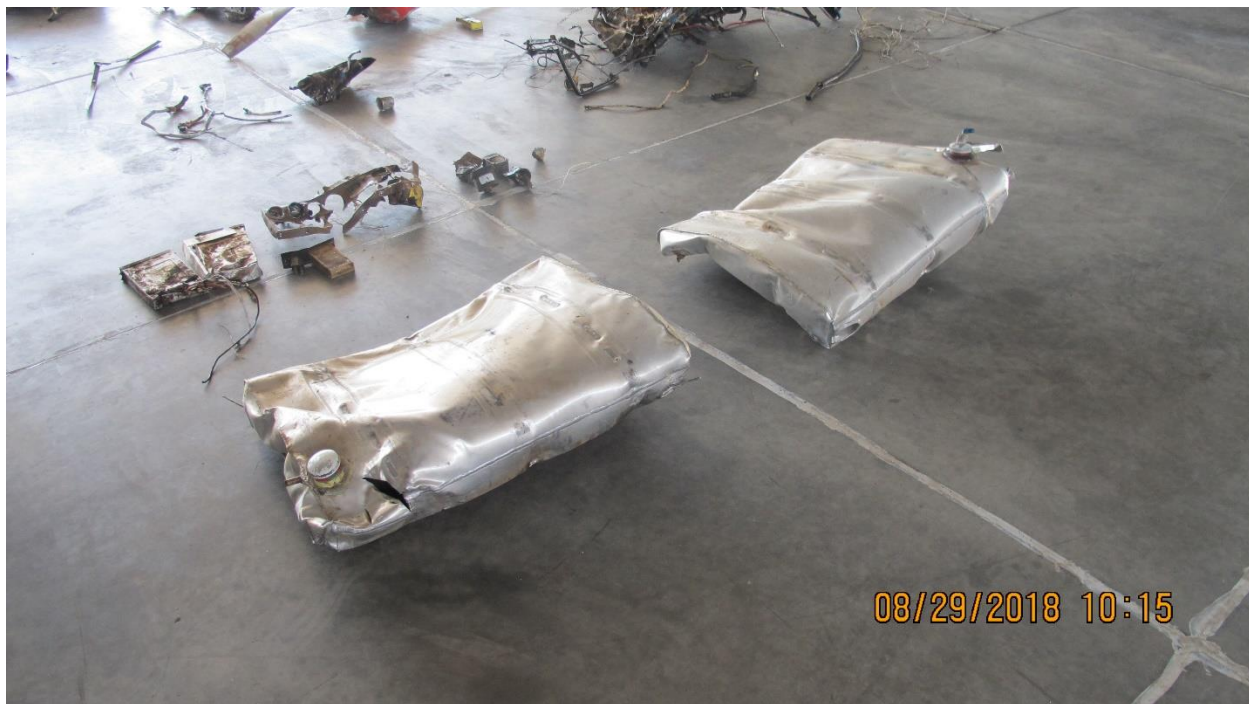
**Figure 5-Wing fuel tanks**

The fuel strainer remained attached to the firewall and was disassembled. The screen was clear of debris and no contaminants were found in the bowl. The fuel selector had impact damage and its internal position was not known. Several fuel lines were separated from the main wreckage. The fuel header tanks separated from the main wreckage and was crushed.

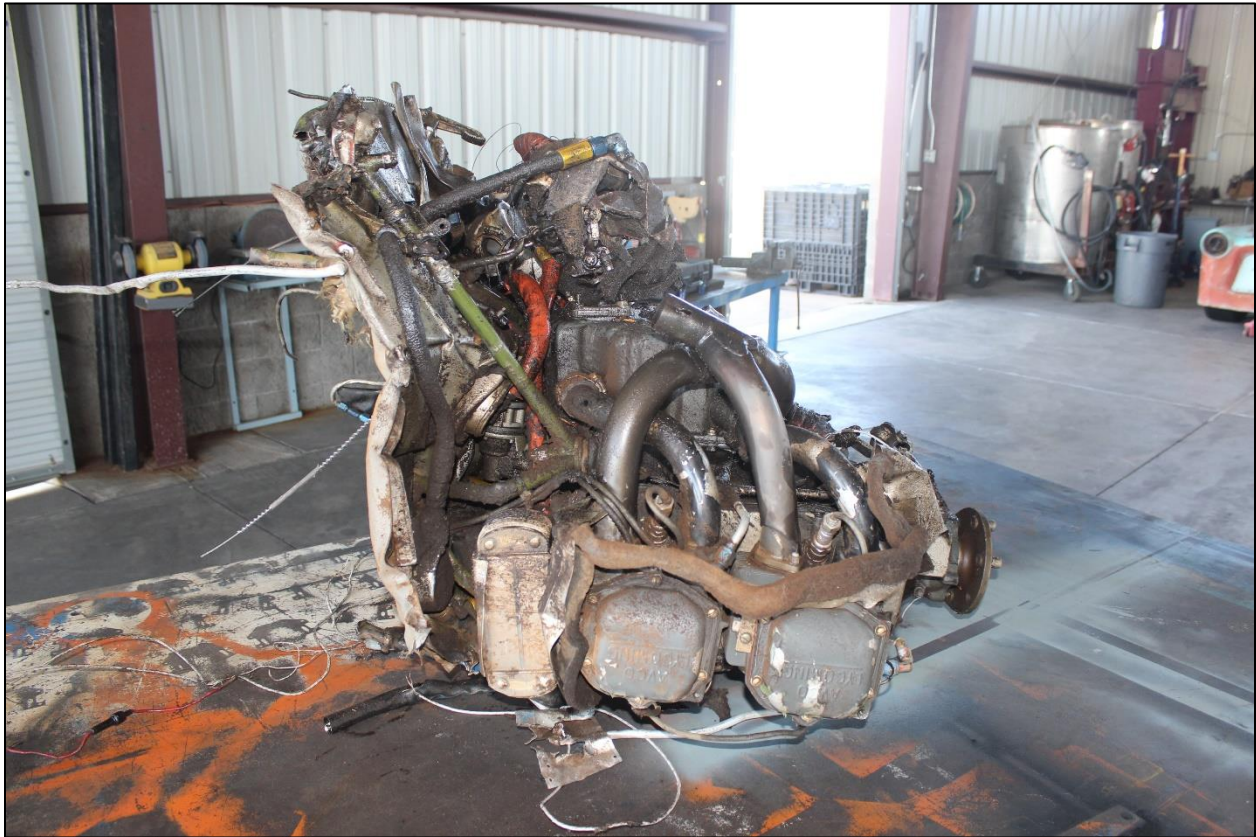
**Figure 6-Engine**

The airplane was equipped with a Textron Lycoming IO-320-E2A engine rated for 150 horsepower at 2,700 rpm. The engine was equipped with a 2-blade, Sensenich propeller. The engine was examined by the manufacturer and no evidence of preimpact mechanical malfunctions were observed.
