## **NATIONAL TRANSPORTATION SAFETY BOARD**

# **AIRFRAME AND ENGINE EXAMINATION**

**WPR18FA244**

Location: Redding, CA  
Date: August 29, 2018  
Aircraft: Cessna 150F, N7990F  
NTSB IIC: Fabian Salazar

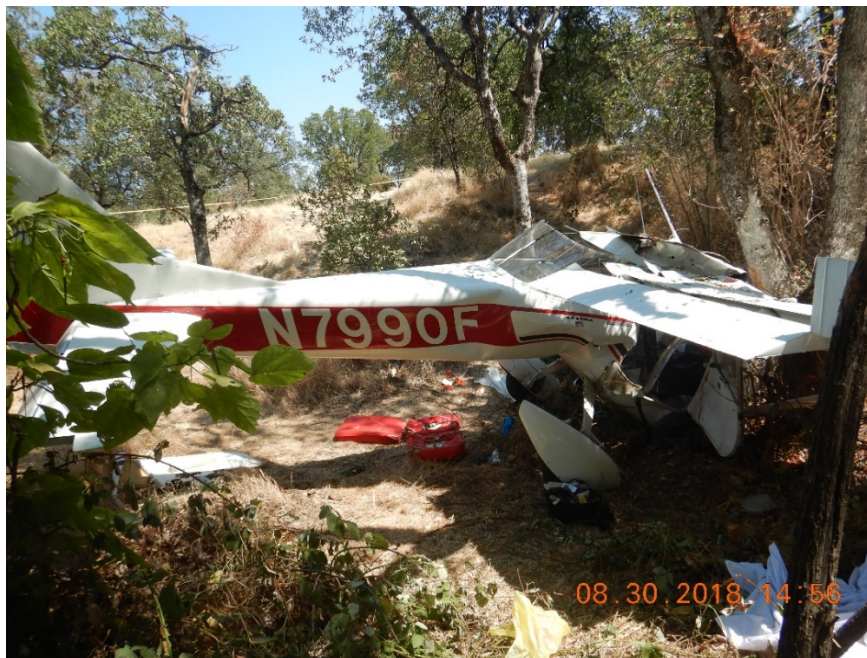
**Fuselage.** Examination of the fuselage revealed the engine and cabin area were crushed from below, upwards and aft. The roof of the cabin had detached and moved forward, along with the left wing, pivoting near the root of the right wing. The fuselage buckled on the right side, just aft of the main landing gear and allowed the aft portion of the fuselage and the empennage to displace downward about 40°. The fuselage buckled on the left side then cracked open, just aft of the main landing gear, allowing the aft portion of the fuselage and the empennage to displace about 40° downward. The right door remained attached to the fuselage. The top hinge was damaged allowing the upper half to bend inwards. The door window was intact. The left door was removed as part of the recovery effort and was found near the left side of the airplane. The windshield was cracked and scattered in front of and to the right of the centerline of the airplane.

Photo 1. Right view of airplane.

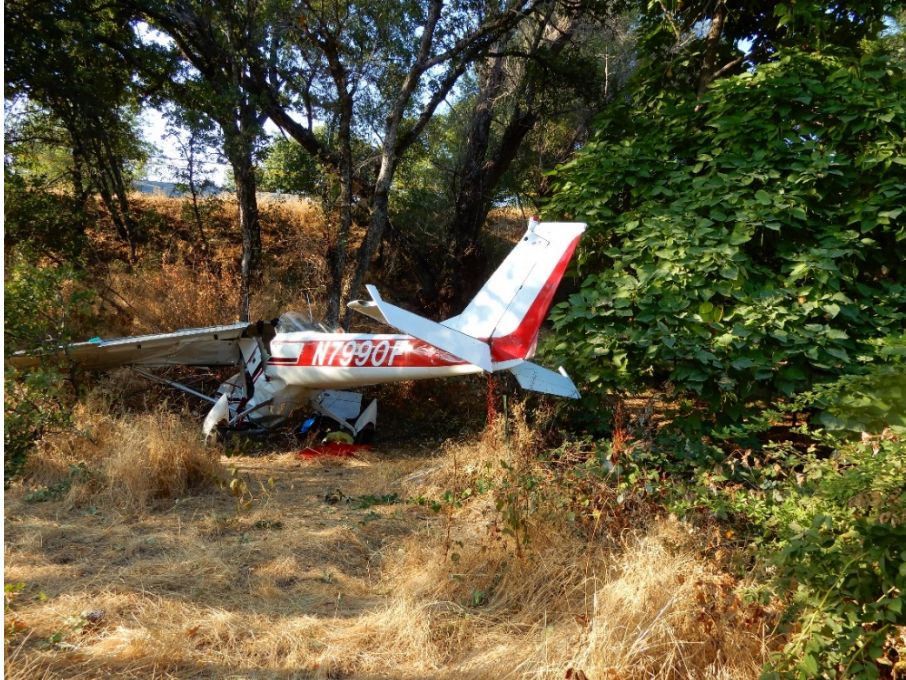
**Left Wing.** The left wing detached from the fuselage, along with the cabin roof, and displaced forward about 15°; pivoting near the right-hand side of the fuselage. The entire wing assembly and cabin roof had collapsed down toward the cabin area. The aileron control cable remained attached to the bell crank. The push/pull tube was broken. The main control cable was continuous from the bell crank to the control column. The balance cable was observed in tension overload. Both the flap and aileron remained attached to their respective hinges. The left-wing tip and about 12 inches of wing were separated from the wing. The aileron had about a 12-inch bend to the trailing edge, the rest was undamaged. The leading edge, about 15” from the wing-tip, displayed a dent, cylindrical in shape, with traces of tree bark embedded in the aluminum,

Photo 2. Left view of airplane.

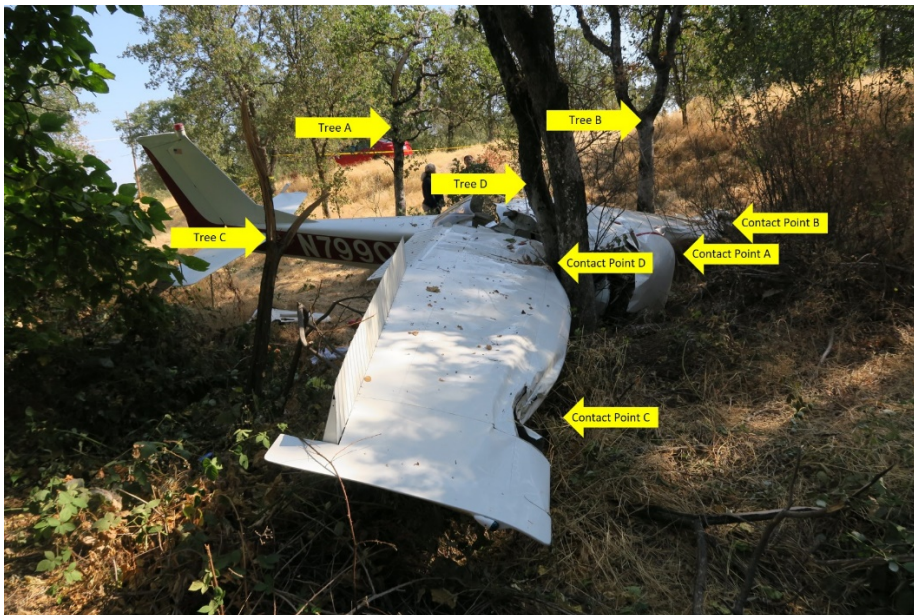
consistent with striking a tree. A tree, identified as tree “B”, with damage to its bark was found about 2 ft aft of the left-wing. The separated portion of the left wing was found adjacent to tree B. A second cylindrical dent, with traces of tree bark embedded in the aluminum, consistent with striking a tree, was found about 30” outboard from the wing root directly in front of the fuel vent tube and wing strut. A tree, identified as tree “A”, with damage to its bark, was found about 7 ft aft of the left wing. The entire wing was buckled down; with a high point just above the wing strut. The left flap appeared undamaged and was in about a 10° to 20° down position. The landing light plexiglass, located on the leading edge of the left wing, was broken away entirely. One landing lamp was broken and one remained intact. The fuel cap was attached. The fuel tank was breached with fuel leaking to the ground. As a safety measure, the remaining 2 gallons of fuel was removed from the tank. These 2 gallons from the left wing were combined with the recovered fuel from the right wing and stored in a used fuel container. This fuel tested negative for water.

Photo 3. Leading edge contact points and trees with damage.

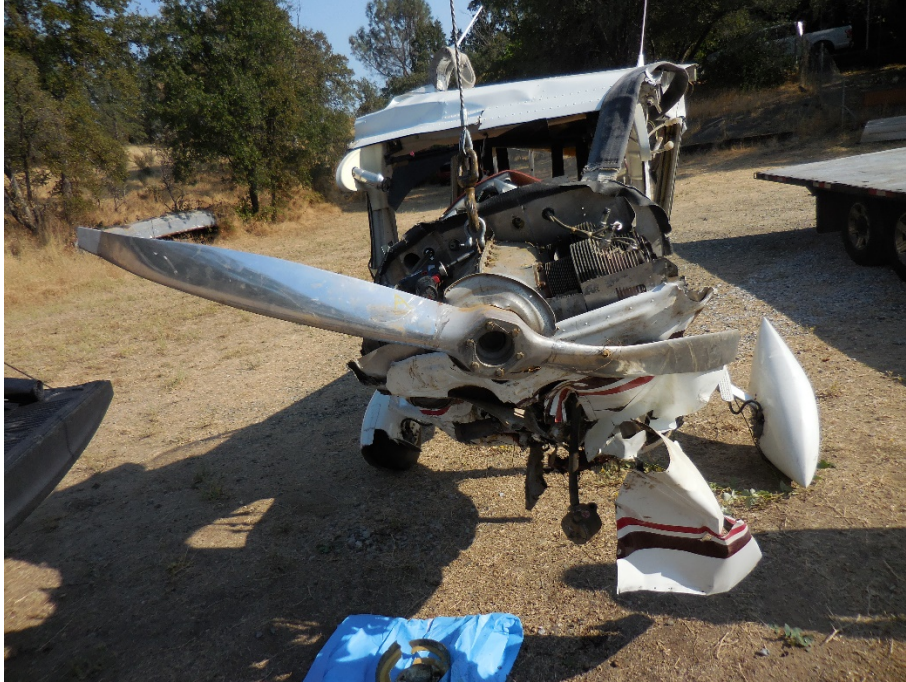
The engine was examined at the accident site. The engine remained attached to the fire wall. The rear of the engine is pushed up towards pilot’s glare shield. The engine sustained impact damage, which had fractured the intake manifold allowing the carburetor to separate. The mixture control arm and the throttle control arm moved freely throughout their full range. The carburetor bowl was removed to examine the floats. The float bowls were brass in appearance and moved through their full travel. The floats displayed hydraulic damage. The airframe fuel strainer was damaged and there was no presence of fuel. No contaminations were found on the carburetor fuel finger strainer. The accelerator pump functioned normally. A blue fluid with the appearance and smell of aviation gasoline was found in the carburetor bowl. This fluid tested negative for water and was free of debris. The upper spark plugs were removed at the scene and appeared undamaged. Spark plugs number 1, 2, and 3 appeared dark in color and dry. Sparkplug number 4, appeared darker in color and wet. Thumb compression was obtained on all four cylinders. All rocker arms moved freely when the engine was rotated. The carburetor had a red Precision Airmotive Corporation data tag riveted to it. The data tag displayed the following information: Model: MA-35PA, Part No.: 10-4894, Serial Number: 3E-0-231 or BE-0-231.

Photo 4. Engine at the accident site.

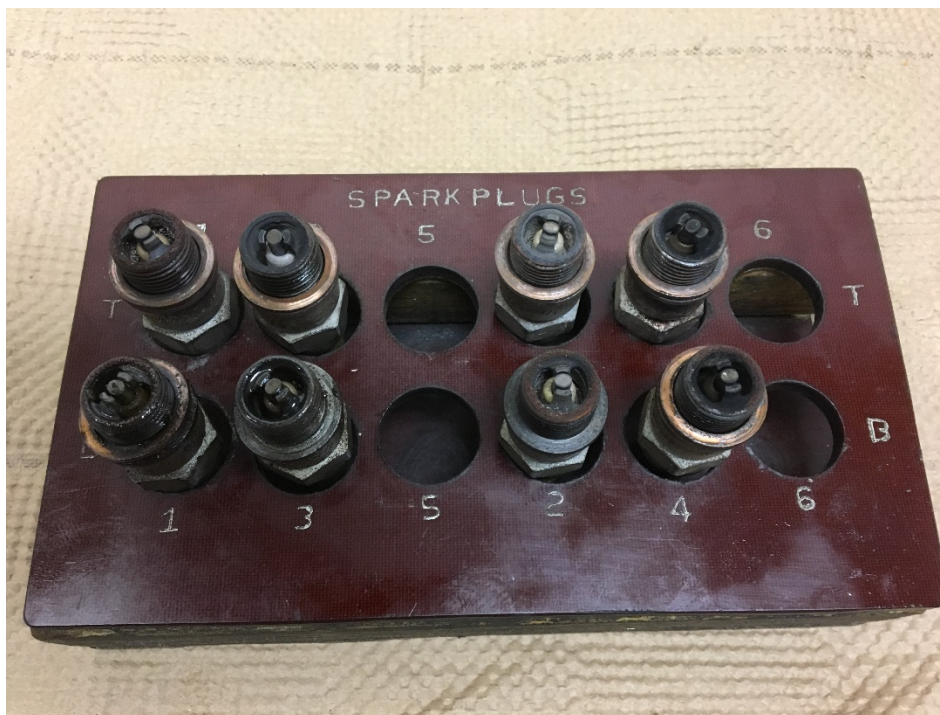
The engine could be rotated freely by turning the propeller mounting flange. All cylinders appeared intact without damage. The lower spark plugs were removed. Spark plugs number 1, 2, and 3 appeared dark in color, dry and undamaged. Spark plug number 4, appeared darker in color and wet. Various shields and non-system items were removed.

Photo 5. Upper and lower spark plugs.

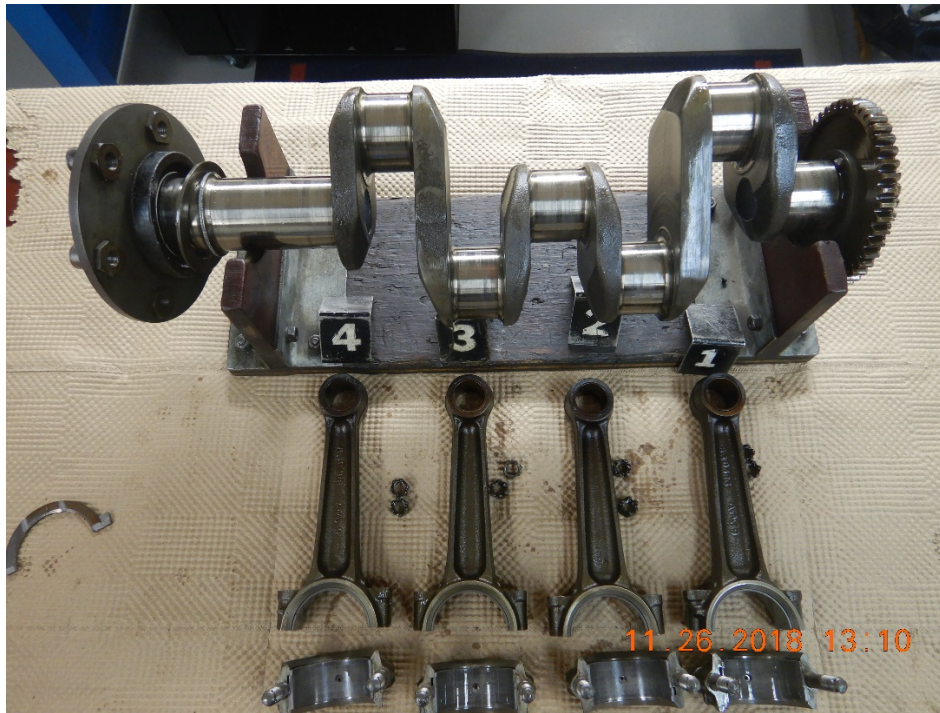
10% blockage. The oil pump attachment bolts did not have safety wire but appeared to retain their torque. The oil pump gears appeared normal. The engine was verified to be timed correctly at 24°. The left magneto, Left, S/N: A58836, was test run and verified to function correctly. The right magneto, S/N: A58837, was test run and verified to function correctly. The generator appeared normal. The exhaust mufflers appeared normal. The intake manifold was broken at the carburetor mount, otherwise it appeared normal. The number two cylinder had a chrome cylinder. The remaining three were not chrome. All the cylinders appeared normal. All valves appeared normal. All pistons appeared normal with a light to medium coat of carbon deposits on the tops. The pistons were a standard bore size. All piston rods appeared normal. All wrist pins appeared normal. All rod end bearings appeared normal. All lifter guides appeared normal. The number 2 intake and number 3 exhaust guides were pitting at the point where the cam lobes meet the guide. The cam appeared normal. All cam bearings appeared normal. The crank case appeared normal with all bearing surfaces appearing normal.

Photo 6. Crank Shaft, Connecting rods and bearings.

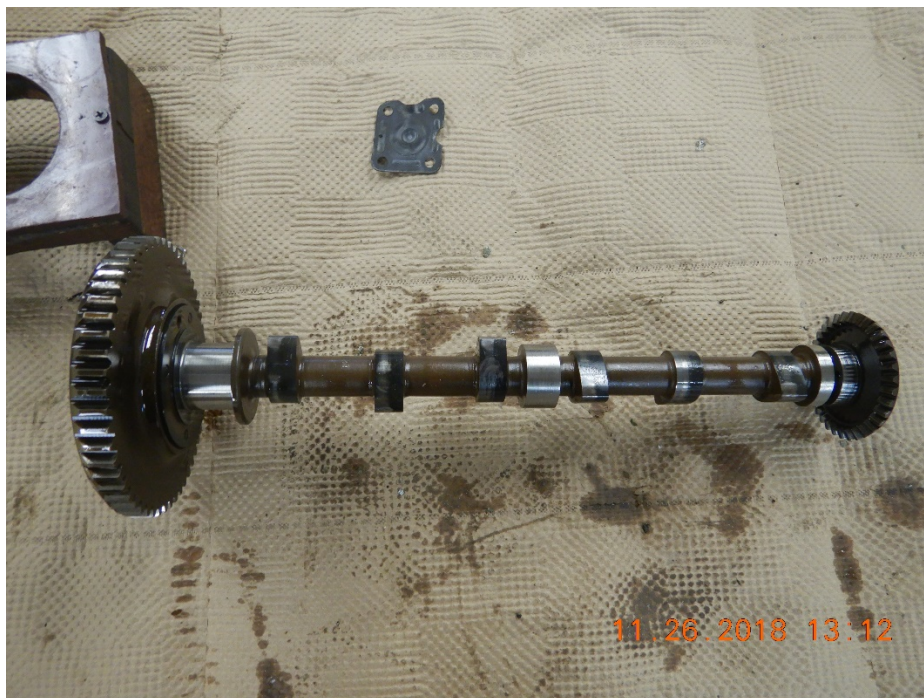
Photo 7. Engine cam.

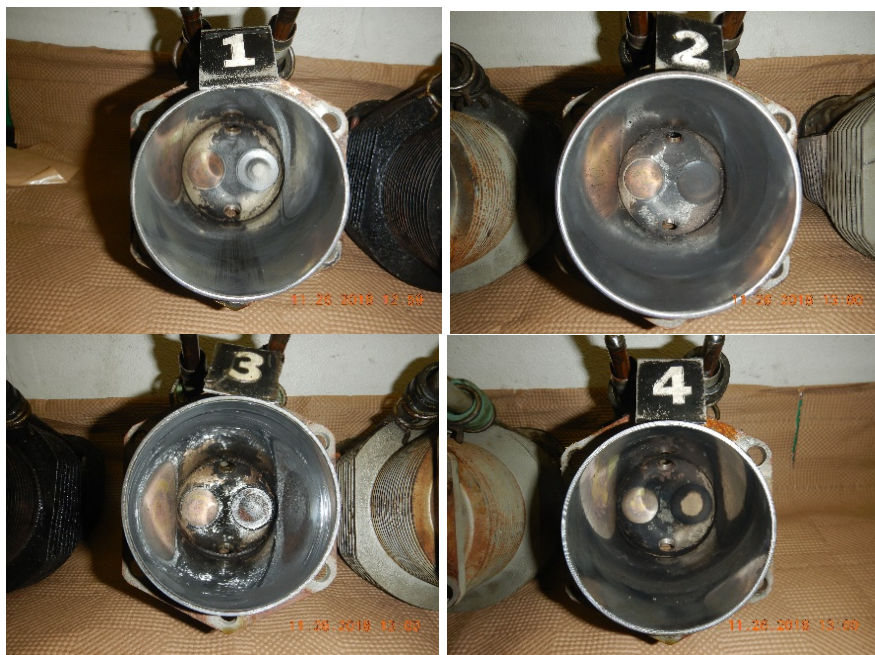
Photos 8. thru 11. Cylinders.

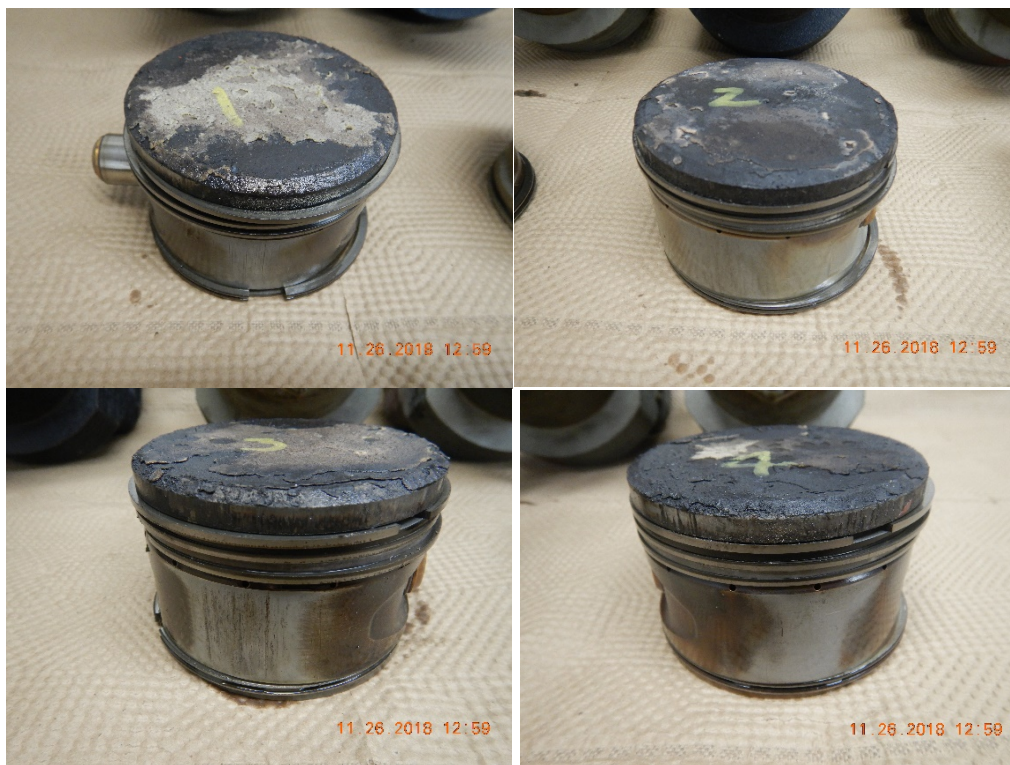
Photos 12 thru 15. Pistons.

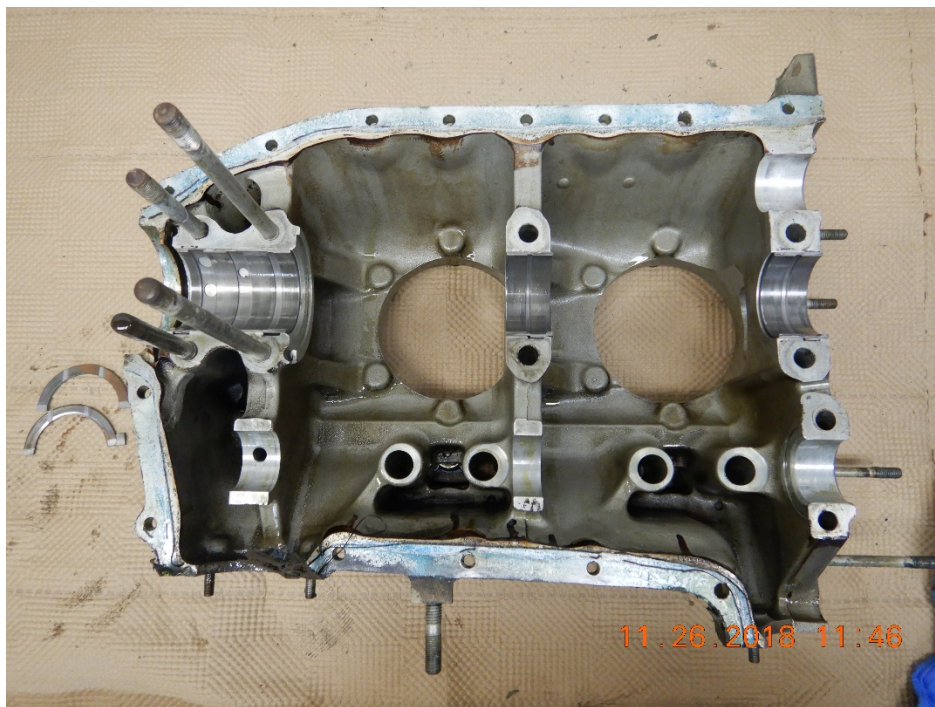
Photo 16. Right Engine Case.

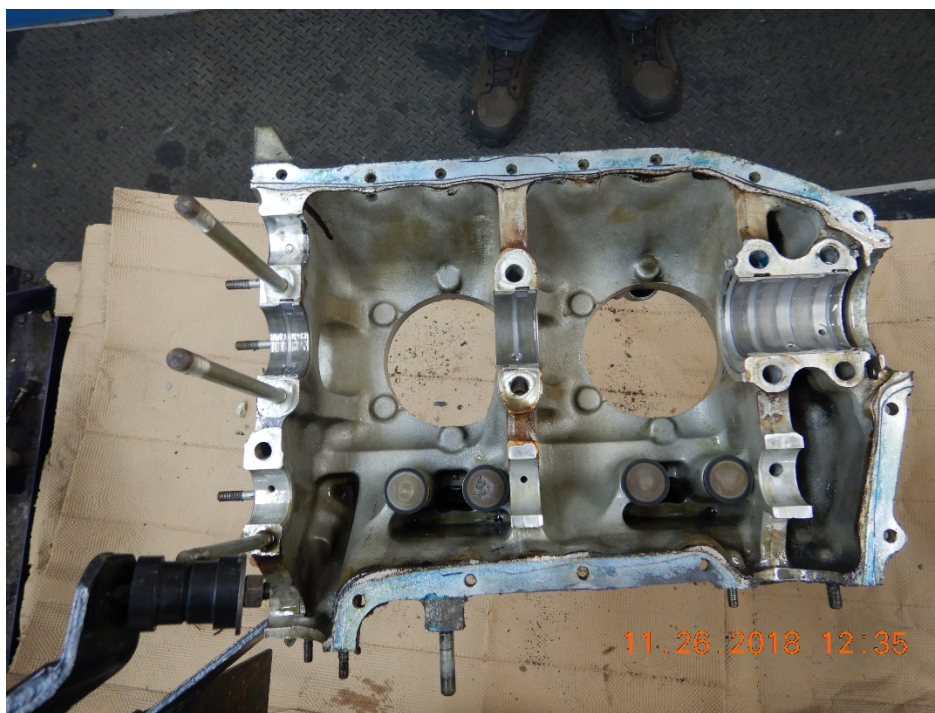
Photo 17. Left Engine Case.
