## EXAMINATION NOTES

### HISTORY OF FLIGHT

On August 29, 2018, about 2035 mountain standard time, a Cessna P210, N6500W, impacted terrain short of the runway in Prescott, Arizona. The pilot, who was the registered owner, was operating the airplane under the provisions of 14 *Code of Federal Regulations* (CFR) Part 91. The airline transport pilot, the sole occupant, sustained fatal injuries; the airplane sustained substantial damage. The personal local flight departed from Ernest A Love Field Airport, Prescott, Arizona, about five minutes prior to the accident. Visual meteorological conditions prevailed and no flight plan had been filed.

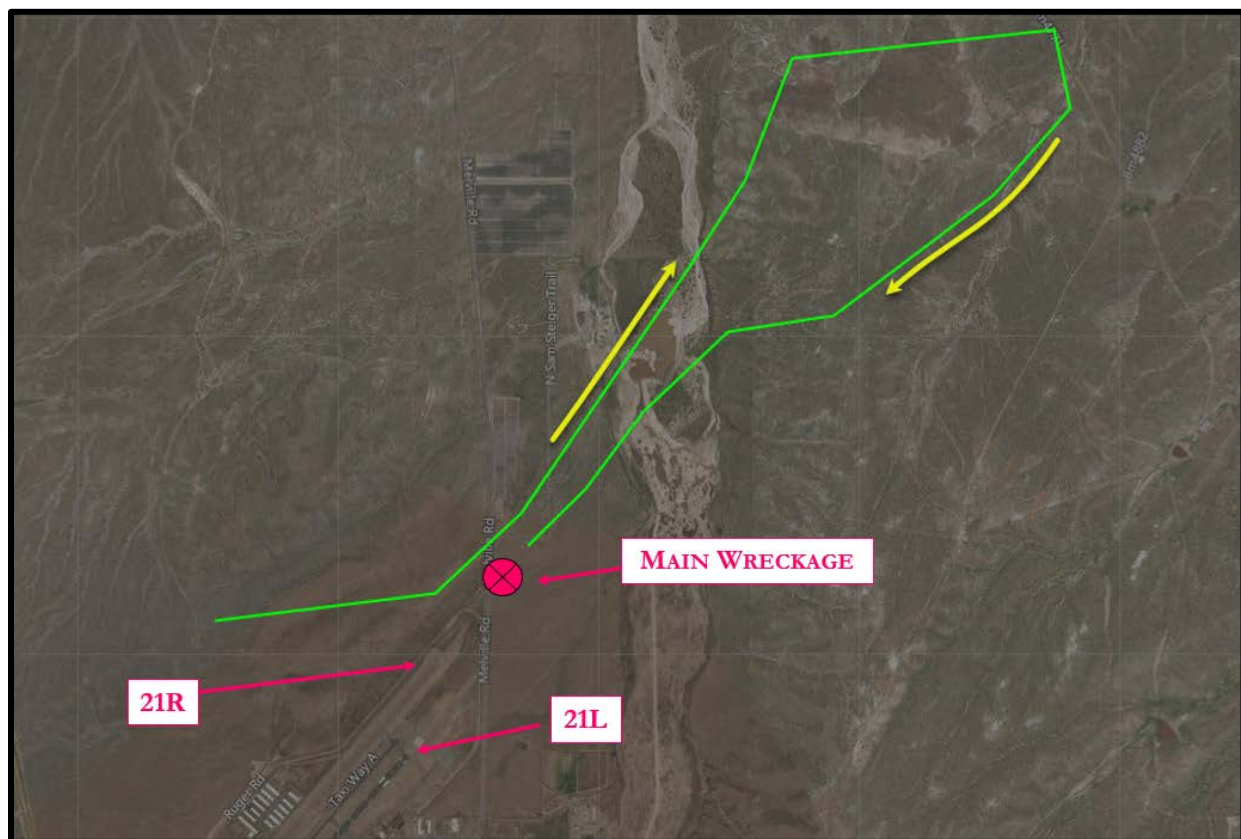
Figure 3: Radar Track Data

A review of the preliminary radar track data indicated that after departure, the airplane adjoined a right traffic pattern for runway 21R. On the downwind leg, the track continued toward the runway and it appeared the airplane was close to being above the approach end. The track then progressed into a long teardrop-shaped 180° turn by first heading northeast. At 2.8 nautical miles (nm) from the approach end of runway 21R, the airplane's heading turned right toward the runway. The track continued toward the southwest making a few shifts consistent with the pilot correcting the airplane to become aligned with 21R. The last recorded plot was at 2034:17 and located 740 feet northeast of the accident site. At that time, the airplane was about 5,050 ft mean sea level (msl), equating to about 145 ft above ground level (agl), at a ground speed of 99 kts.

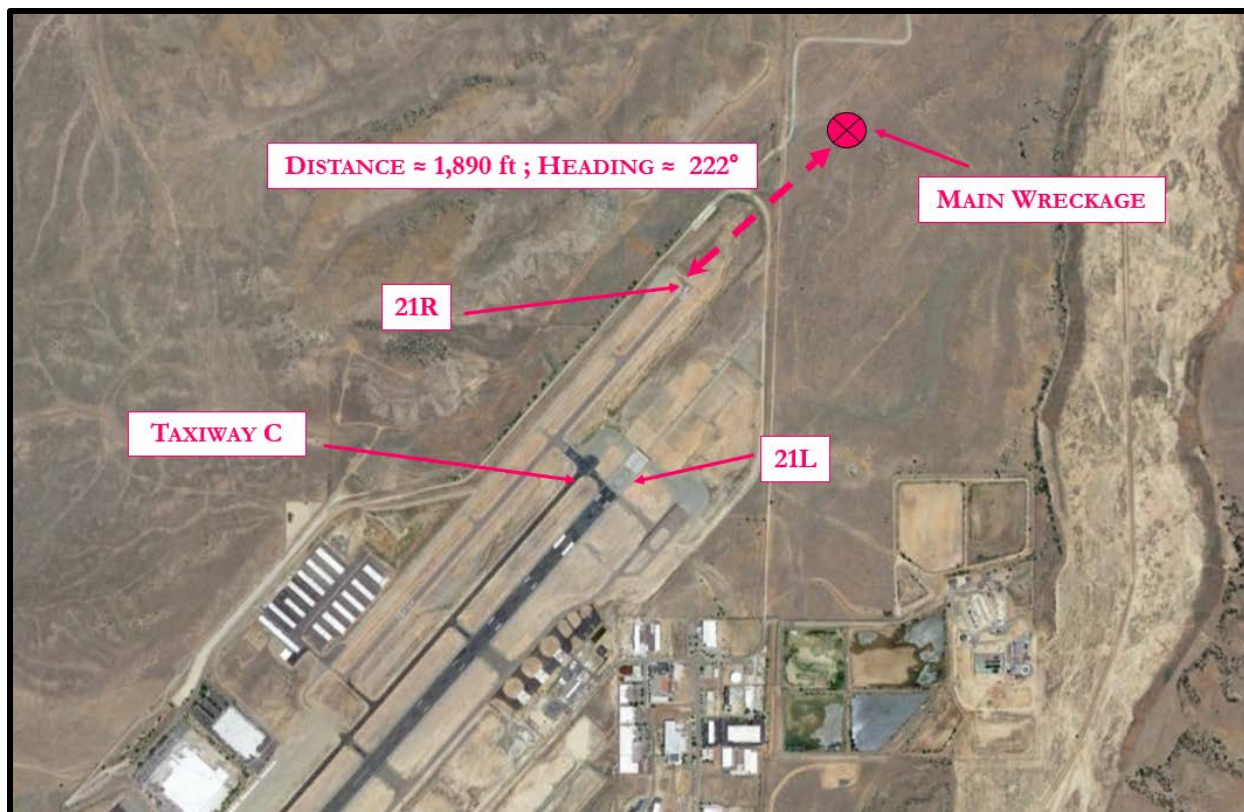
Figure 4: Accident Site in Reference to the Runways

The accident site was located in the desert terrain about 1,890 ft from the approach end of runway 21R. In character, the terrain was composed of dry, soft dirt and prairie grass. The wreckage was found distributed over a 240 ft distance on a median magnetic bearing of about 222°.

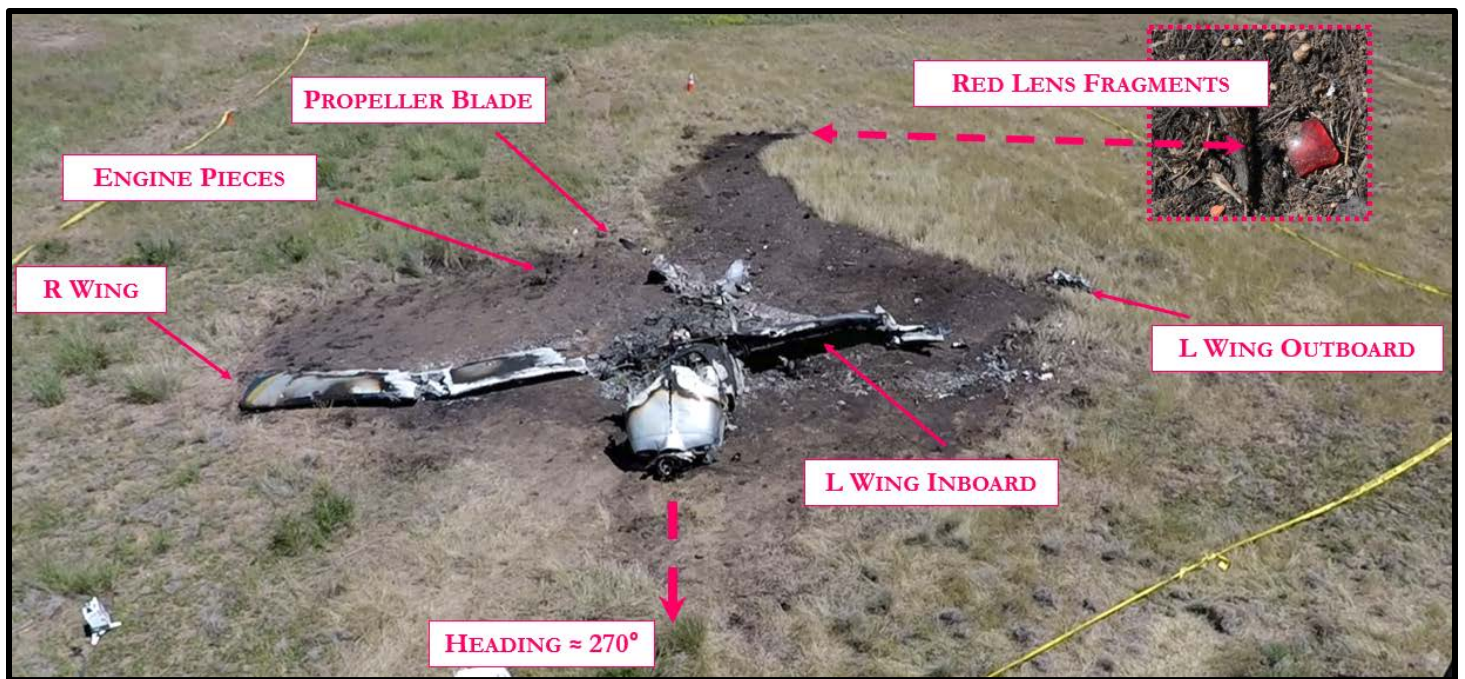
Figure 6: Main Wreckage

The main wreckage consisted of a majority of the airframe and engine, which had been consumed by fire. The main wreckage came to rest on a heading of about 270°. The remaining wreckage was found in the debris field and adjacent to the main wreckage and principally consisted of the outboard left wing, the nose landing gear doors, a propeller blade, and nose cowlings pieces.

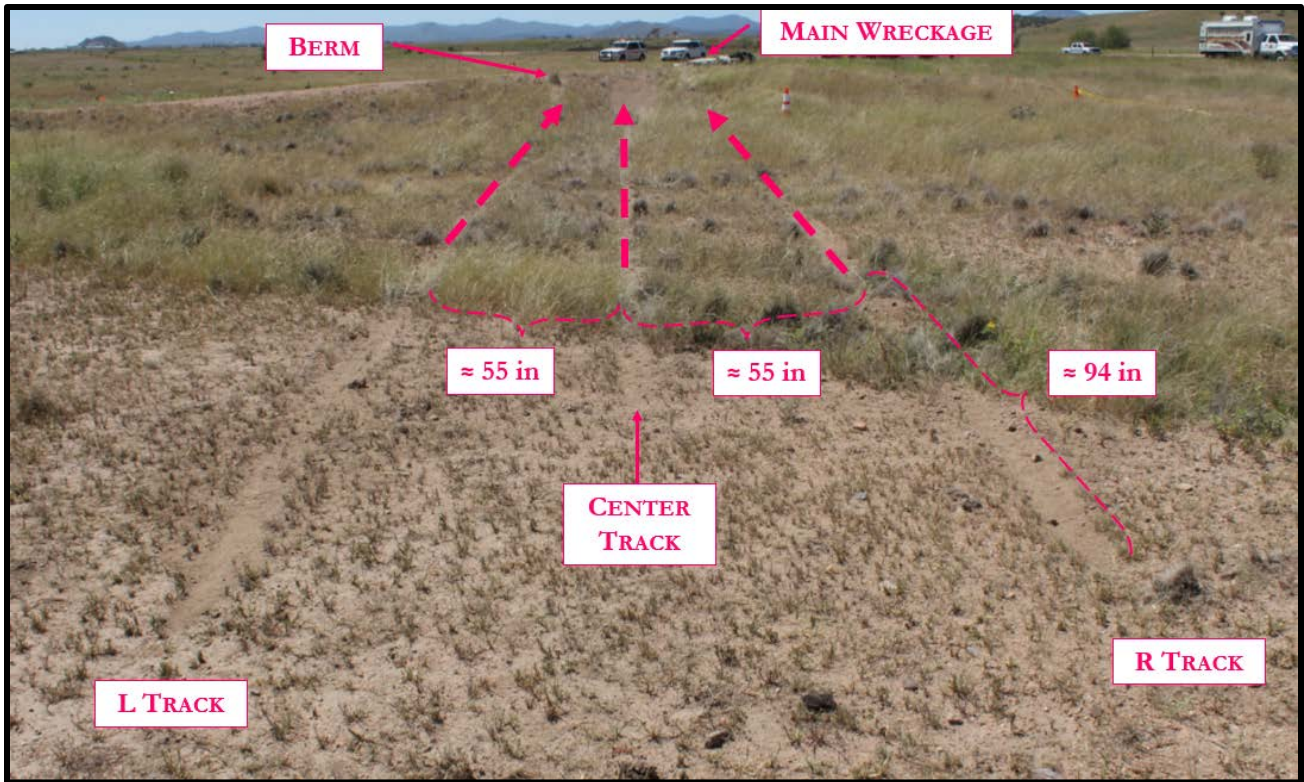
Figure 8: Beginning of Debris Field

The first identified points of contact consisted of disrupted dirt and grass on the flat desert terrain making up the far northeastern end of the debris field. The markings started as two nearly parallel indentations in the vegetation and dirt spaced about 110 inches apart. The craters were in the same location in the debris path and continued southwest toward the main wreckage. A center indentation appeared about 94 inches down the debris field and was

space equally between the right and left craters. The craters were consistent in size and orientation to that of the landing gear wheels.

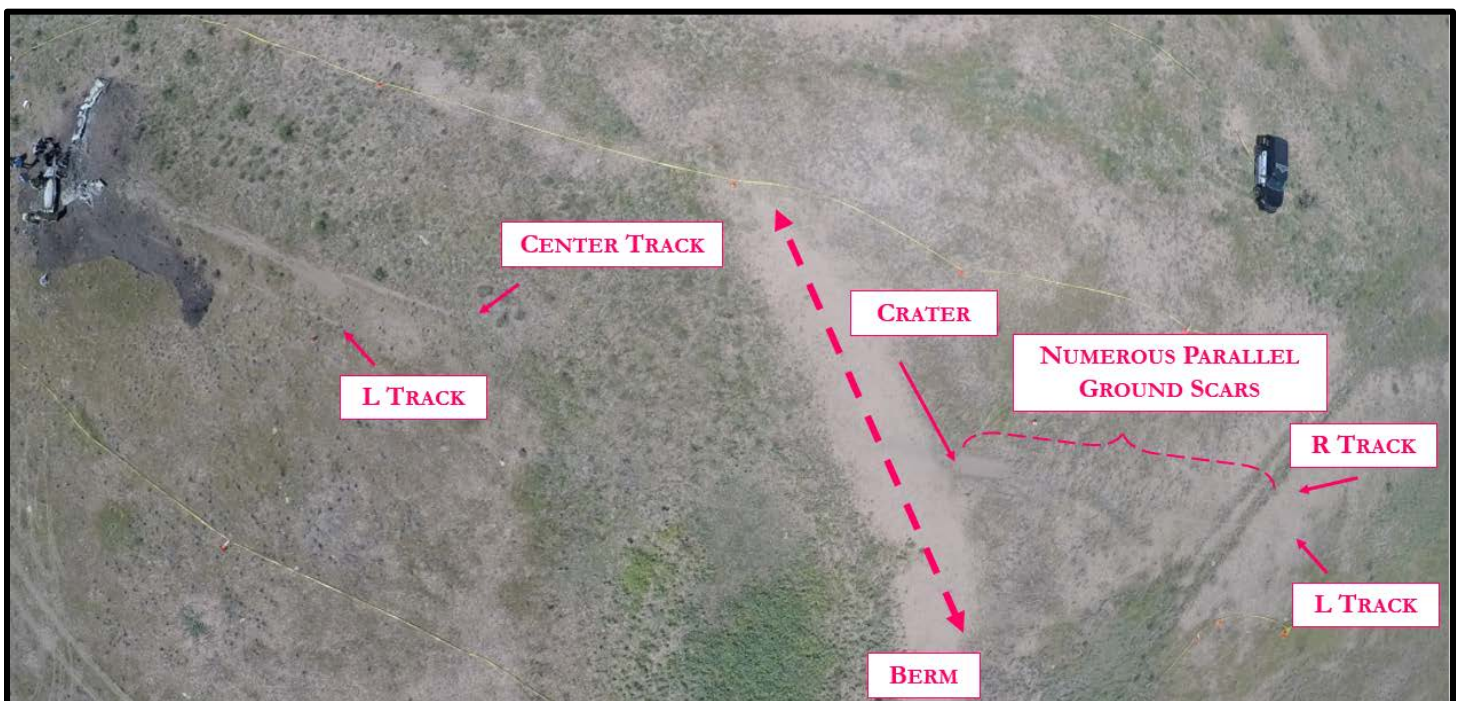
Figure 9: Debris Field Showing Ground Scars

The indentations were continuous about 60 ft until reaching a northwest-southeast oriented berm that was about 2 feet higher than the surrounding terrain. There were numerous parallel ground scars that were located perpendicular to the direction of the center indentation and immediately over it. The size and location was consistent with propeller slashes.

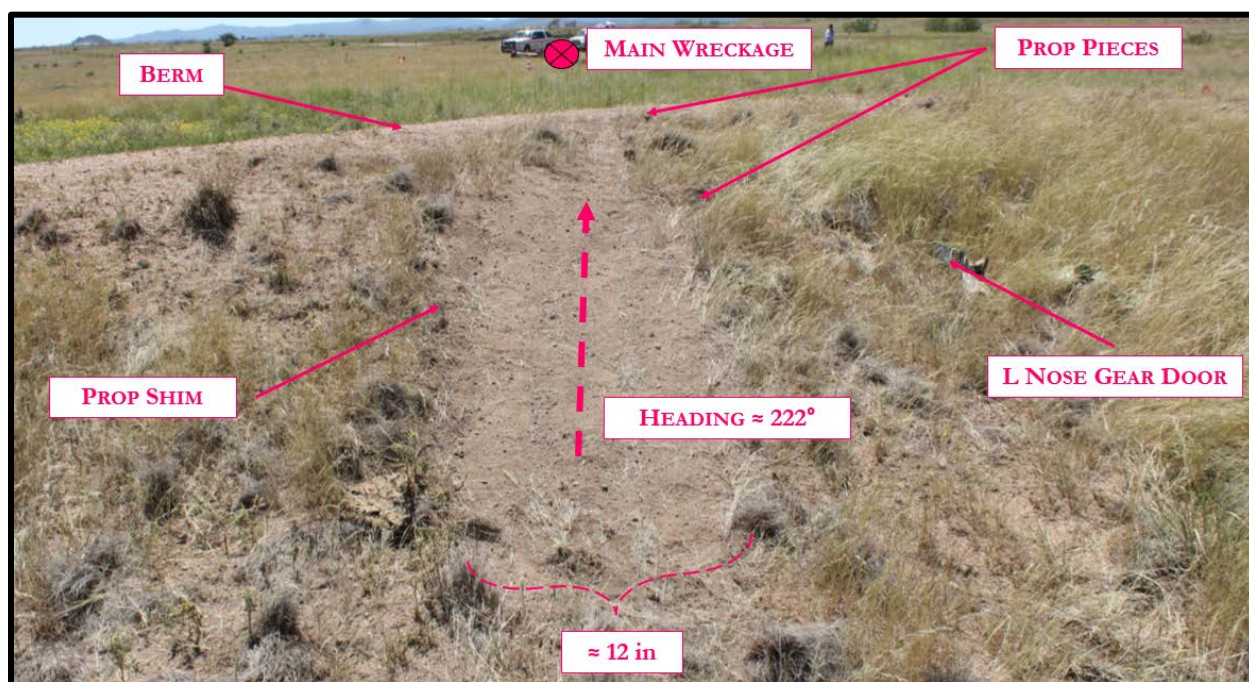
Figure 11: Debris Field Referencing the Berm

Located on the east side of the berm there was a crater in the upsloping soft dirt that was 12 inches wide. The left landing-gear nose gear door, propeller hub shims, and a propeller ball bearing were located adjacent to the indentation.

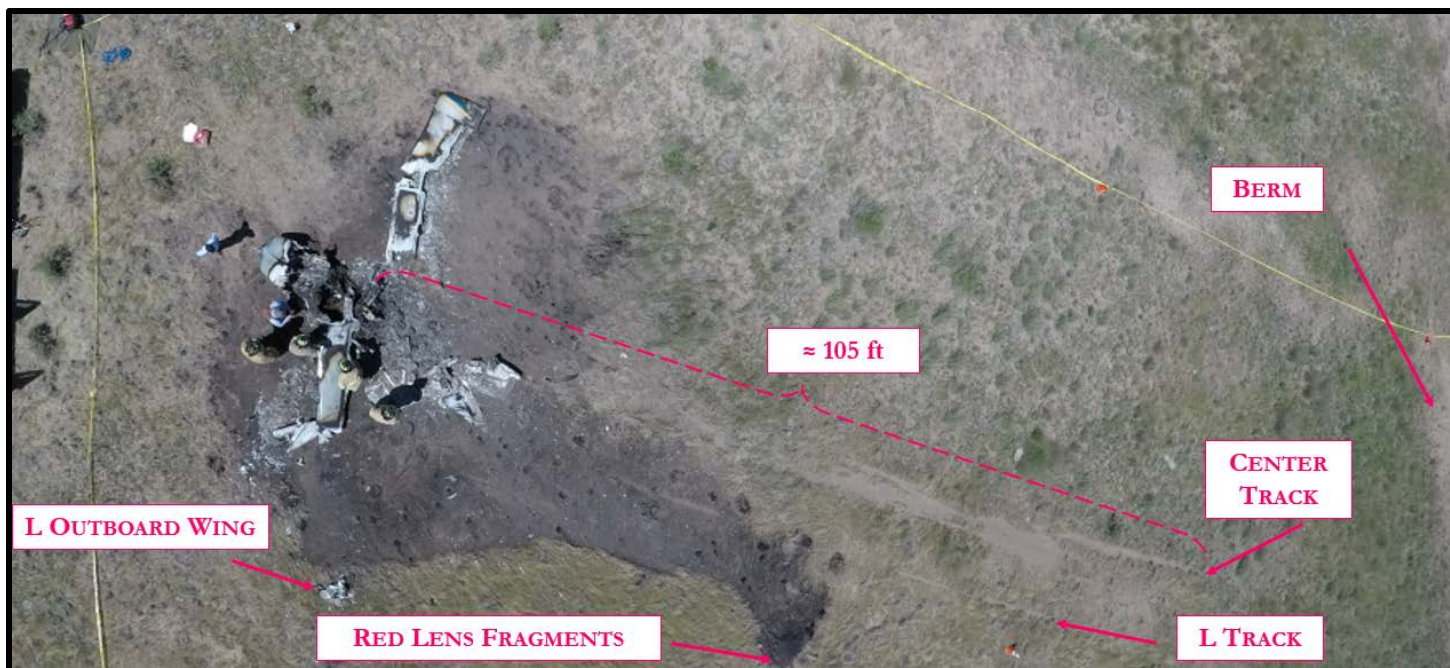
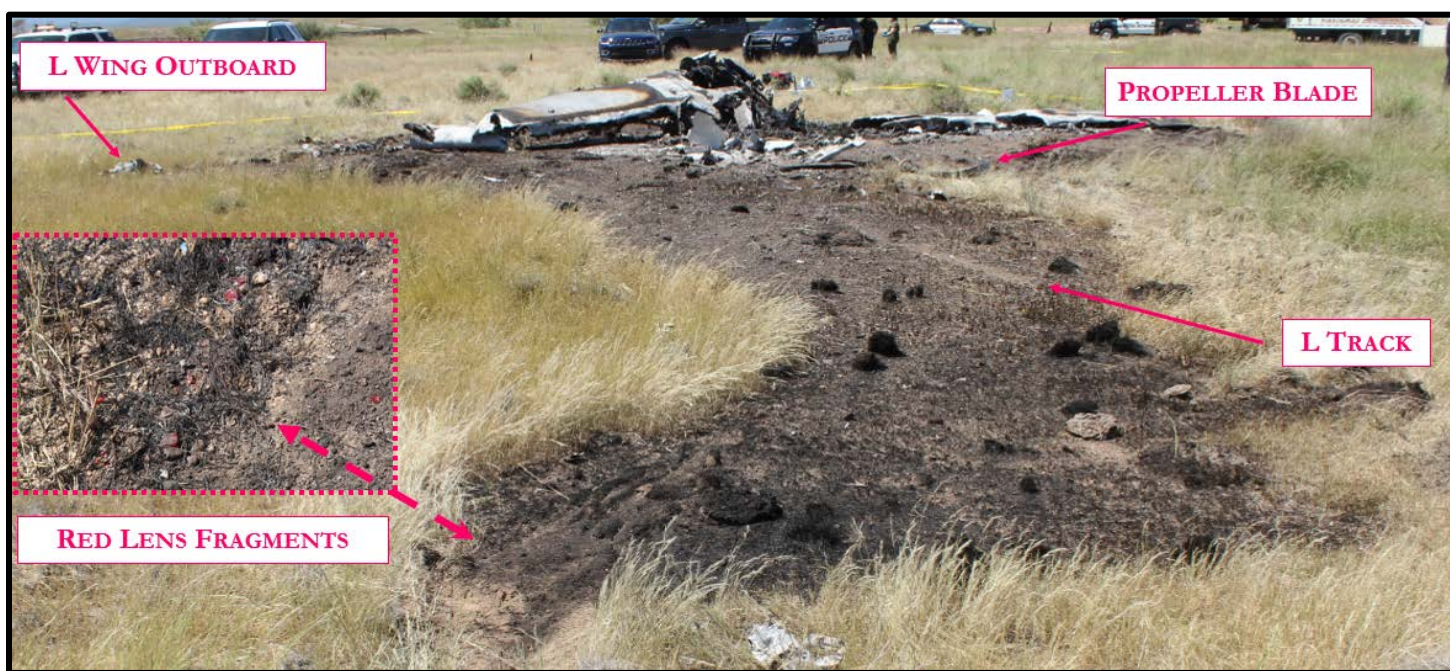
Figure 12: Debris Field From Berm to Main Wreckage

There were no indentations from the apex of the berm until about 105 ft from the main wreckage where there were several paint chips and nose fairing pieces scattered. There was an indentation left of the main indentation that continued toward the wreckage and contained red and white lens fragments imbedded in the terrain. The grass was burned in that area and up to the wreckage. From the lens fragments to the main wreckage was about 45 ft.

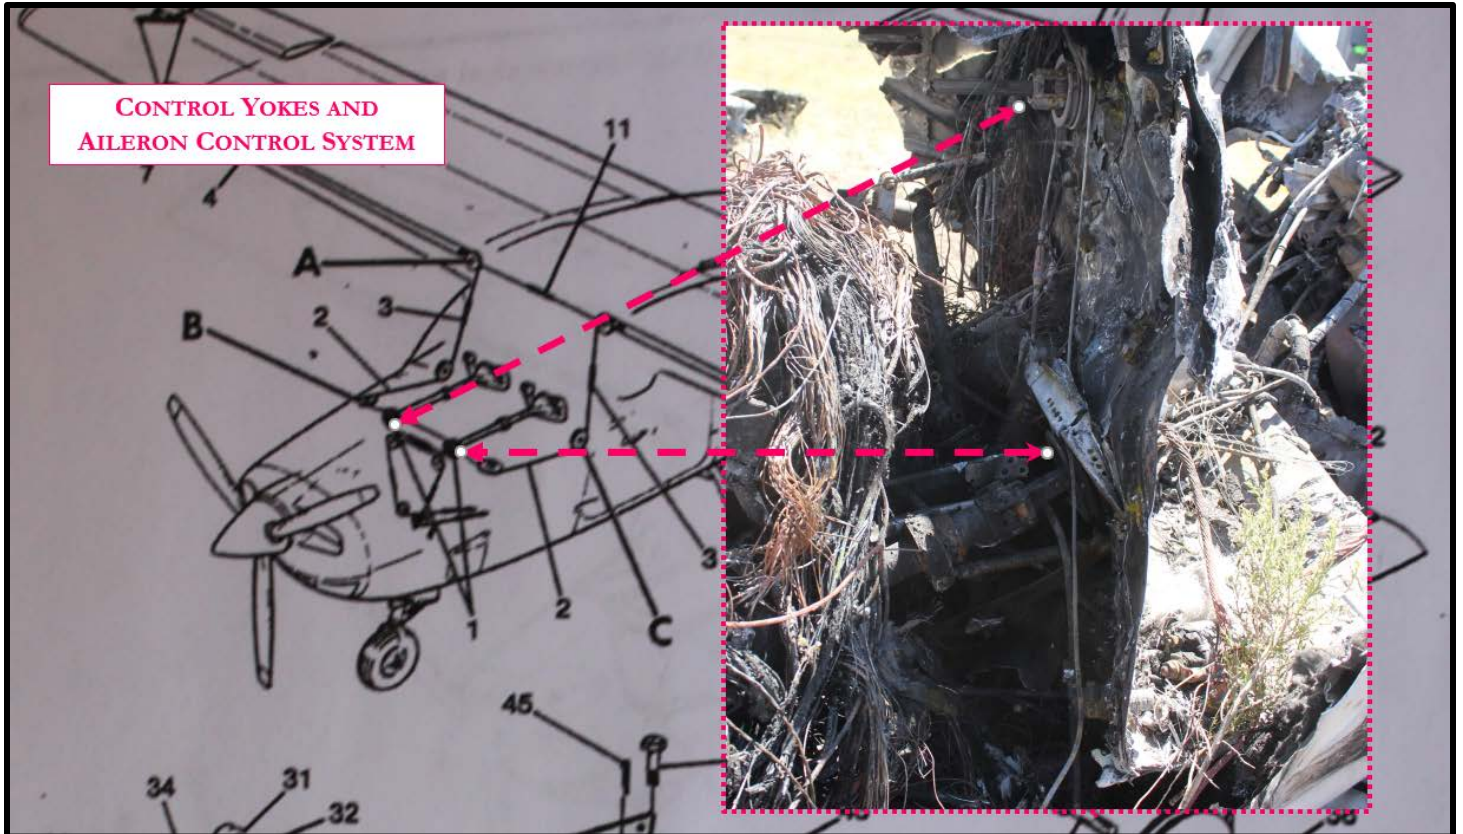
Figure 14: Cockpit Control Yokes

The inboard section of the left wing still had the partially consumed aileron and wing flap control surfaces attached. The outboard section was about 10 ft from the main wreckage and consumed by fire. Flap cable continuity was established from the control surface to the cockpit area; the flap handle was in the 10° position. The aileron cable continuity was established from the control surfaces to the control yoke assembly although there were several cuts made from recovery.

The right wing remained affixed to the fuselage with the aileron and wing flap control surfaces still attached at their respective hinges. The outboard section had less burn the main wreckage and fuel was found inside. The flap actuator jackscrew was examined by measuring the exposed threads, which totaled 3.2. A representative from Textron Aviation stated that the position of the jackscrew was consistent to the flaps being extended between 5° and 10°. Flap cable continuity was established from the control surface to the cockpit area. The aileron cable continuity was established from the control surfaces to the control yoke assembly.

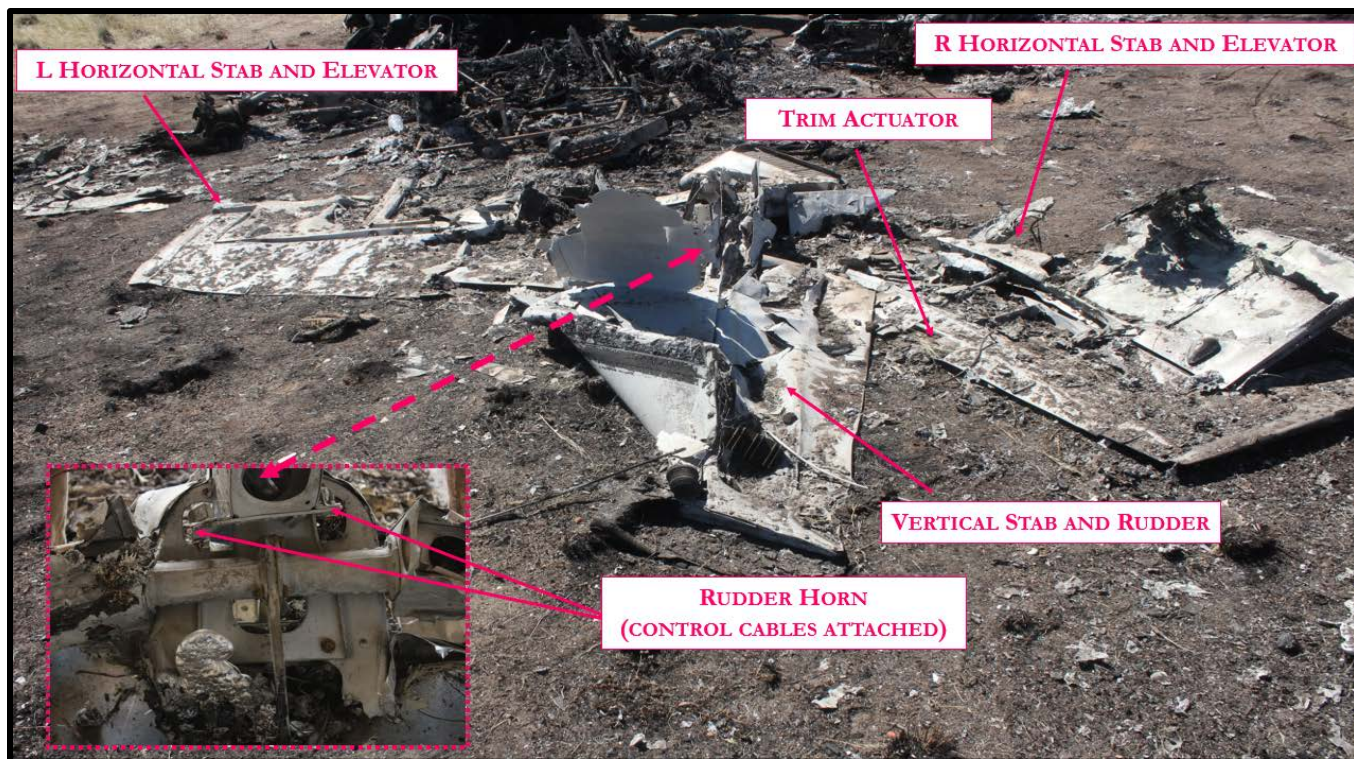
Figure 15: Tail Section

The rudder control surface remained affixed to the vertical fin structure. The rudder cables were attached to the rudder horn, and continuity was established to the aft baggage compartment through a series of pulleys and runs through lightning holes; the ends were attached to their respective bell cranks at the rudder pedal mixing control bar.

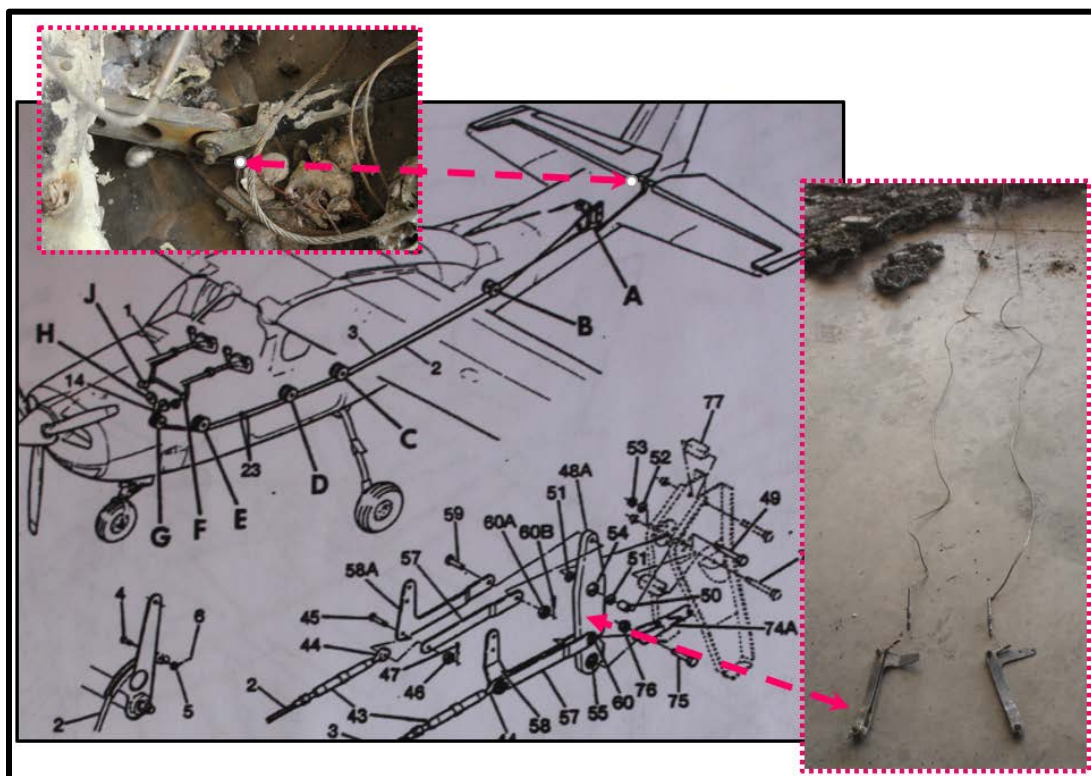
Figure 16: Elevator System

The horizontal stabilizer and elevator remained attached to the empennage. The elevator was attached to the aft push-pull tube connect, which was partially consumed. The elevator cables were attached to their respective bellcrank arms and continuity was established in the aft baggage compartment through a series of pulleys and runs through lightning holes to the control yoke area. Elevator trim tab actuator was 1.5 inches which it consistent with 5 degrees tab down

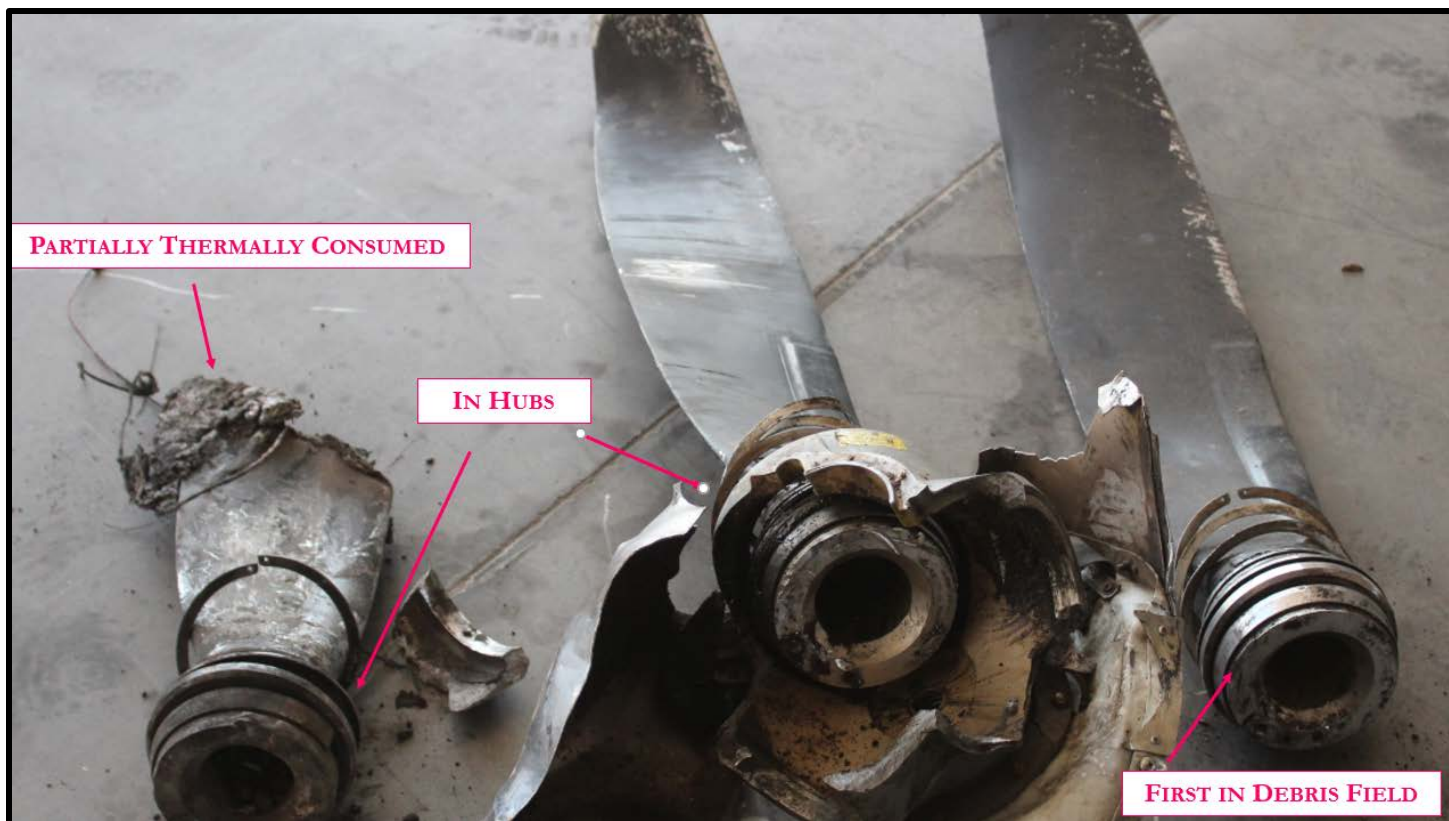
Figure 17: Propeller Blades

Two of the propeller blades were in the hub, one of which was partially consumed by fire. The remained blade was found in the debris field. The two blades that were not thermally consumed exhibited leading edge polishing and gouges, with the tips curled aft.
