# NATIONAL TRANSPORTATION SAFETY BOARD

## MATERIALS LABORATORY FACTUAL REPORT

Report No. 19-049

Place : Prescott, Arizona  
Date : August 29, 2018  
Vehicle : Cessna P210N, N6500W  
NTSB No. : WPR18FA245  
Investigator : Zoë Keliher, AS-WPR

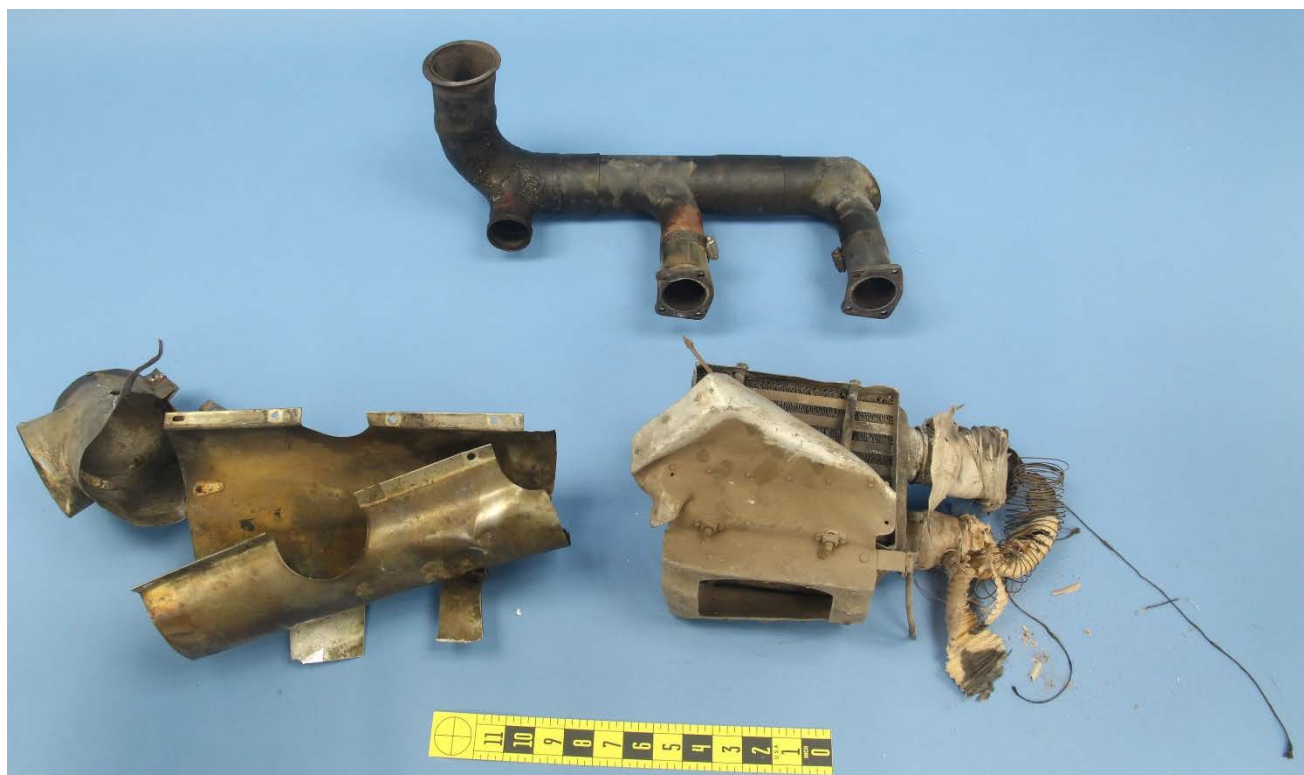
Figure 1 shows the components from the exhaust system, as received. Of note was a cracked flange on the exhaust manifold tube. This crack was located along the flange on the side of the output port side of the primary manifold tube. This location is demonstrated in Figure 2 and Figure 3, as viewed from the top and side, respectively.

Figure 1 – The components from the exhaust system, as received.

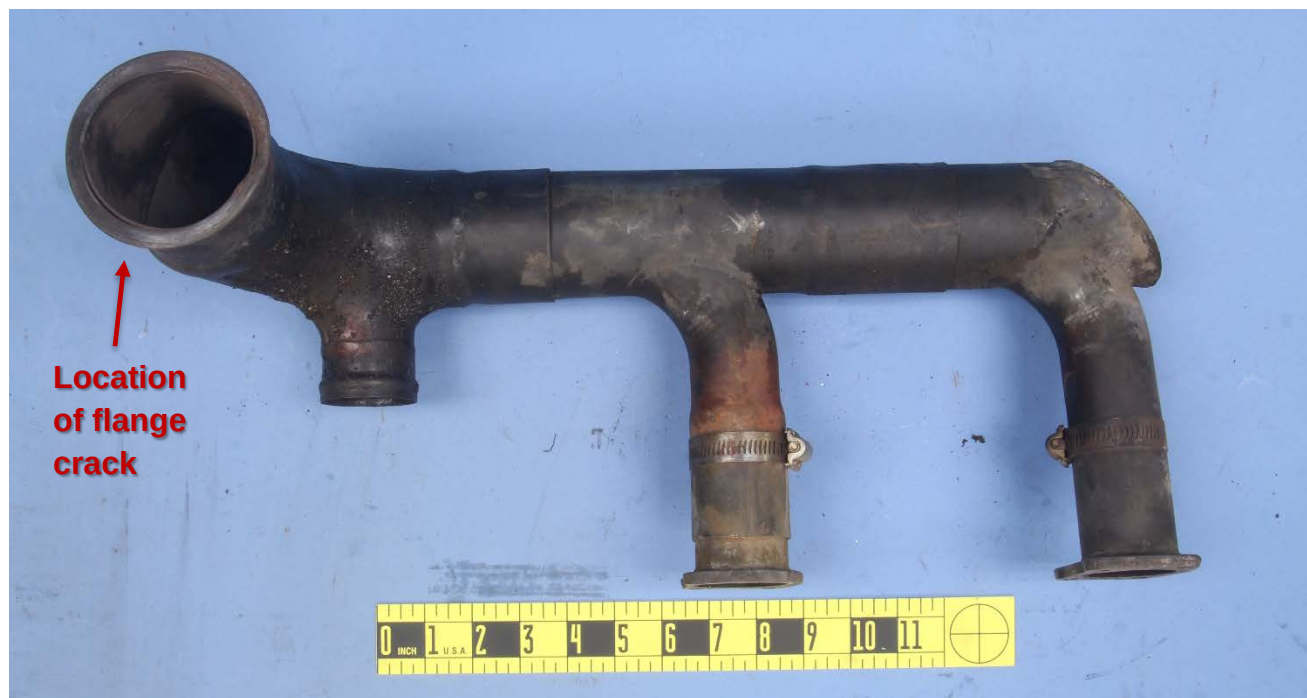
Figure 2 – The exhaust manifold, showing the location of the crack on the output flange.

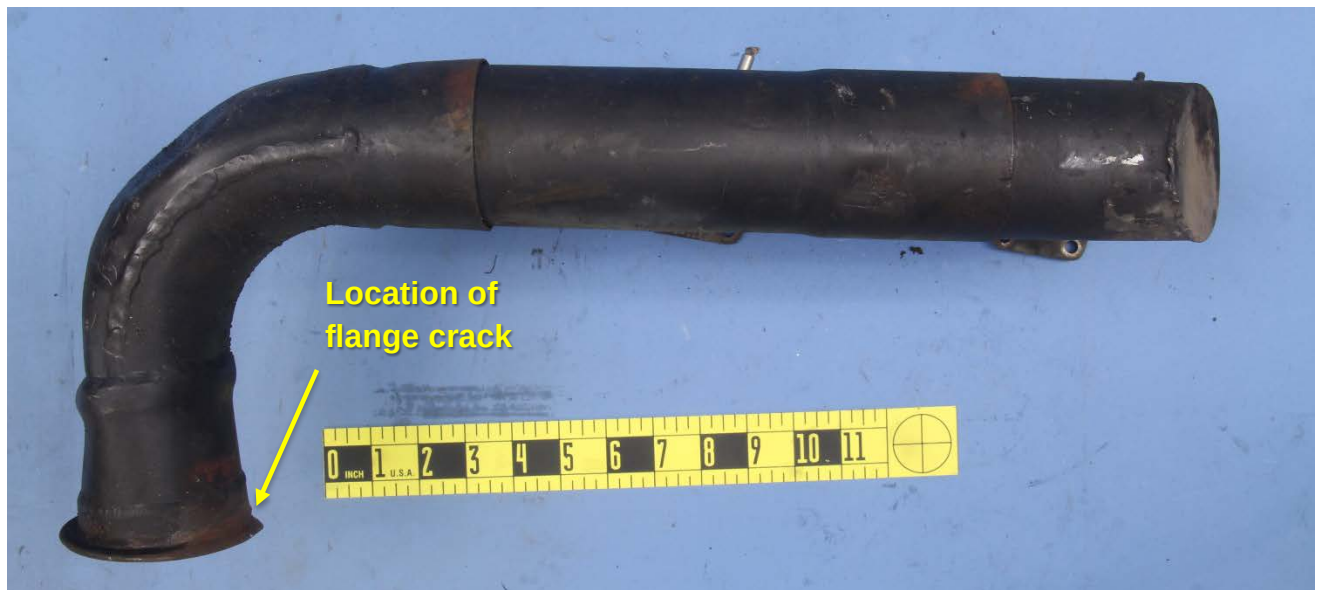
Figure 3 – View of the exhaust manifold, rotated 90° from Figure 2, with the crack location labeled.

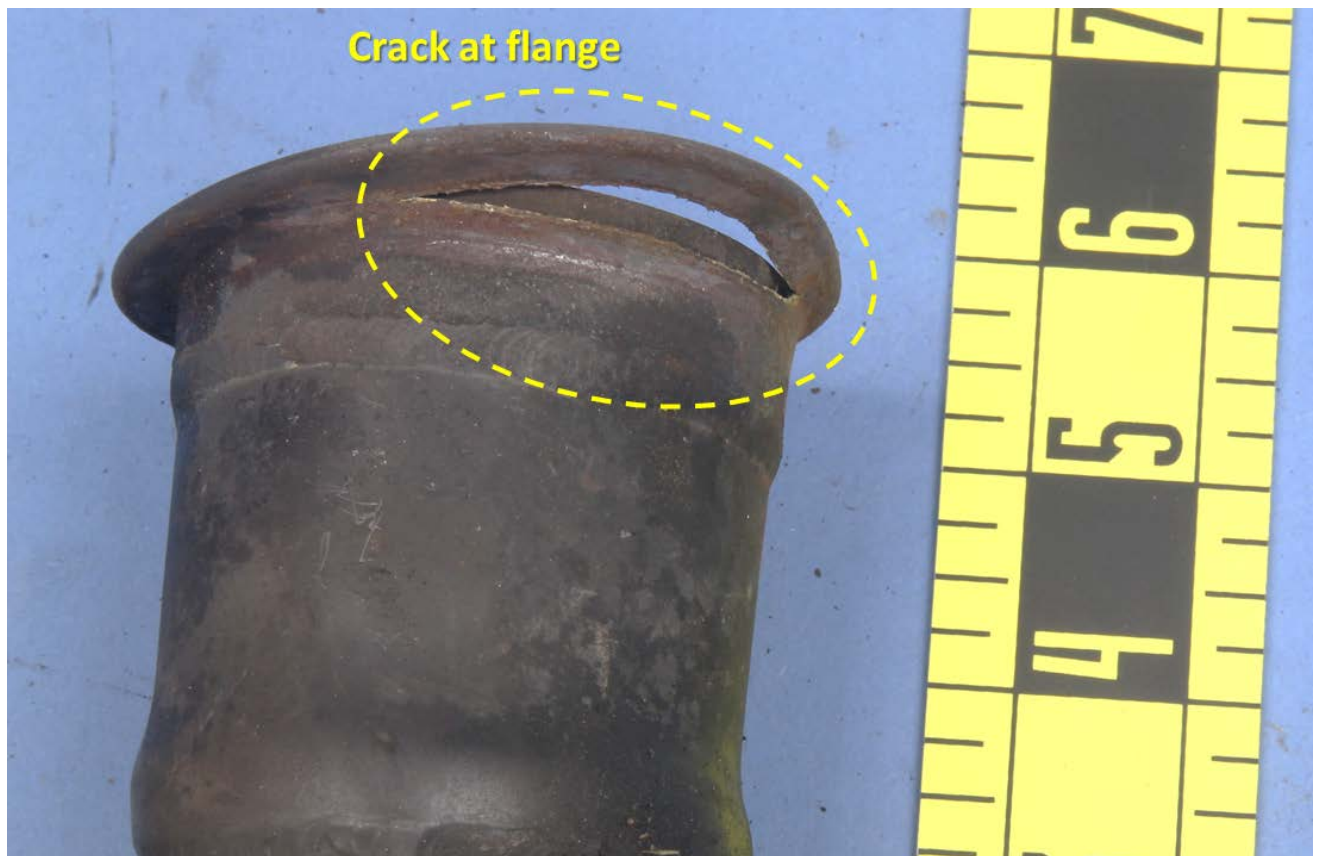
Figure 4 highlights the crack along the exhaust manifold flange, viewed from an angled position to demonstrate the size and gap in the material. The flange consisted of the outer metal sheet material having been bent outward and then back inward. The crack was located along this first outer bend. The linear length of the crack was approximately 1.81 inches. The maximum gap in the flange at the crack was approximately 0.20 inches wide.

Figure 4 – Closer view of the flange crack on the output port of the manifold, as received.

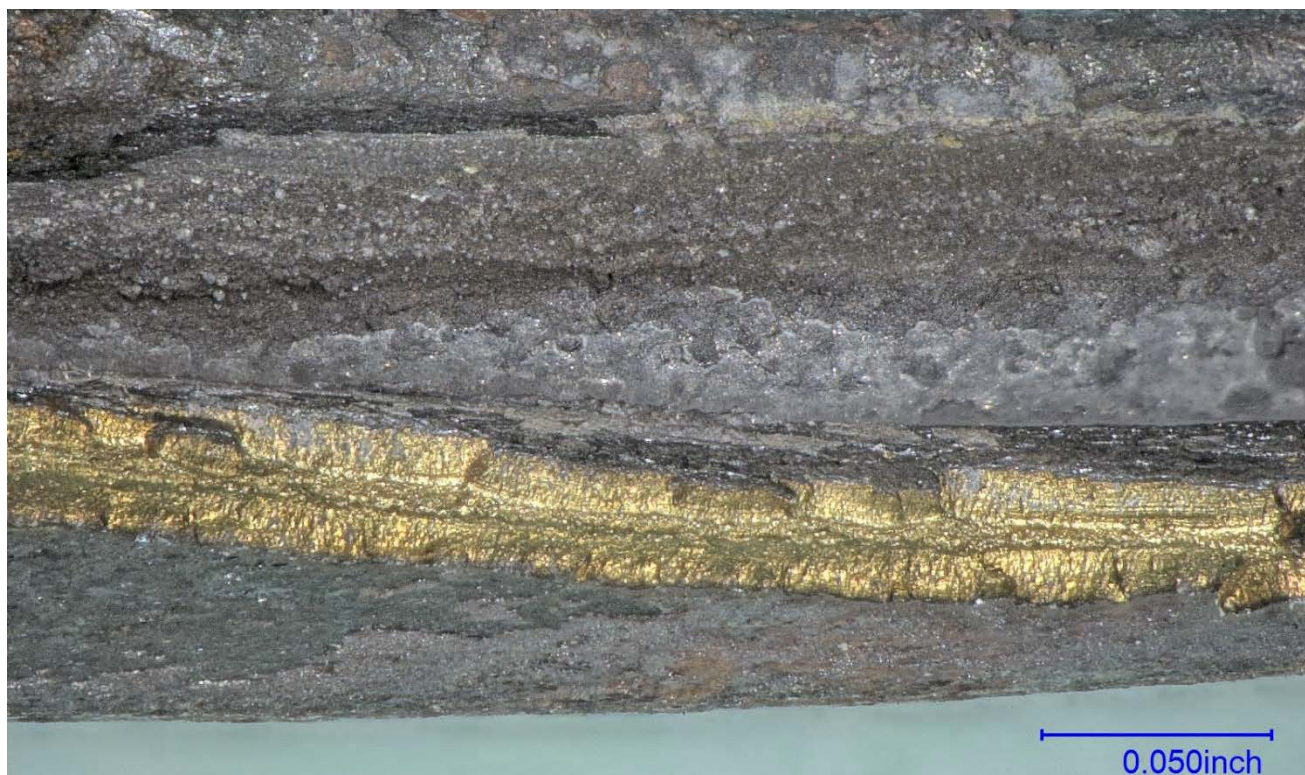
area of one of the mating crack faces is shown in Figure 5. Whereas the majority of the surface of the exhaust manifold exhibited a dull, black color, the crack faces exhibited a shiny, golden-yellow color. Visually, the crack faces exhibited three distinct regions—two outer layers with crack arrest marks and ratchet marks, and an inner layer with a rougher surface texture.

Figure 5 – Closer view of a portion of the opened crack, showing multiple thumbnail cracks and ratchet marks.

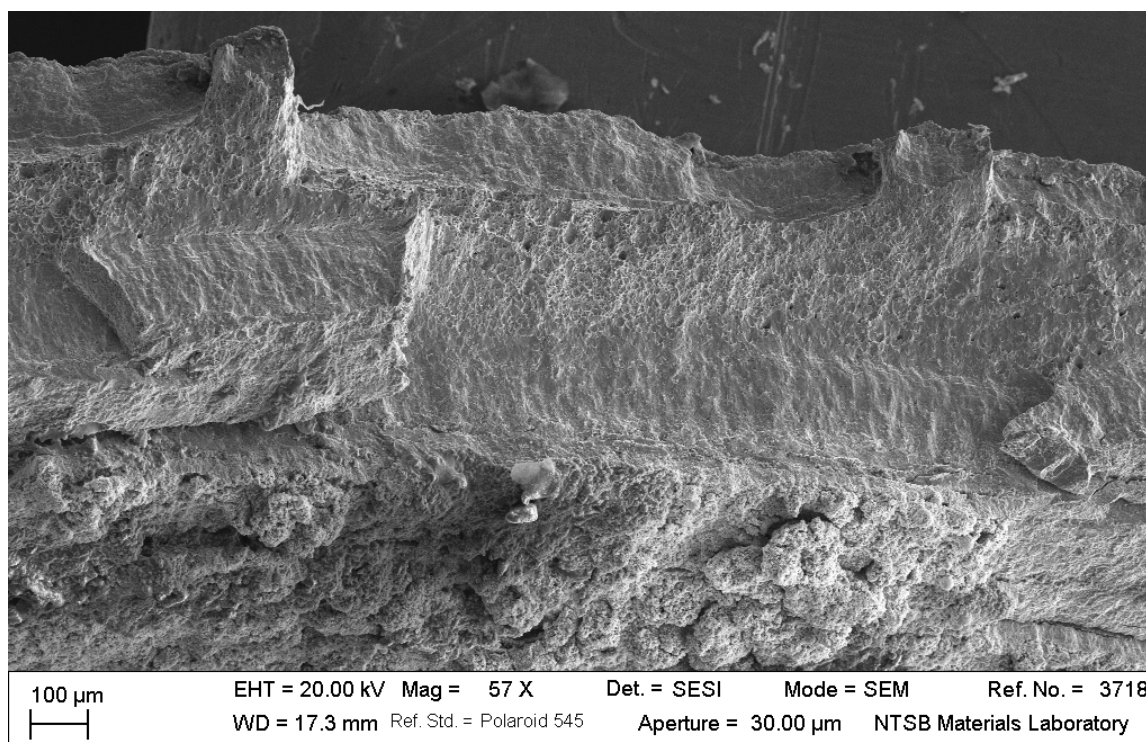
One of the crack faces was examined using a scanning electron microscope (SEM). Figure 6 shows a typical view of one of the crack faces. The two outer layers exhibited multiple individual thumbnail cracks. These cracks were separated by ratchet marks, which are jogs that form between cracks propagating on a fracture surface when multiple smaller cracks grow and eventually coalesce. These outer layers exhibited crack arrest marks and fatigue striations (see Figures 7 through 9). The orientation of these features was consistent with crack propagation from the surface inward. The striations shown in Figures 8 and 9 were consistent with fatigue crack propagation.

Figure 6 – Secondary electron micrograph of part of the opened crack, showing multiple individual smaller cracks that propagated inward.

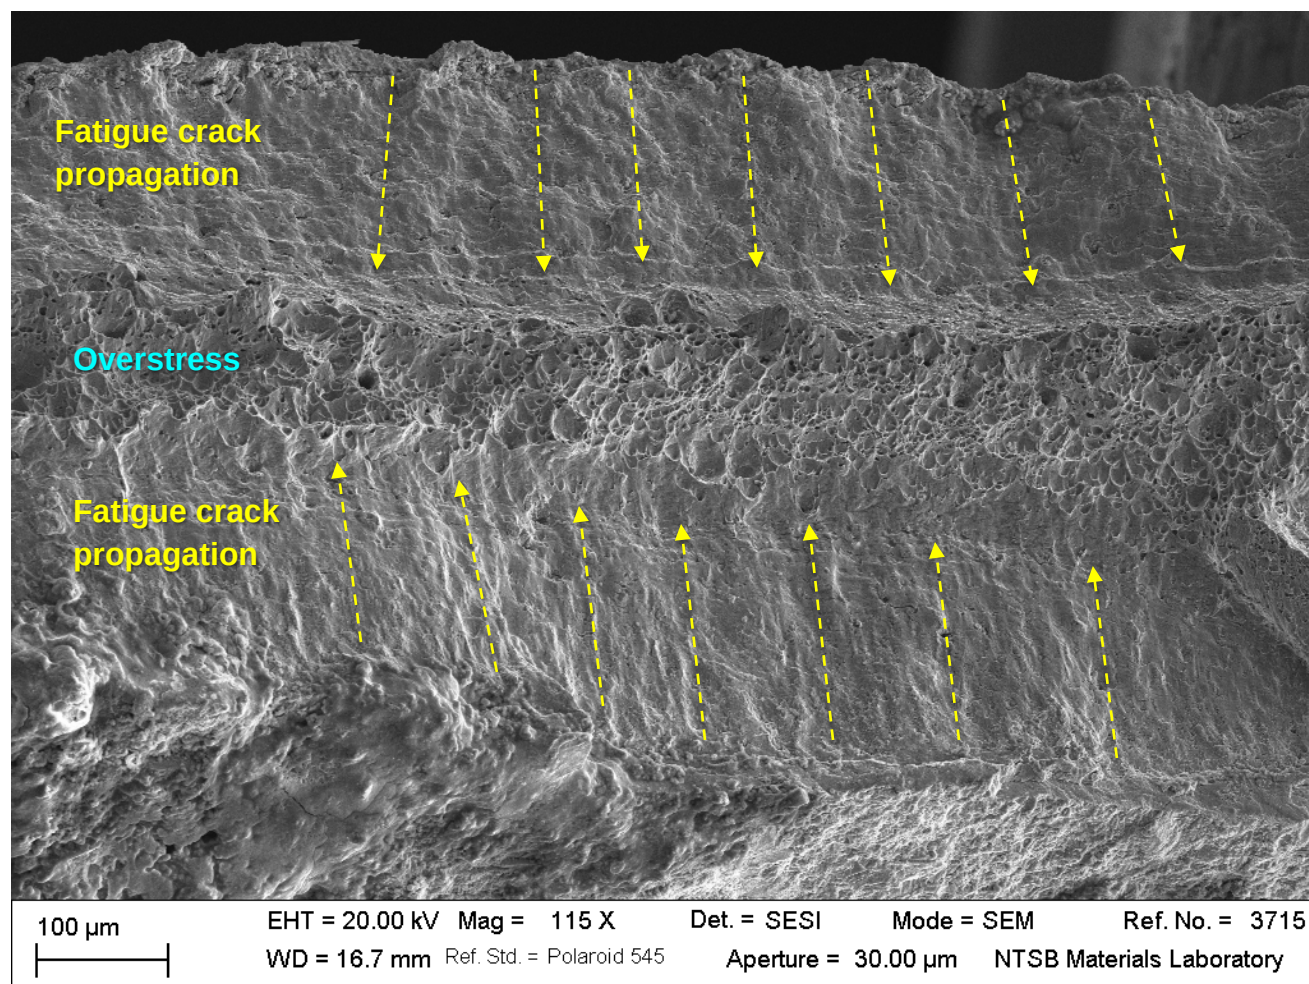
All the above fracture features were consistent with reverse bending fatigue. This is a fatigue crack propagation mechanism whereby cracks initiate on opposite surfaces of a component that is being bent back and forth. The crack propagated inward from opposite surfaces until the remaining material cross section could no longer bear the stress, resulting in the middle remaining material fracturing from overstress (as exemplified by dimple rupture).

Figure 7 – SE micrograph of the opened crack showing opposite fatigue cracks propagating inward, with a middle region of dimple rupture (overstress).

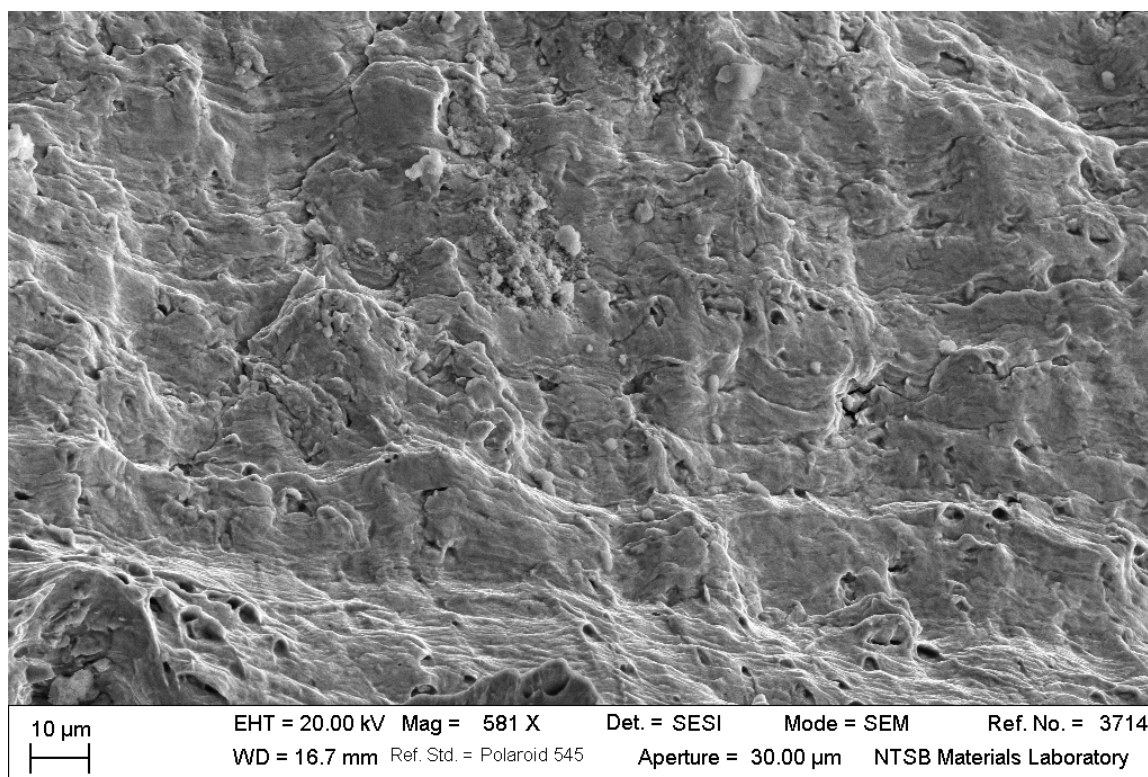
Figure 8 – SE micrograph of a typical area of fatigue striations on the crack.

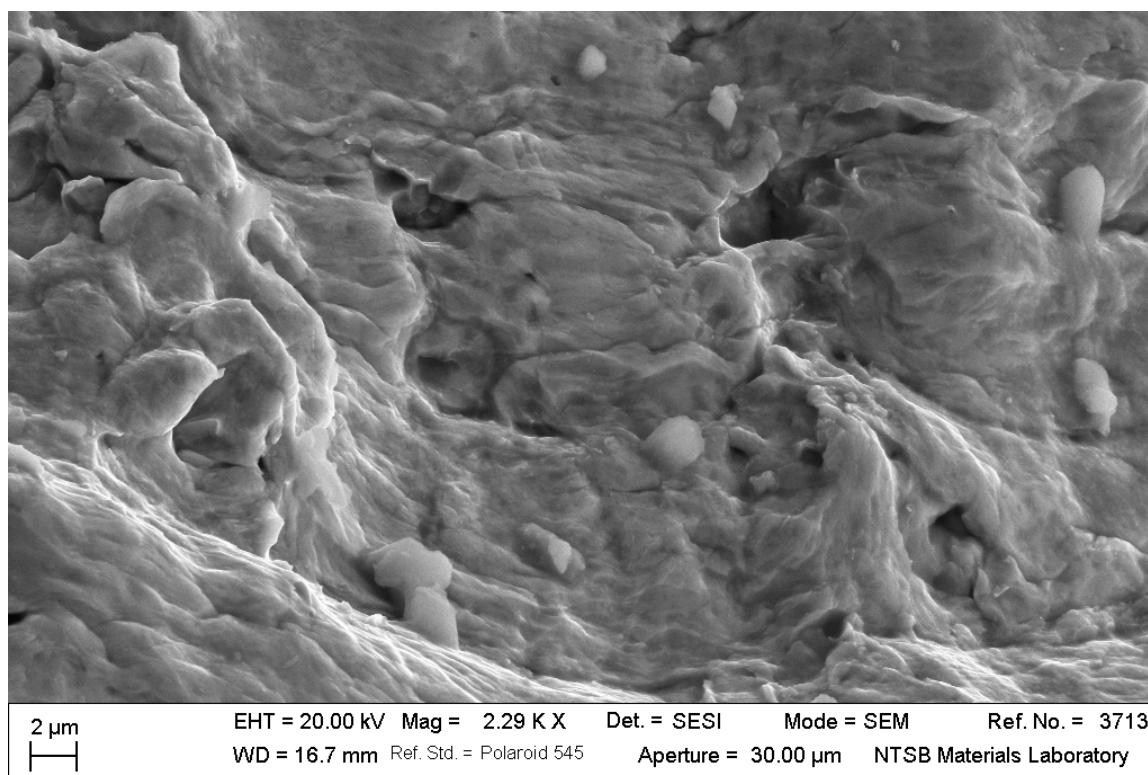
Figure 9 – SE micrograph showing a closer view of the striations in Figure 8.

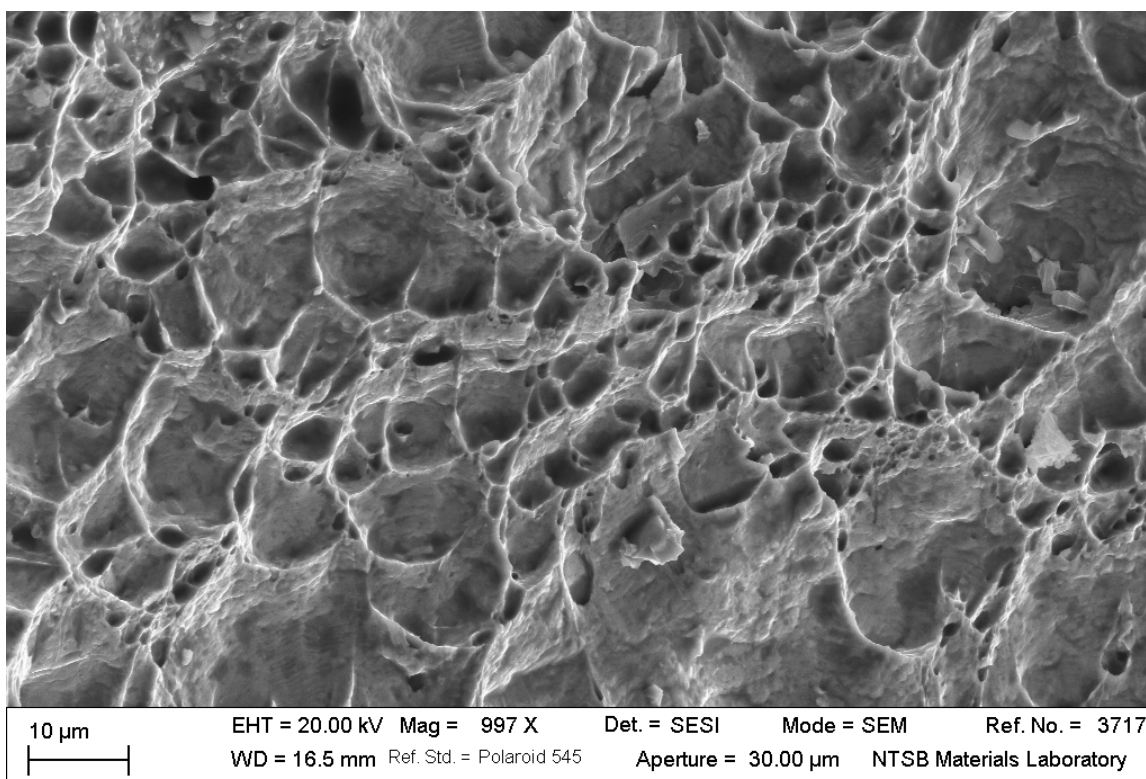
The middle region on the crack face consisted of rougher surface texture with different fracture features. Figure 10 shows a closer view of the middle region on the opened crack face. The middle region exhibited dimple rupture, consistent with subsequent overstress fracture.

Figure 10 – SE micrograph of dimple rupture in the middle region of the crack.

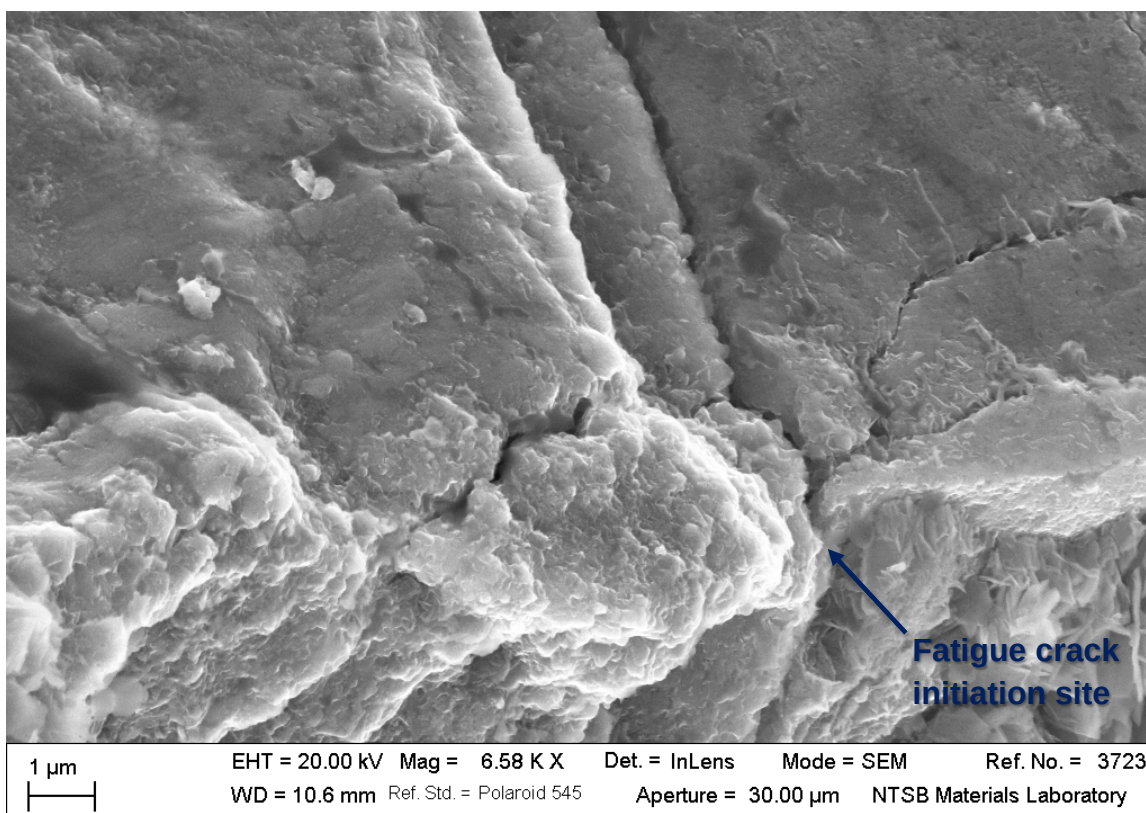
The crack faces exhibited multiple fatigue crack initiation sites. One such site is highlighted in Figure 11. None of the crack initiation sites exhibited material deficiencies much as inclusions, pits, or voids. As these edges were oxidized and damaged from post cracking damage, it could not be determined if there were any pre-cracking mechanical defects at the initiation sites.

Figure 11 – SE micrograph of a fatigue crack initiation site on the crack.

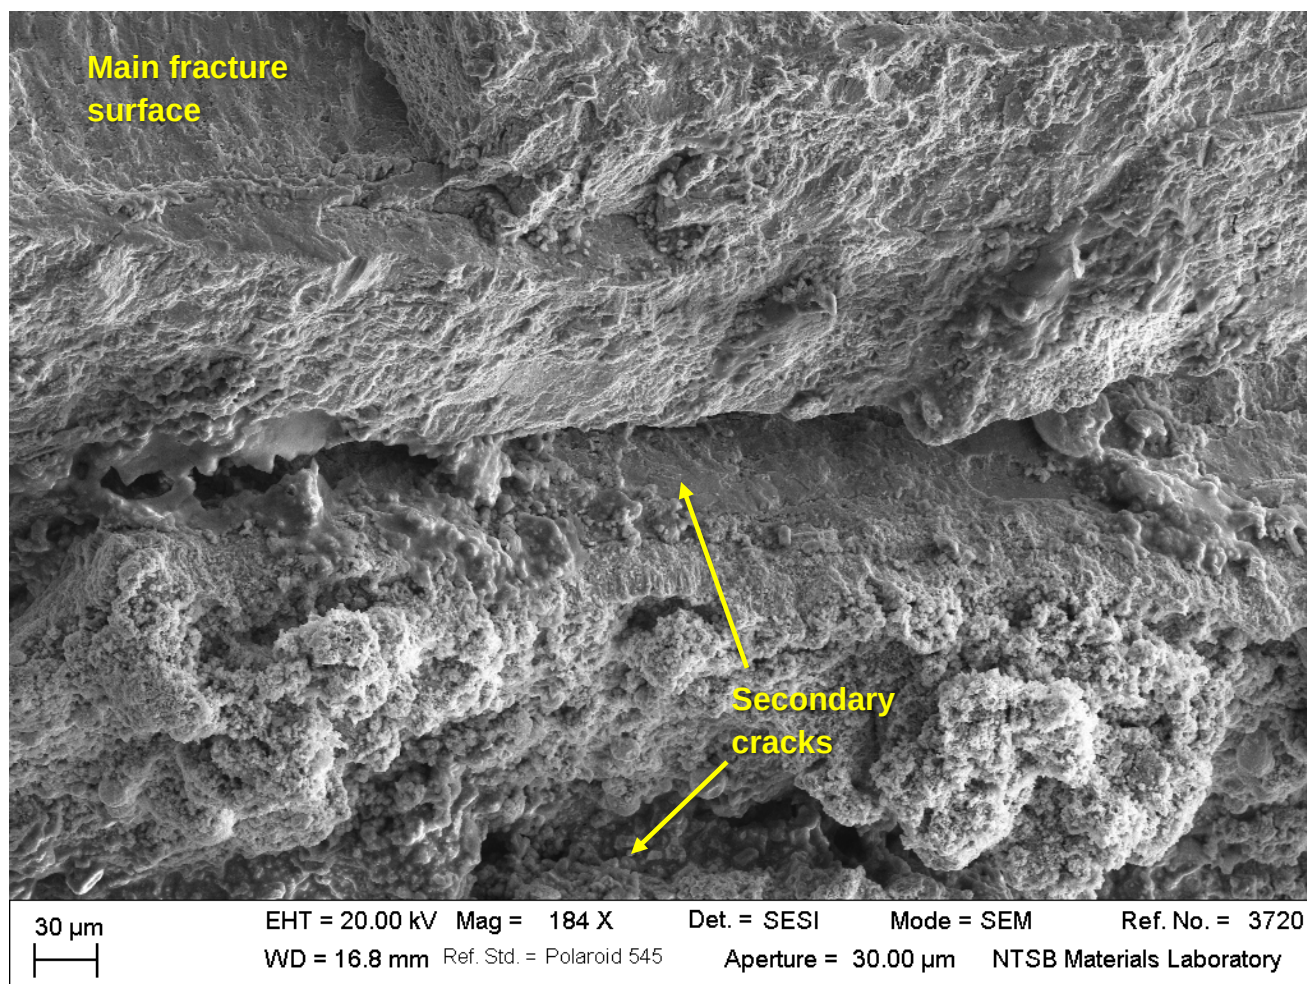
Besides the main crack face that was laboratory opened, there were several secondary cracks observed in the SEM (see Figure 12). These cracks were located below the primary crack face. These cracks exhibited fatigue striations. However, these cracks had not propagated to the size of the main crack face.

Figure 12 – SE micrograph showing smaller, secondary fatigue cracks below the main crack.

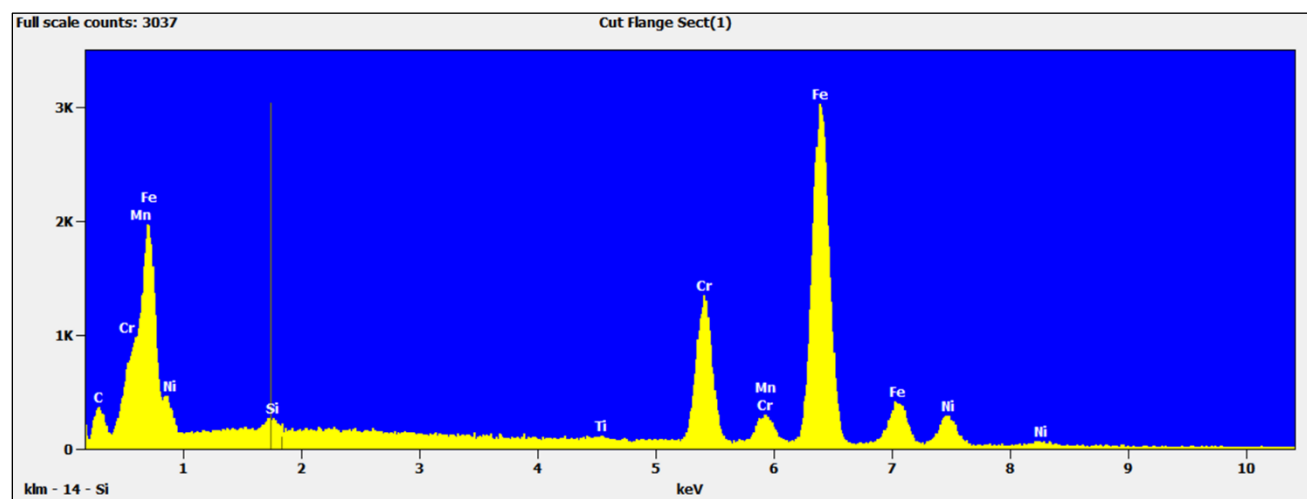
A portion of the exhaust manifold tube flange was sectioned and examined using energy dispersive x-ray spectroscopy (EDS) for chemical composition. A typical EDS spectrum of the flange section is shown in Figure 13. The chemical composition was consistent with an austenitic stainless steel.

Figure 13 – EDS spectrum of a typical sectioned area of the exhaust manifold flange.
