# NATIONAL TRANSPORTATION SAFETY BOARD

## MATERIALS LABORATORY ADDENDUM REPORT

Report No. 19-049B

Place : Prescott, Arizona  
Date : August 29, 2018  
Vehicle : Cessna P210N, N6500W  
NTSB No. : WPR18FA245  
Investigator : Zoë Keliher, AS-WPR

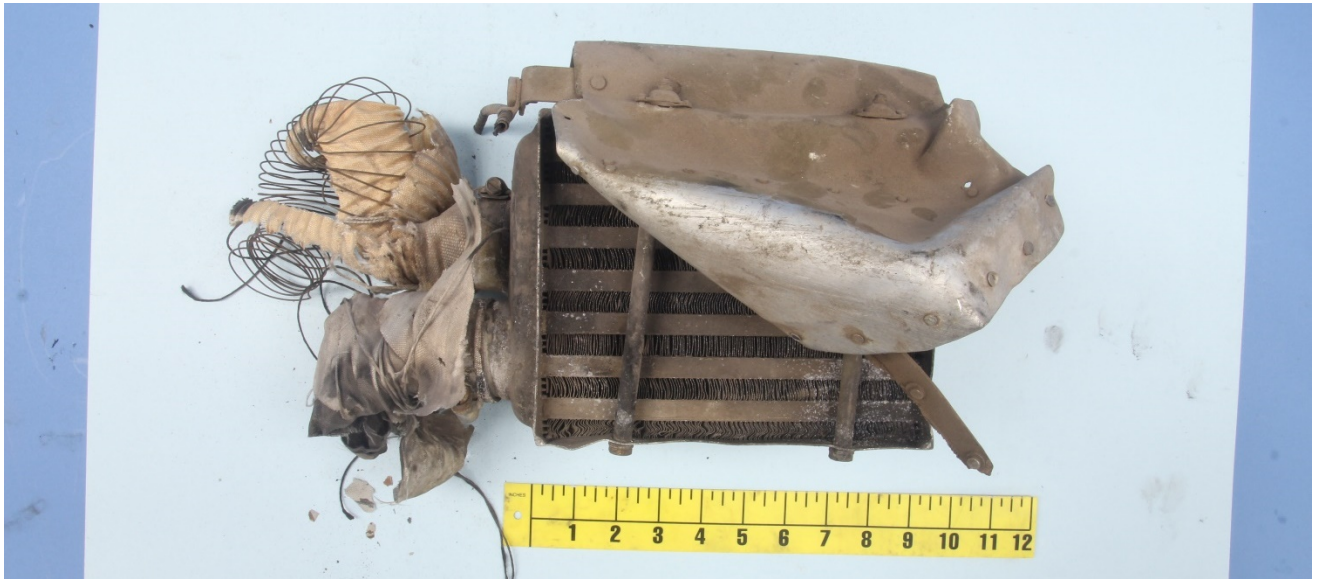
Figure 1 shows the heat exchanger and adjacent components, as received. The heat exchanger assembly remnants had been removed from the overall exhaust system of the airplane prior to receipt at the NTSB Materials Laboratory. As shown in Figure 2, the assembly had experienced severe deformation, charring, and distortion consistent with a post-crash fire. The primary duct material for the inlet and outlet ducts was missing in multiple locations, leaving only the metallic reinforcing wire. The remaining duct material crumbled upon touch or movement.

Figure 1 – View of the heat exchanger and surrounding housing and tube, as received.

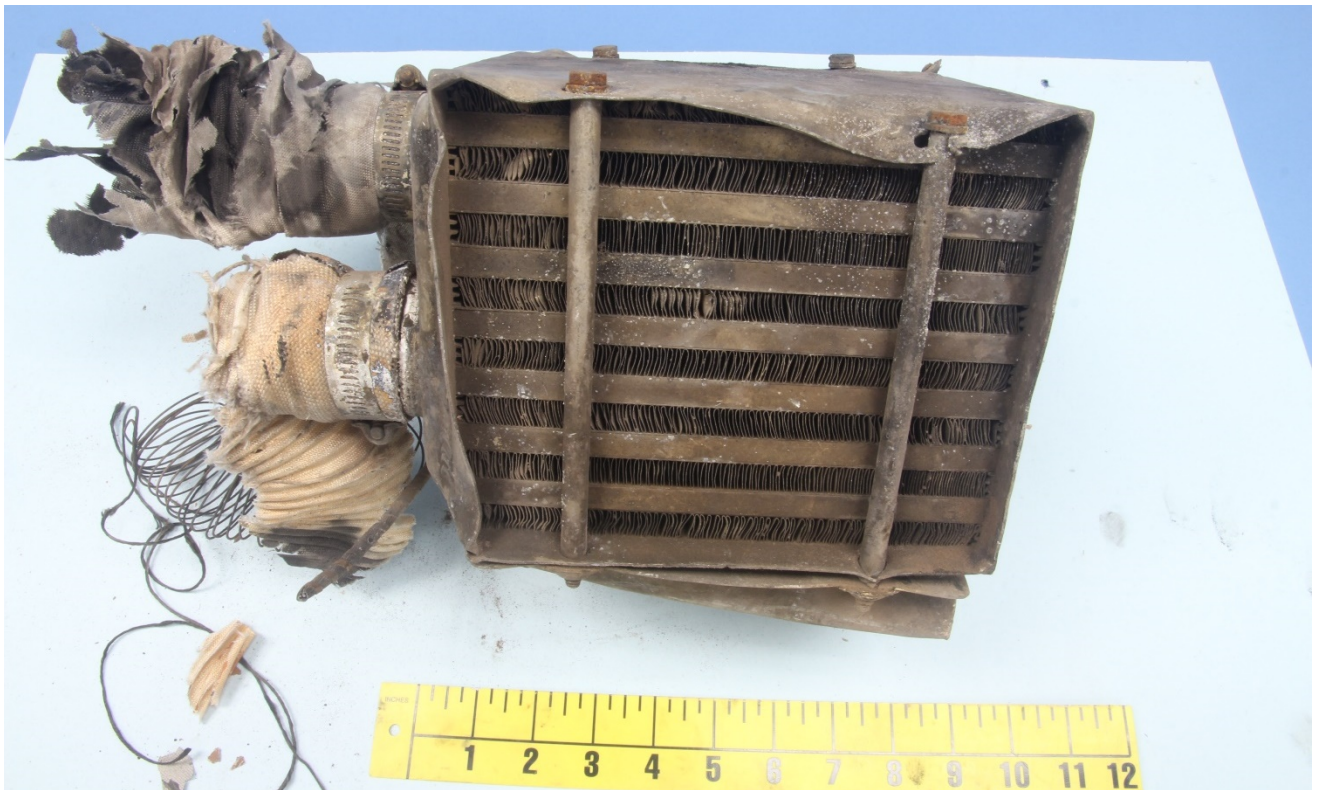
The heat shield had been deformed outward and then back inward toward the heat exchanger. Visual indications of soot and charring were present on the outer surfaces of the heat exchanger and heat shield.

Typically, a pressure test can be performed to determine if the shrouds between the two sides of a heat exchanger are compromised, allowing an undesired gas path. However, in this case, the heat exchanger had been damaged from the accident impact forces, as highlighted in Figures 3a and 3c as well as Figure 2. There were multiple locations on the ram air sides of fins and shrouds having separated from each other and the primary plates. This damage was consistent with overstress fracture from the accident impact.

Figure 2 – Side view of the heat exchanger, showing the extent of damage to the assembly, as received.

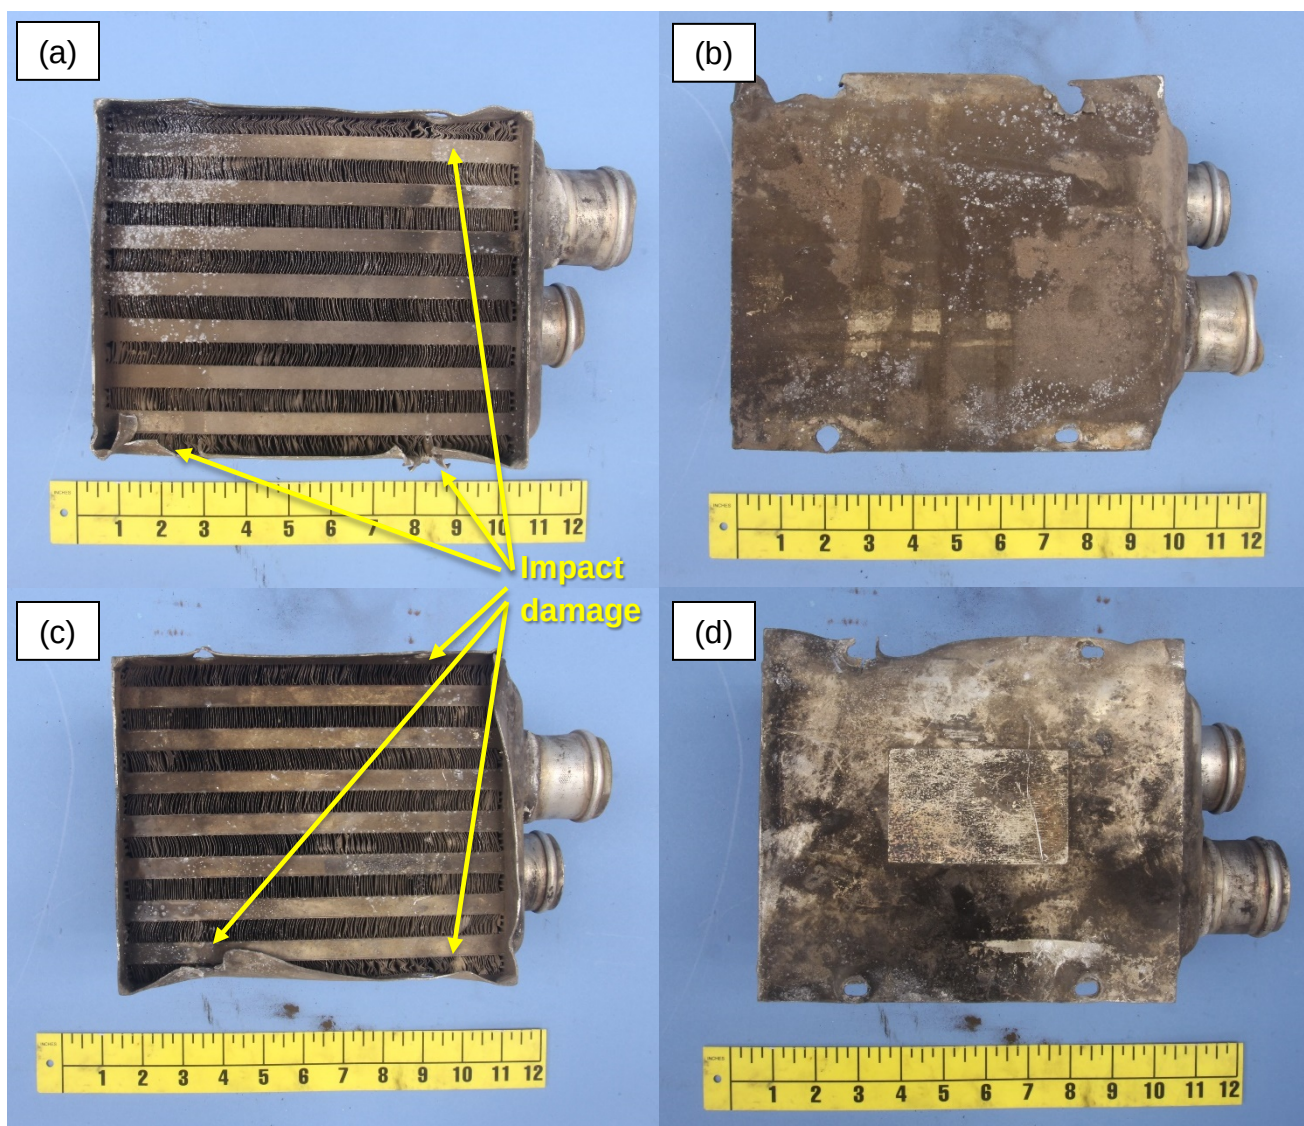
The fire damage had destroyed the markings on the plate, shown in Figure 3d. Searches of replacement parts for a Cessna P210N typically listed a Janitrol air-to-air heat exchanger, with specification number C166051. These listed parts were consistent with the dimensions and features of this accident heat exchanger.

Figure 3 – View of the heat exchanger after removal of the damaged brackets and tubes, from (a) the ram air side, (b) the unmarked cover, (c) the opposite ram air side, and (d) the marked cover side where the markings had been obliterated.

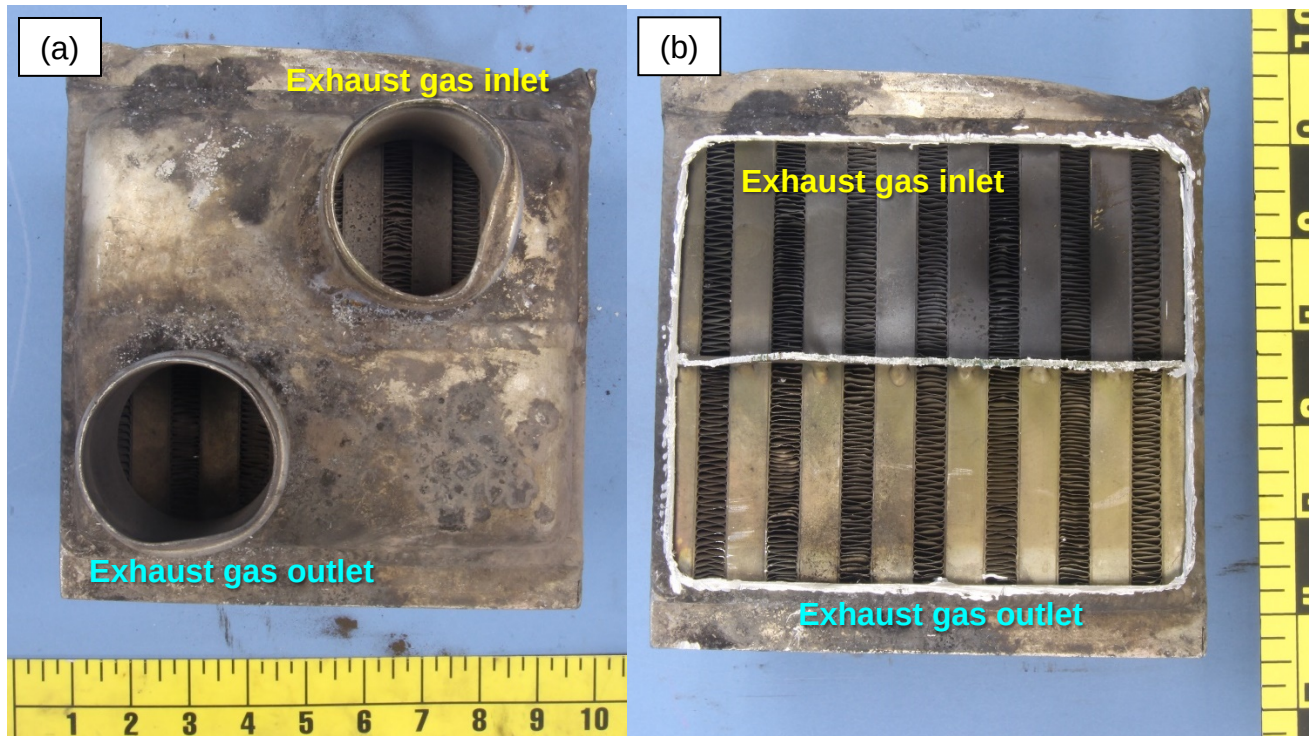
The heat exchanger was a plate-fin air-to-air type. The heated ram air from the engine manifold was designed to pass through the exchanger on the side depicted in Figure 4a, where inlet and outlet ports are located. The compressor discharge air for cabin pressurization was designed to pass through the larger sides, shown in Figures 3a and 3c. In the heated air selection, the compressor air would be warmed, by the heated ram air from the left manifold.

The exhaust outlet/inlet cover was sectioned from the body of the heat exchanger. The exposed interior is shown in Figure 4b (compare with Figure 4a). The inlet side, which experienced higher temperature gasses exhibited a black coloring. The outlet side exhibited yellowish coloring. Compounds adhered to each side were examined using energy dispersive x-ray spectroscopy (EDS) for chemical composition. The compositions were consistent with each other, containing primarily iron oxides and silicon dioxide. There were detectable (less than 5 weight percent) levels of cadmium, sulfur, and chlorine on the inlet (black) side. Detectable levels of magnesium and potassium were noted on the outlet side (yellow).

Figure 4 – View of the inlet and outlet ports of the heat exchanger (a) after removal of the damaged ducts and shield covering, and (b) after sectioning of the port housing.
