**NATIONAL TRANSPORTATION SAFETY BOARD**  
Vehicle Recorder Division  
Washington, DC 20594

## **Onboard Image Recorder**

**Specialist's Factual Report**  
**By Sean Payne**

| Aircraft: | Cessna 150L, N10789 |

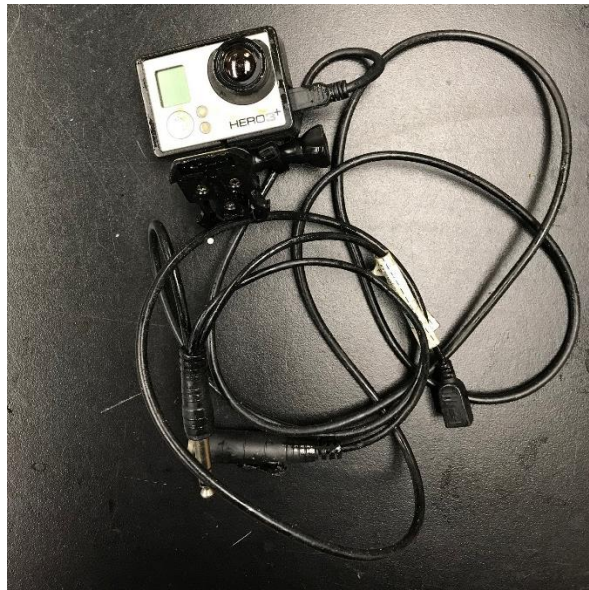
Upon arrival at the NTSB Vehicle Recorder Division, it was evident that the GoPro Hero had sustained only light structural damage. The device's memory card was undamaged and the video and audio information was extracted from the memory card normally, without difficulty

Figure 1. The condition of the GoPro upon arrival to the laboratory.

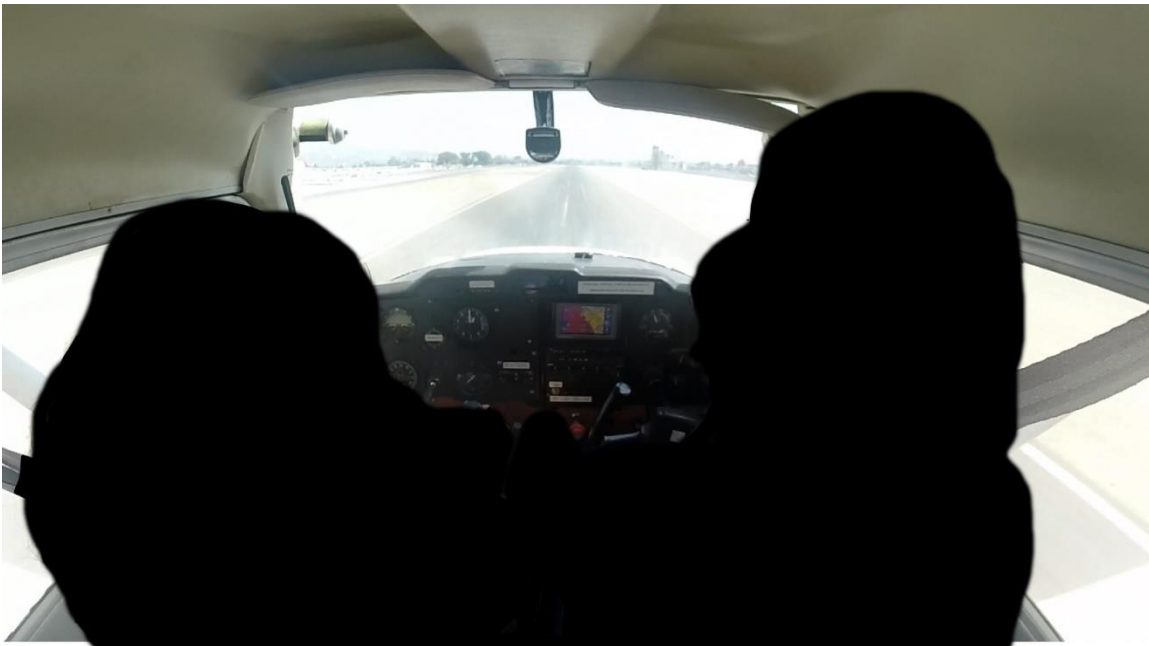
The image recording contained an over the shoulder view of the aircraft occupants and the instrument panel. The camera was mounted on the headliner of the aircraft behind and between the instructor pilot and the passenger. Figure 2 is a redacted screenshot of the camera's field of view on a flight previous to the accident. The instructor is on the right and the passenger is on the left. The engine RPM gauge was occasionally visible depending on the instructor pilot's body position. Other engine instrument gauges which were mounted on the instrument panel in front of the instructor pilot were never visible on the recording.

Figure 2. A redacted screenshot of the camera's field of view.
