## **NATIONAL TRANSPORTATION SAFETY BOARD**

### **ON SCENE OBSERVATIONS**

**WPR18FA249**

Location: Pacoima, California  
Date: September 3, 2018  
Aircraft: Cessna 150L, Registration N10789, Serial #15075041  
NTSB IIC: Samantha Link

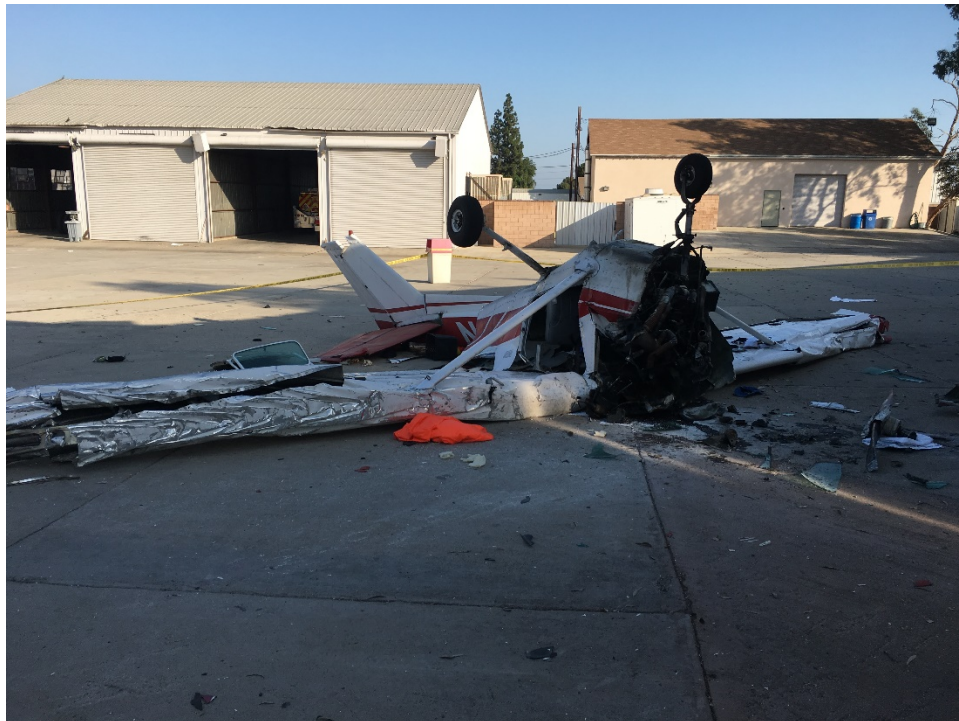
Figure 1: Front of Airplane

The first identified point of impact was the edge of a building roof which exhibited downward crush damage. The airplane impacted the ground below the roofline and it came to rest upside down. The debris path was mostly contained within this area. The spinner was crushed flat and the propeller assembly along with a small portion of crankshaft was found fracture separated. The two propeller blades were mostly flat, one had minor aft bending at blade tip, however, both remained secured at the hub. The engine was pushed upward and back; the top of the engine was embedded into the firewall. The #4 cylinder was found separated from the engine and came to rest below the engine. In addition, the oil filter, journal bearings, and fragments of cylinder and crankcase were noted in the area immediately below the engine. The wings remained attached at the fuselage. The left-wing leading edge was crushed aft to the wing spar throughout its entire span. An impact mark that exhibited chevron marks was observed on the pavement; the mark was consistent with the damage to the left wing's leading edge. The flap

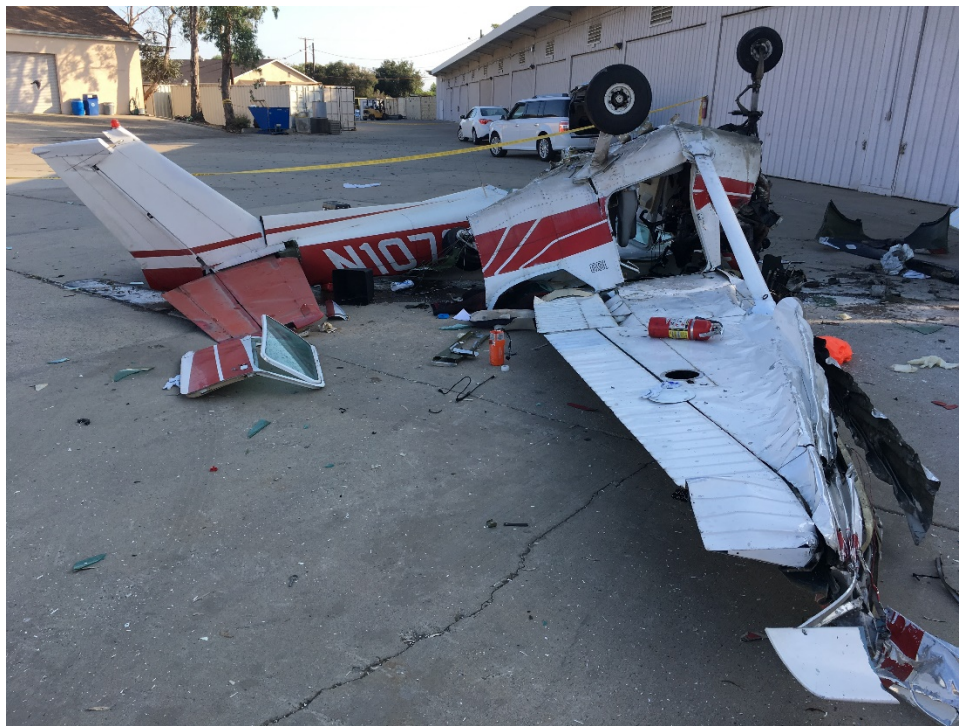
Figure 3: Left Side of Airplane

was observed in the up position. The aft fuselage was completely separated aft of the cabin and came to rest upright. A crack was noted along the bottom center of the lower fuselage and oil was noted along the underside. The empennage was mostly intact and exhibited some crush damage. The right wing was still secured to the airframe. The outboard leading edge was crushed aft to the wing spar. The right main landing gear was fracture separated at the landing gear bulkhead. The left main landing gear and nose wheel remained attached. A coating of oil was noted on the nose landing gear. The cabin area remained intact, however, the instrument panel was crushed back into the cabin area. Oil was noted along the underside of the cabin area.

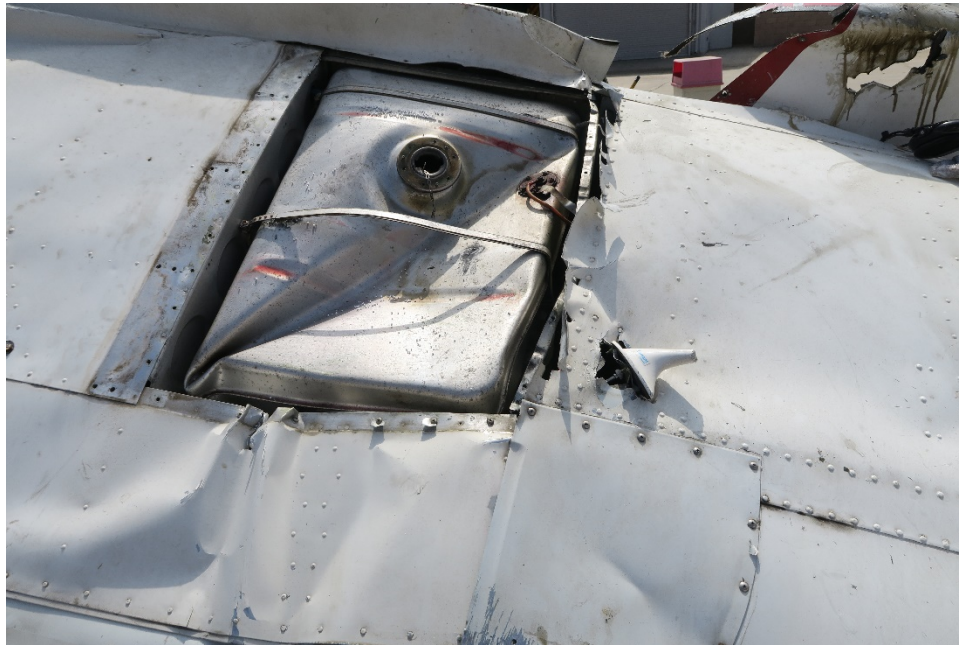
**Figure 7: Left Fuel Tank**

- The fuel tanks were damaged, however, they were not breached
  - The total fuel removed from the airplane was less than one full gallon
    - About 3 quarts of fuel was drained from the left fuel tank

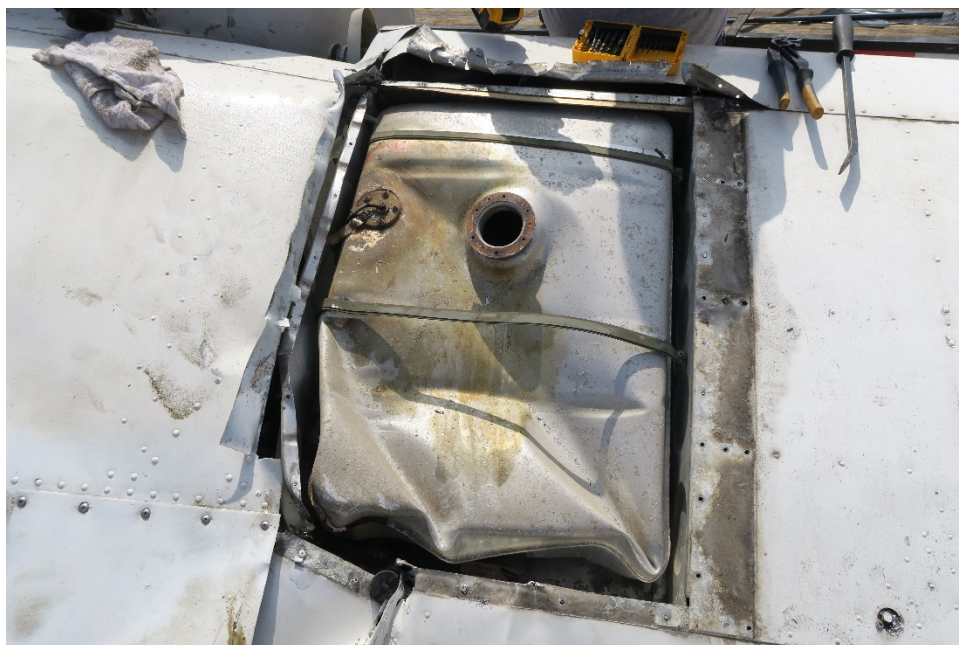
**Figure 8: Right Fuel Tank**

- As the airplane was flipped over for recovery purposes, about 2-3 ounces of fuel was observed exiting from the left wing root.
    - Less than one quart of fuel was drained from the right fuel tank.

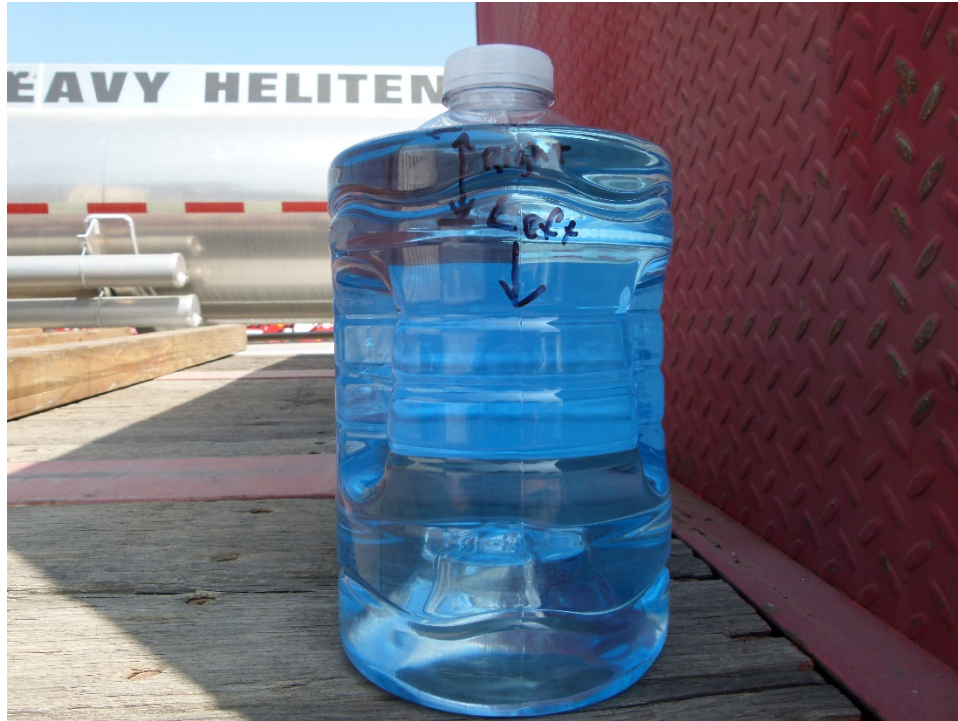
Figure 9: Total Fuel Removed from Airplane

- The fuel was blue in color, smelled consistent with 100LL, and tested negative for water.
  - The fuel lines exiting the fuel tanks were compromised due to impact damage

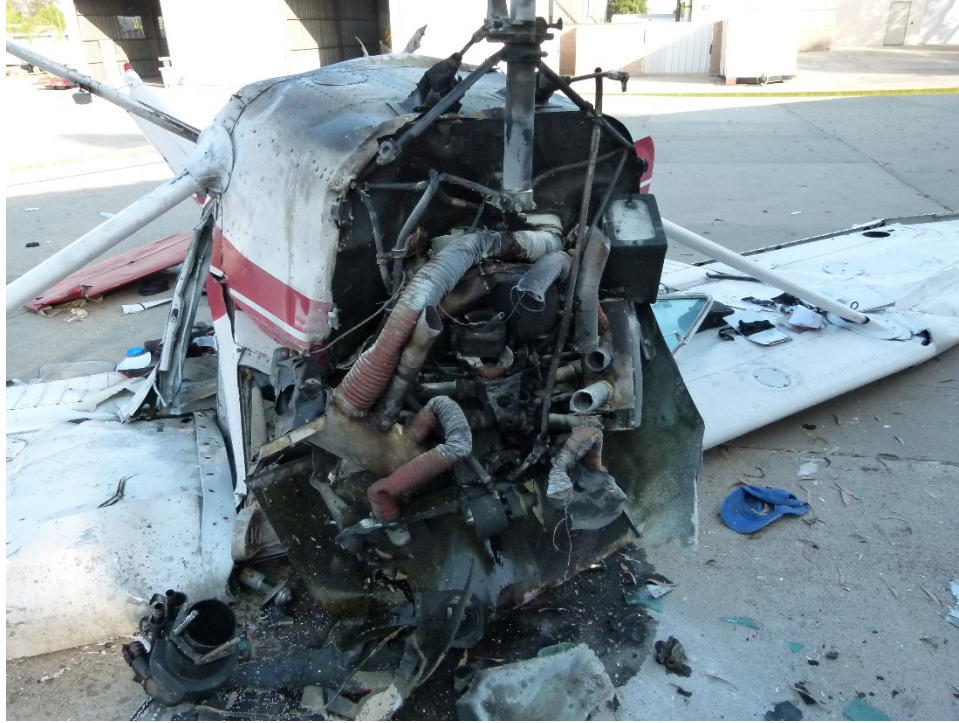
Figure 10: The Engine Compartment

- The top of the engine came to rest embedded into the airplane's firewall
- Fire related damaged was noted to the carburetor and accessory section of the engine.
- The number four cylinder was found fracture separated from the engine
- The propeller assembly remained secured to the crankshaft, however, the forward most about 5 inches of crankshaft was fracture separated from the engine.
  - The spinner was crushed flat to propeller hub
  - The propeller blades remained secured at the propeller hub
    - Both blades were mostly flat, one had minor aft bending at the blade tip.
    - Chordwise scratches were noted throughout both blades
