## **NATIONAL TRANSPORTATION SAFETY BOARD**

# **AIRFRAME AND ENGINE EXAMINATION**

**WPR18FA249**

Location: Pacoima, California  
Date: September 3, 2018  
Aircraft: Cessna 150L, Registration N10789, Serial #15075041  
NTSB IIC: Samantha Link

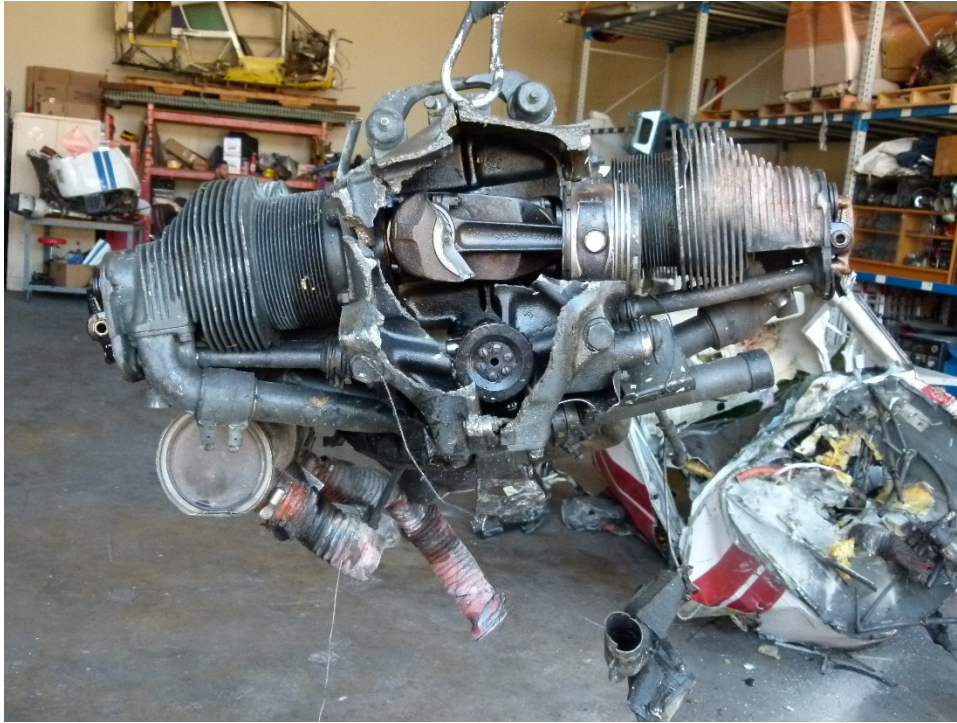
Figure 1: Front of Engine

- The engine exhibited heavy crush damage throughout
  - o Number 4 cylinder was fracture separated
  - o The crankshaft was fracture separated near the propeller flange
    - It remained attached to the propeller assembly

- The forward section of the crankcase was damaged and fragmented exposing internal engine components. The damaged opening to the crankcase appeared to be bulged outward.

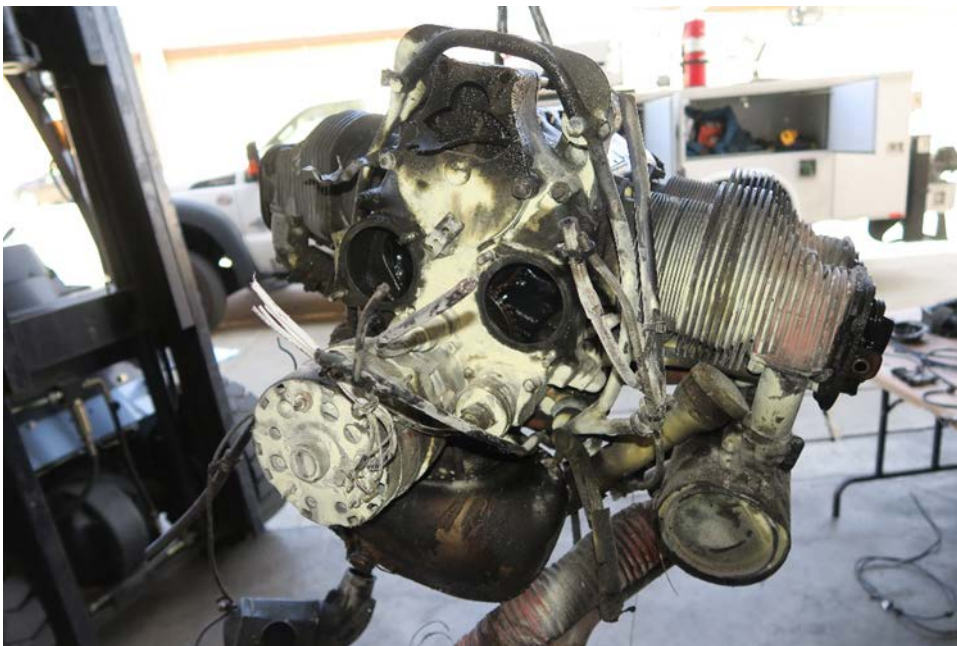
Figure 2: Accessory Section of Engine

- Fire damage was noted to the carburetor, as well as the accessory section of the engine.
- The ignition harness exhibited impact related damage
- The magnetos were removed from their attachment points

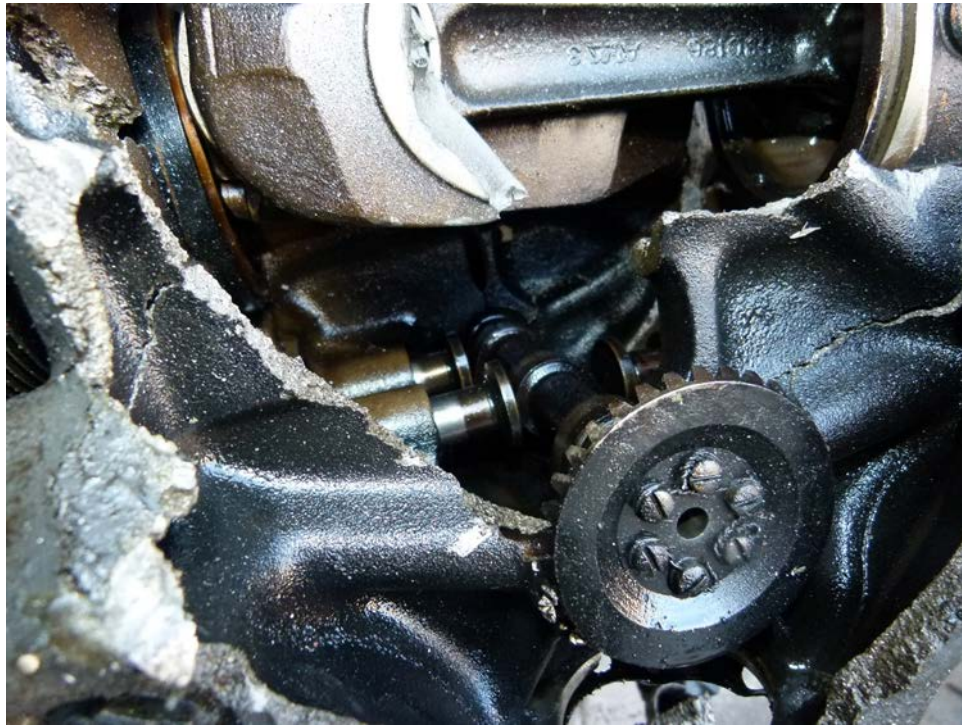
Figure 3: Internal Components

- The engine could not be rotated by hand due impact related damage to the crankcase
- Oil was observed throughout the engine
  - No thermal discoloration was noted

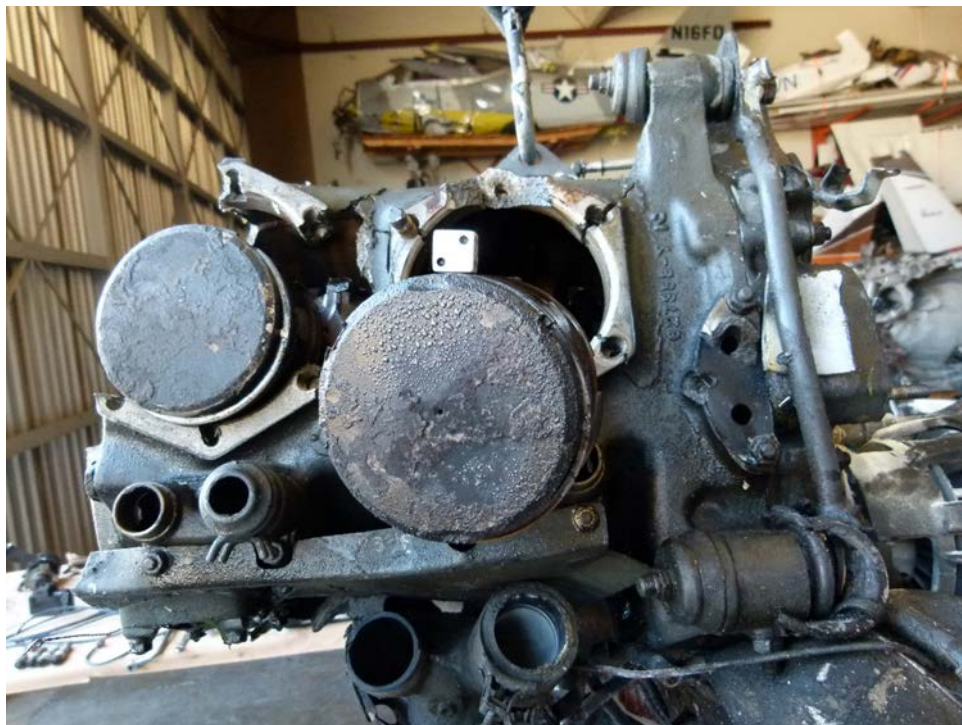
Figure 4: Pistons from Cylinders #2 and #4

- The piston faces were slightly rich but were otherwise consistent with normal operating signatures.
- Cylinder #2 was removed
  - The connecting rod was bent, however, it remained attached

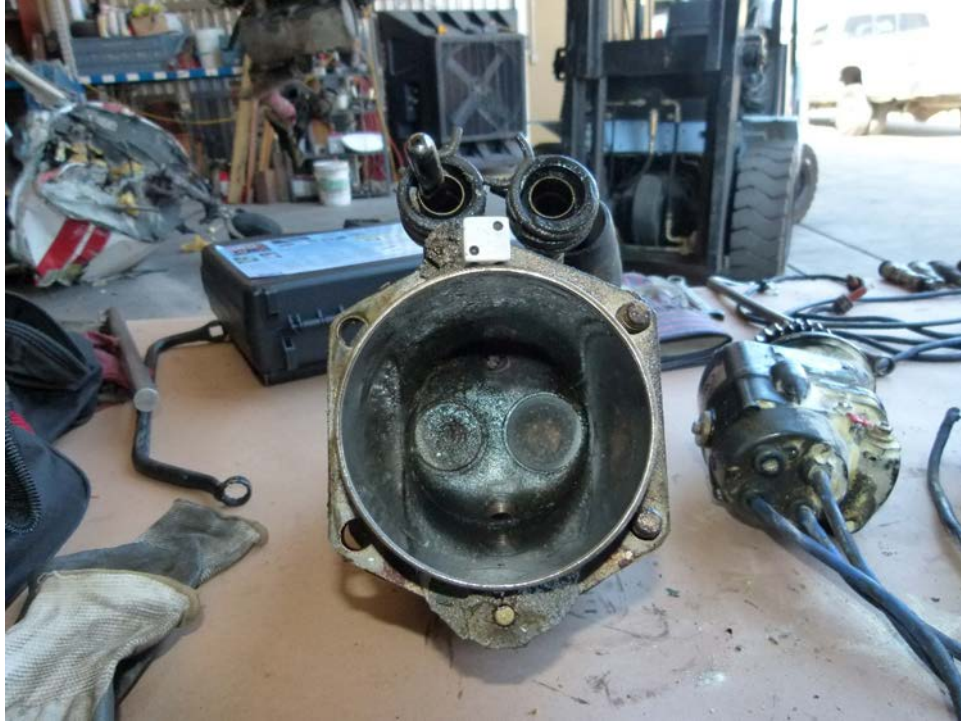
Figure 5: Cylinder #2

- All valves appeared normal and the springs were undamaged
- Cylinders were borescoped and they exhibited normal, although slightly rich, operating signatures

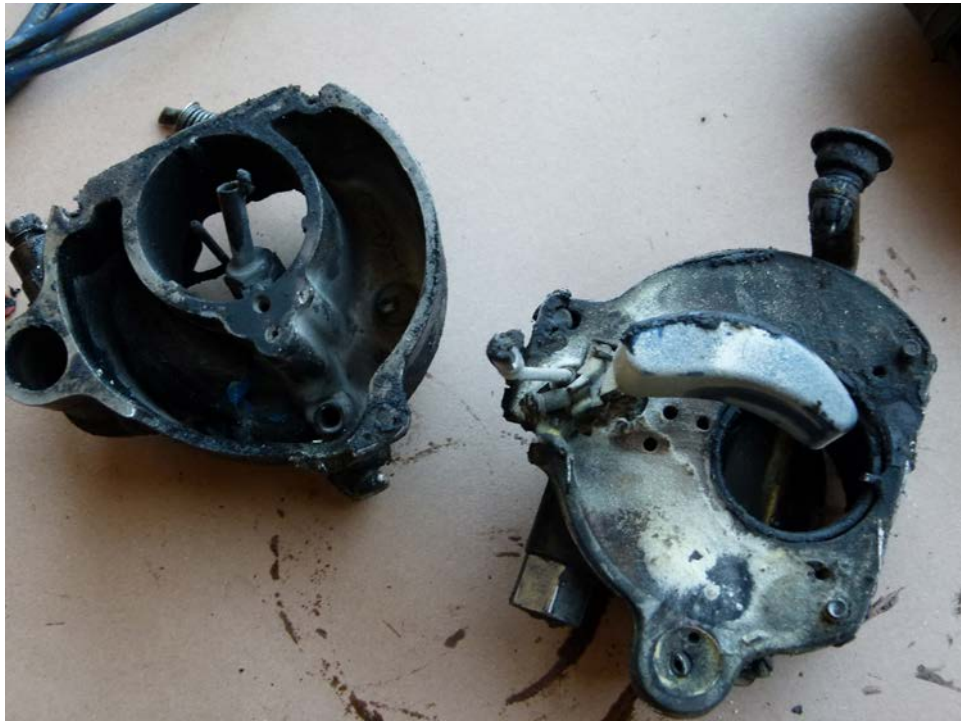
Figure 6: Carburetor

- When rotated by hand spark was produced throughout
- The carburetor was fracture separated, however, partially attached by the mixture cable
  - The inlet screen was clear of debris

- The bowl was fracture separated and was empty
  - The floats exhibited fire damage
    - One was mostly melted
  - The accelerator pump was found broken and completely separated from the carburetor

- The mixture lever moved freely by hand, however, the lever was bent due to impact related damage which prevented full travel
  - The throttle lever moved freely by hand, however, the damaged accelerator pump prevented full travel of the lever

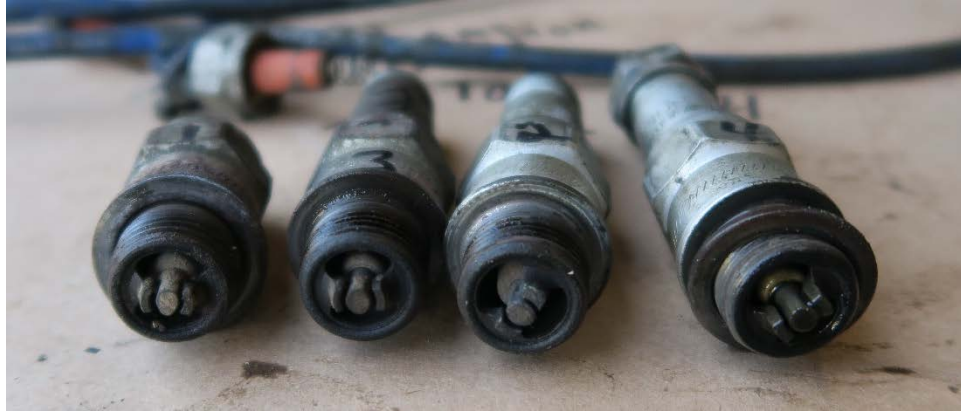
Figure 7: Spark Plugs

- The spark plugs were removed and exhibited normal operating signatures
  - The plugs indicated slightly rich
  - The center electrodes exhibited varying degrees of wear
