## **NATIONAL TRANSPORTATION SAFETY BOARD**

### **FOLLOW-UP AIRFRAME & ENGINE EXAMINATION**

**NTSB Accident: WPR18FA251  
Accident Date: September 4, 2018**

Location: Palo Alto, California  
Date: September 4, 2018  
Aircraft: Mooney M20J, N701JM, Serial # 24-3281  
NTSB IIC: Michael Huhn

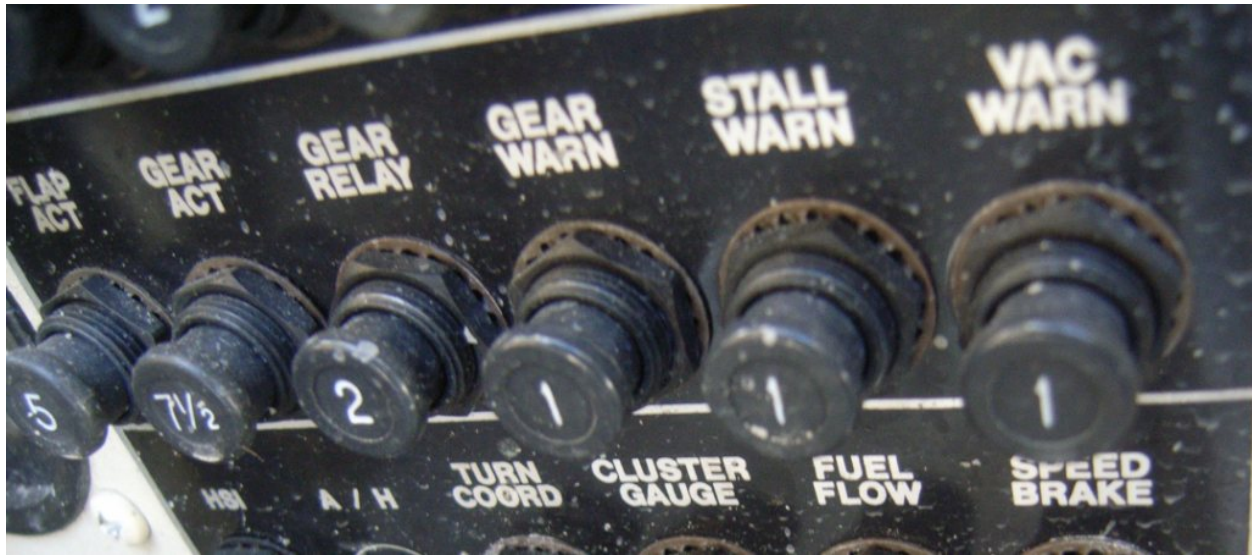
- No indications of arcing or other non-impact damage were observed
- The 1A circuit breaker had not 'popped'
  - The CB was intact in its mount
  - Its connections were secure

- The CB was able to be physically cycled without difficulty
  - Its electrical functionality was not checked
- The SWS horn was securely mounted in its installed position

Figure 1 - SWS Circuit Breaker

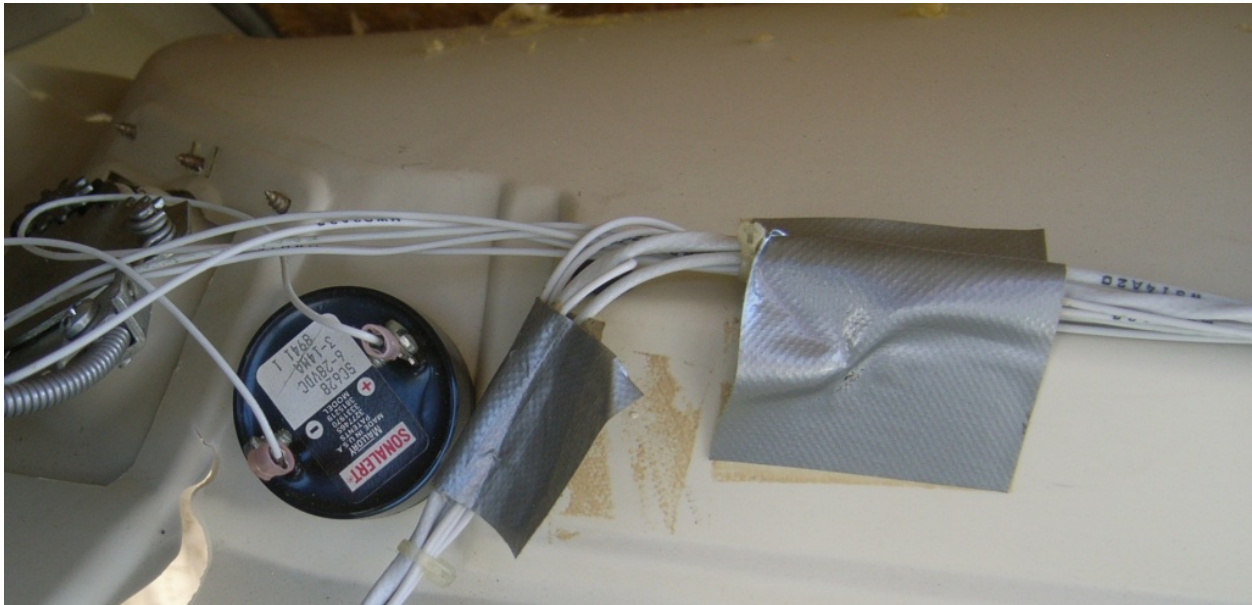
- This location was in the overhead panel approximately adjacent to the left seat occupant's right ear
  - The wiring was securely attached, and showed no indications of arcing or other damage

Figure 2 - SWS Horn (in situ)

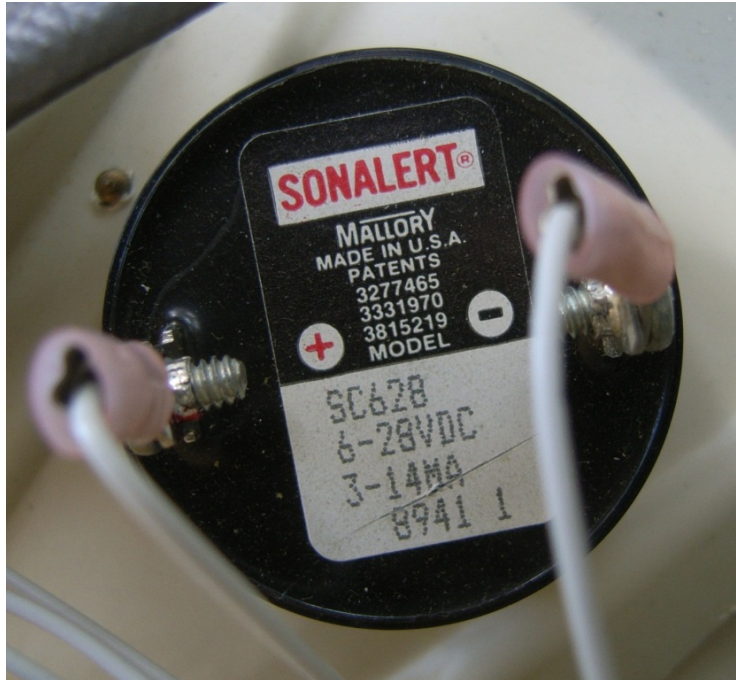
- The horn was a Mallory brand 'Sonalert' Model SC628 8941-1
  - The horn functioned/sounded normally upon application of 24vdc
  - Tone was loud and constant

Figure 3 - SWS Horn (back)

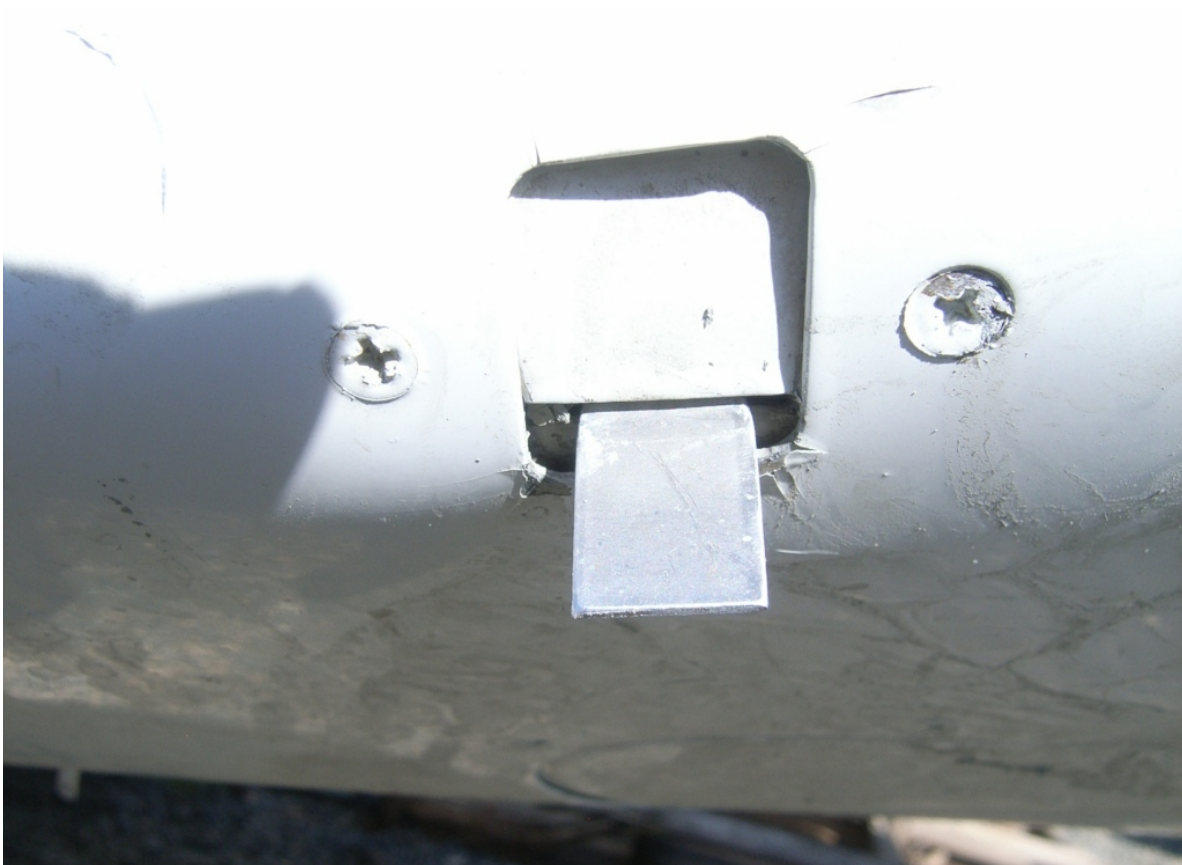
- The SWS vane and switch assembly remained securely mounted in the LE of the left wing
  - It appeared undamaged
  - It could be moved easily/freely with light finger pressure

Figure 4 - SWS Vane (in situ)

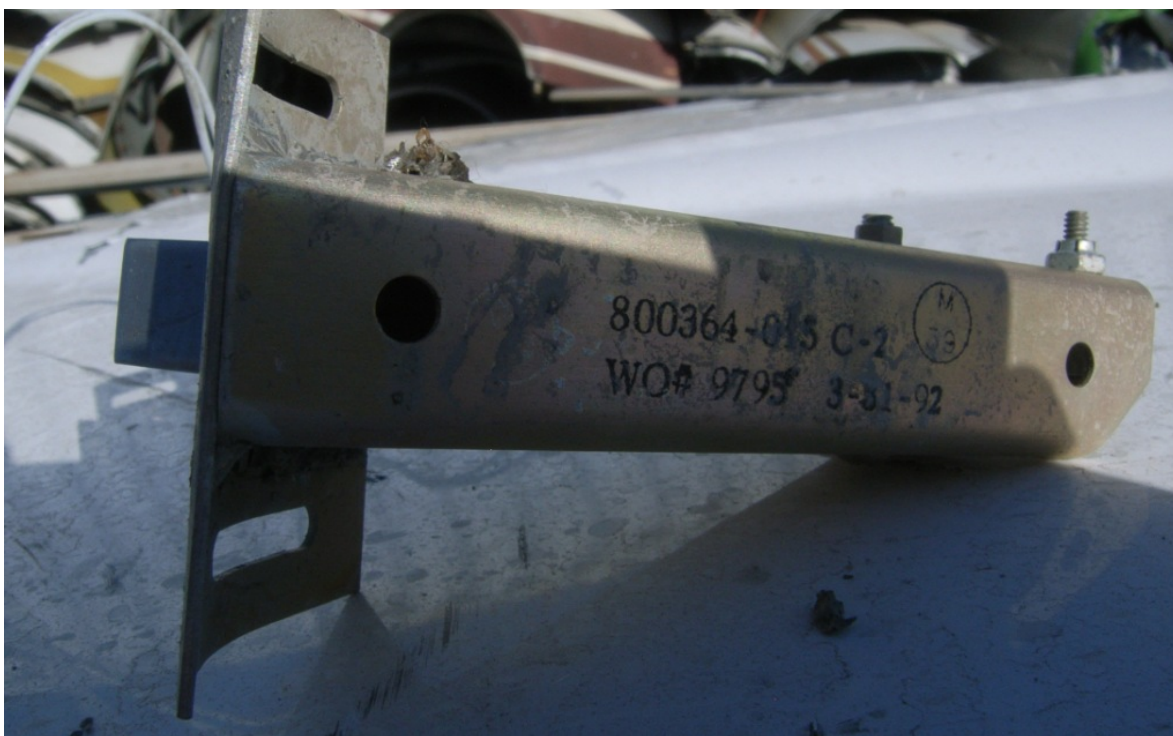
- The wing access panel for the vane was affixed by blind rivets
- The vane and switch assembly was removed from the wing
  - Its wiring was securely attached and undamaged

- The vane/switch operated normally with regard to making/breaking the electrical circuit
  - The vane calibration was not determined

Figure 5 - SWS Vane & Switch Assembly

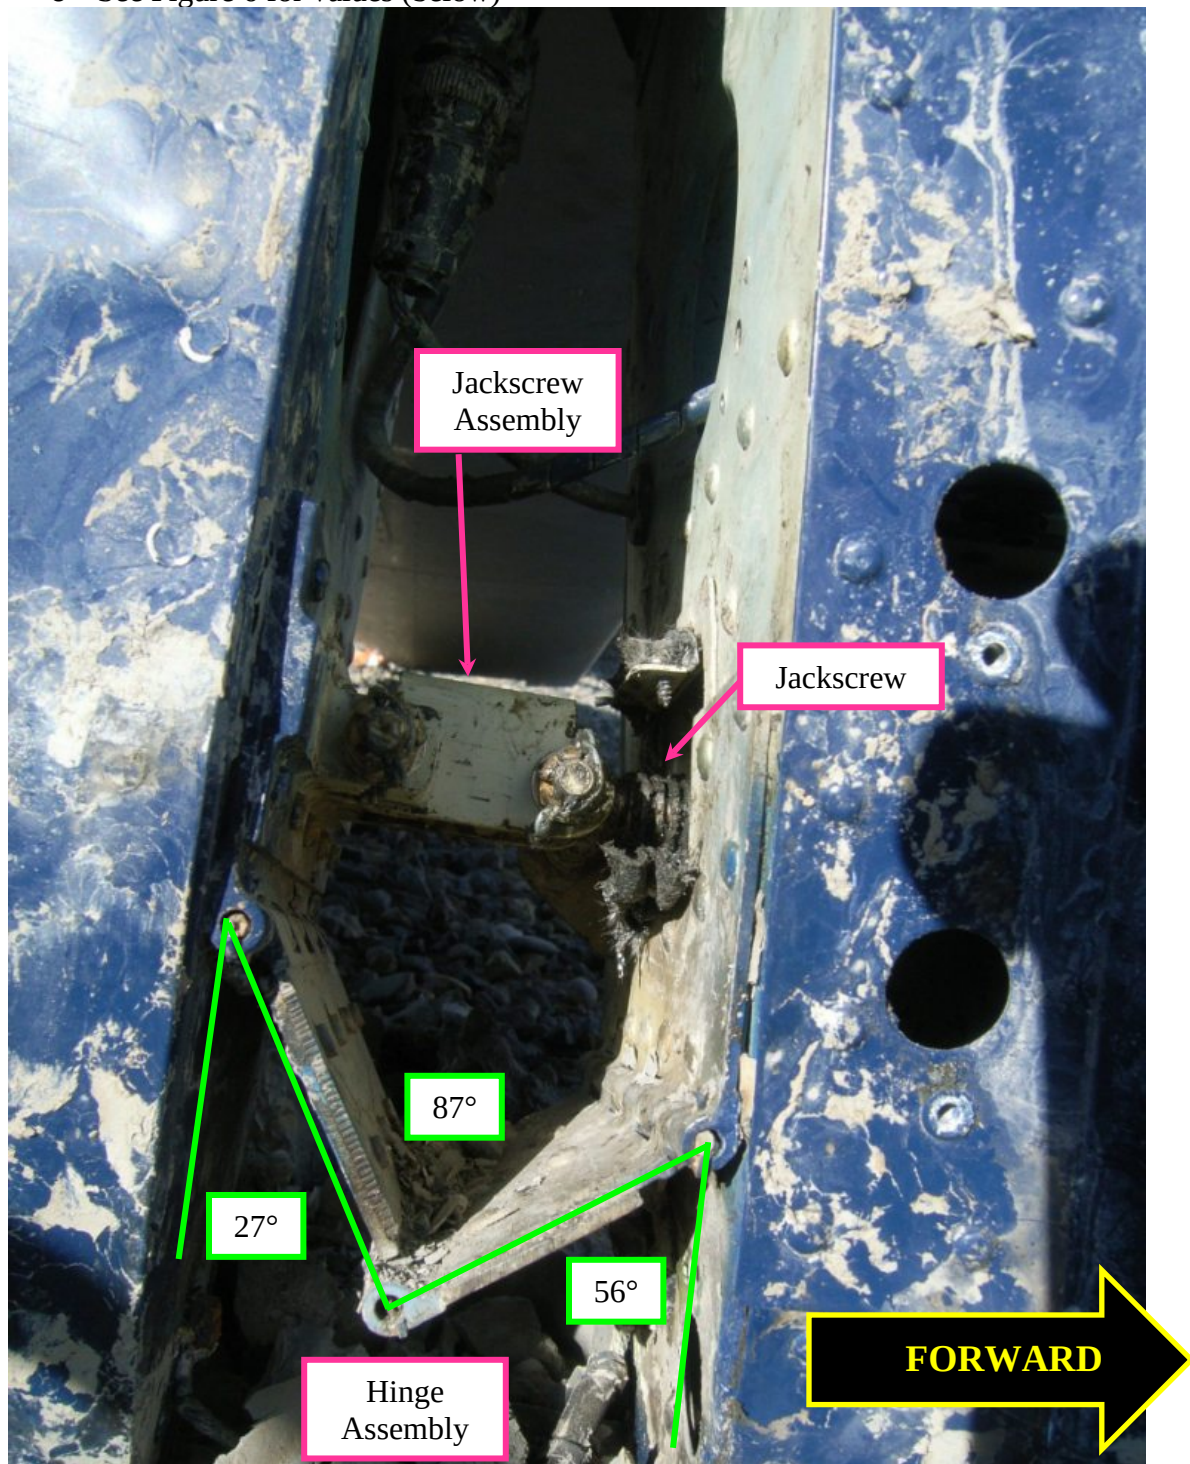
- The cockpit trim position indicator also depicted a setting AND from the normal T/O setting
- The hinge angles were measured as a backup means for determining pitch trim setting

- o See Figure 6 for values (below)

Figure 6 - Pitch Trim Hinge and Jackscrew Assemblies

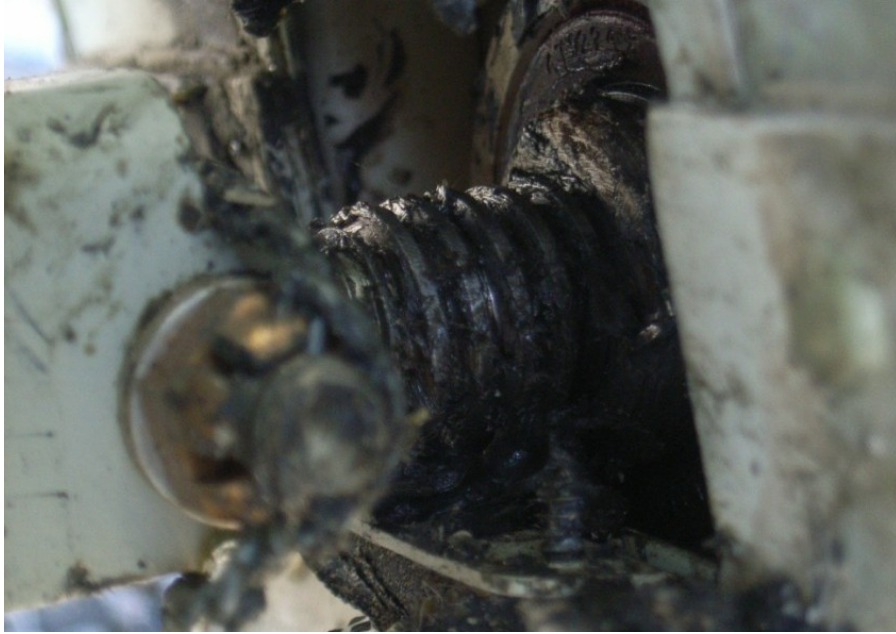
- The empennage access panels and jackscrew flexible boot were removed to obtain physical and visual access to the jackscrew
- The jackscrew was observed to be extended to the position where 5 full threads were exposed

- 7 threads – Normal takeoff setting (approx. 1 1/4 inch extension)
  - 0 threads – Full AND
- Based on these values, the airplane pitch trim was found slightly AND from the normal T/O setting

Figure 7 - Pitch Trim Jackscrew

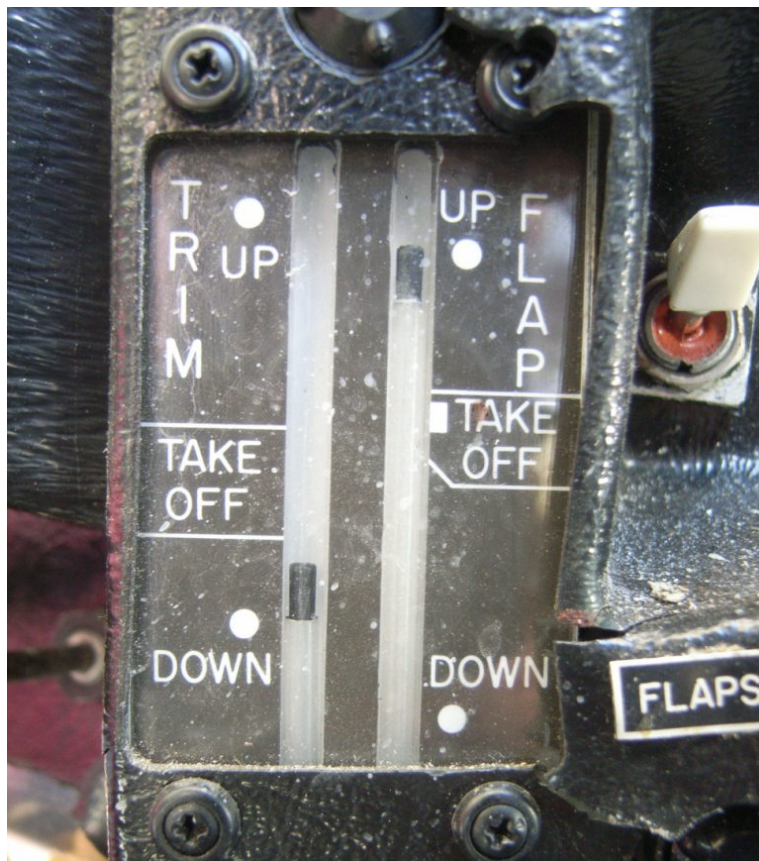
Figure 8 - Pitch Trim & Flap Cockpit Indicators

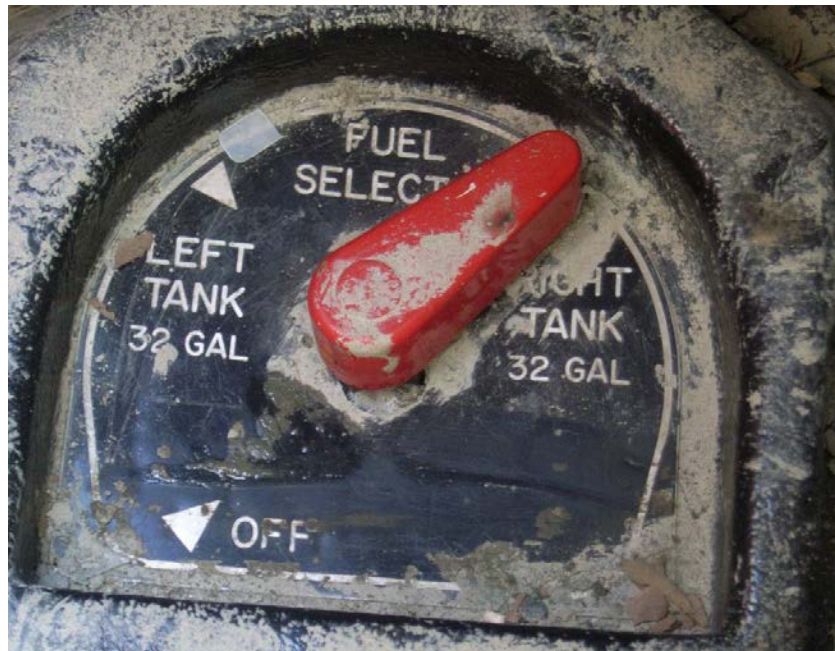
- The airplane was equipped with one integral fuel tank per wing
- The 3-position (OFF, LEFT, RIGHT) fuel selector valve cockpit handle was found set to the RIGHT tank

- The handle was unable to be rotated
- The caps were present and securely attached
  - The left cap operated easily and correctly
  - The right cap was stiffer in operation; this was assumed to be a result of impact and exposure effects

Figure 9 - Fuel Selector

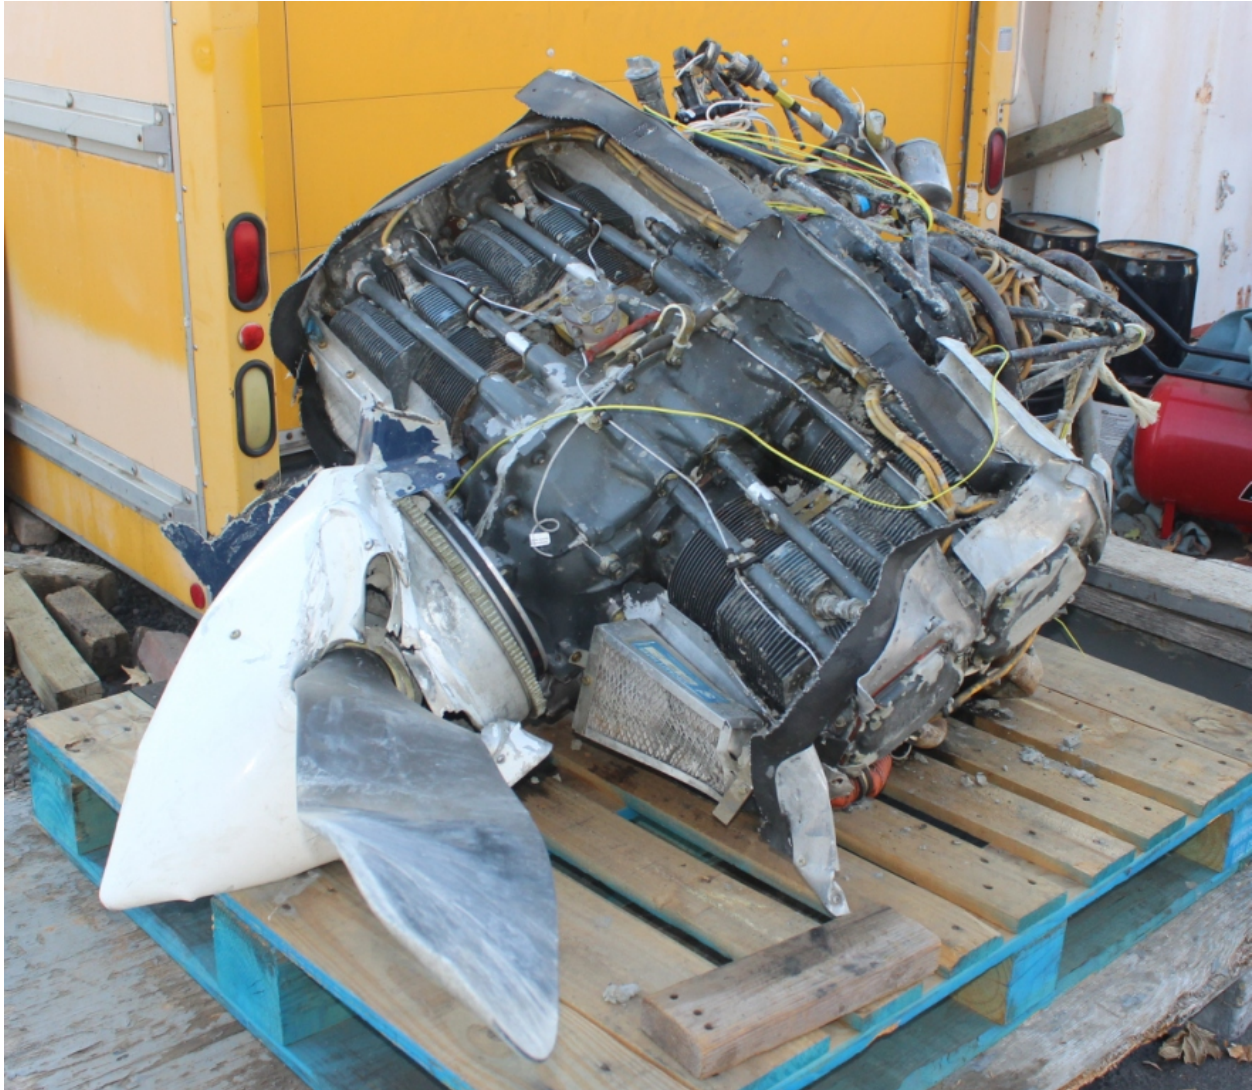
The engine and portions of the engine mount had been liberated from the airframe during the accident and recovery sequence. The engine had come to rest submerged in mud and silt. The engine sustained minor impact damage. Recovery personnel rinsed the engine off with fresh water. The engine exhibited external and internal corrosive signatures consistent with water immersion. Visual examination of the engine revealed no evidence of pre-impact catastrophic mechanical malfunction or fire.

**Figure 10 - Engine and Propeller**

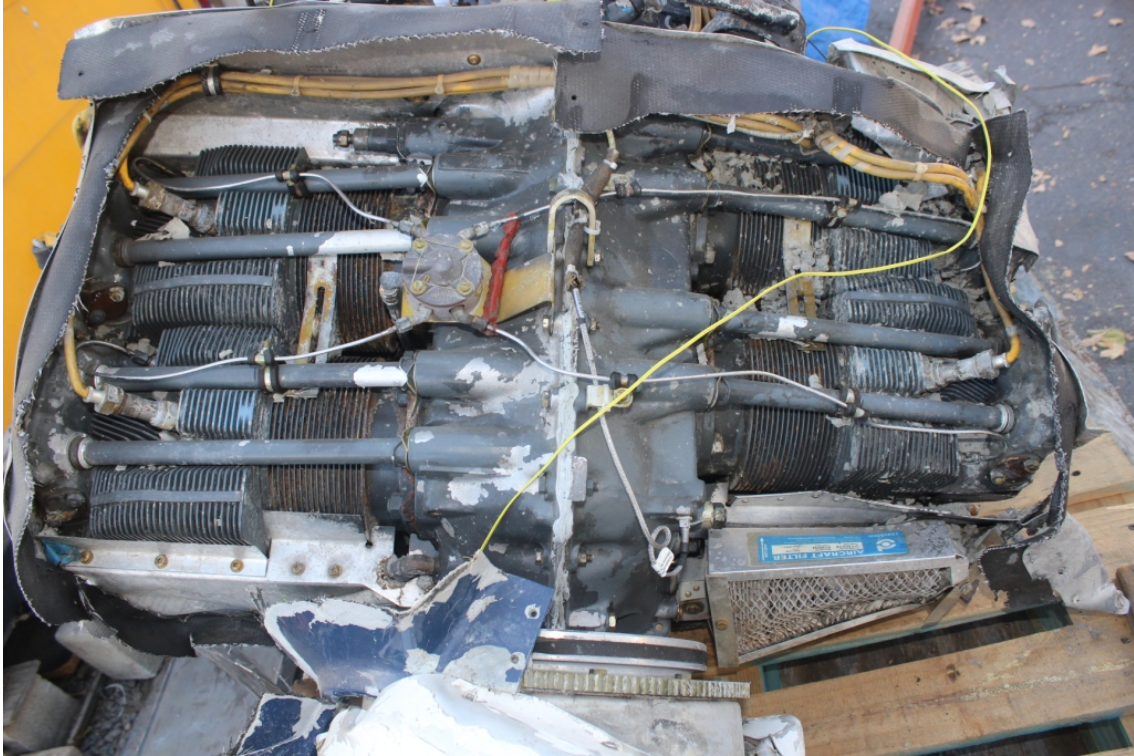
**Figure 11 - Engine**

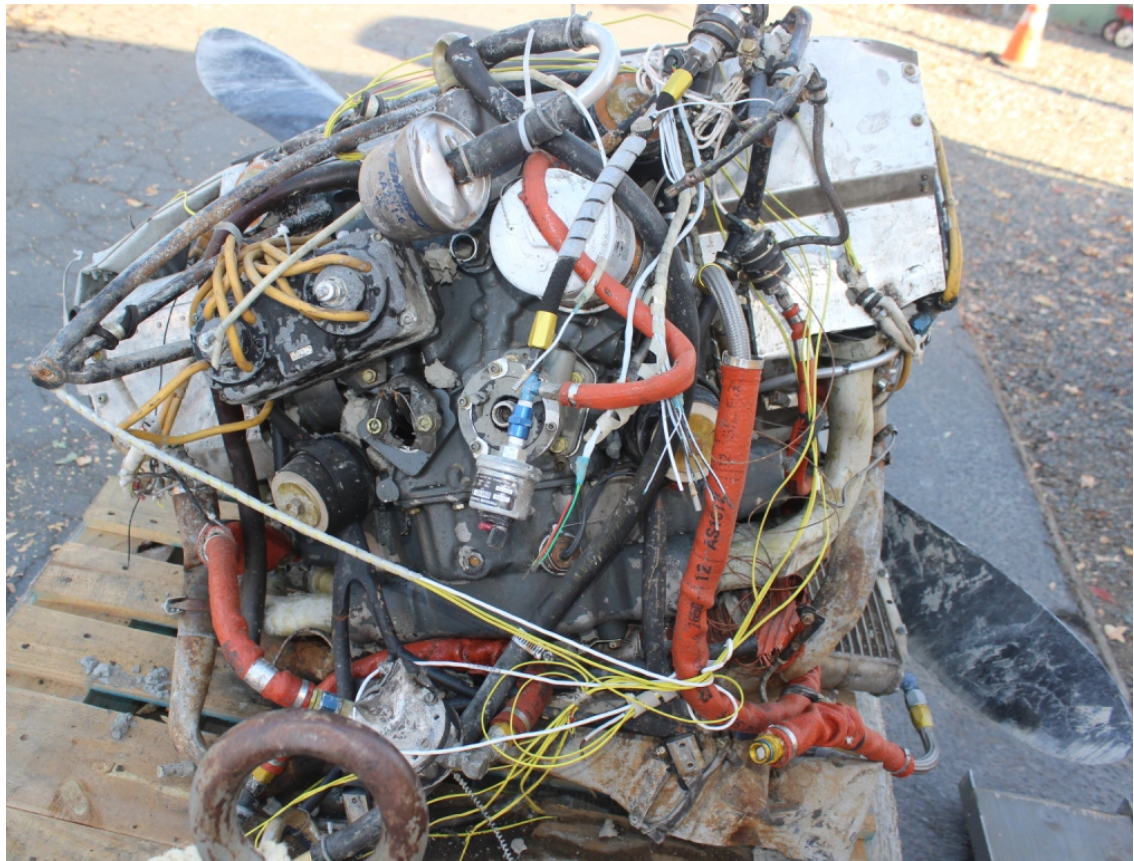
A lighted borescope was inserted into the accessory case at the magneto and fuel pump mounting pad holes to visualize internally. The accessory gears including the crankshaft gear, bolt and dowel were intact and remained undamaged by any pre-impact malfunction.

**Figure 12 - Engine Accessory End**

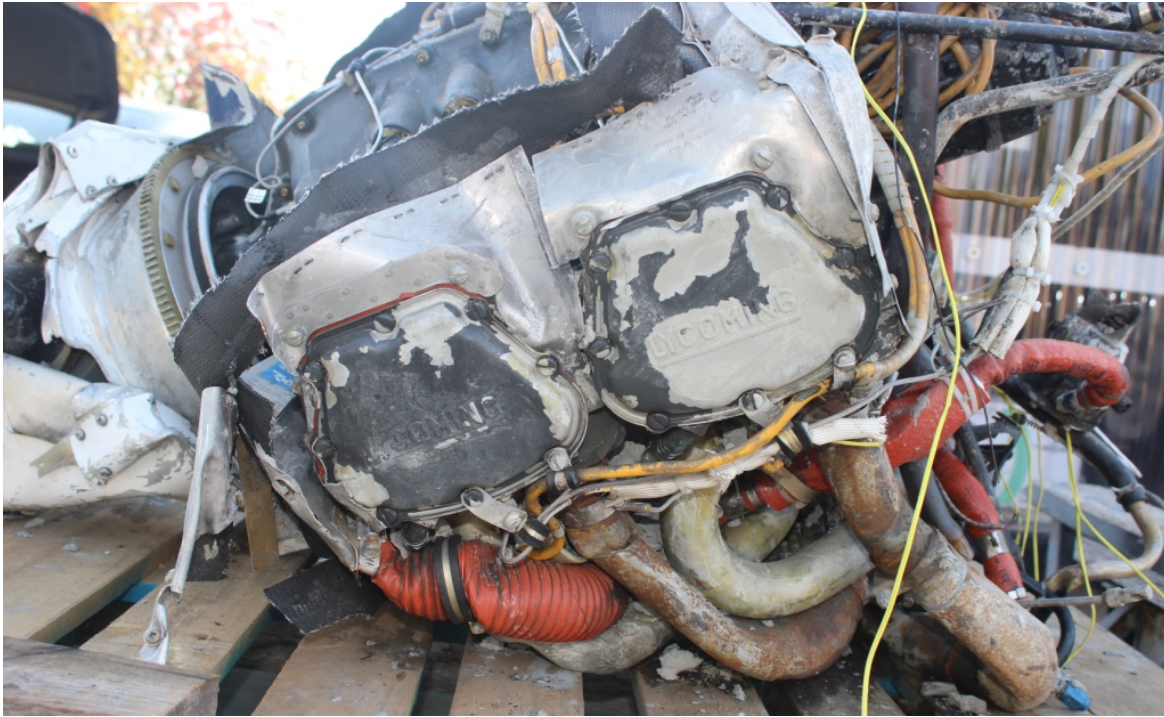
**Figure 13 - Engine Left Side**

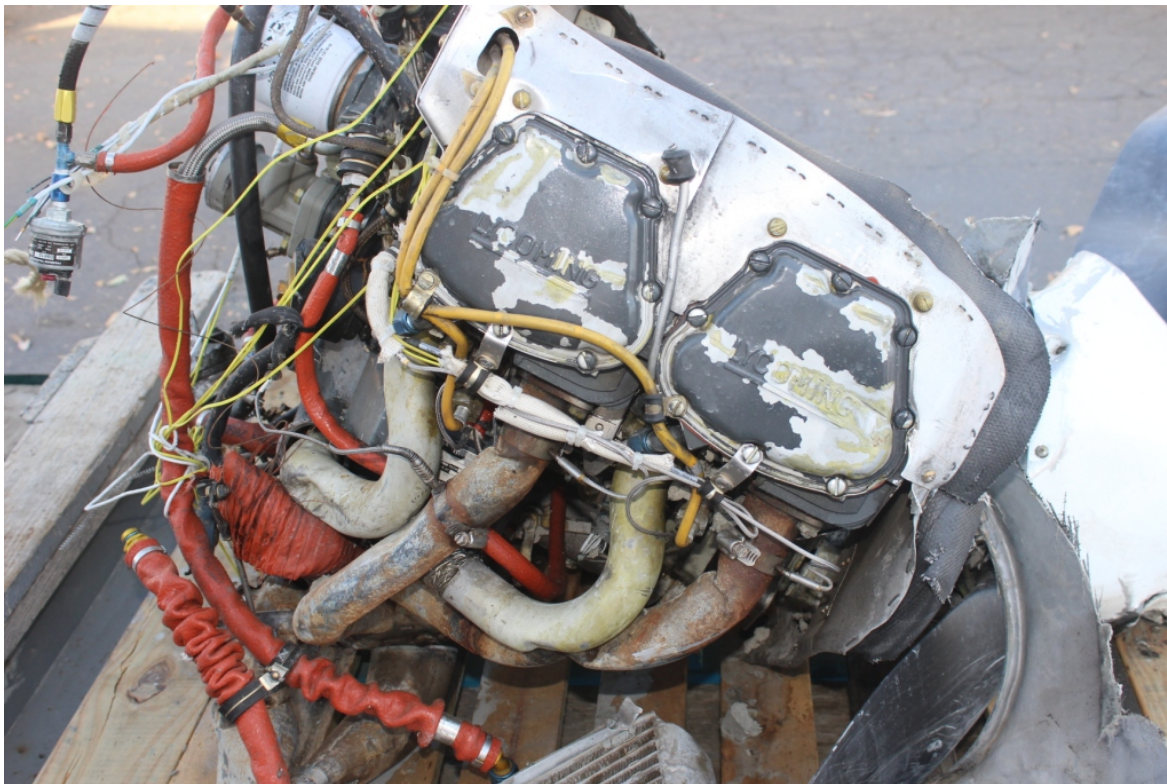
**Figure 14 - Engine Right Side**

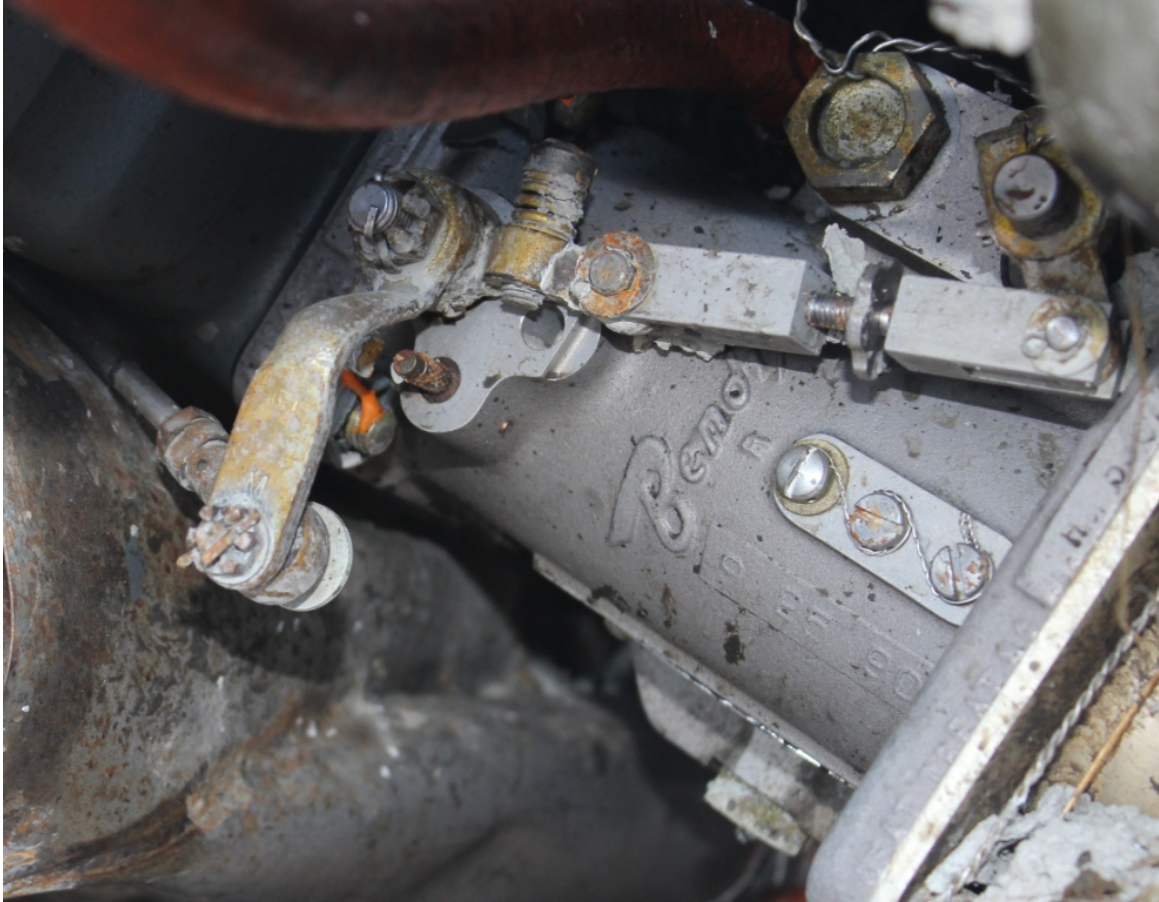
The fuel injection servo remained securely attached at the mounting pad of the plenum. The throttle/mixture controls were found securely attached to the servo at their respective control arms. The castellated nut and cotter pin remained secure and the serrated interface at the throttle and mixture arm remained securely mated. The plug on the side of the injector body was secure with the safety wire in place. The servo fuel inlet screen was found properly installed and free of contamination.

**Figure 15 - Fuel Servo**

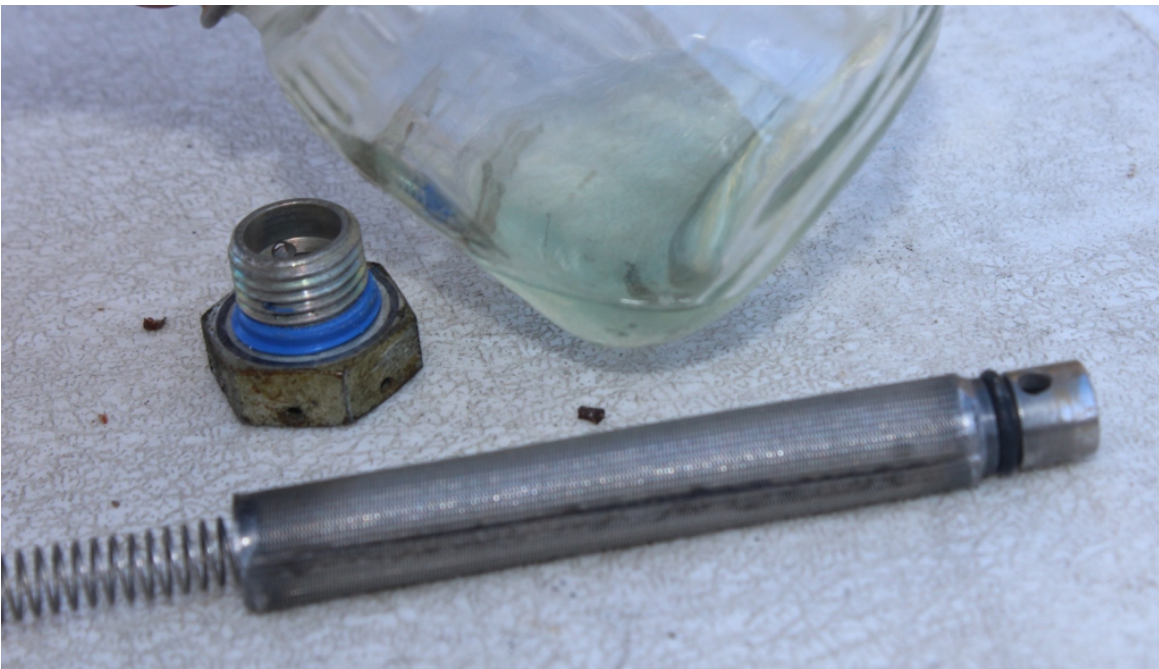
Approximately 1 ounce of fluid consistent with the appearance and odor of aviation fuel was drained from the fuel injection servo drain plug. A water test of the fuel sample was conducted using "Kolor-Kut" water finding paste with negative results.

**Figure 16 - Fuel Screen and Fuel**

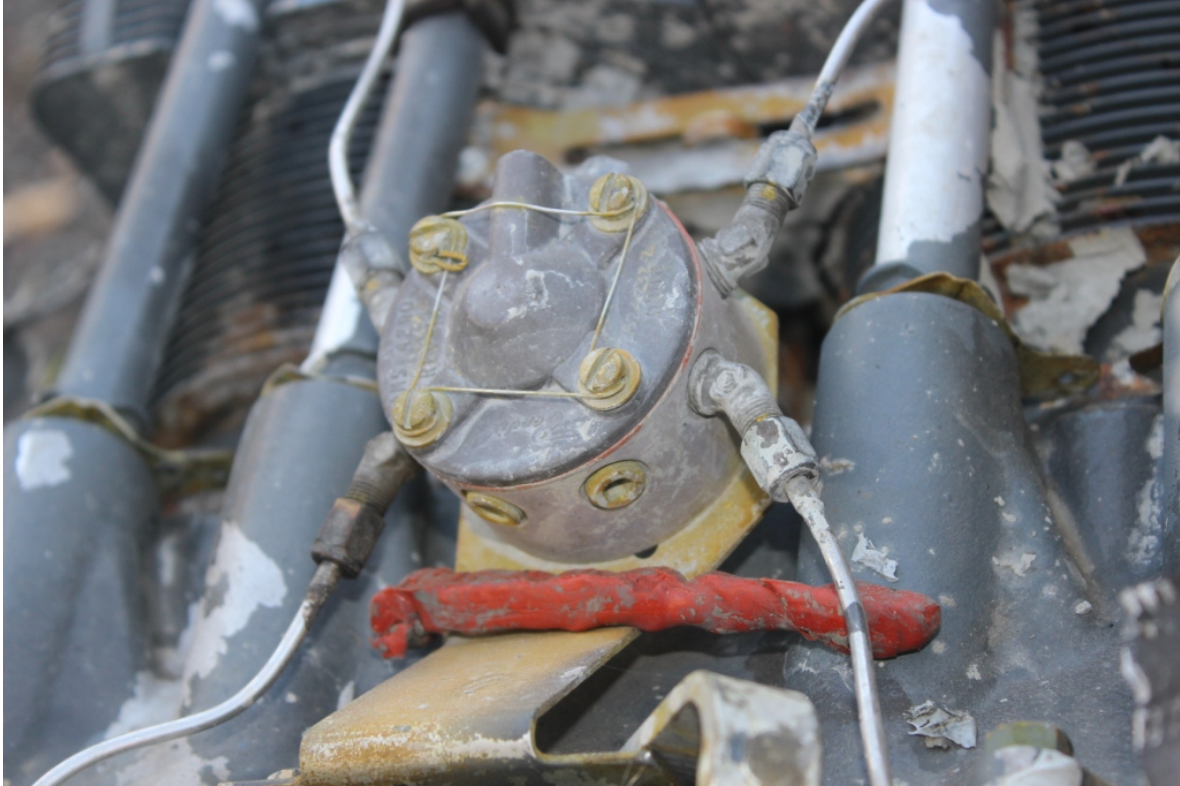
The fuel flow divider ('spider') remained secure at the mounting bracket situated at the top of the engine. The fuel lines remained secure at each flow divider fitting and fuel injector at each cylinder. The flow divider was disassembled. There was no evidence of pre-impact internal mechanical malfunction or obstruction to fuel flow. The diaphragm remained intact and undamaged.

**Figure 17 - Manifold Fuel Distribution Valve**

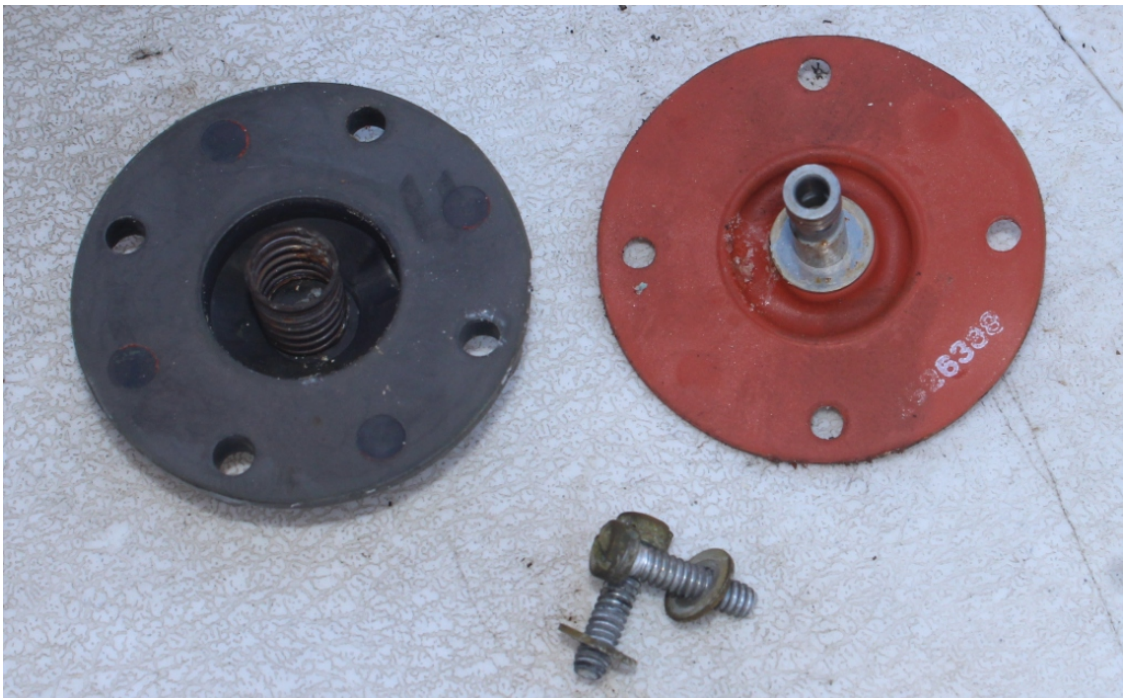
**Figure 18 - Fuel Distribution Valve Diaphragm**

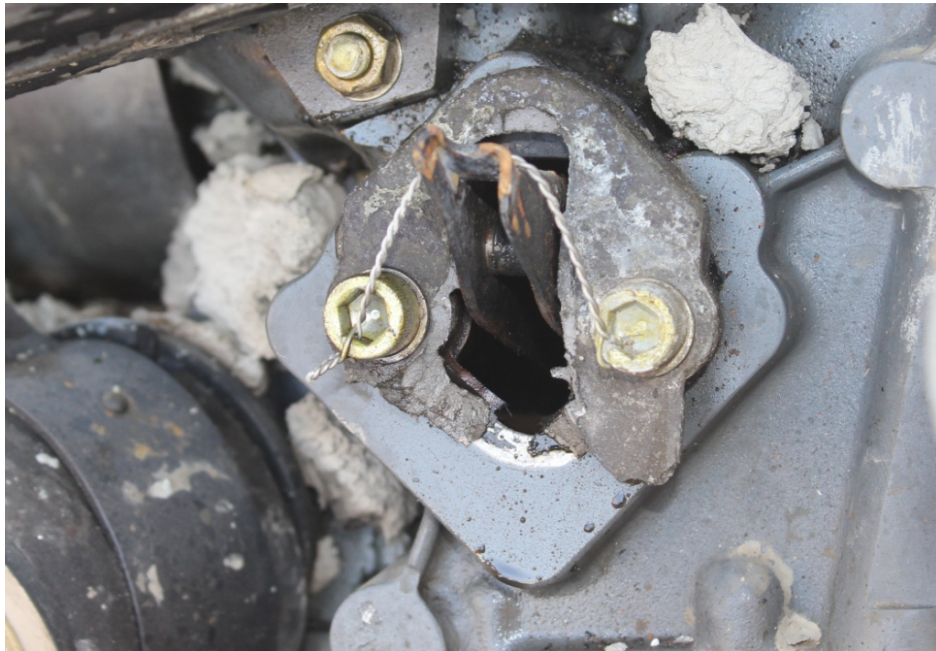
The bulk of the fuel pump was fracture-separated from the engine, while some of the mounting flange remained secure at the mounting pad. The fracture surfaces exhibited signatures consistent with overload. The fuel pump was opened for examination. The fuel pump remained free of internal mechanical malfunction and obstruction to flow. The diaphragm remained intact.

**Figure 19 - Fuel Pump Mounting Pad**

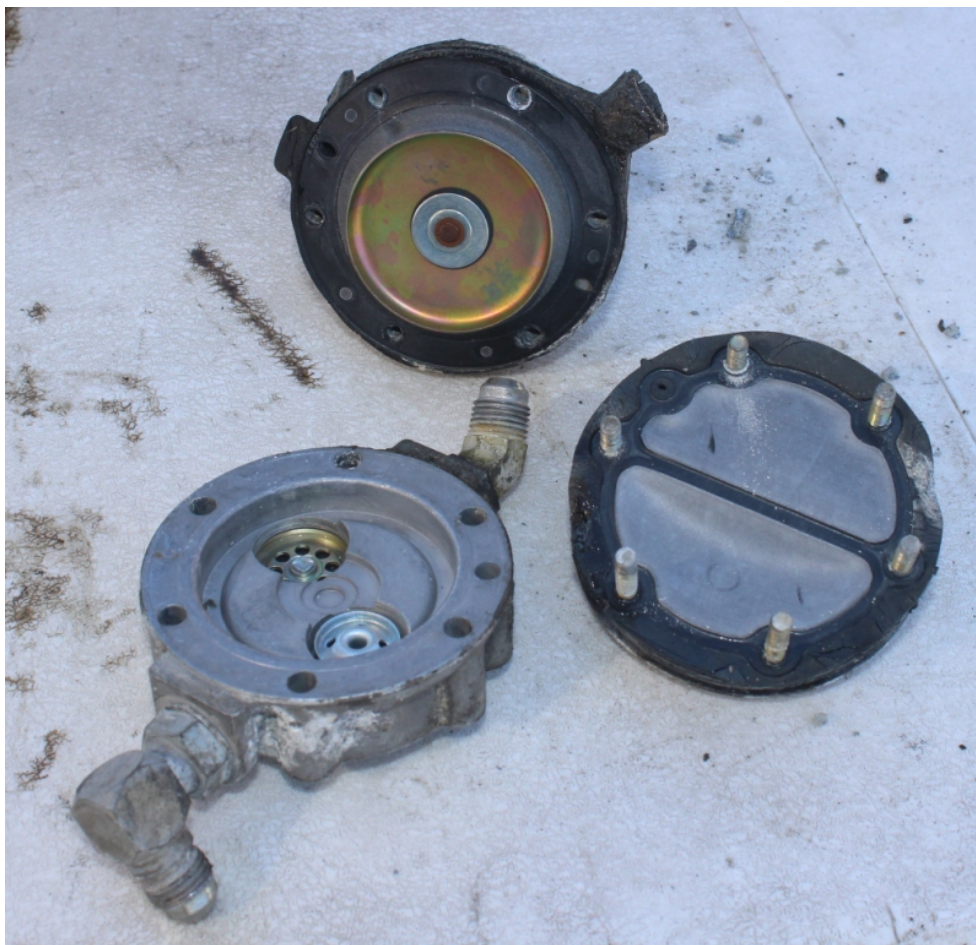
**Figure 20 - Disassembled Fuel Pump**

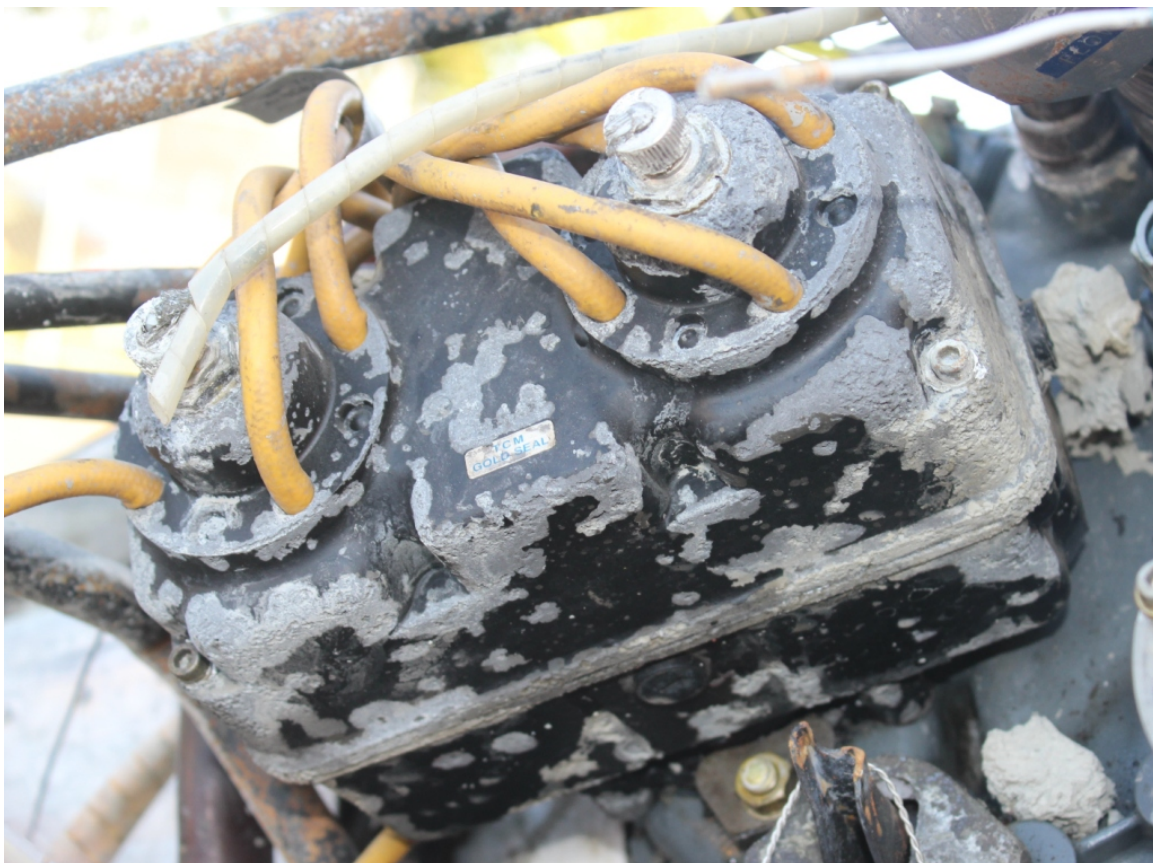
The single-drive dual magneto was found securely clamped at the mounting pad. Magneto to engine timing could not be ascertained. The magneto cap was removed to expose the internal mechanism, contact assemblies, and gears. The magneto internal cavities exhibited the presence of water, mud, silt and organic material. The magneto was removed for further examination. The impulse coupler drive was observed to be intact and properly safetied. There were no mechanical disconnects or damage to any gear teeth. Due to the effects of water immersion and resulting corrosion the magneto drive could not be turned by hand.

Figure 21 - Dual Magneto

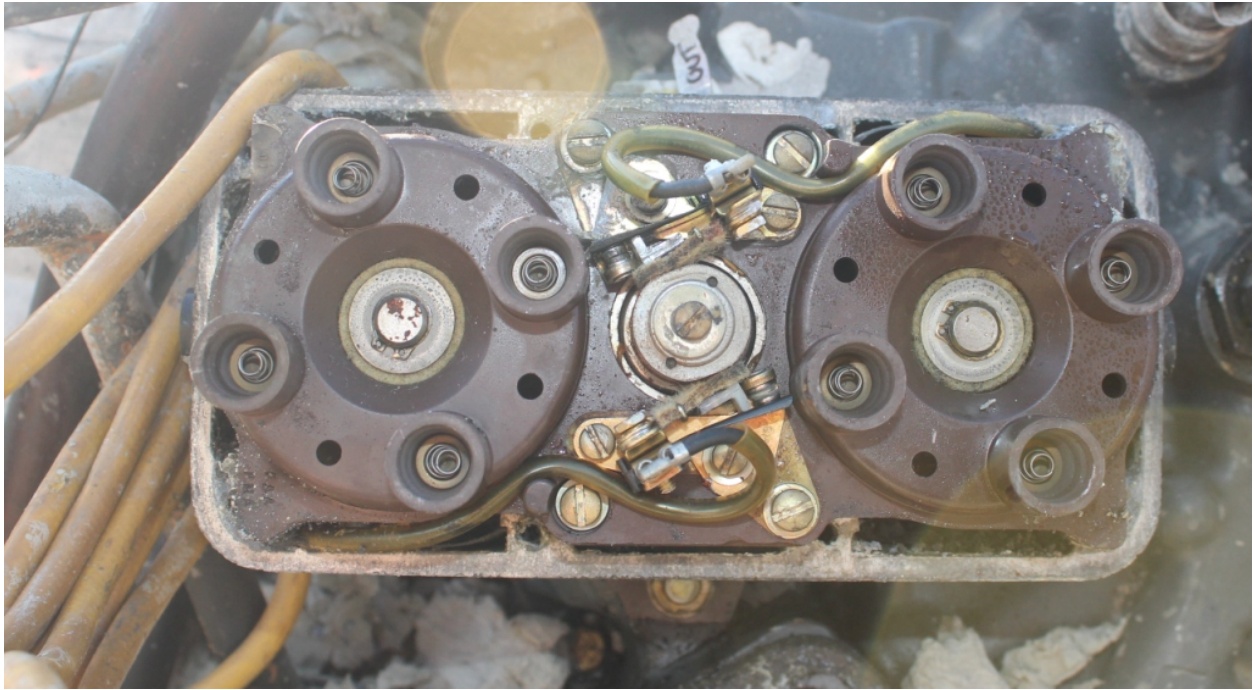
**Figure 22 - Opened Magneto (base)**

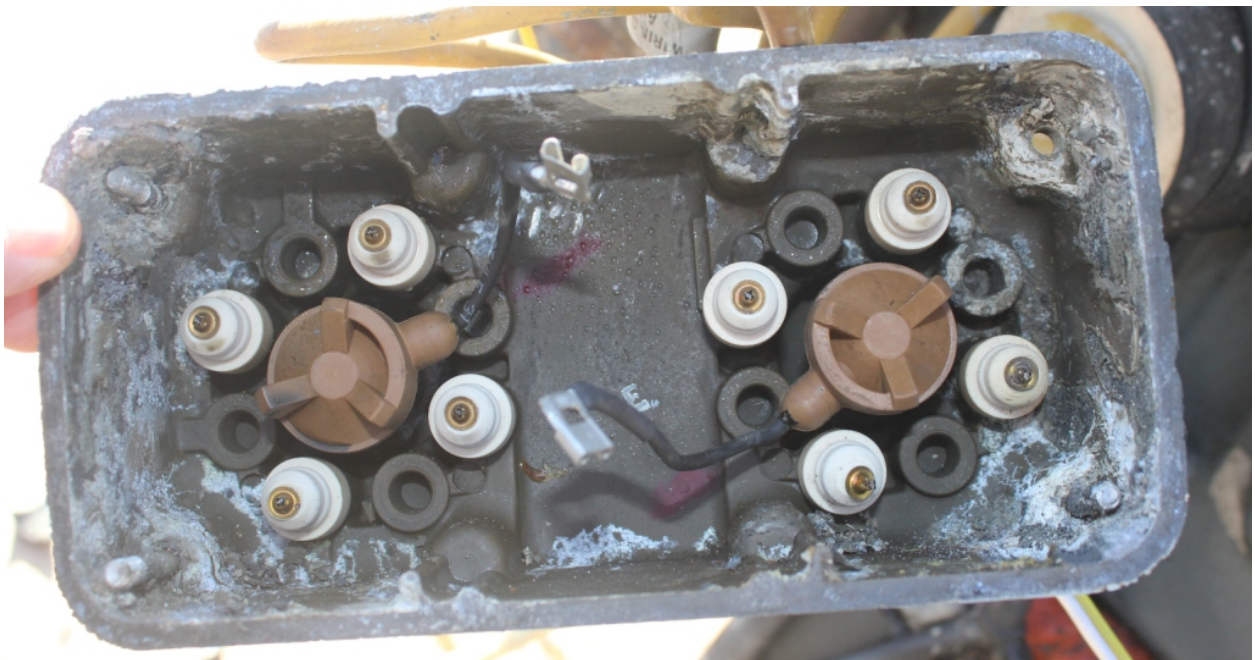
**Figure 23 - Opened Magneto (cover)**

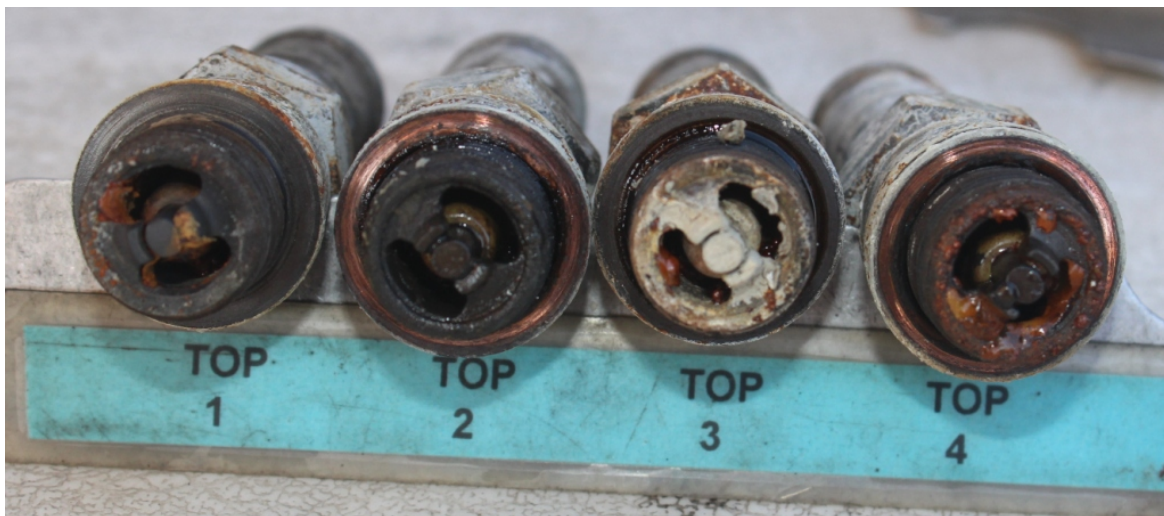
The spark plugs were secure at each position with the lead attached. The spark plugs were removed, examined and photographed. The spark plug electrodes remained mechanically undamaged, and displayed varying degrees of corrosive effects due to the water immersion at the accident site. The spark plug electrodes were coated with varying degrees of mud, silt and organic material.

Figure 24 - Top Spark Plugs
