## **NATIONAL TRANSPORTATION SAFETY BOARD**

### **FOLLOW-UP AIRFRAME & ENGINE EXAMINATION**

**NTSB Accident: WPR18FA251  
Accident Date: September 4, 2018**

Location: Palo Alto, California  
Date: September 4, 2018  
Aircraft: Mooney M20J, N701JM, Serial # 24-3281  
NTSB IIC: Michael Huhn

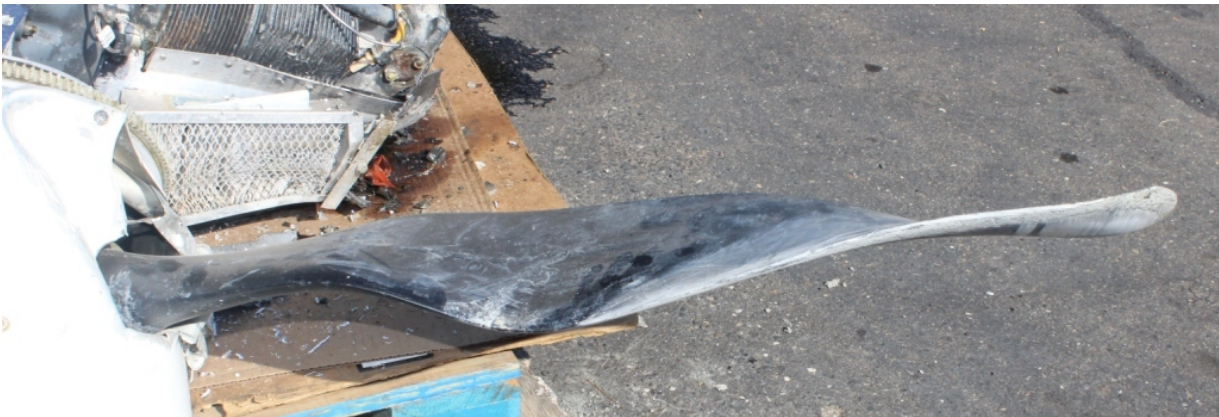
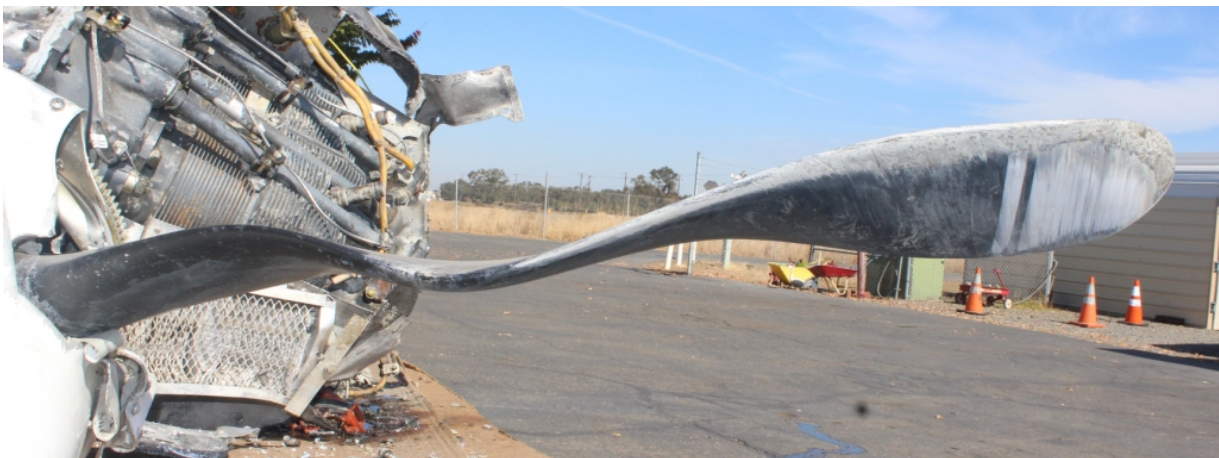
The two-bladed, constant-speed, all-metal propeller remained attached at the crankshaft flange. The metal spinner was attached to the propeller and had sustained impact damage. The propeller blades remained attached to the propeller hub. The propeller blades displayed varying degrees of leading edge gouging, torsional twisting, chordwise striations across the cambered surface and trailing edge "S" bending. The signatures were consistent with the absorption of rotational forces applied at the crankshaft at the time of impact.

Figure 25 - S-bent Blade

Figure 26 - S-bent Blade

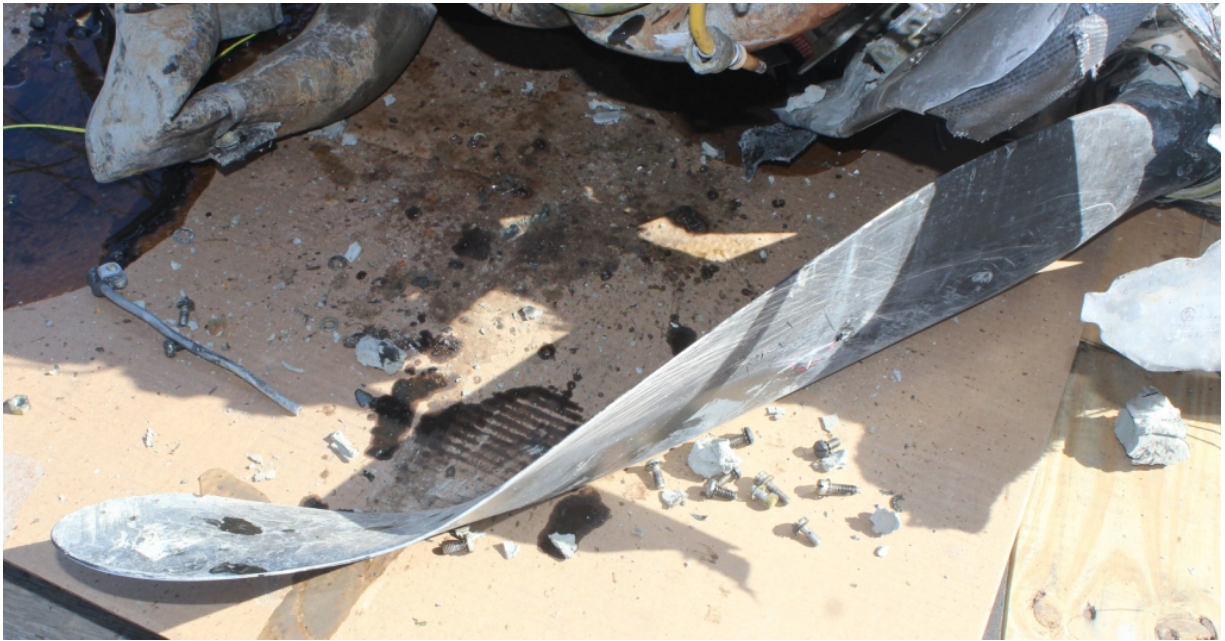
Figure 27 - Other Blade
